# Inspection Photos

Operator: QB ENERGY OPERATING LLC

Location ID: 334922

Inspection Doc: 719200028

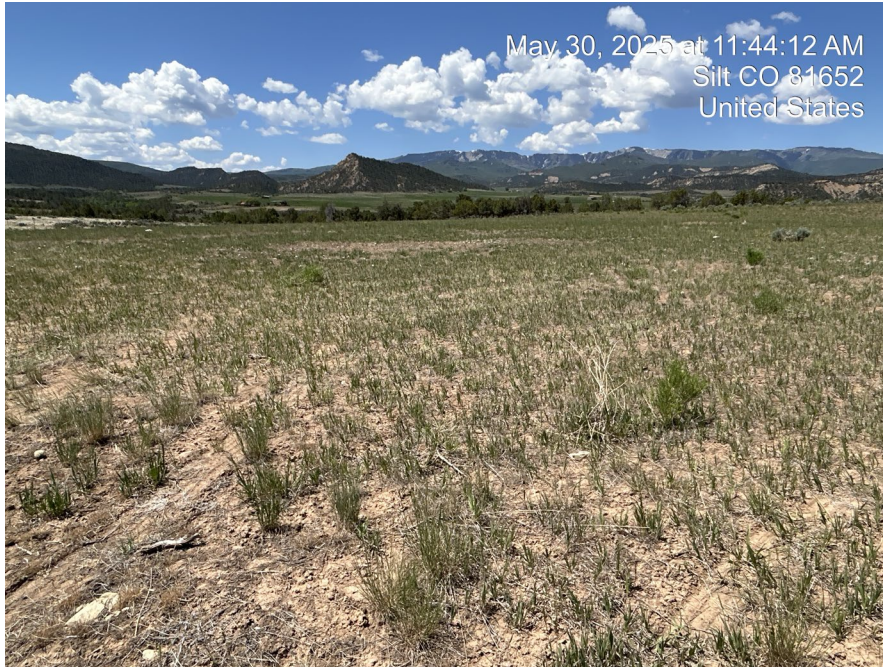
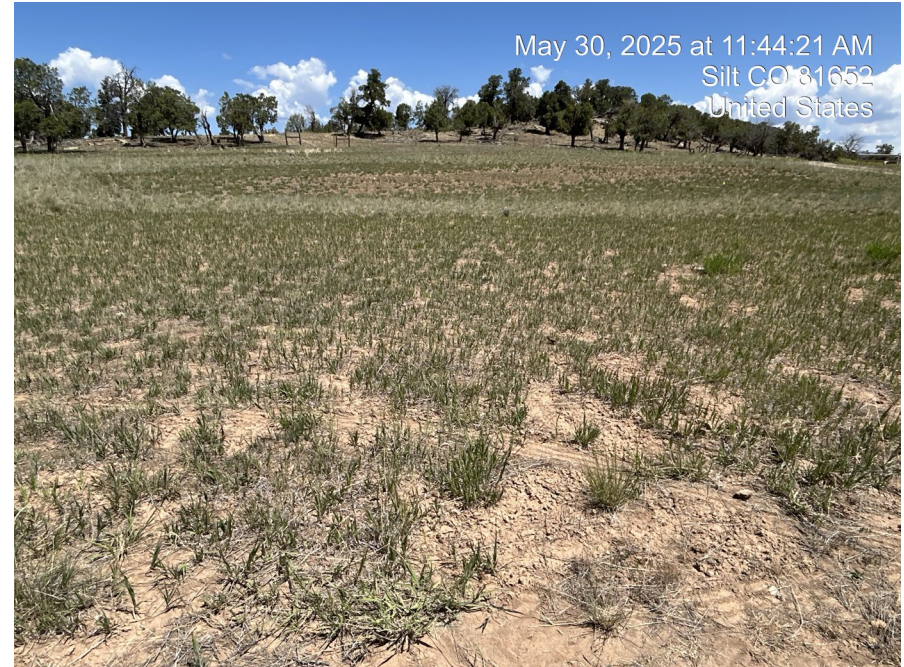
**Photo 1:** Photos taken from the east end of the Location provide an overview to the west and north, respectively. Vegetation is composed of smooth brome, western wheatgrass and intermediate wheatgrass. Vegetation appears to meet 1004 final reclamation requirements.

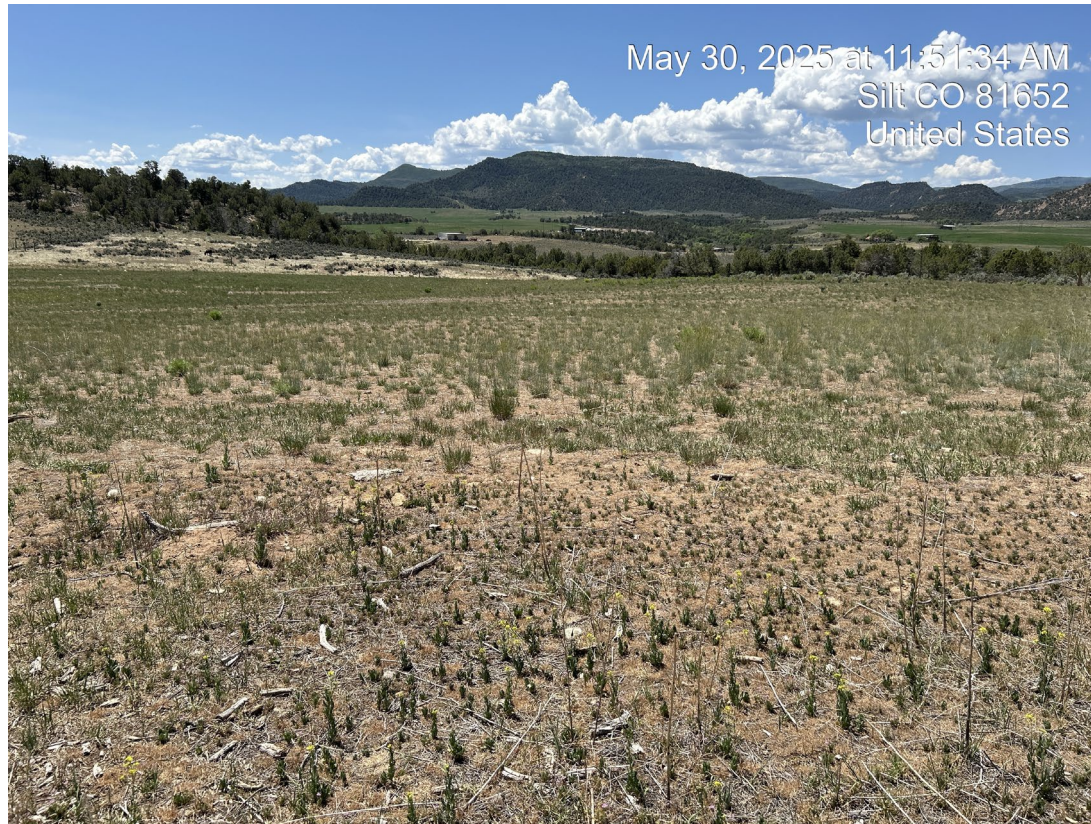
**Photo 2:** Photo taken from the central portion of the Location provides an overview looking south. Vegetation appears to meet 1004 final reclamation requirements.

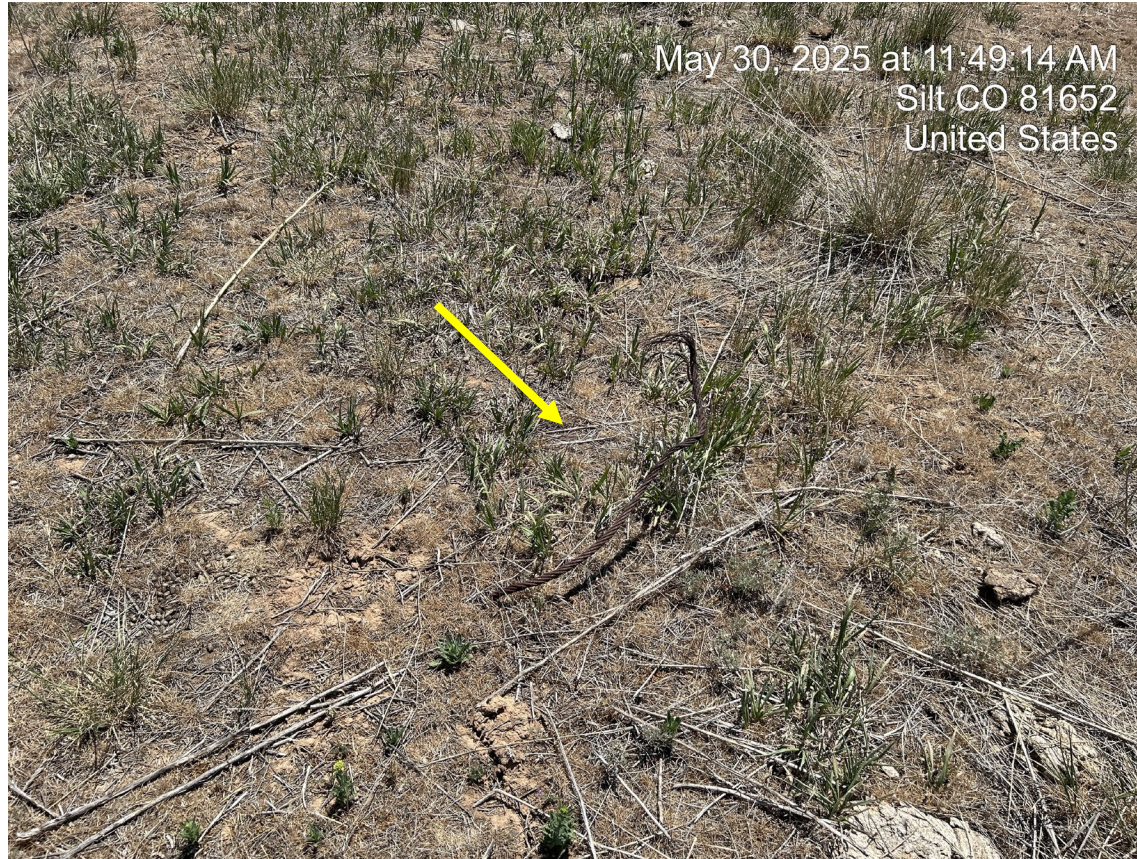
**Photo 3:** A steel cable protruding from the ground on the western portion of the Location. Removal is advised.

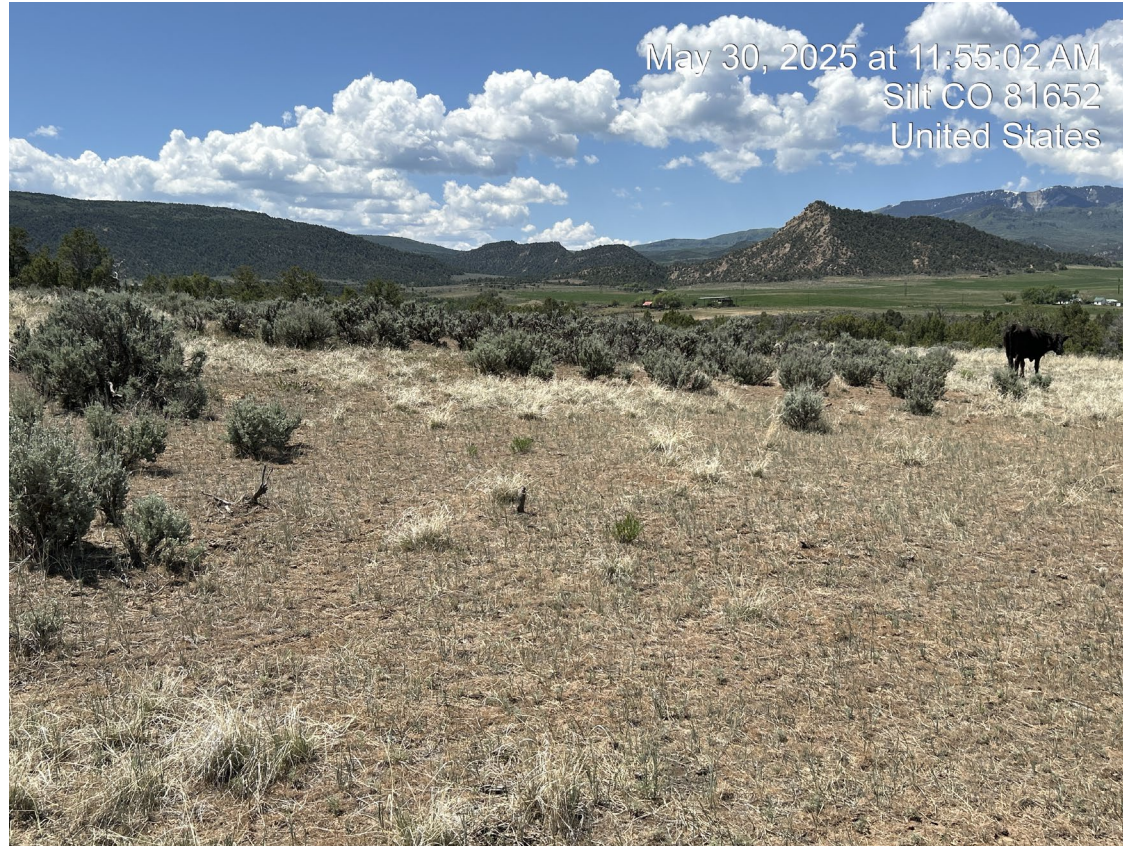
**Photo 4:** Photo showing the adjacent reference area to the south of the Location is used for livestock grazing and is mostly composed of big sagebrush and native grasses.
