Inspection Photos

API: 071-06343

Operator: OGRIS OPERATING LLC

Inspection Date: 6/30/2025

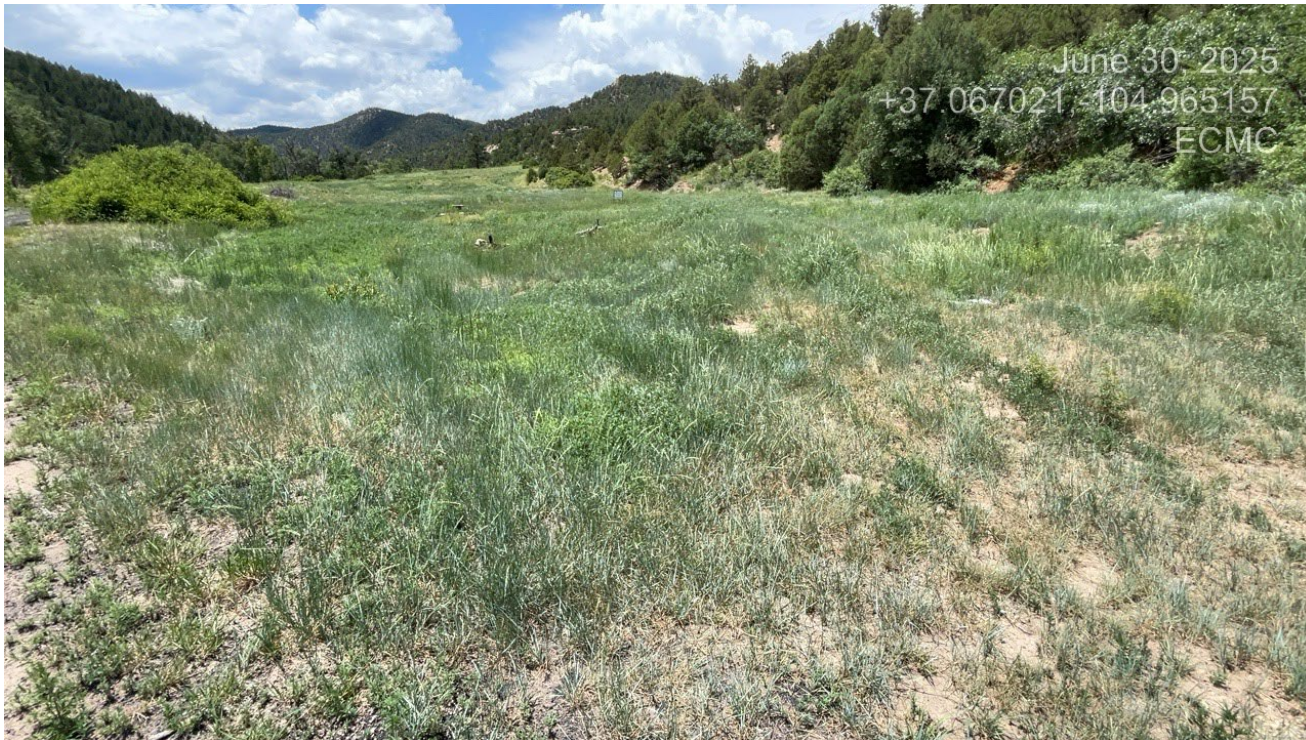
Photo 1. Facing west toward the location. The electric utility line has been removed back to towards the active well to the east.

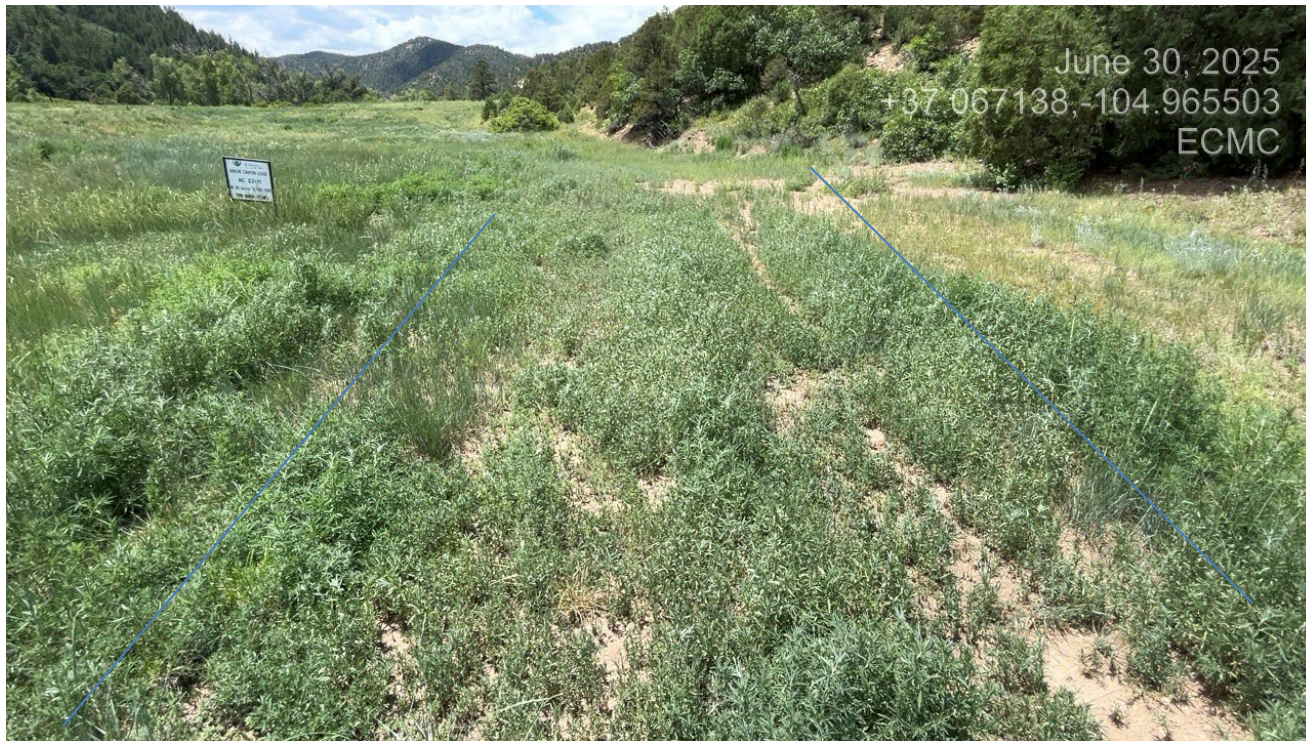
Photo 2. Facing west at the abandoned wellsite. This area of the former road needs to be reseeded. There is mostly weeds (Kochia) growing in the area between the two blue lines.
