Final Reclamation Inspection

Operator: NOBLE ENERGY INC - 100322

Location ID: 305079

Inspection Photos
Location Name: MOSER H #26-13
Location ID: 305079

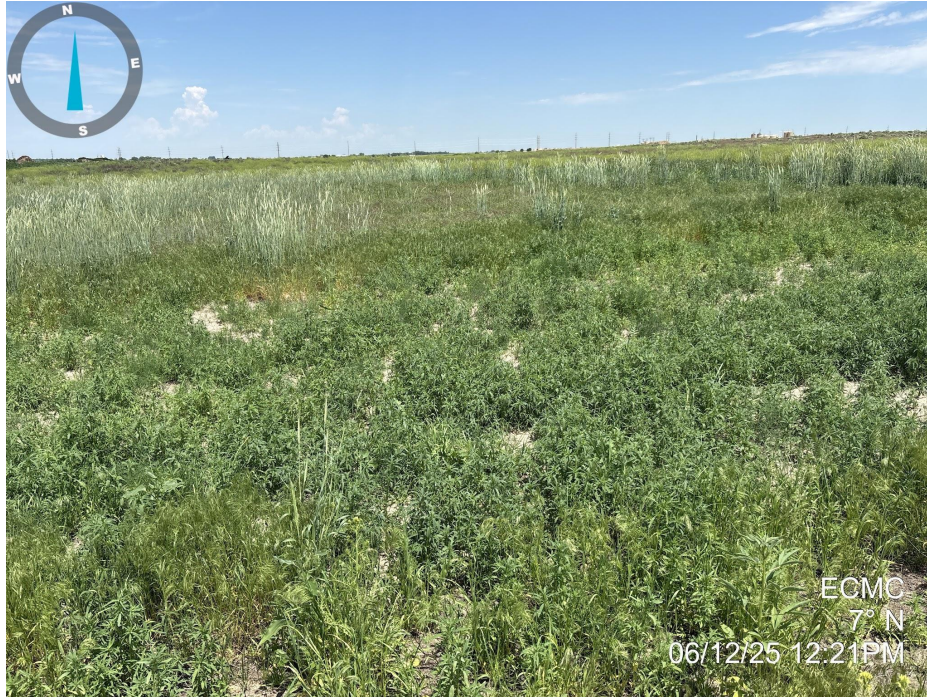
Photo 1. Photo taken from the well location, facing North. Photo illustrates that final reclamation activities have taken place, but the site is dominated by weedy annual vegetation including cheatgrass (*Bromus tectorum*), a List C Noxious Weed species, and kochia (*Bassia scoparia*).

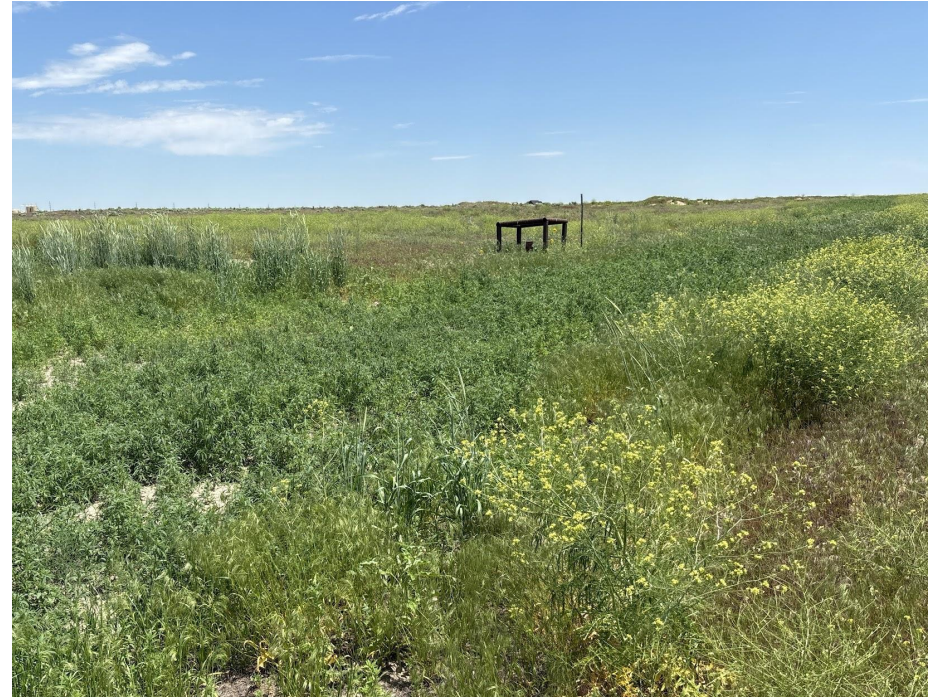
Photo 2. Photo taken from the well location, facing East. See comments under Photo 1.

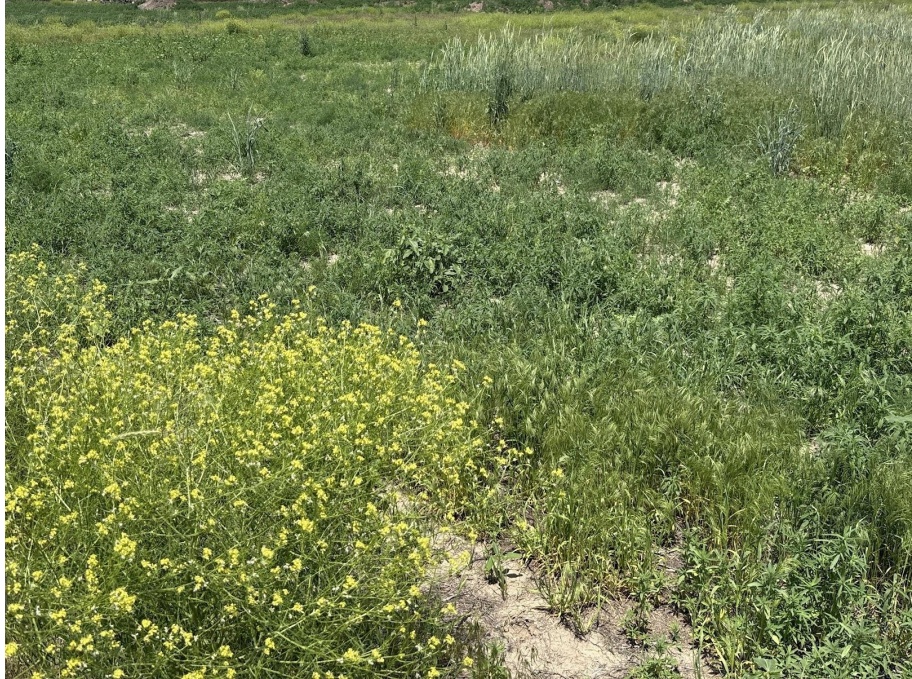
Photo 3. Photo taken from the well location, facing South. See comments under Photo 1.

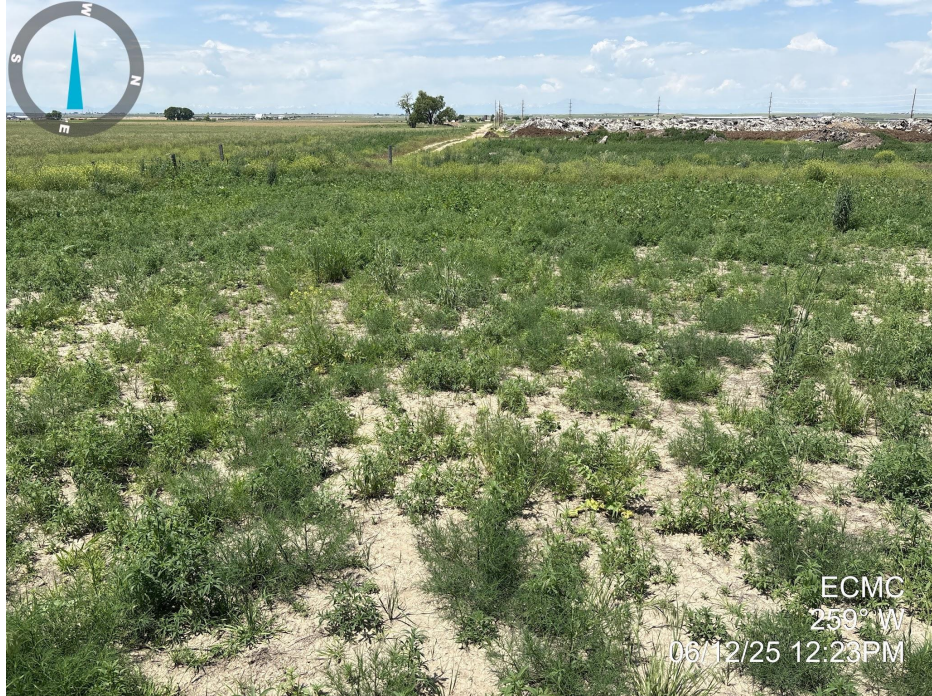
Photo 4. Photo taken from the well location, facing West. See comments under Photo 1.

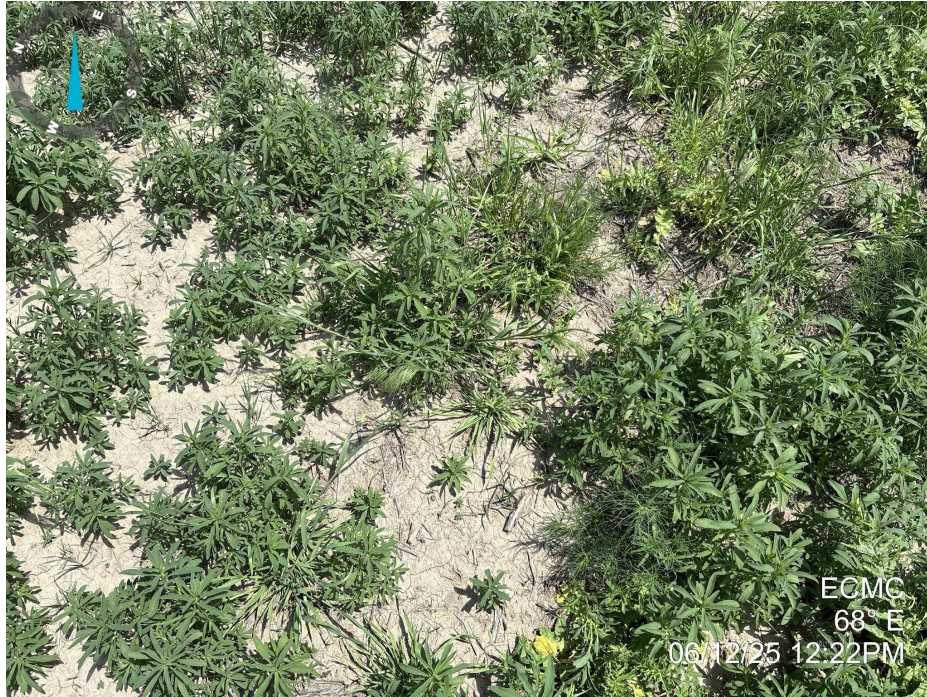
Photo 5. Photo taken of ground cover at the well location. Photo illustrates weedy annual vegetation, including kochia (*Bassia scoparia*) and bare ground.

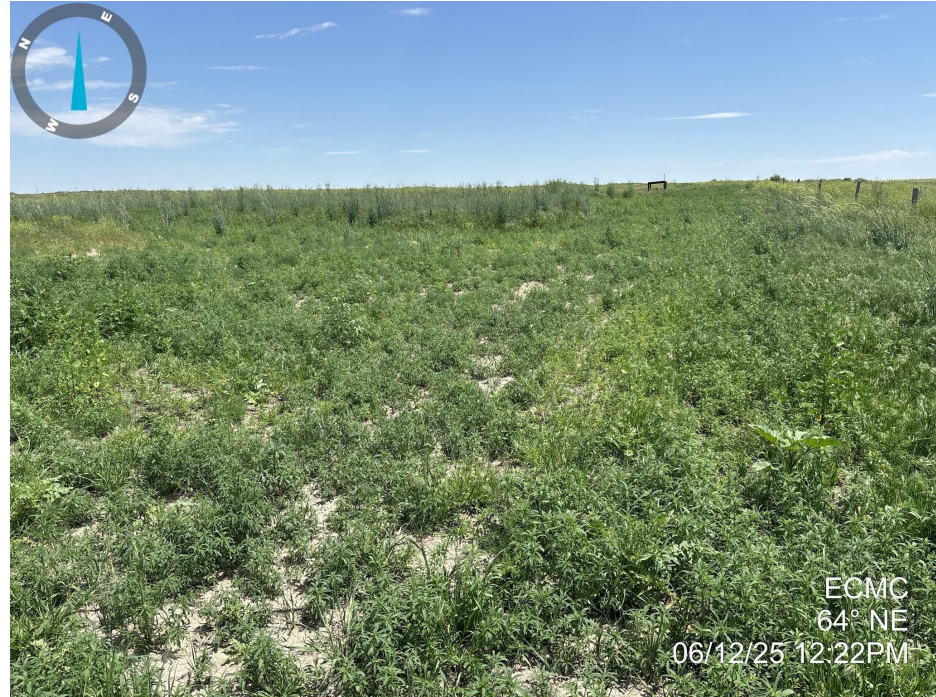
Photo 6. Photo taken of the access road, from the well location, facing Northeast away from the location. Photo illustrates that weedy annual vegetation dominates the access road.

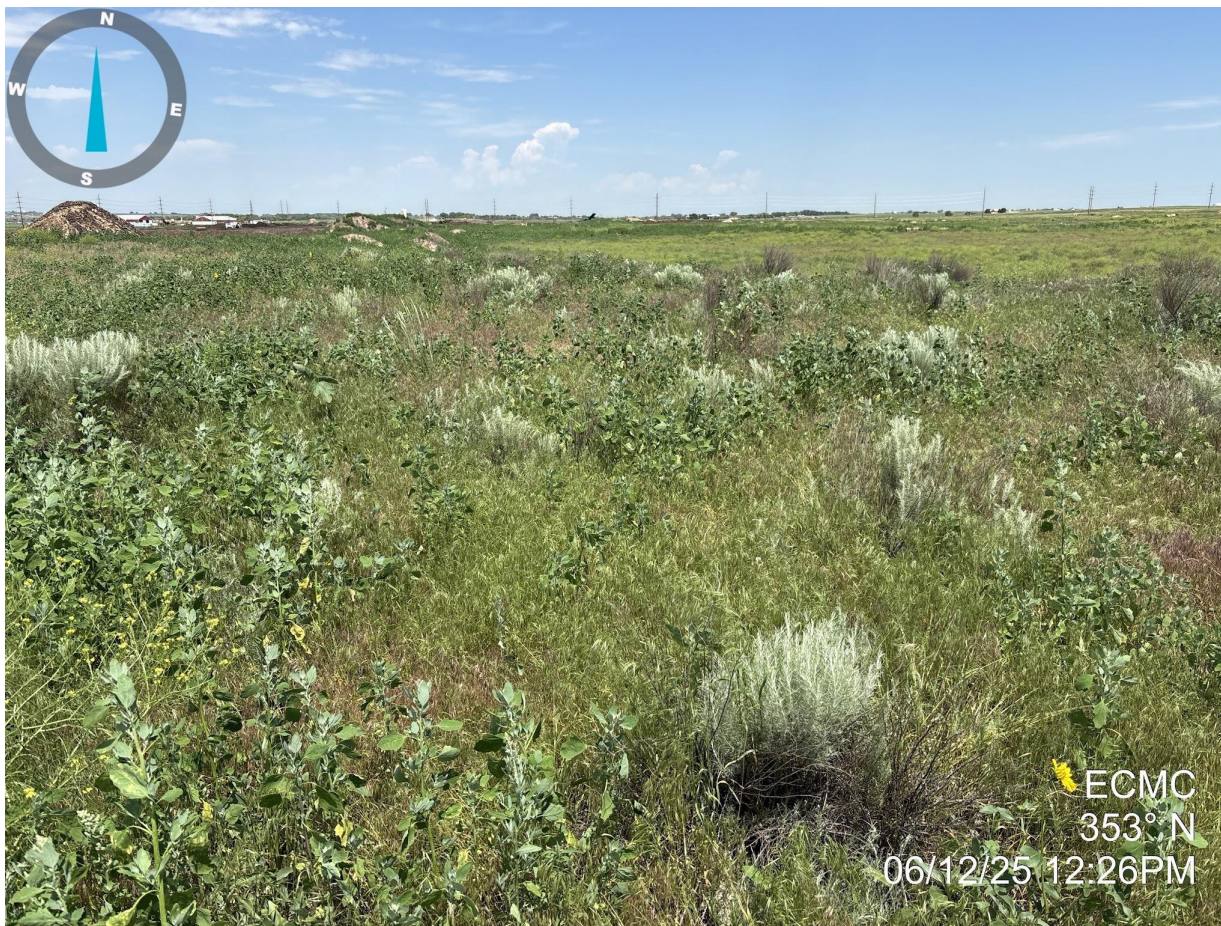
Photo 11. Photo taken of reference area to the well location, north of the location, facing North. Photo illustrates shrub and perennial grass vegetation with some annual weedy vegetation.
