# Final Reclamation Inspection

Operator: NOBLE ENERGY INC - 100322

Location ID: 330385

Inspection Photos  
Location Name: HSR-FOSTER #3-35  
Location ID: 330385

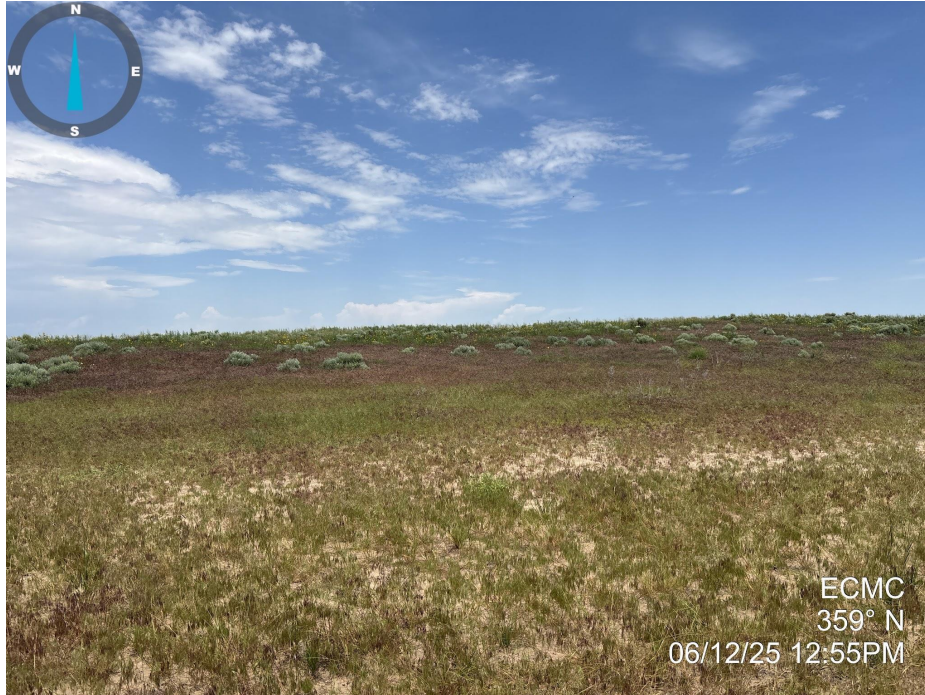
**Photo 1.** Photo taken from the well location, facing North. Photo illustrates that final reclamation activities have taken place, with evidence of drill rows from seeding, but vegetation establishment does not meet Rule 1004 standards. The site is dominated by weedy annual vegetation, including cheatgrass (*Bromus tectorum*), a List C Noxious Weed species.

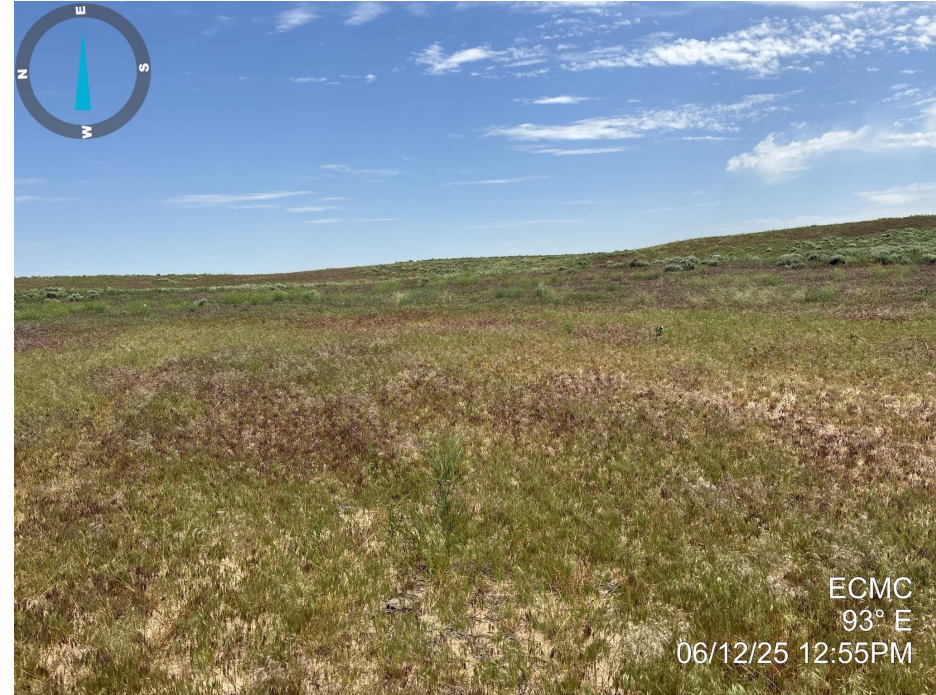
**Photo 2.** Photo taken from the well location, facing East. See comments under Photo 1.

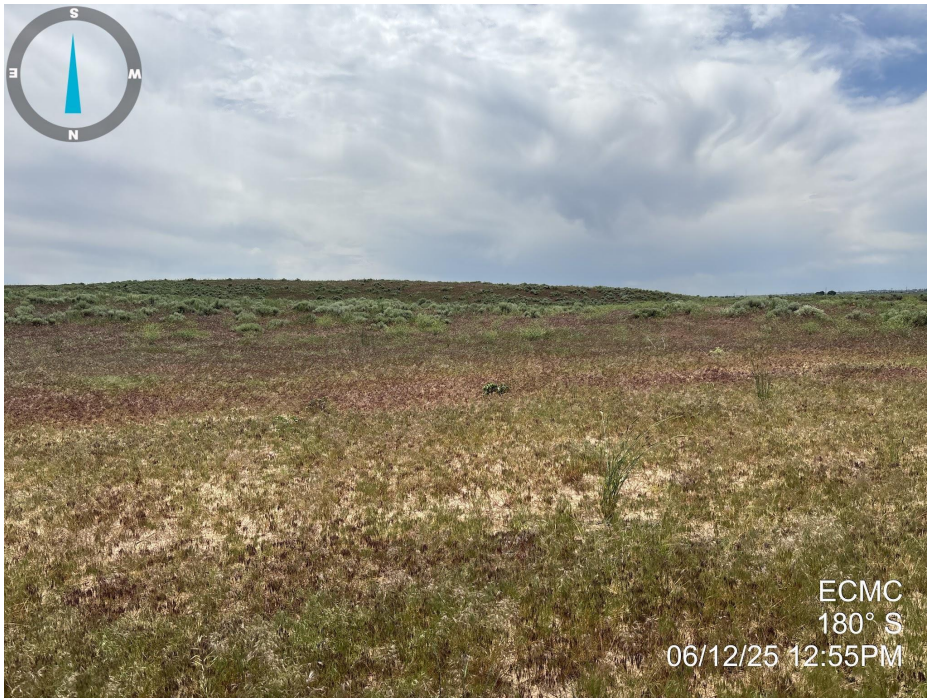
**Photo 3.** Photo taken from the well location, facing South. See comments under Photo 1.

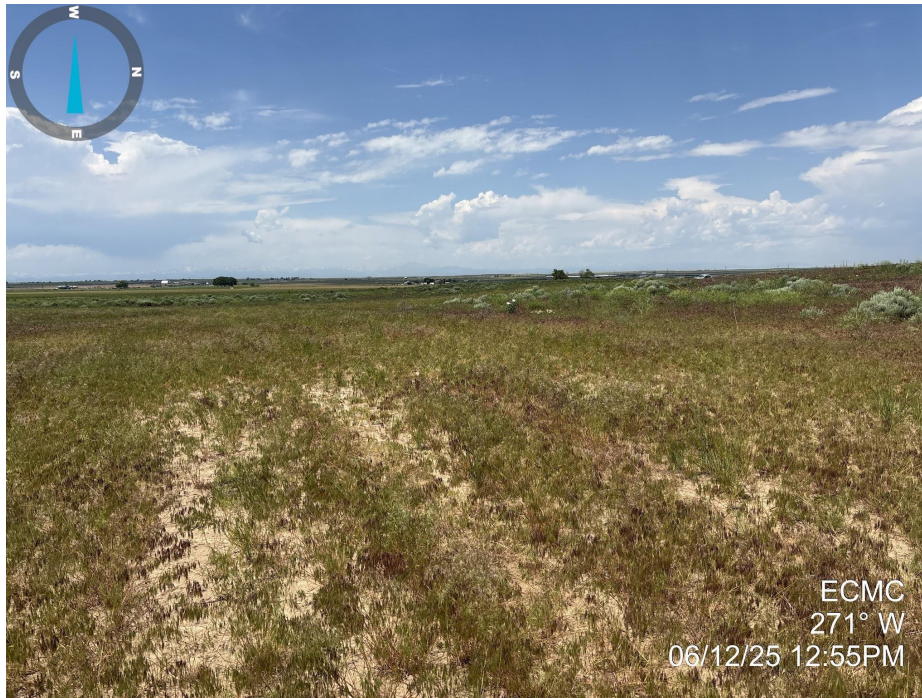
**Photo 4.** Photo taken from the well location, facing West. See comments under Photo 1.

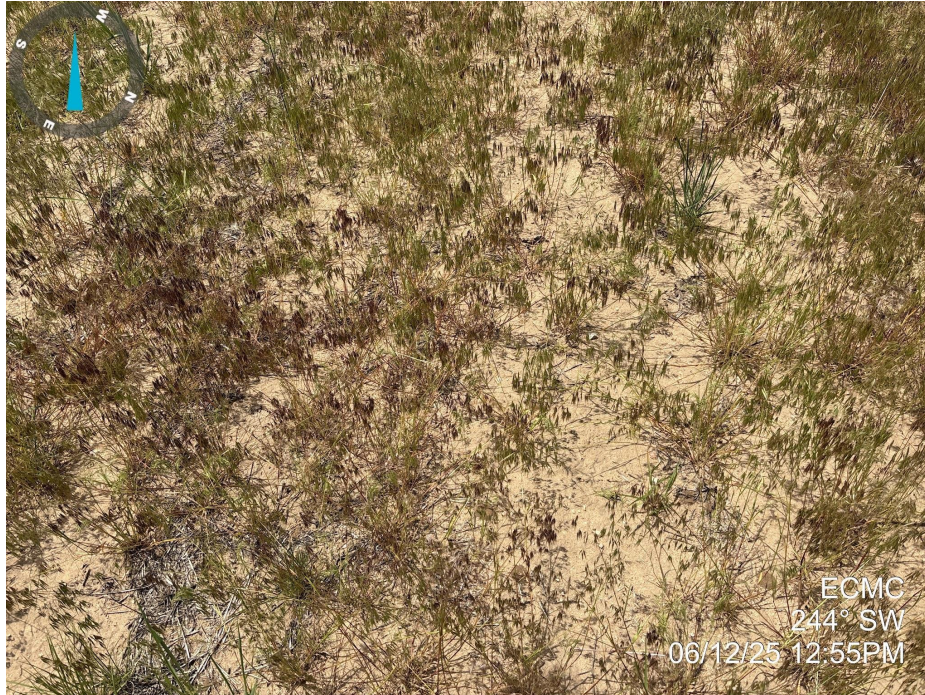
**Photo 5.** Photo taken of ground cover at the well location. Photo illustrates cheatgrass (*Bromus tectorum*), a List C Noxious Weed species.

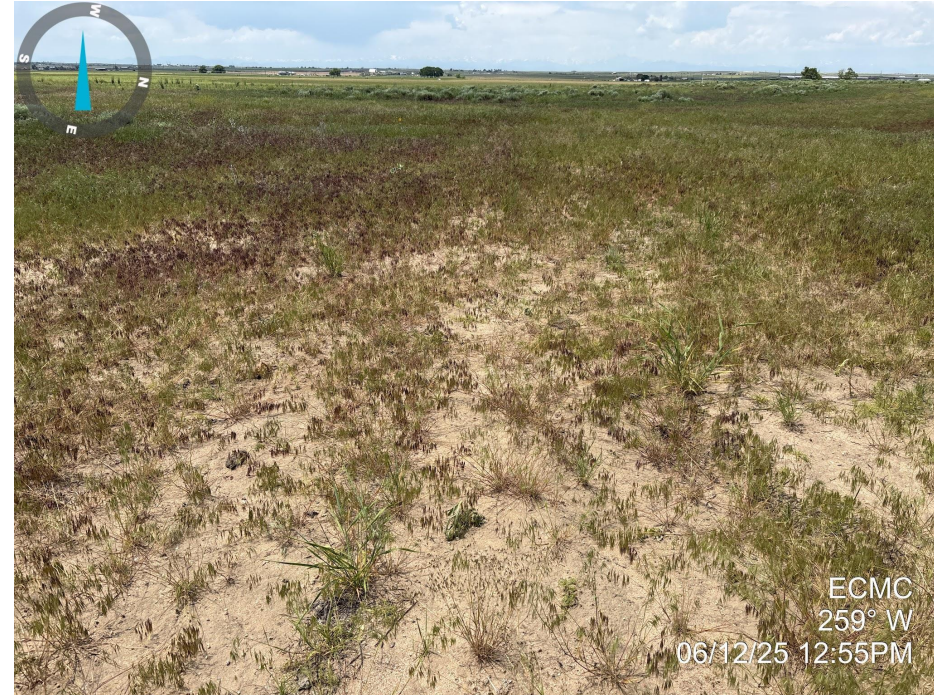
**Photo 6.** Photo taken of the access road, from the well location, facing West. Photo illustrates that final reclamation has taken place, but the location is dominated by weedy annual vegetation, including cheatgrass.

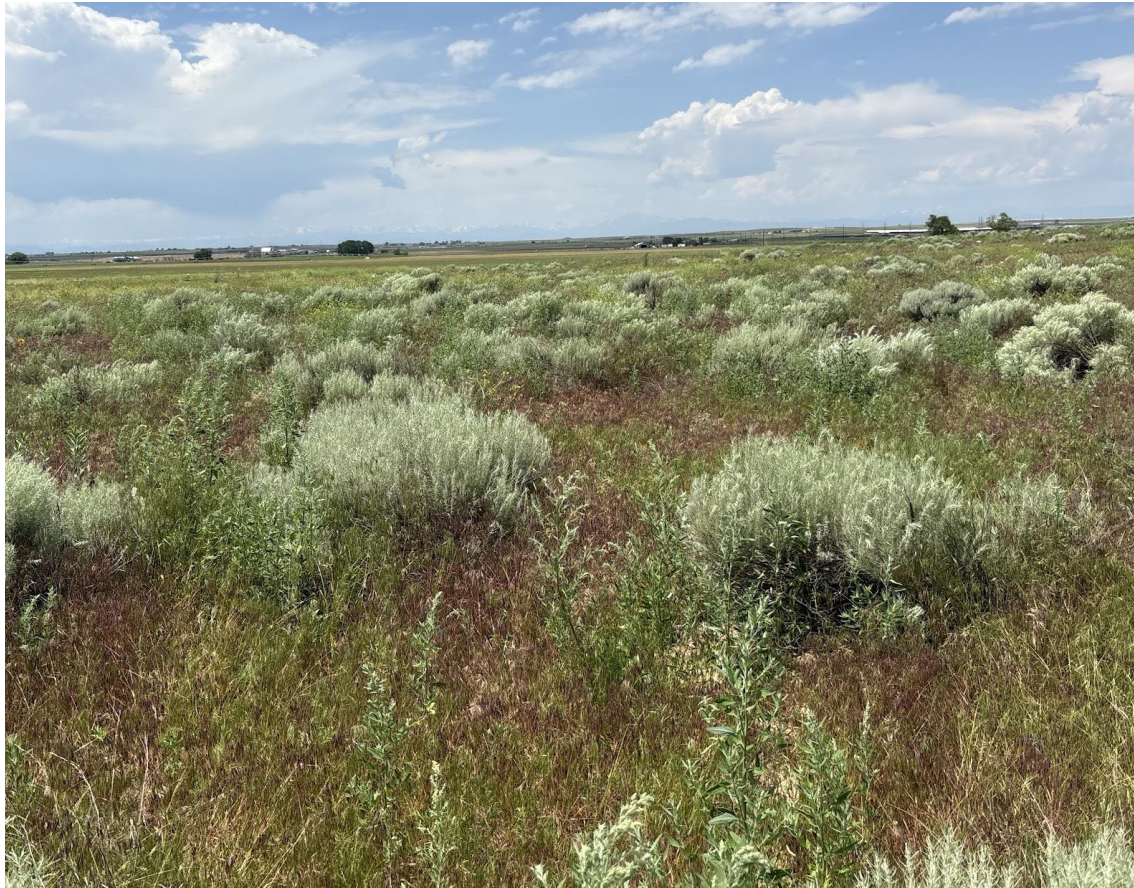
**Photo 7.** Photo taken of reference area to the well location, north of the location, facing West. Photo illustrates sand sagebrush (*Artemisia filifolia*), with some weedy annual vegetation, including cheatgrass (*Bromus tectorum*).
