# Final Reclamation Inspection

Operator: NOBLE ENERGY INC - 100322

Location ID: 489425

Location Name: Moser H 26-13,14,24 3N65W Tank Battery

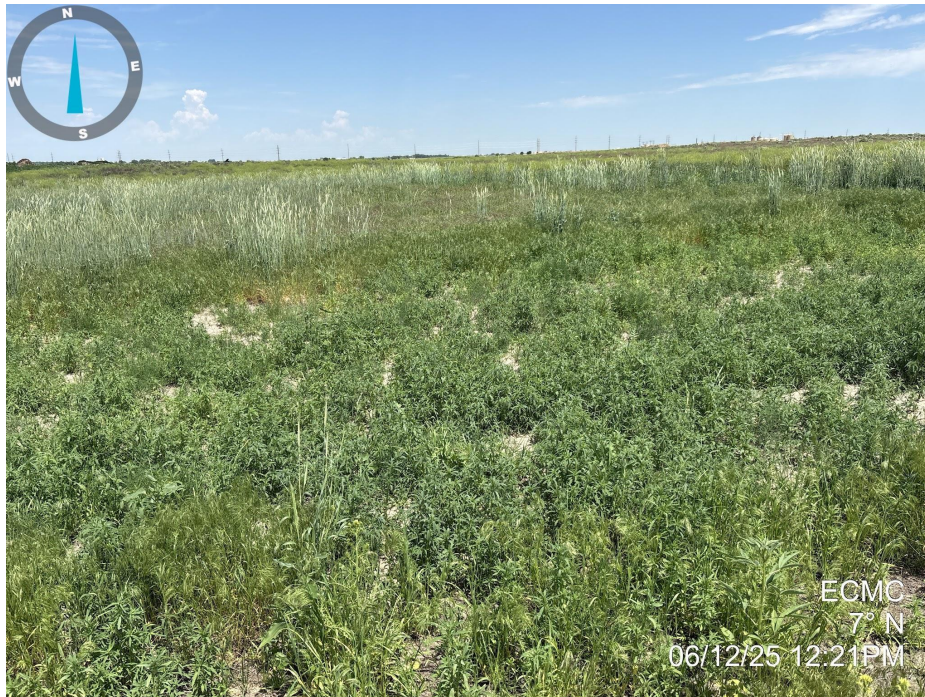
**Photo 1.** Photo taken of the tank battery location, facing North. Photo illustrates that final reclamation activities have taken place, but vegetation has not established to Rule 1004 standards. Weedy annual vegetation, including kochia (*Bassia scoparia*) and cheatgrass (*Bromus tectorum*), a List C Noxious Weed species, was observed at the location.

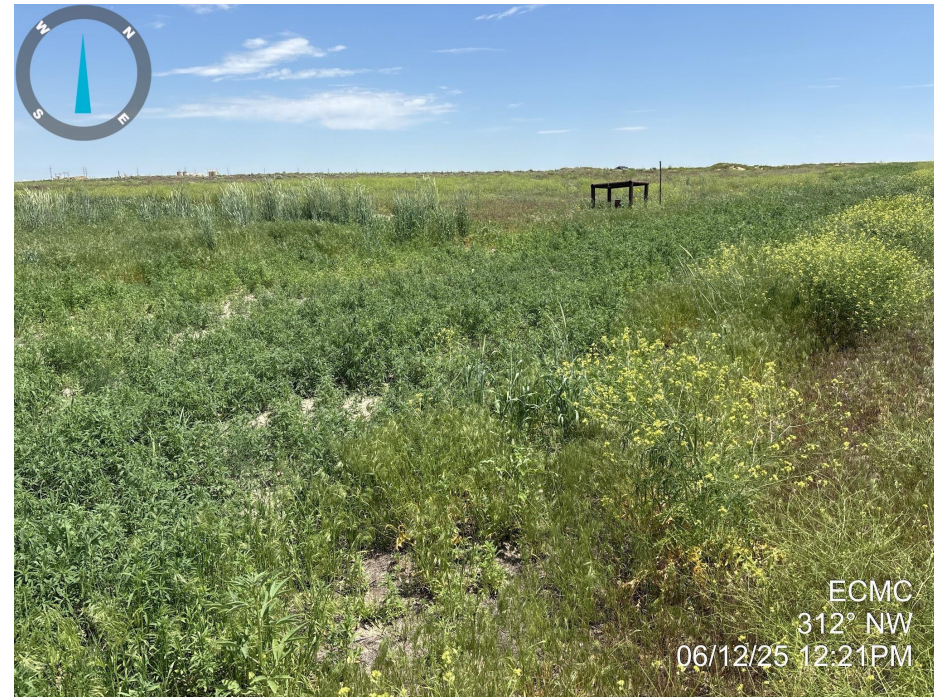
**Photo 2.** Photo taken of the tank battery location, facing Northwest. See comments under Photo 1.

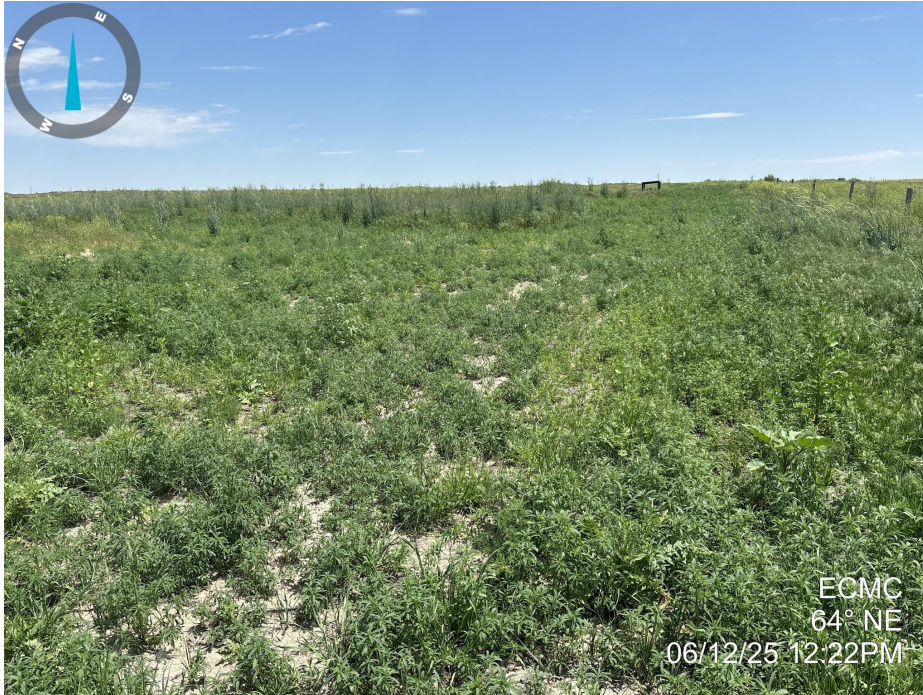
**Photo 3.** Photo taken of the tank battery location, facing Northeast. See comments under Photo 1.

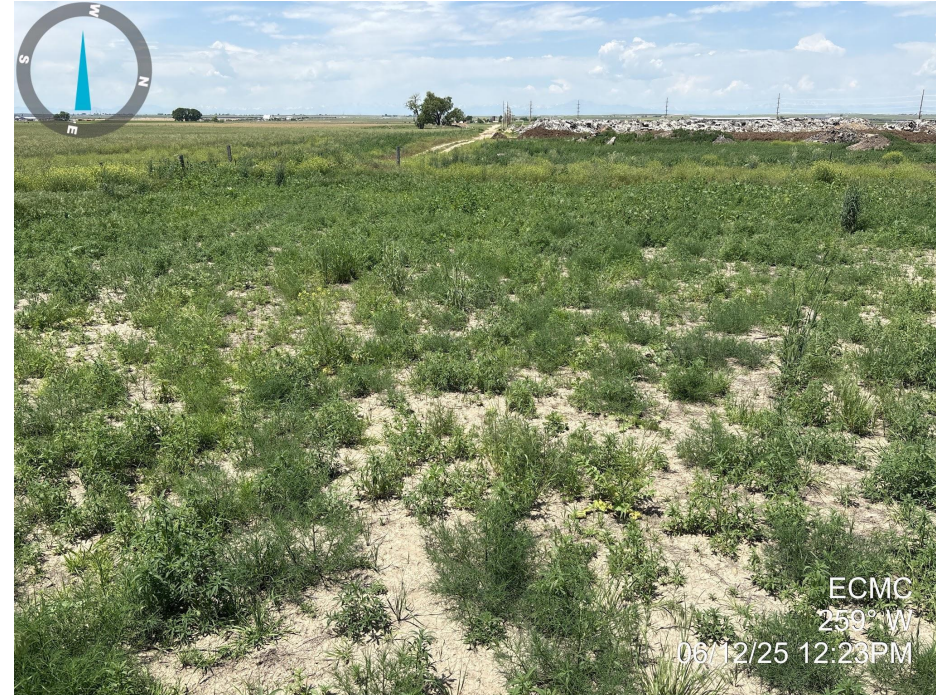
**Photo 4.** Photo taken of the tank battery location, facing West. See comments under Photo 1.

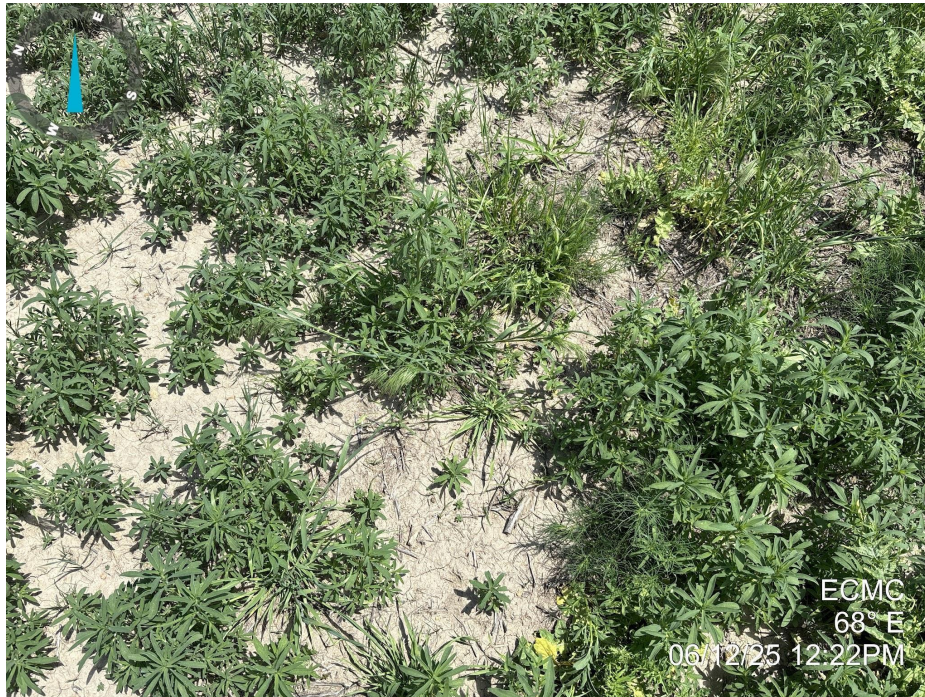
**Photo 5.** Photo taken of ground cover at the tank battery location. Photo illustrates bare ground with weedy annual vegetation, including kochia (*Bassia scoparia*) and cheatgrass (*Bromus tectorum*).

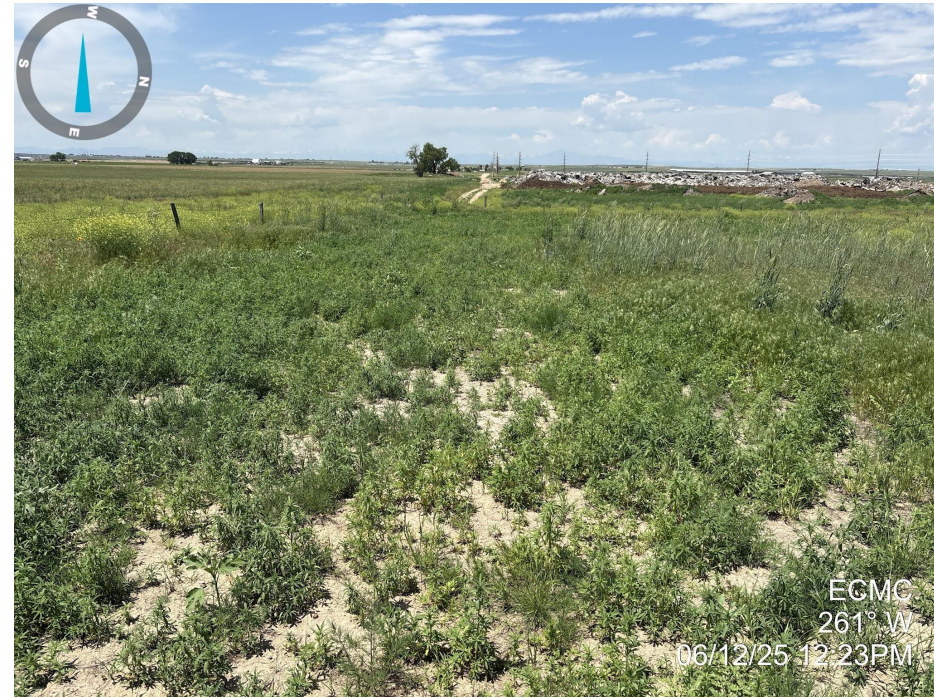
**Photo 6.** Photo taken from the tank battery location, facing west toward the access road to the location. Photo illustrates final reclamation activities have taken place, but vegetation establishment does not meet Rule 1004 standards as the access road is dominated by weedy annual vegetation.

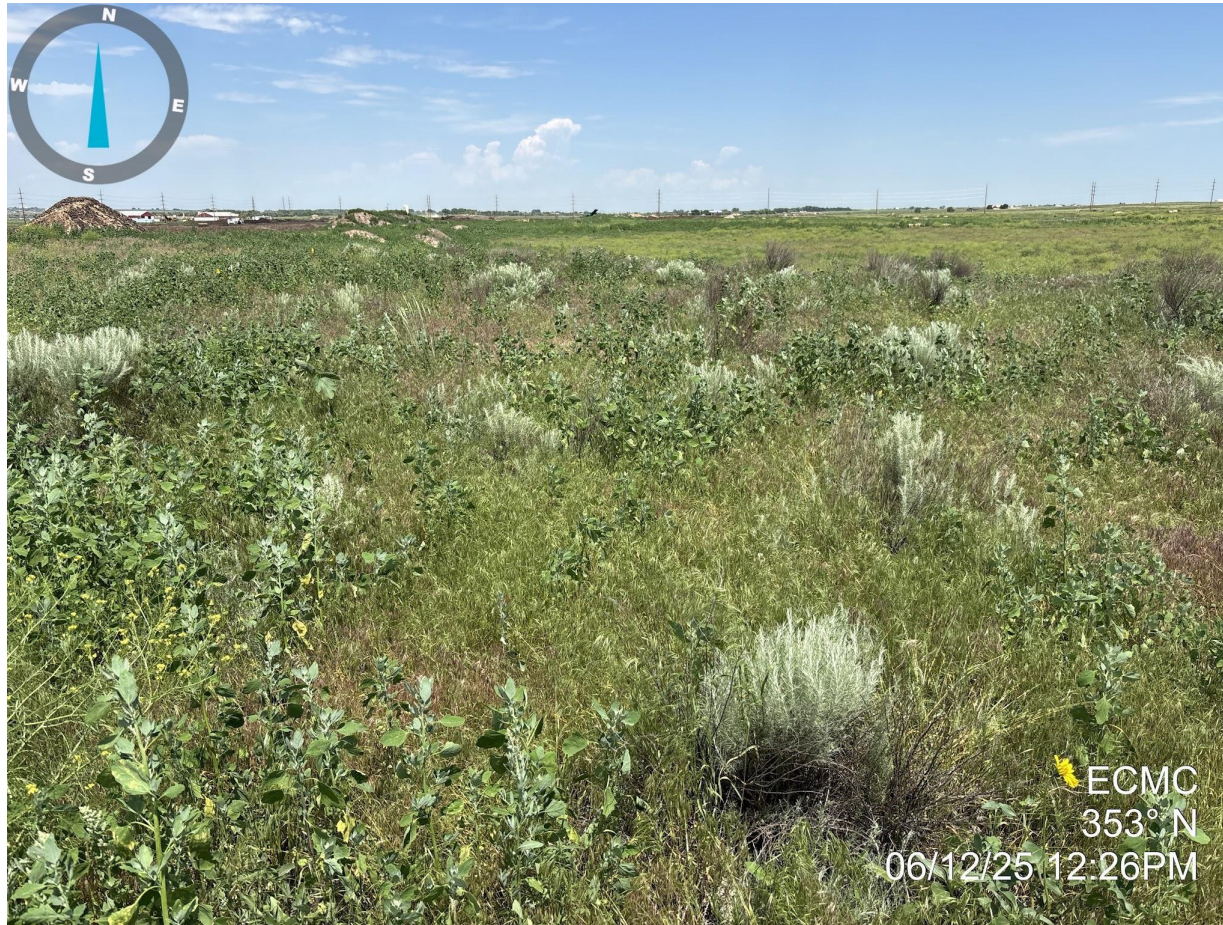
**Photo 7.** Photo taken of the reference area to the tank battery location, located north of the location, facing North. Photo illustrates weedy annual vegetation, sand sagebrush (*Artemisia filifolia*), and perennial grass.
