WELL NAME: CENTAUR 24-36, API #: 071-08349, INSP. # 716301200

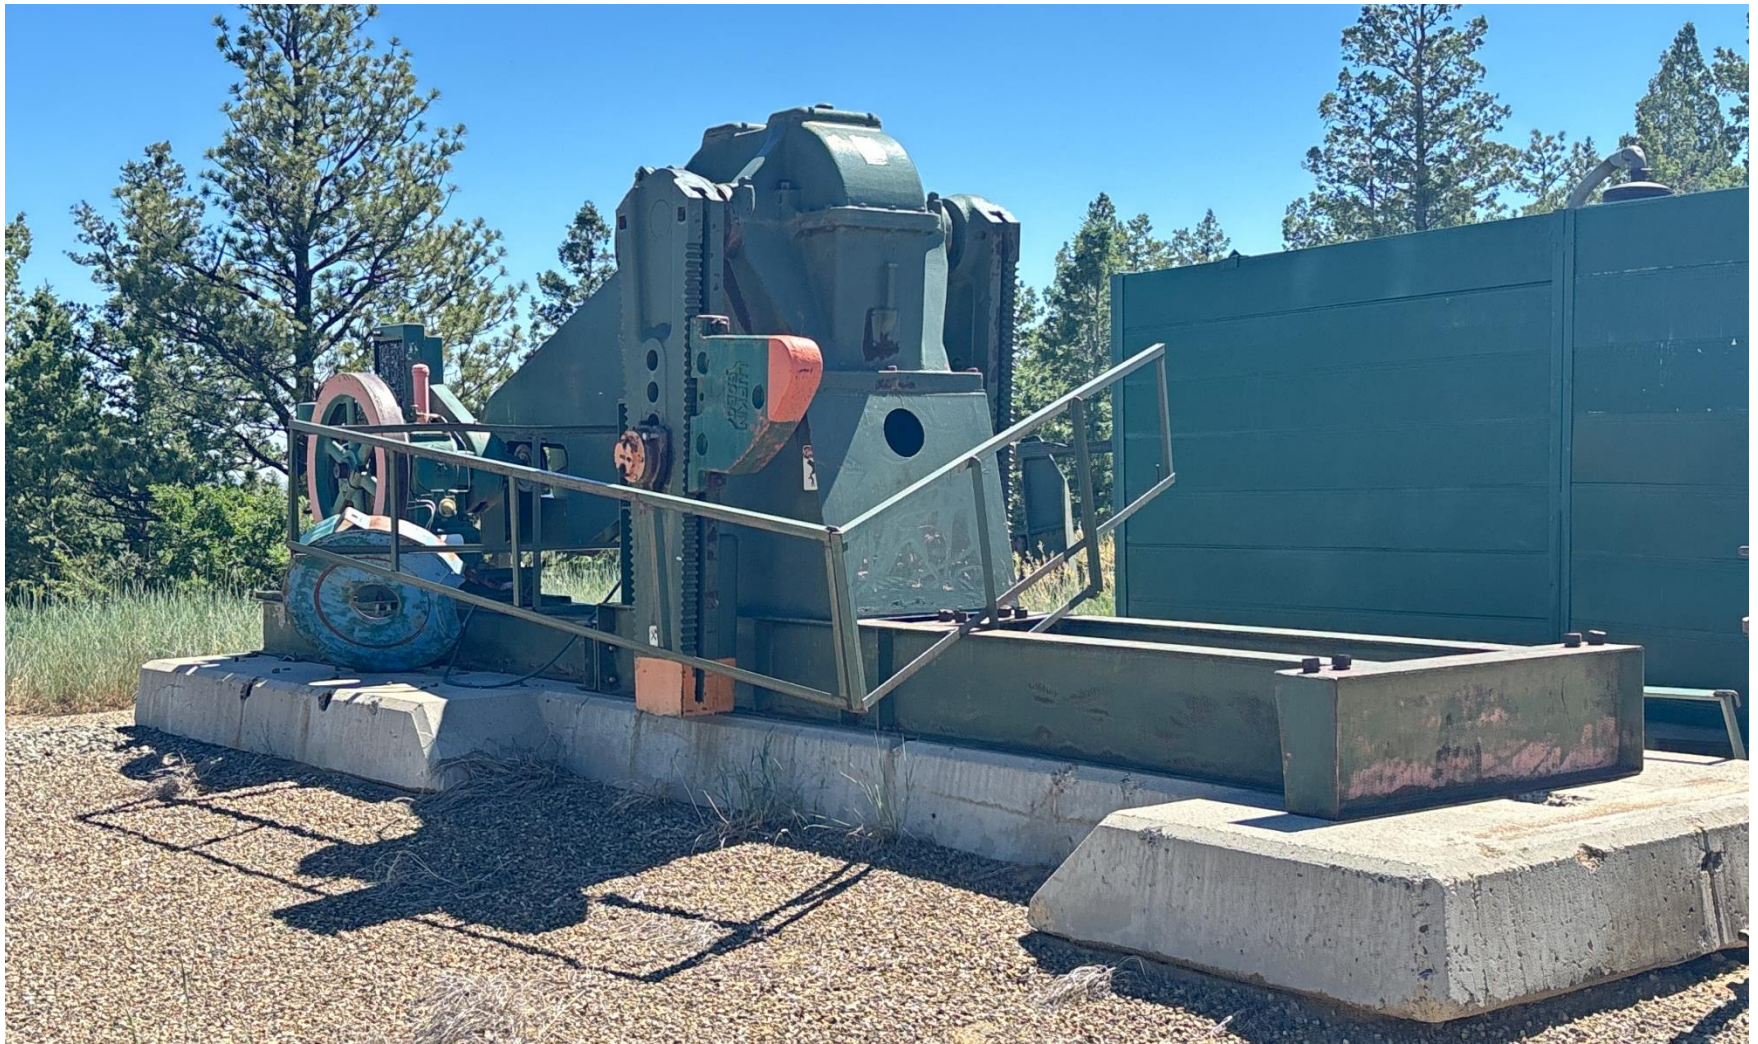
PHOTO 4: UNUSED EQUIPMENT (PUMPJACK AND ALL ITS COMPONENTS INCLUDING CEMENT PAD). REMOVE UNUSED EQUIPMENT PER RULE 606. CA DATE 7-14-2025.

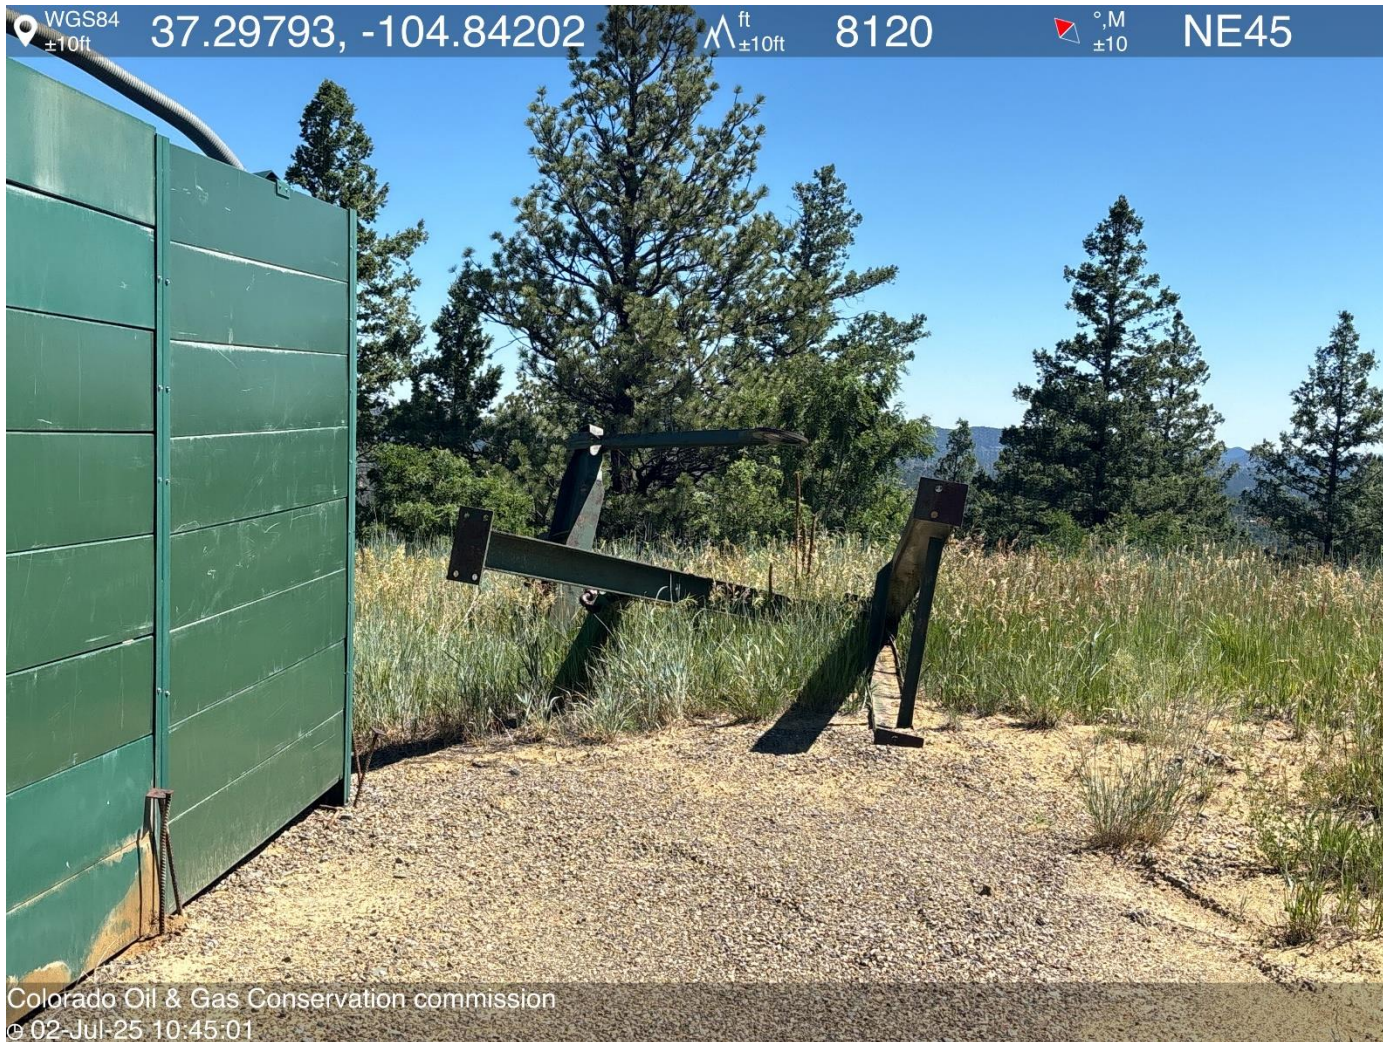
PHOTO 5: UNUSED EQUIPMENT (PUMPJACK AND ALL ITS COMPONENTS INCLUDING CEMENT PAD). REMOVE UNUSED EQUIPMENT PER RULE 606. CA DATE 7-14-2025.

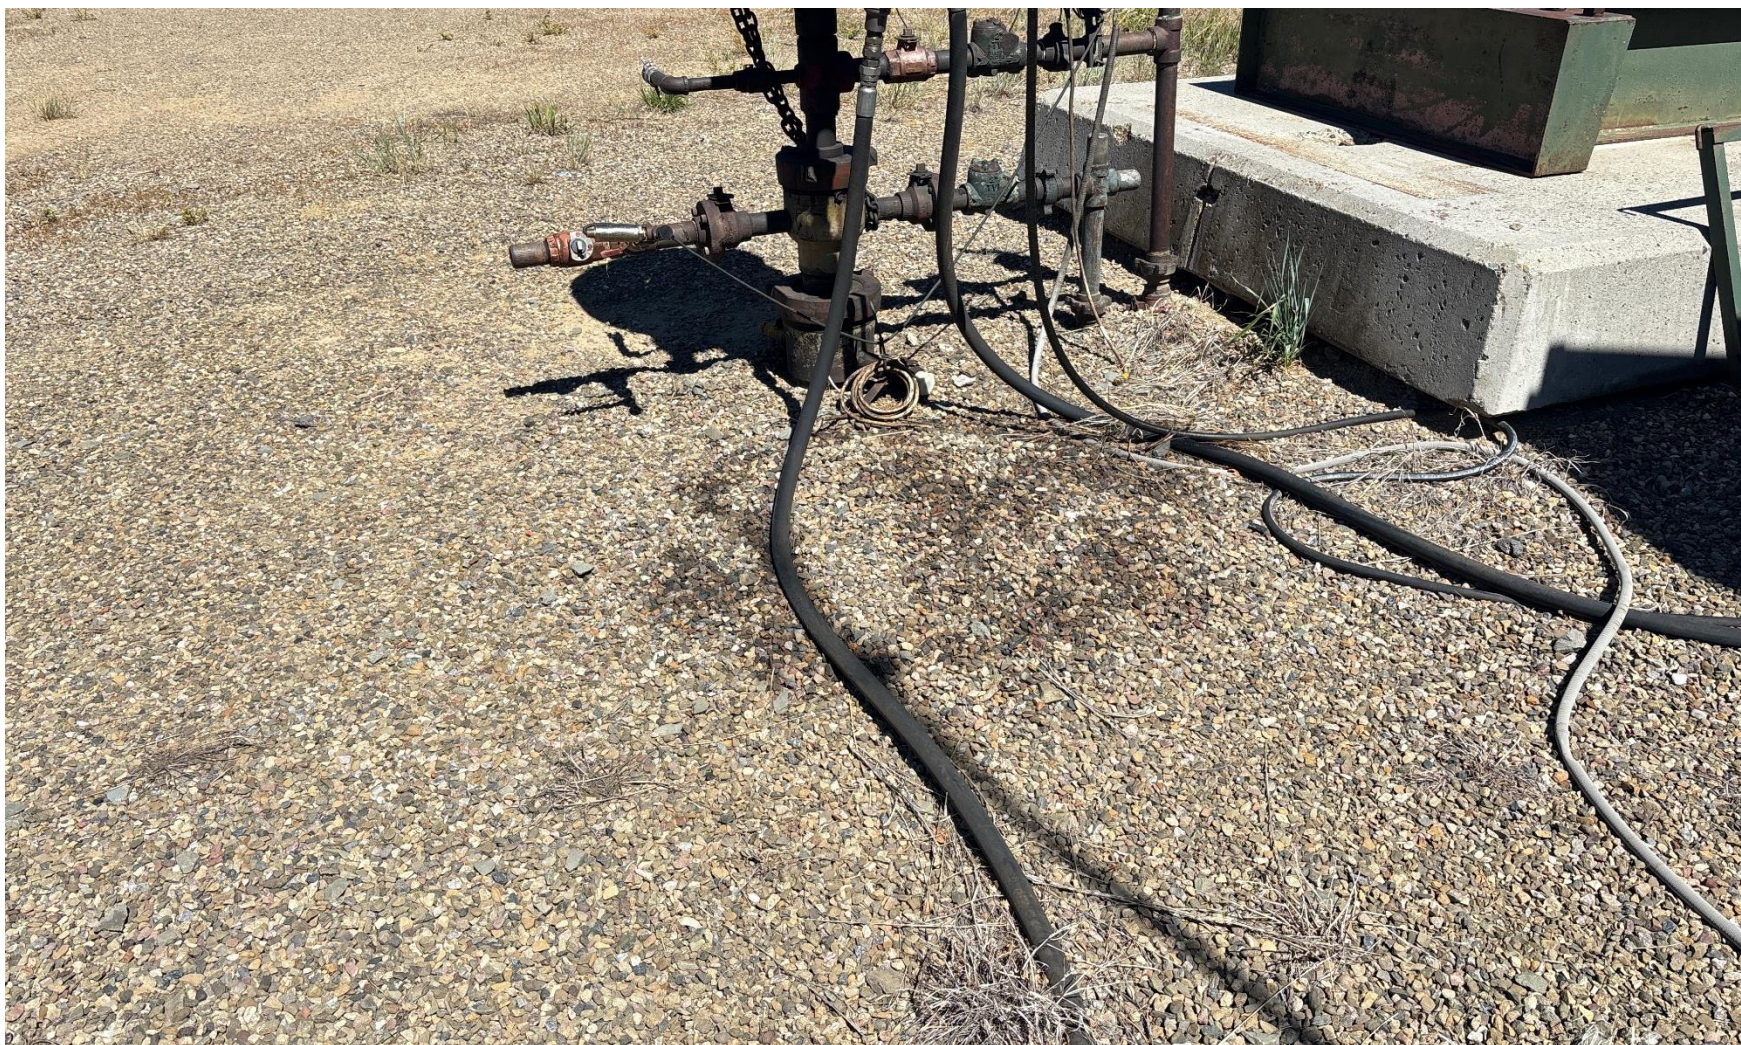
PHOTO 6: AREA OF IMPACTED SOIL NEAR WELLHEAD. Conduct maintenance on equipment, cleanup stained material and review self inspection processes. COMPLY WITH RULE 1002,(2).D. CA DATE 7-14-2025.

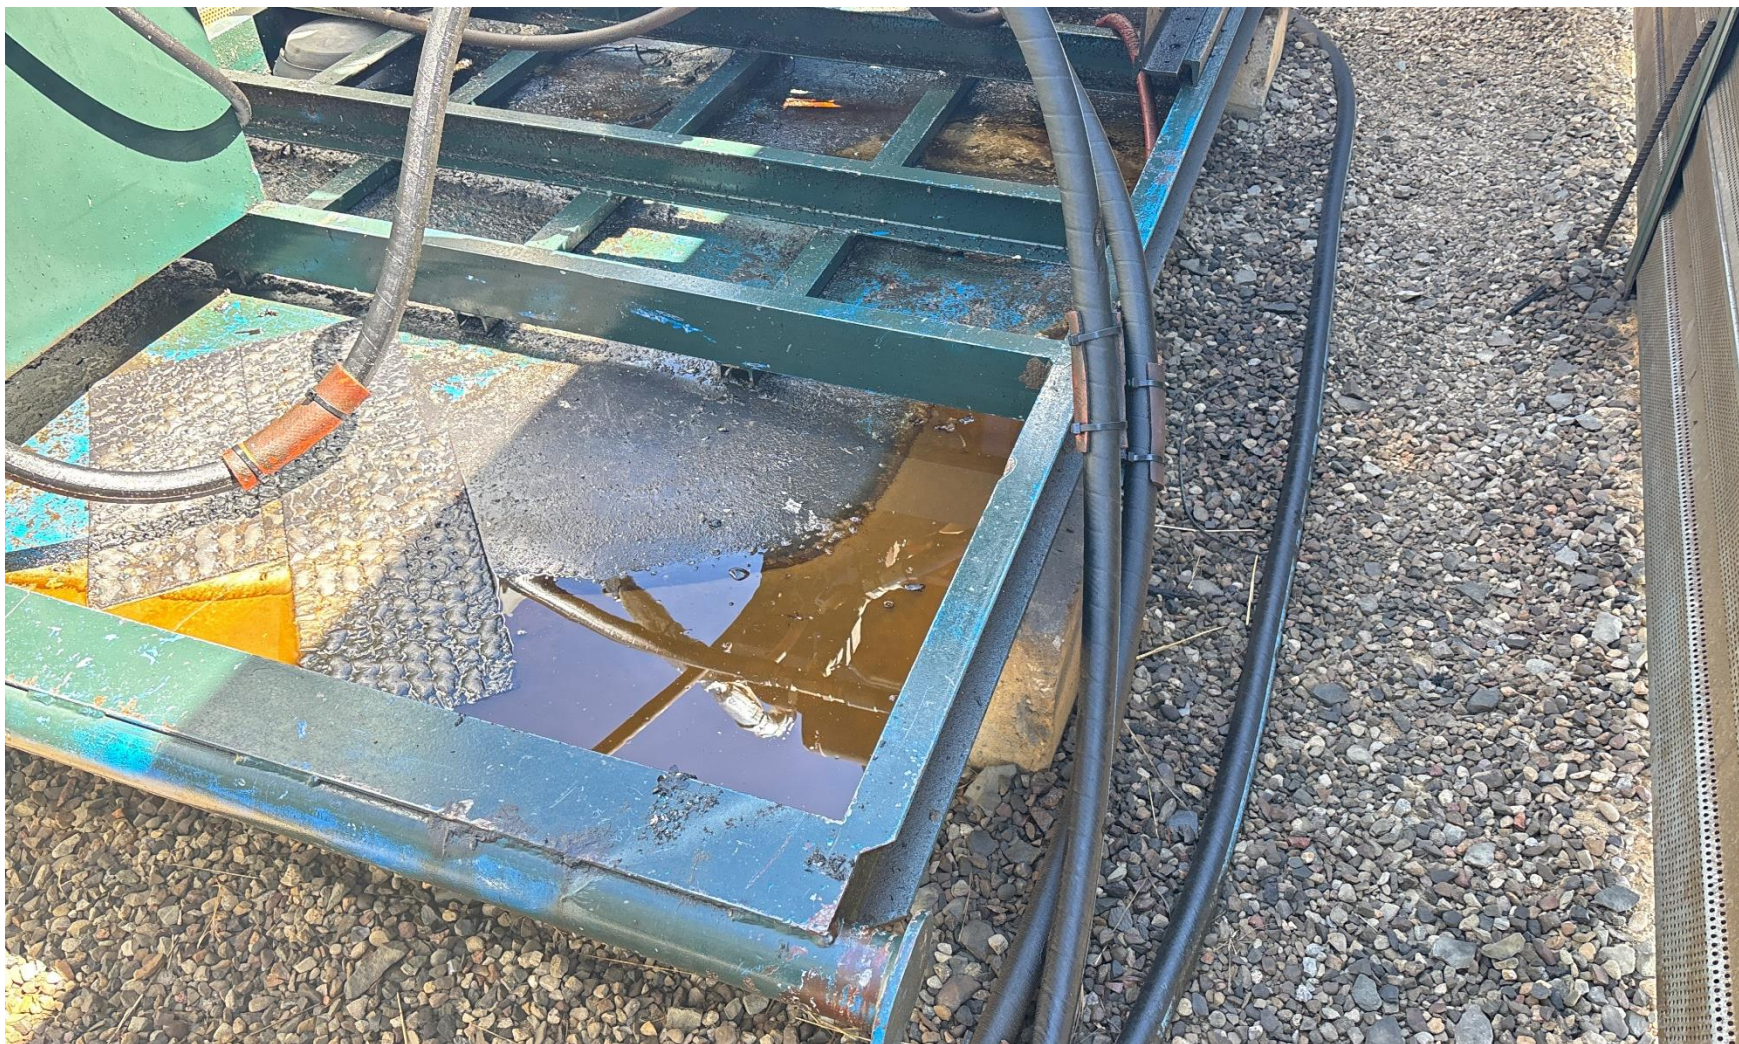
PHOTO 7: OILY WASTE IN PRIME MOVER ENGINE SKID. DRAIN OILY WASTE REPAIR ALL LEAKS AND REMOVE IMPACTED SOIL PER RULE 1002..(2).D & 1002.f.(2)B, Comply with general provisions of the oil and gas act for wildlife protection AND SB-181. 24 OURS TO DRAIL OILY WASTE. CA DATE 7-14-2025.
