# Final Reclamation Inspection

Operator: NOBLE ENERGY INC - 100322

Location ID: 328320

Inspection Photos  
Location Name: CANNON #H 35-12  
Location ID: 328320

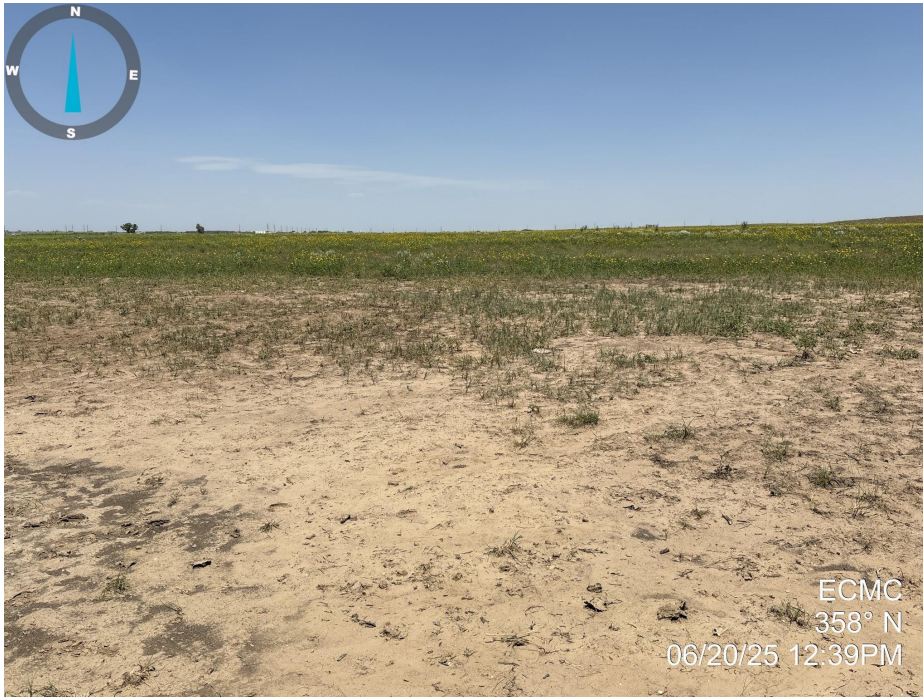
**Photo 1.** Photo taken from the well location, facing North. Photo illustrates that final reclamation activities have taken place, with evidence of drill row seeding. However, vegetation has not established to Rule 1004 standards.

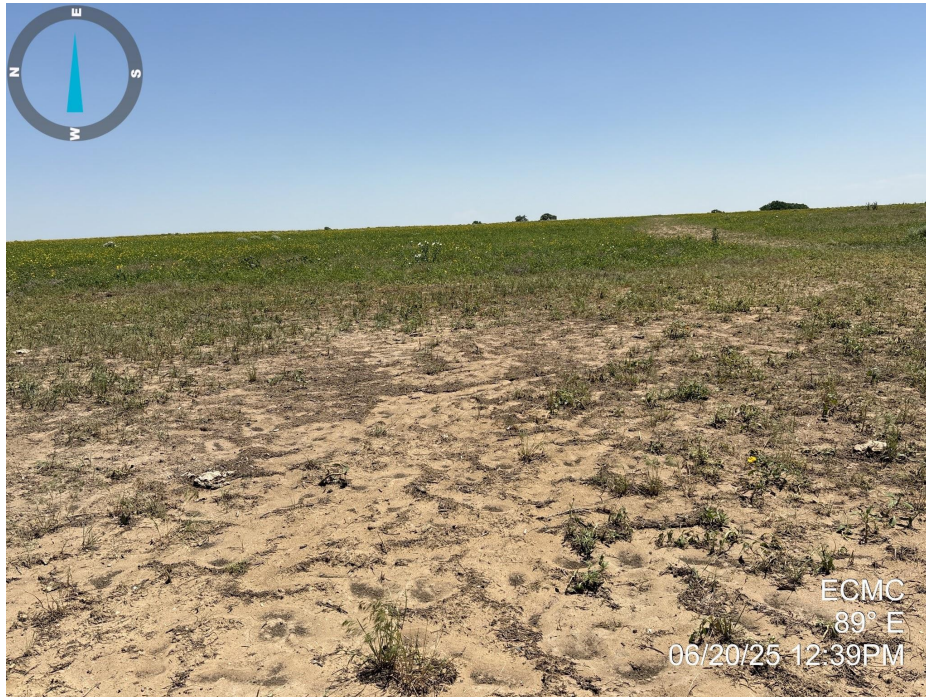
**Photo 2.** Photo taken from the well location, facing East. See comments under Photo 1.

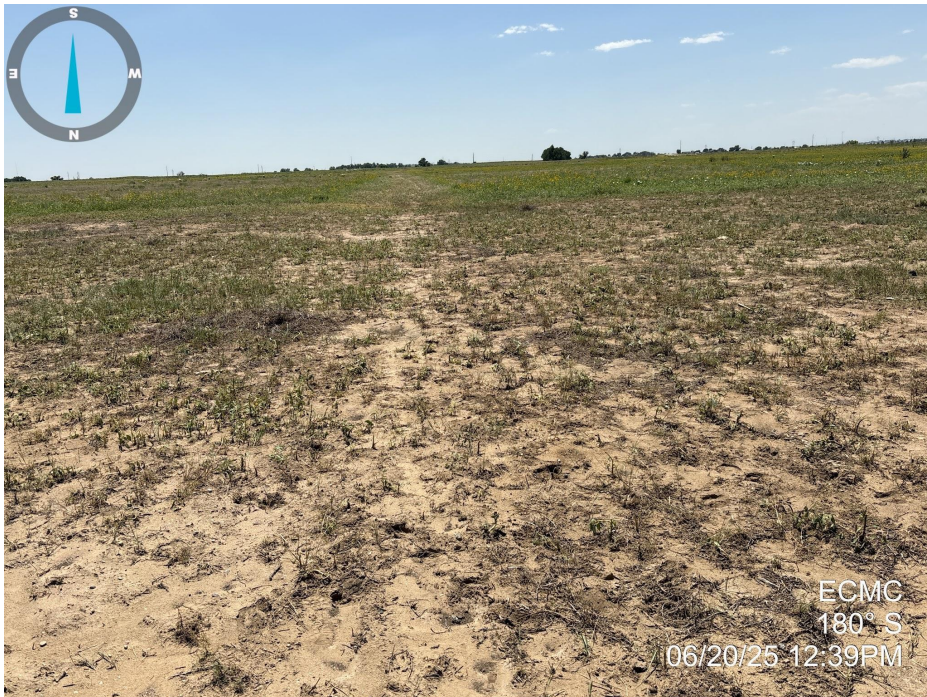
**Photo 3.** Photo taken from the well location, facing South. See comments under Photo 1.

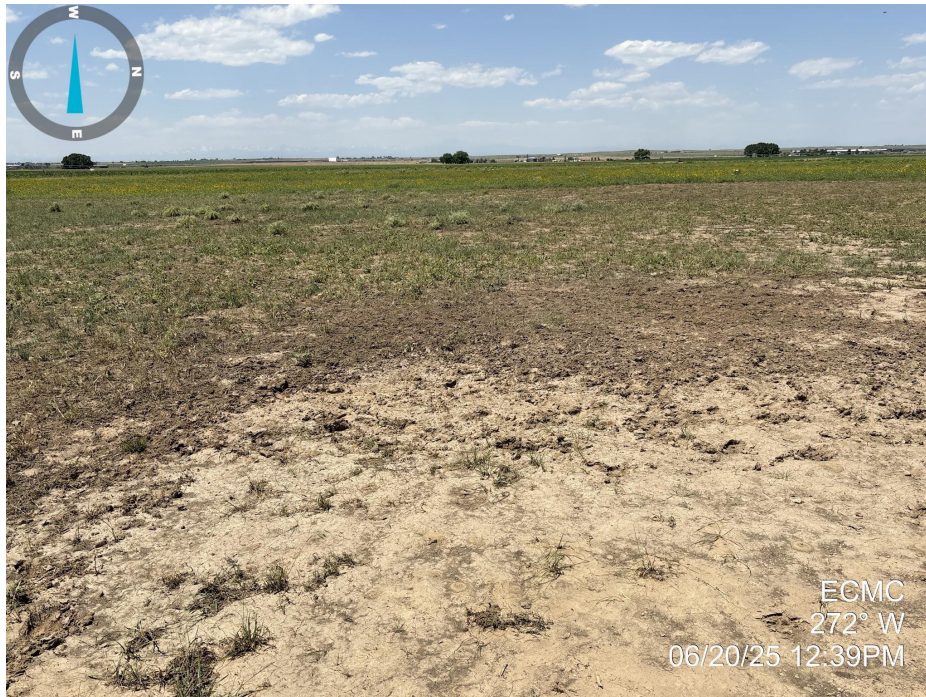
**Photo 4.** Photo taken from the well location, facing West. See comments under Photo 1.

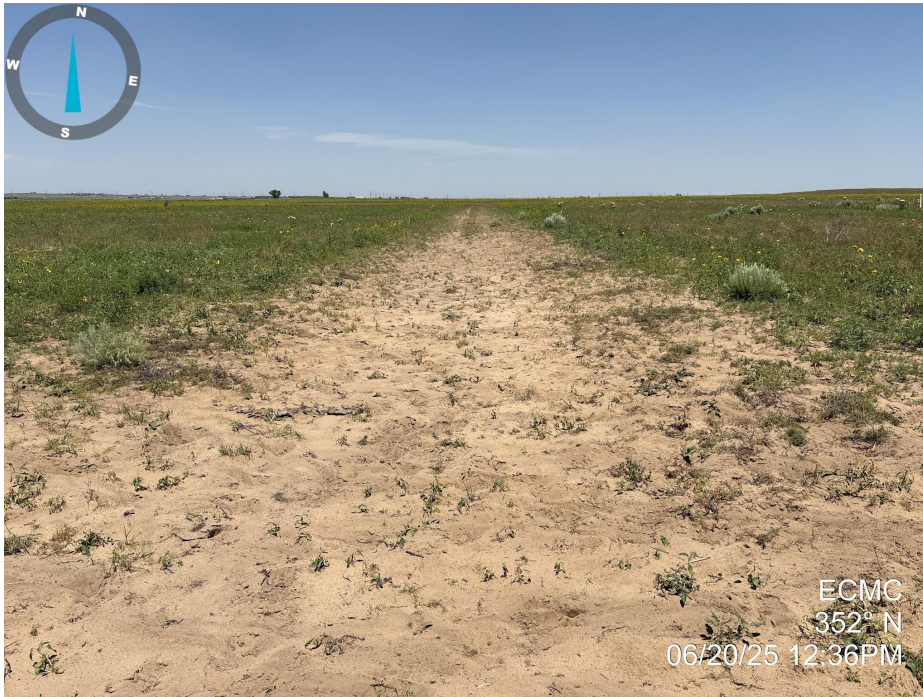
**Photo 5.** Photo taken of the access road to the well location, facing North towards the location. Photo illustrates that final reclamation activities have taken place, with evidence of drill row seeding, but vegetation has not established to Rule 1004 standards.

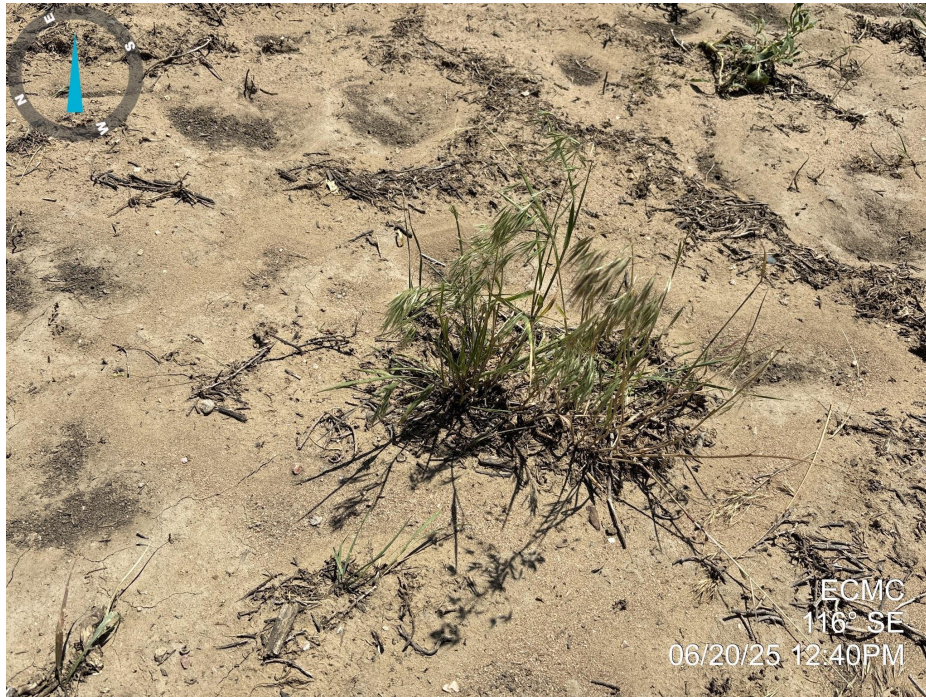
**Photo 6.** Photo taken of ground cover at the well location. Photo illustrates bare ground and weedy annual vegetation, including cheatgrass (*Bromus tectorum*), a List C Noxious Weed species.

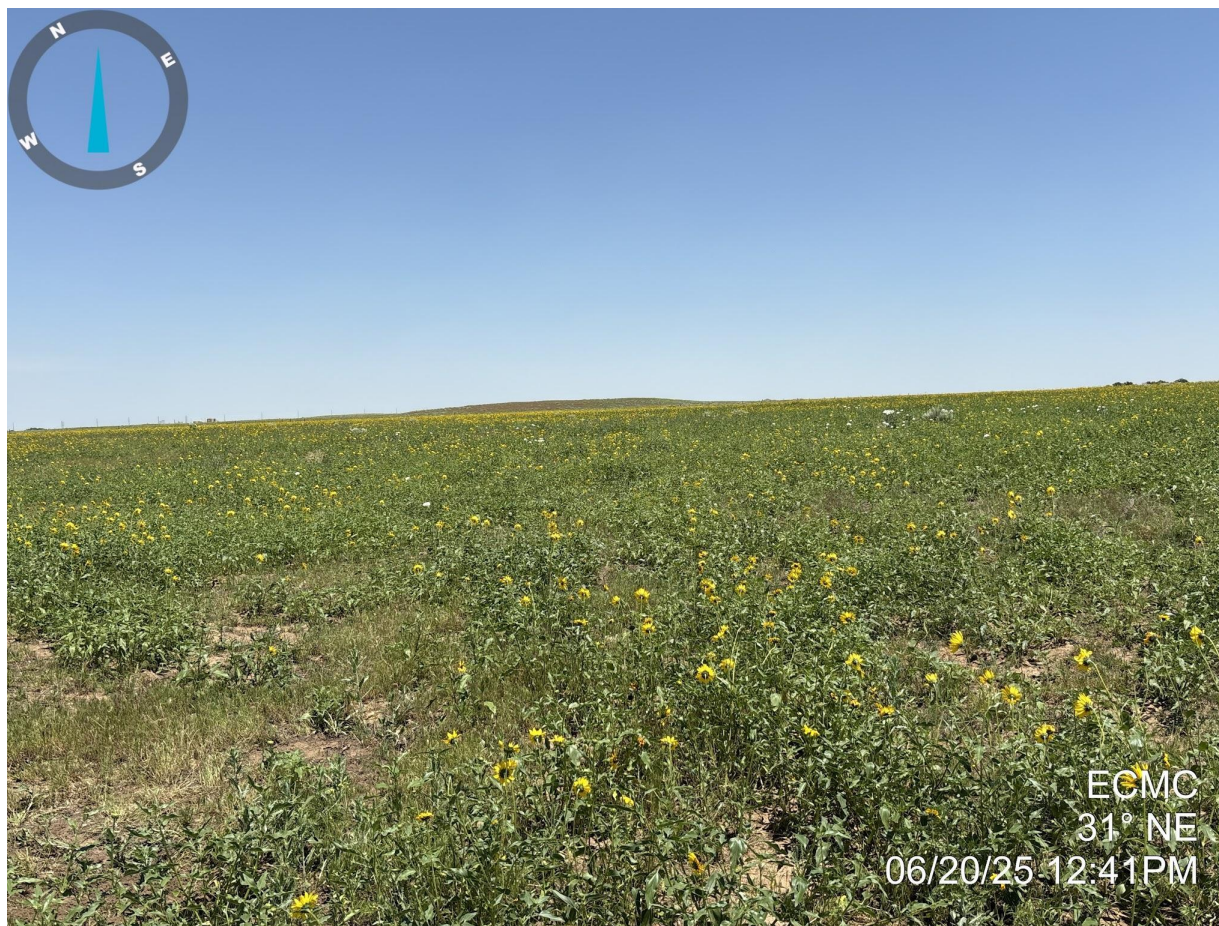
**Photo 7.** Photo taken of the reference area, located east of the well location, facing northeast. Photo illustrates annual vegetation including prairie sunflower (*Helianthus petiolaris*).
