Final Reclamation Inspection

Operator: NOBLE ENERGY INC - 100322

Location ID: 418289

Inspection Photos
Location Name: Cannon H #35-20
Location ID: 418289

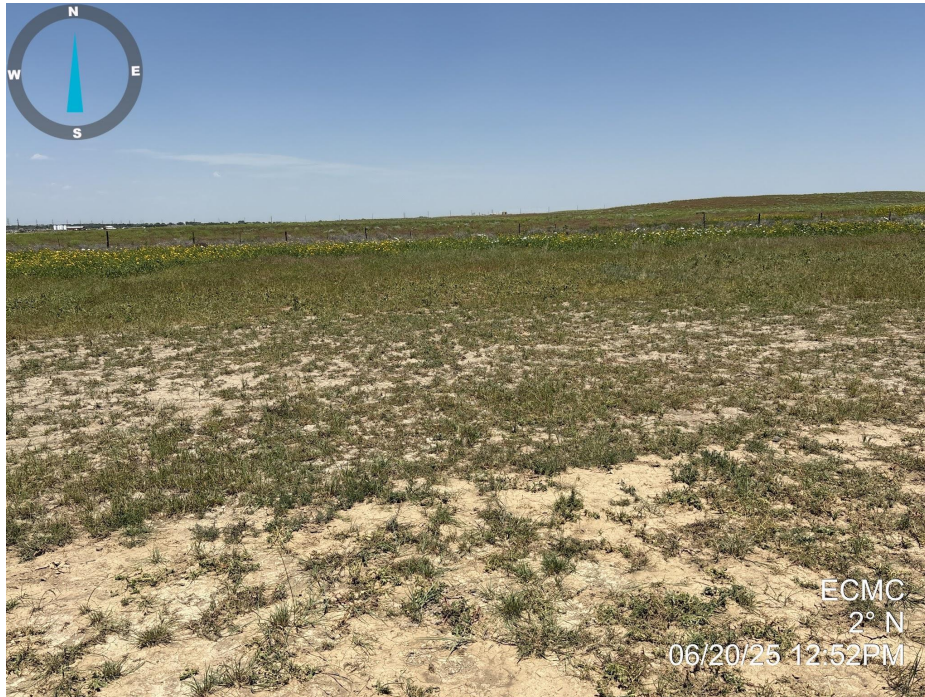
Photo 1. Photo taken from the well location, facing North. Photo illustrates that final reclamation activities have taken place, with evidence of drill row seeding. However, vegetation has not established to Rule 1004 standards and weedy annual vegetation was observed at the location.

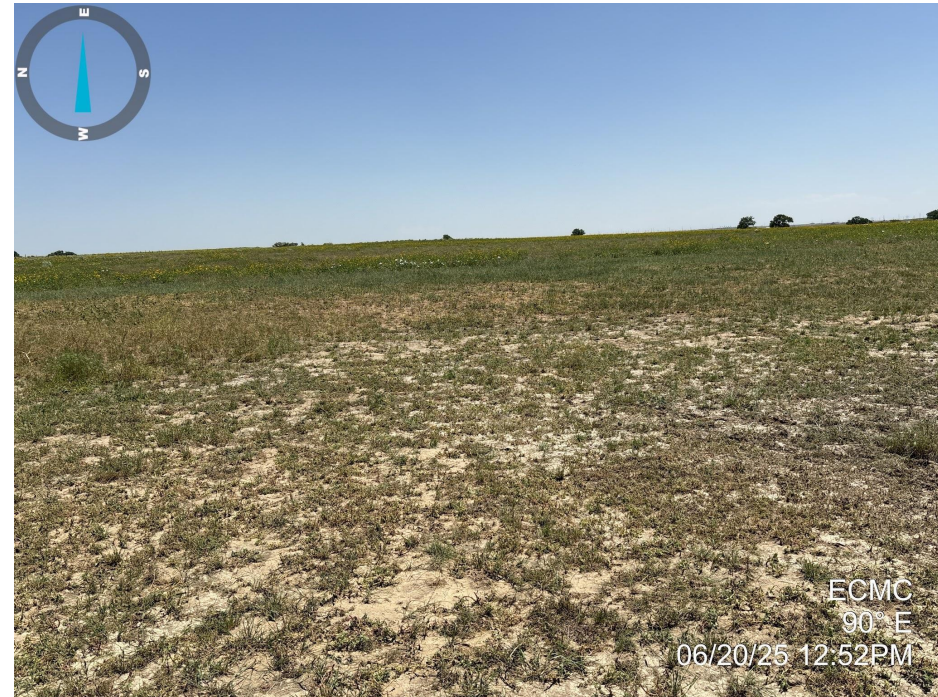
Photo 2. Photo taken from the well location, facing East. See comments under Photo 1.

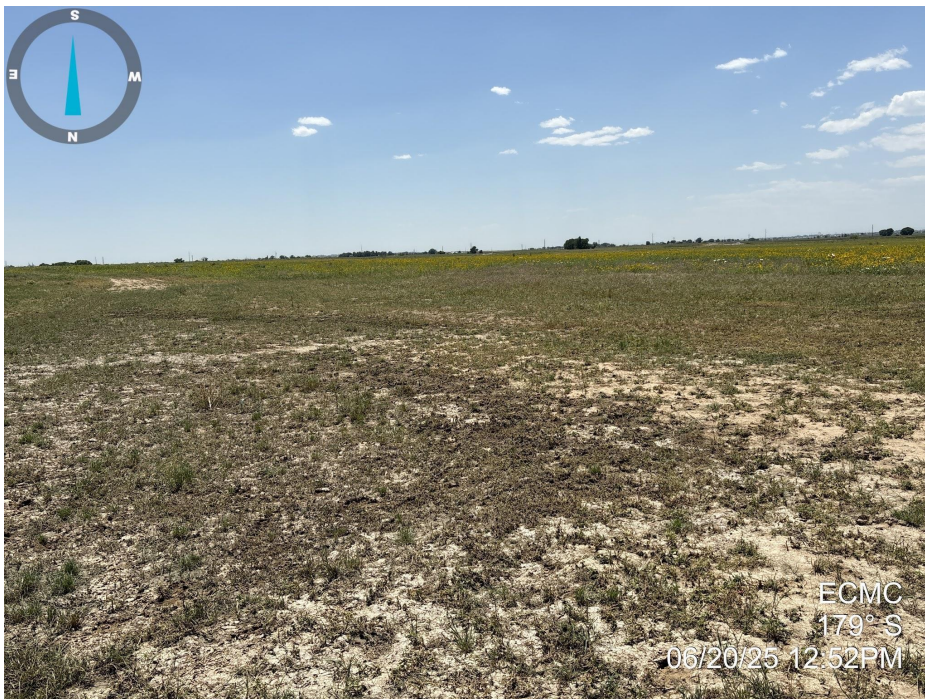
Photo 3. Photo taken from the well location, facing South. See comments under Photo 1.

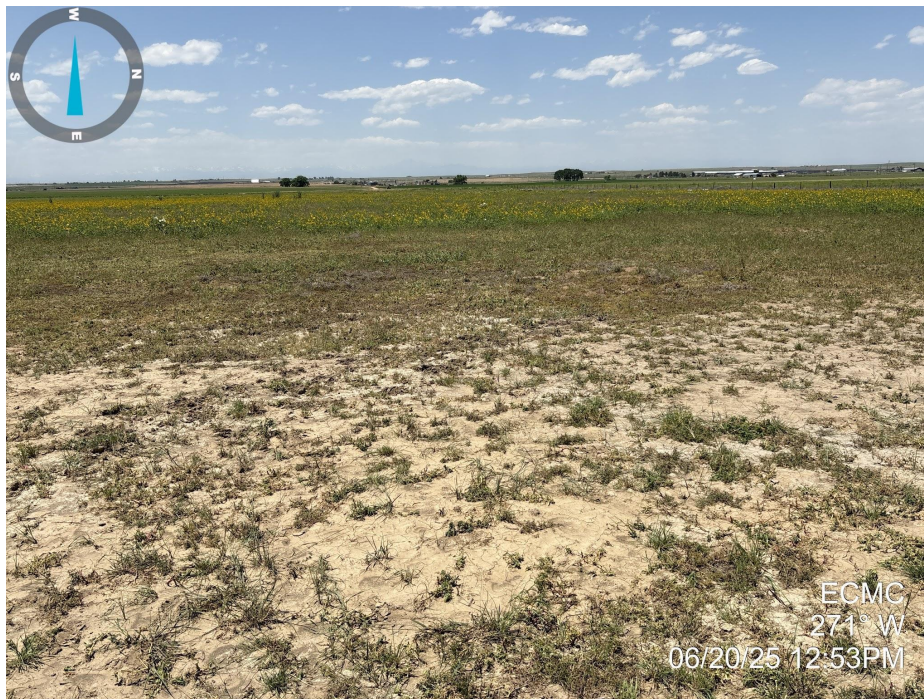
Photo 4. Photo taken from the well location, facing West. See comments under Photo 1.

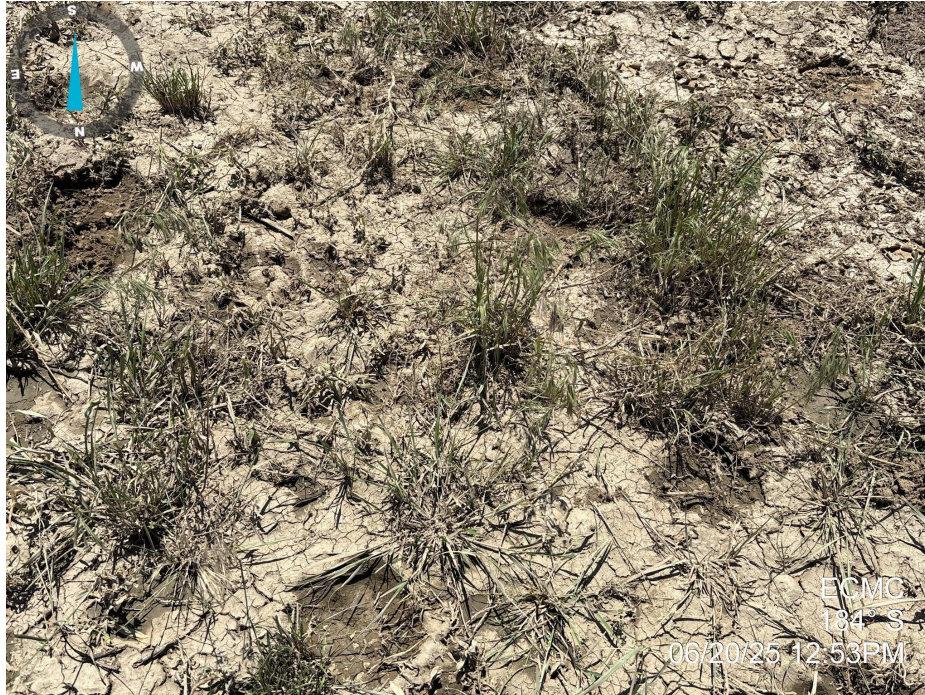
Photo 5. Photo taken of the ground cover at the well location. Photo illustrates weedy annual vegetation including cheatgrass (*Bromus tectorum*), a List C Noxious Weed species.

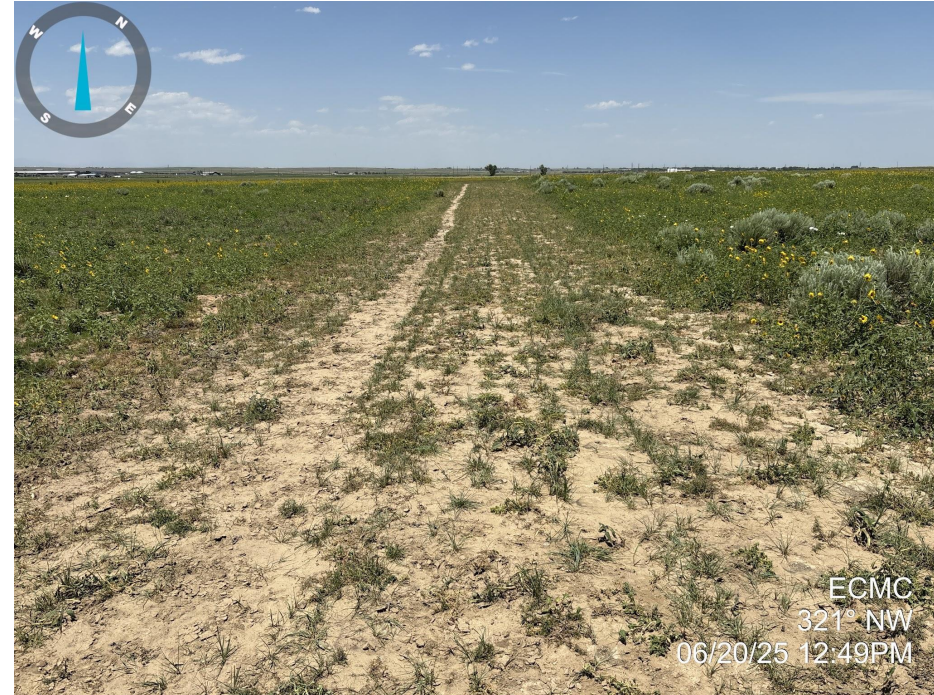
Photo 6. Photo taken of the access road, facing Northwest. Photo illustrates that final reclamation activities have taken place, with evidence of drill row seeding, but vegetation establishment does not meet Rule 1004 standards.

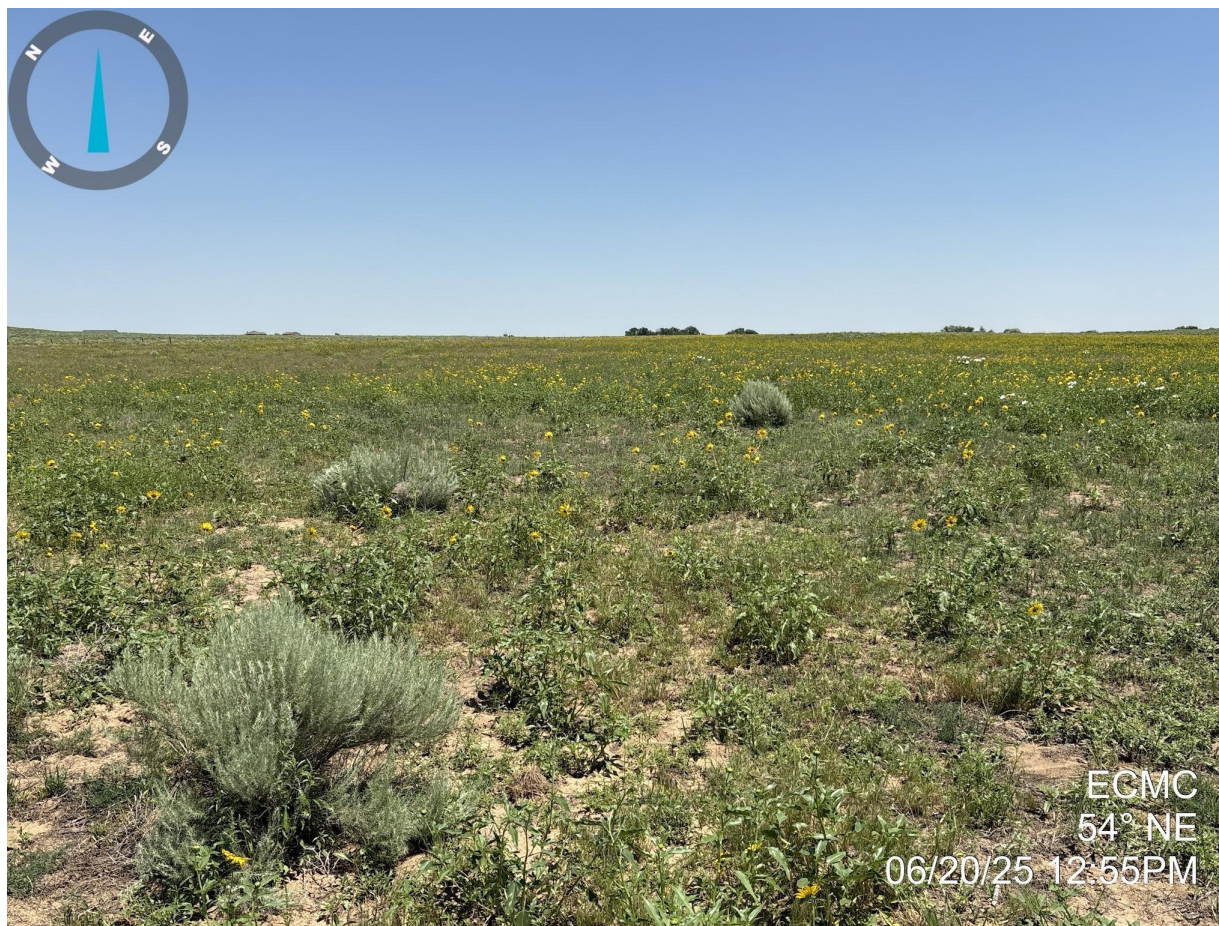
Photo 7. Photo taken of the reference area, located southeast of the well location, facing northeast. Photo illustrates sand sagebrush (*Artemisia filifolia*) and annual vegetation including prairie sunflower (*Helianthus petiolaris*).
