Final Reclamation Inspection

Operator: NOBLE ENERGY INC - 100322

Location ID: 327785

Inspection Photos
Location Name: CANNON H #35-14
Location ID: 327785

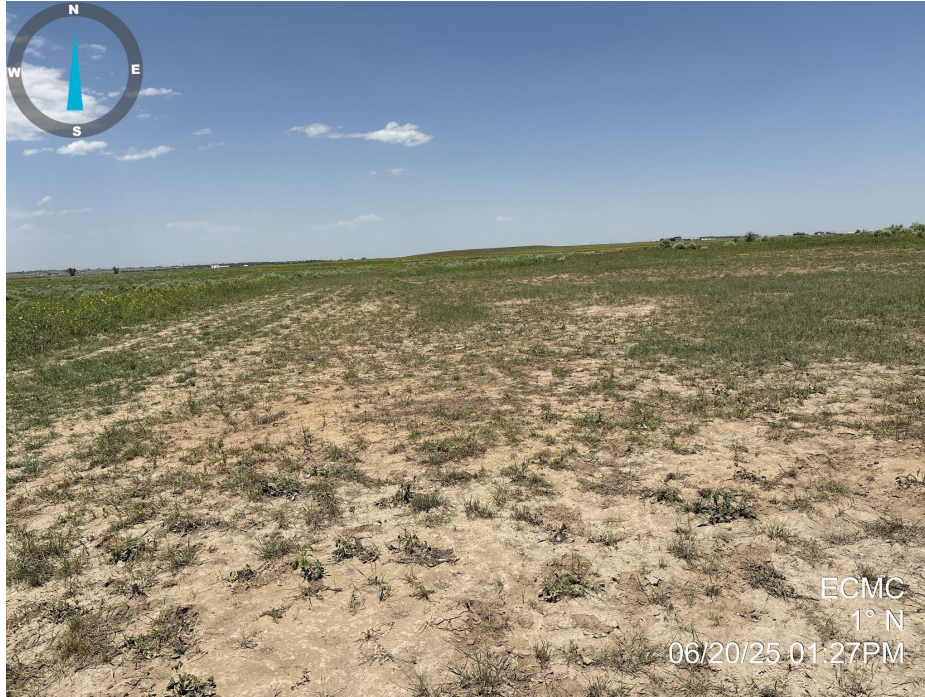
Photo 1. Photo taken from the well location, facing North. Photo illustrates that final reclamation activities have taken place, with evidence of drill row seeding, but vegetation has not established to Rule 1004 standards.

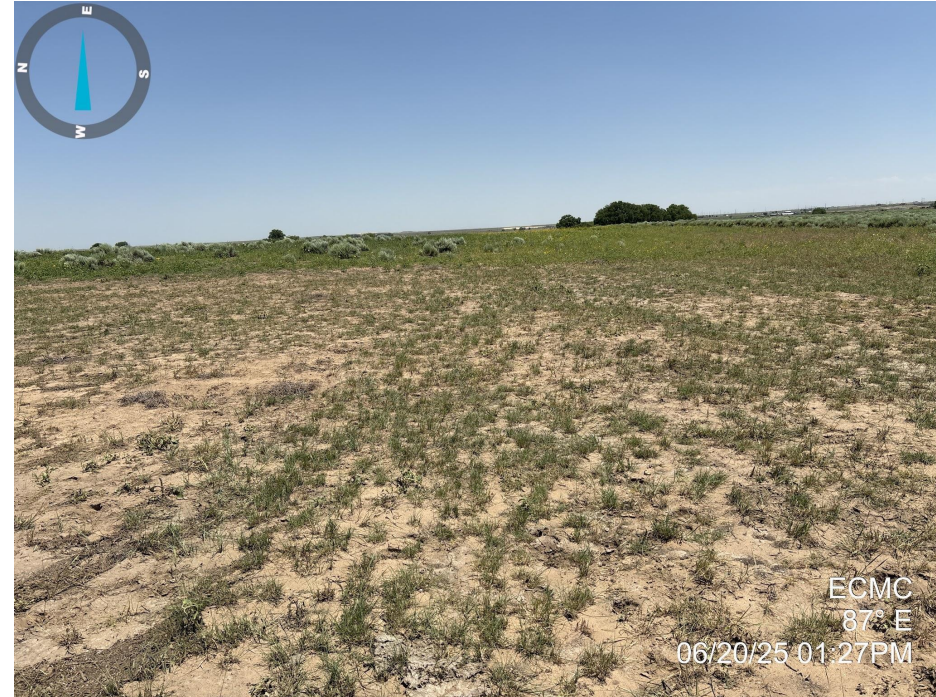
Photo 2. Photo taken from the well location, facing East. See comments under Photo 1.

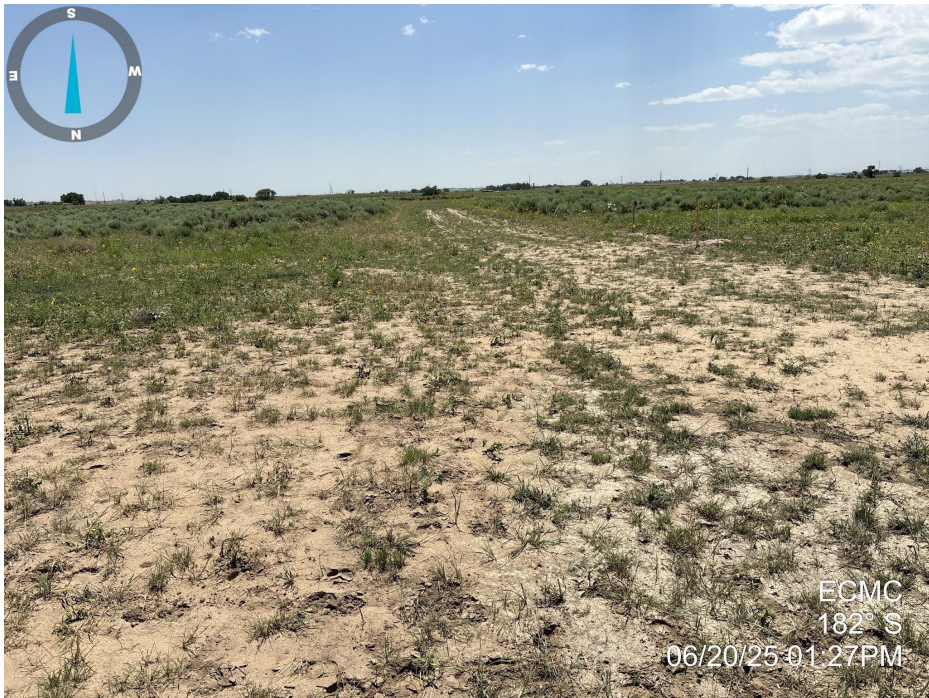
Photo 3. Photo taken from the well location, facing South. See comments under Photo 1.

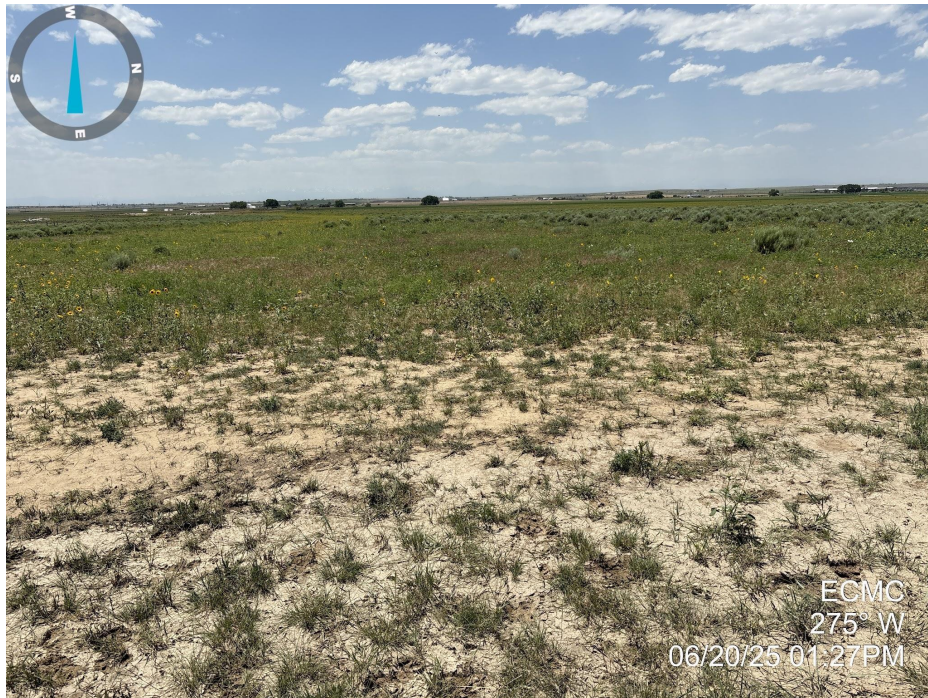
Photo 4. Photo taken from the well location, facing West. See comments under Photo 1.

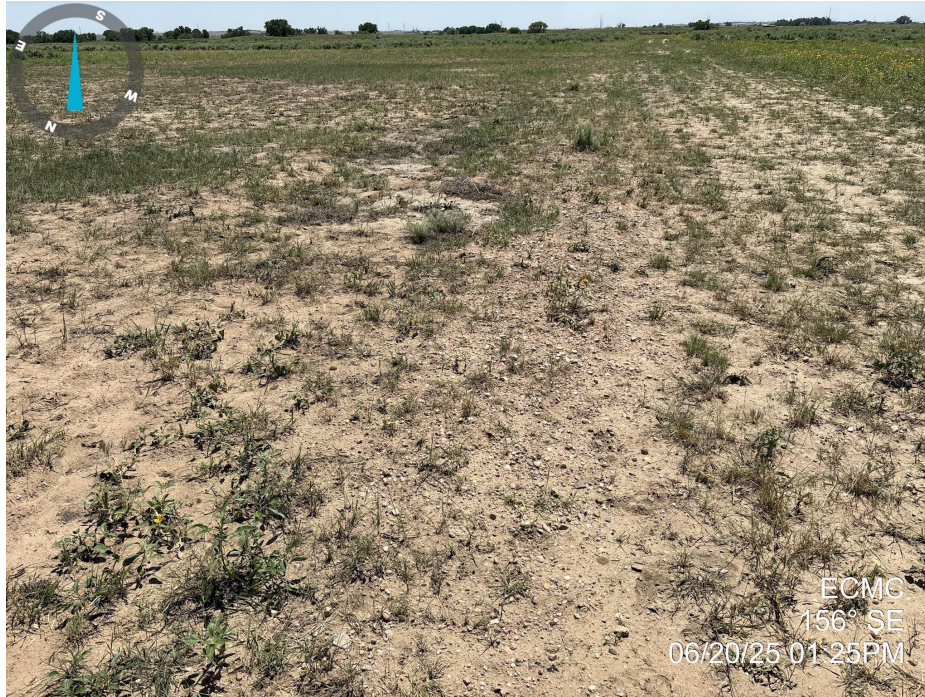
Photo 5. Photo taken of the northern portion of the well location, facing southeast. Photo illustrates gravel remains on a portion of the location.

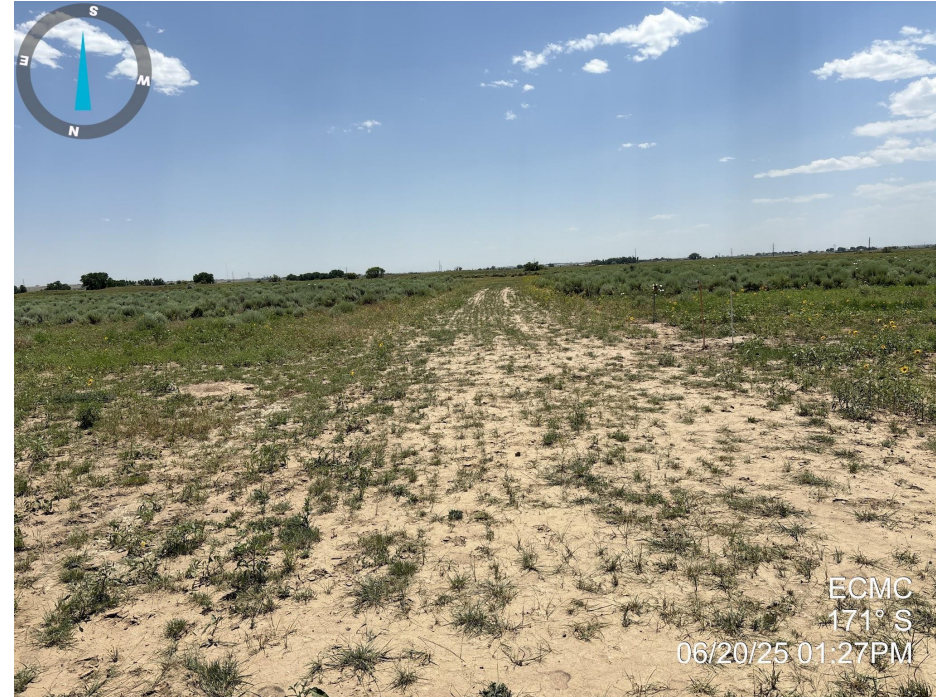
Photo 6. Photo taken of the access road to the well location, facing south. Photo illustrates that final reclamation activities have taken place, with evidence of drill row seeding, but vegetation establishment does not meet Rule 1004 standards.

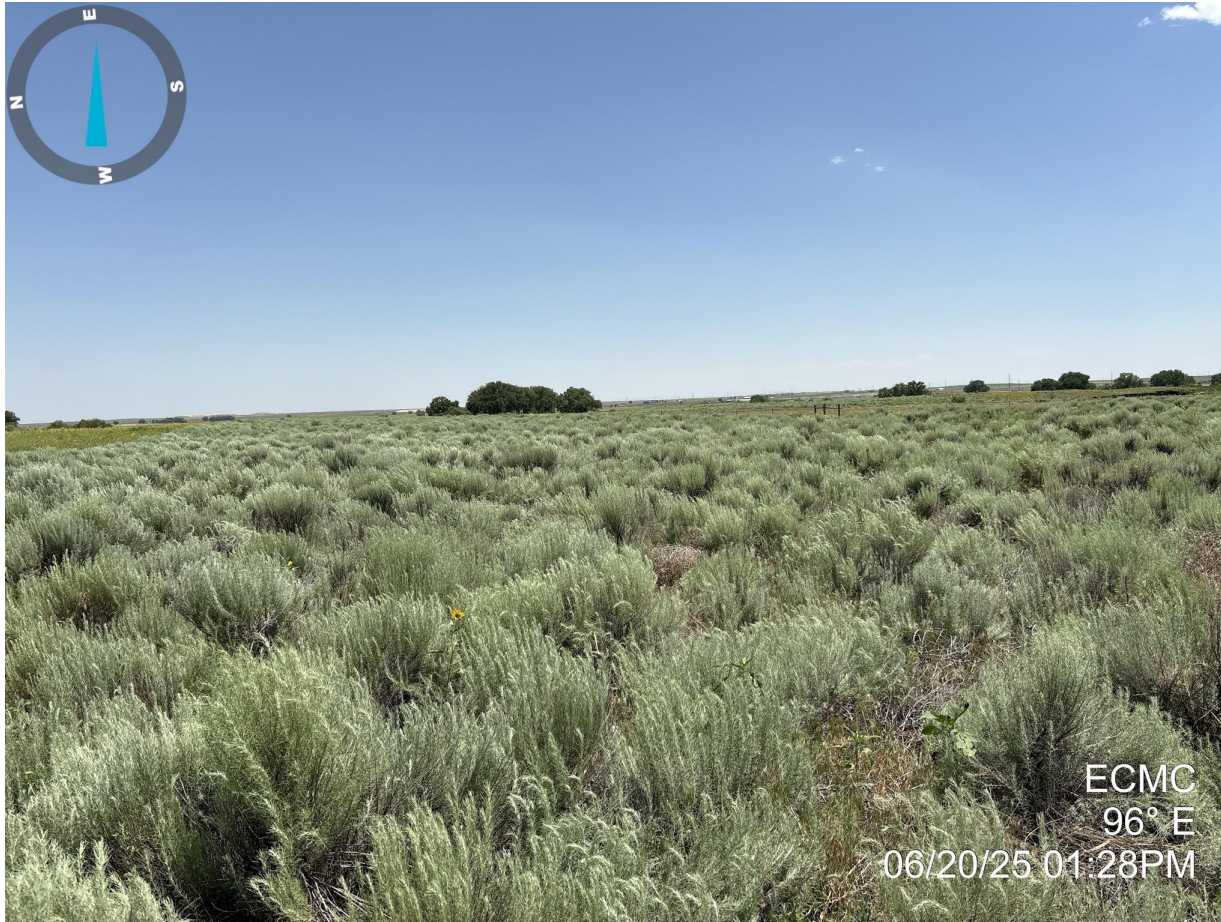
Photo 7. Photo taken of the reference area, located south of the well location, facing east. Photo illustrates the location is dominated by sand sagebrush (*Artemisia filifolia*).
