Final Reclamation Inspection

Operator: NOBLE ENERGY INC - 100322

Location ID: 418287

Inspection Photos
Location Name: CANNON X #02-28
Location ID: 418287

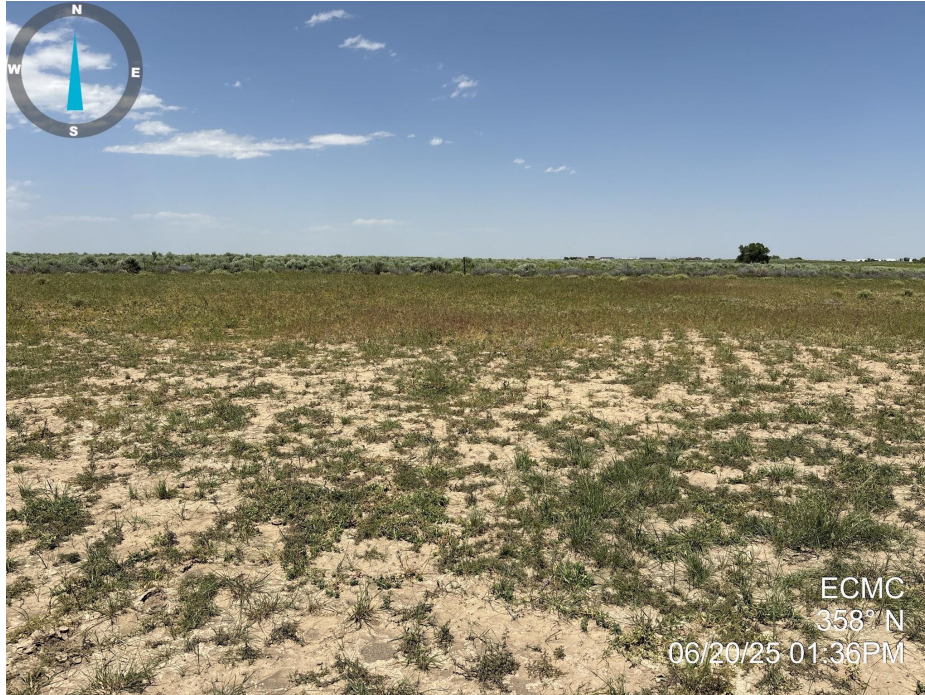
Photo 1. Photo taken from the well location, facing North. Photo illustrates that final reclamation activities have taken place, with evidence of drill row seeding. However, vegetation has not established to Rule 1004 standards.

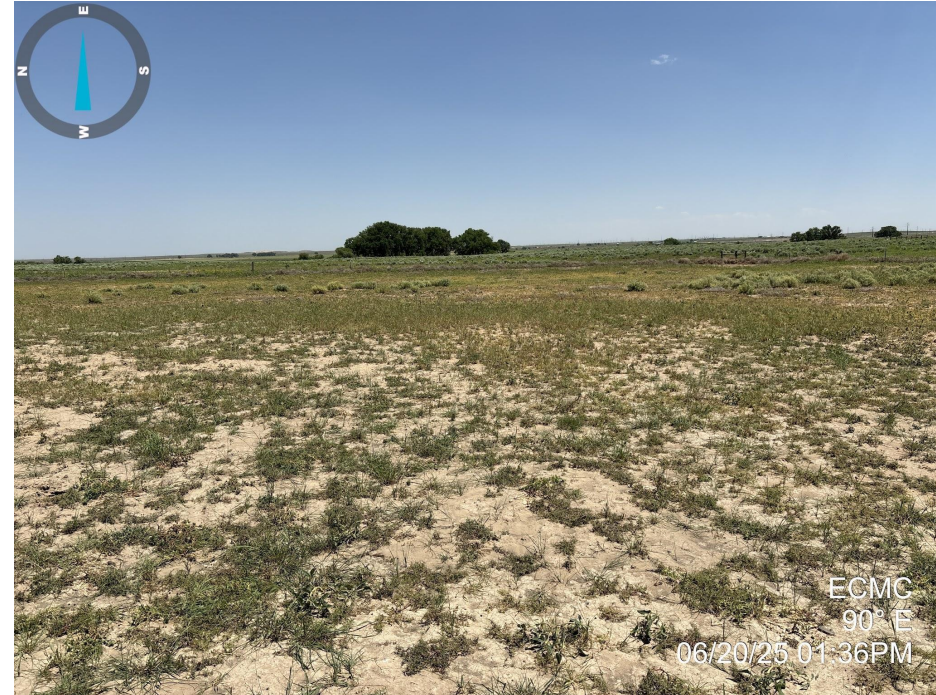
Photo 2. Photo taken from the well location, facing East. See comments under Photo 1.

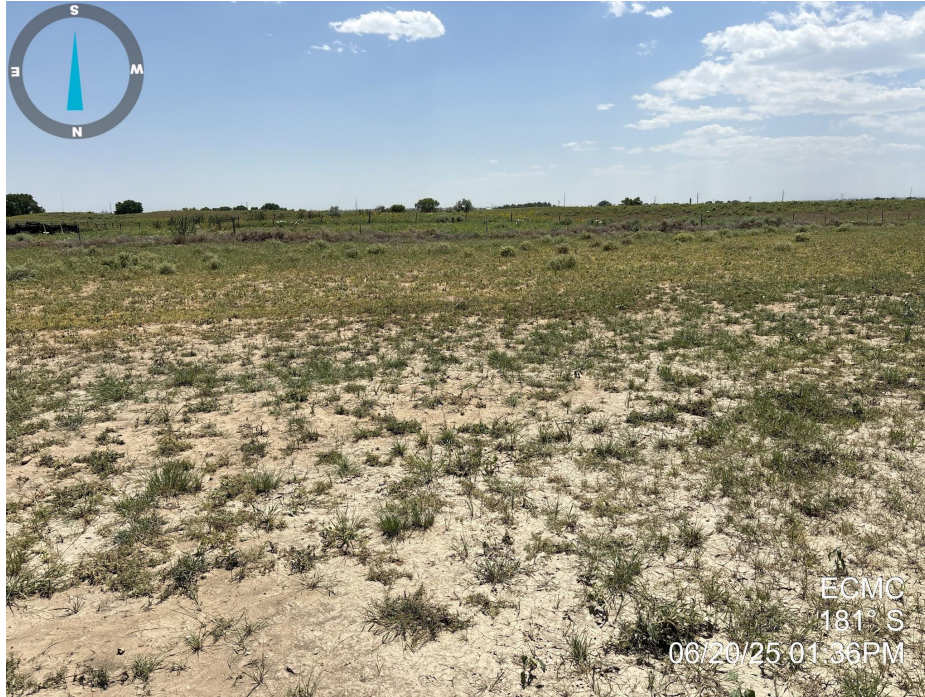
Photo 3. Photo taken from the well location, facing South. See comments under Photo 1.

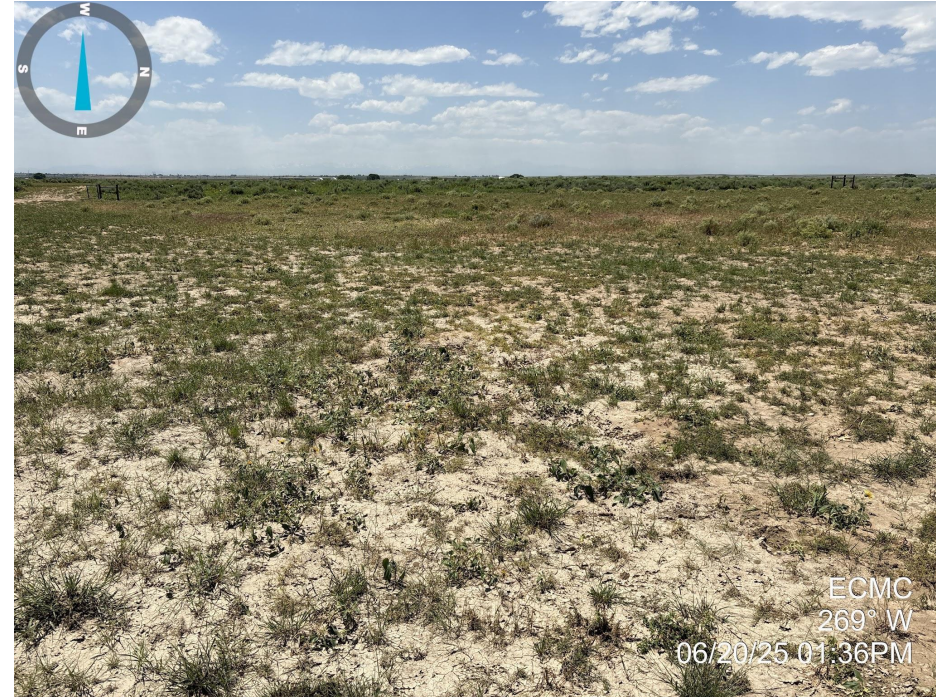
Photo 4. Photo taken from the well location, facing West. See comments under Photo 1.

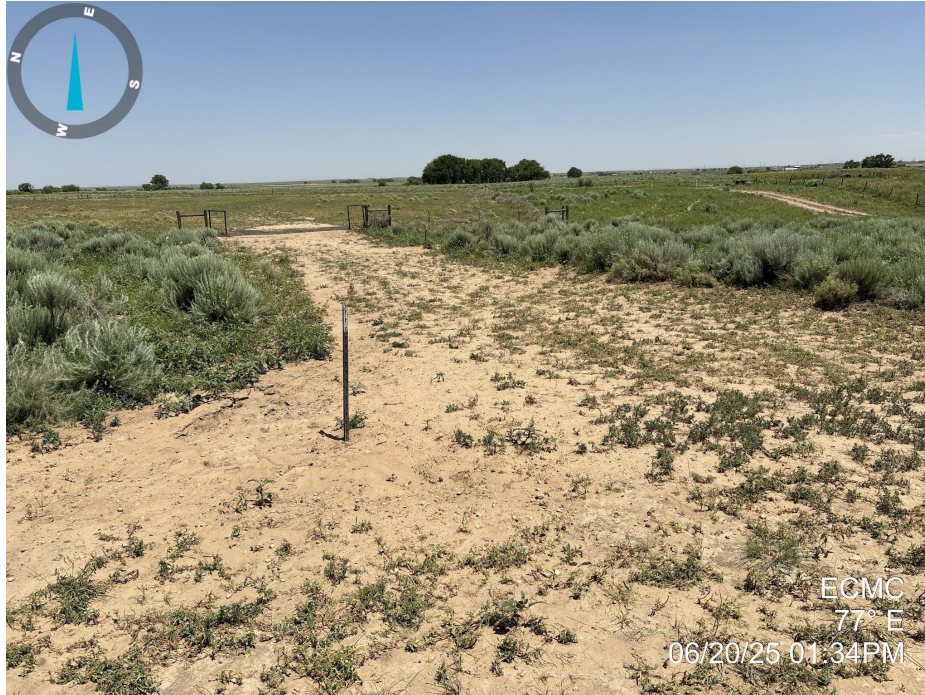
Photo 5. Photo taken of the access road to the well location, facing East. Photo illustrates that final reclamation activities have taken place, with evidence of drill row seeding, but vegetation establishment does not meet Rule 1004 standards.

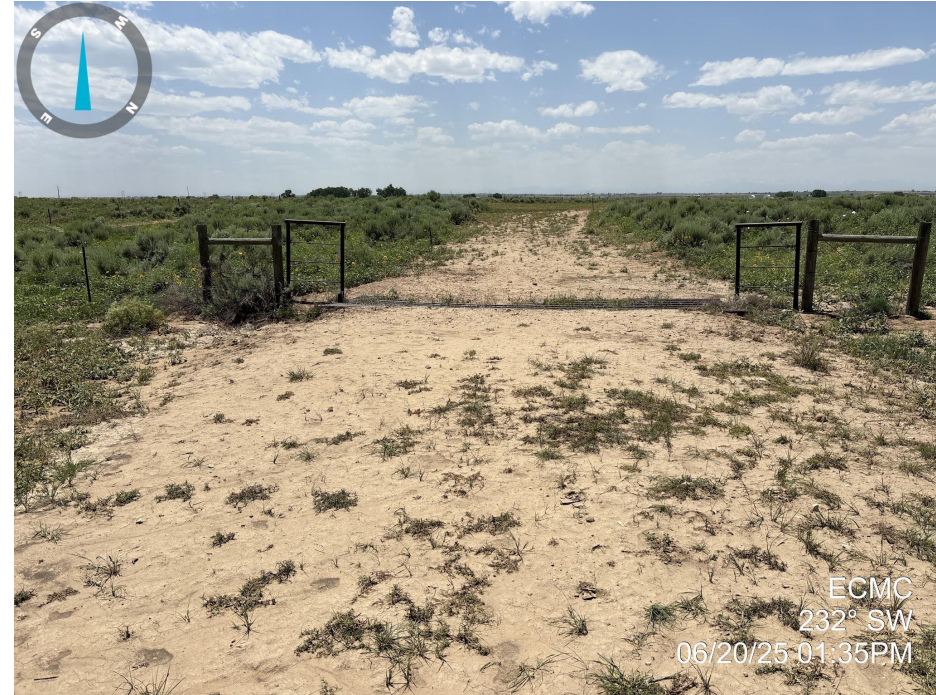
Photo 6. Photo taken of the access road, facing southwest. See comments under Photo 5.

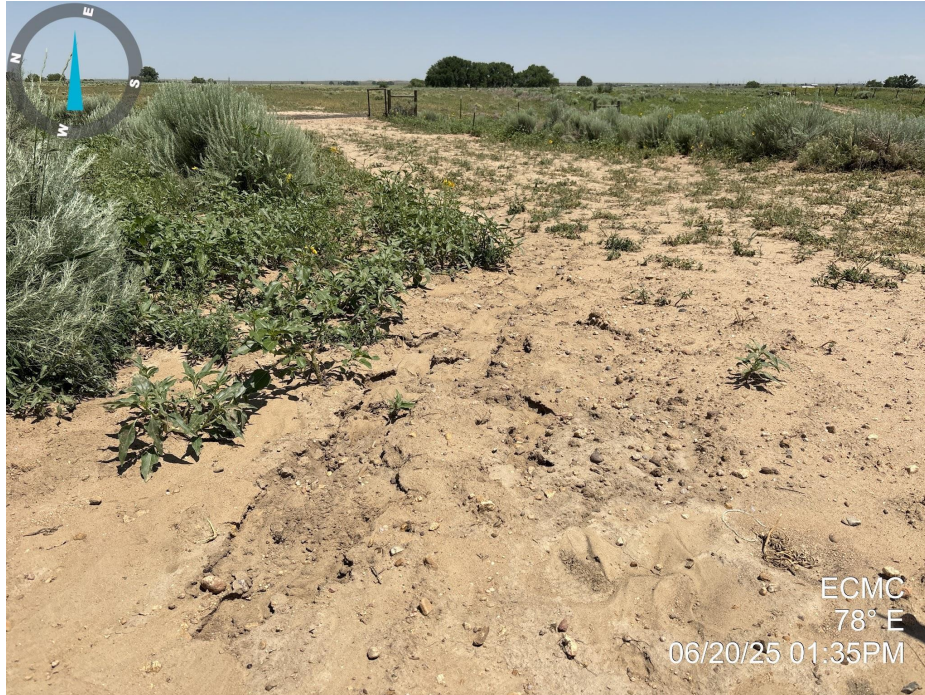
Photo 7. Photo taken of the access road to the well location, facing east. Photo illustrates stormwater erosion along the access road.

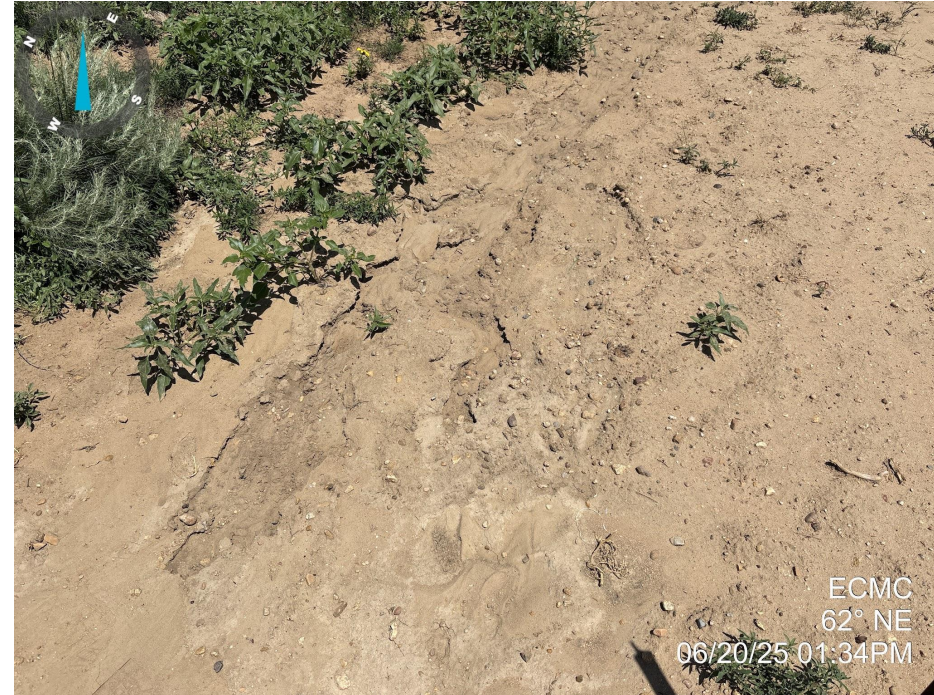
Photo 8. Photo taken of the access road. Photo illustrates stormwater erosion.

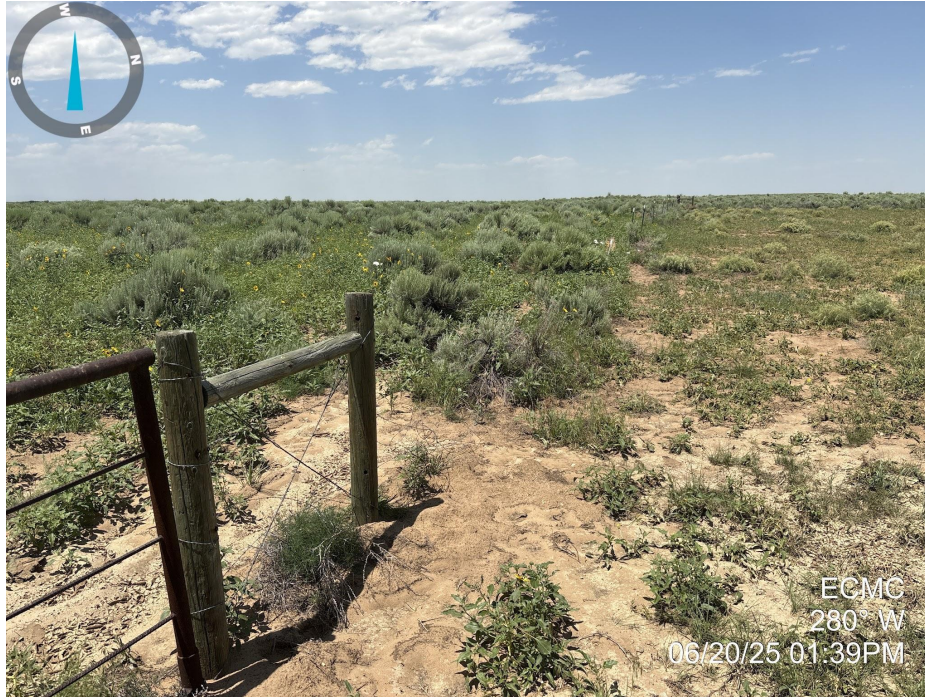
Photo 9. Photo taken from the entrance to the well location, facing west. Photo illustrates fencing remains in place, but is in disrepair.

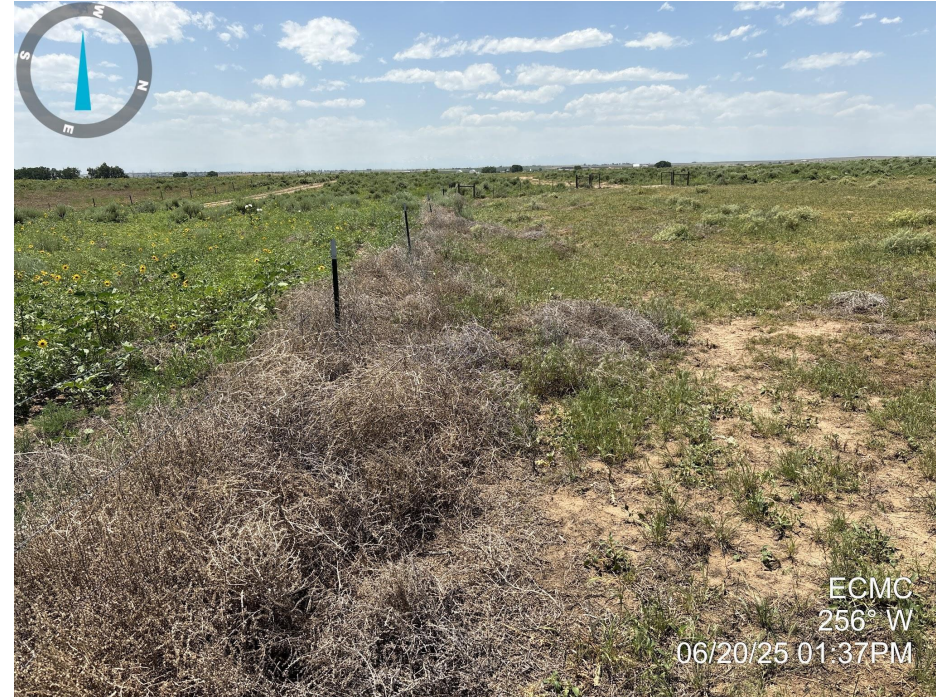
Photo 10. Photo taken from the southern perimeter to the well location, facing west. Photo illustrates weed debris in the form of russian thistle (*Salsola tragus*) was observed in the fence line.

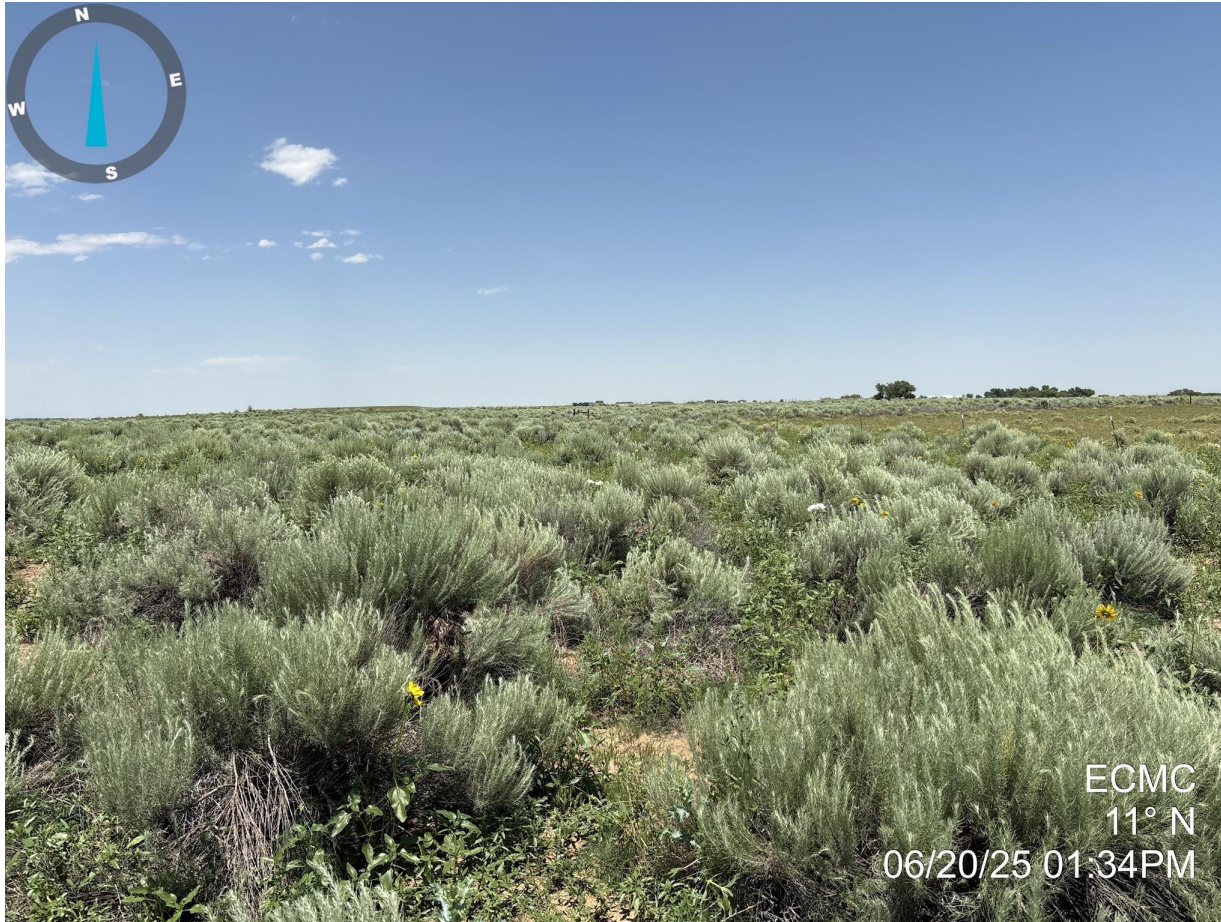
Photo 11. Photo taken of the reference area, located west of the well location, facing north. Photo illustrates that the location is dominated by sand sagebrush (*Artemisia filifolia*).
