Final Reclamation Inspection

Operator: NOBLE ENERGY INC - 100322

Location ID: 420050

Inspection Photos
Location Name: DECHANT STATE H #36-18D
Location ID: 420050

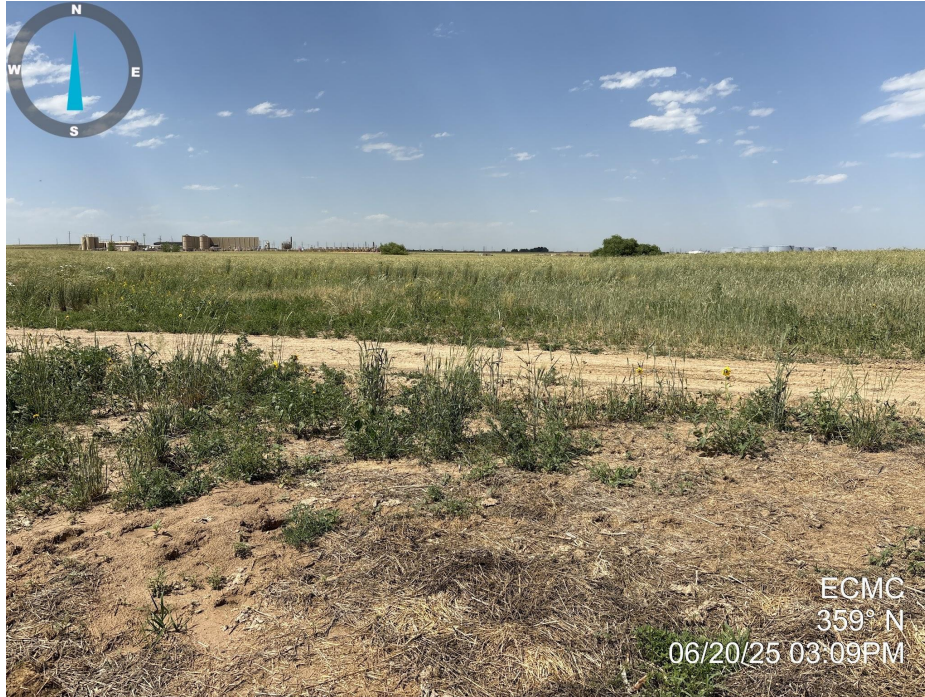
Photo 1. Photo taken from the multi-well location, facing North. Photo illustrates final reclamation activities have taken place, with evidence of straw mulch, but vegetation has not established to Rule 1004 standards at the location.

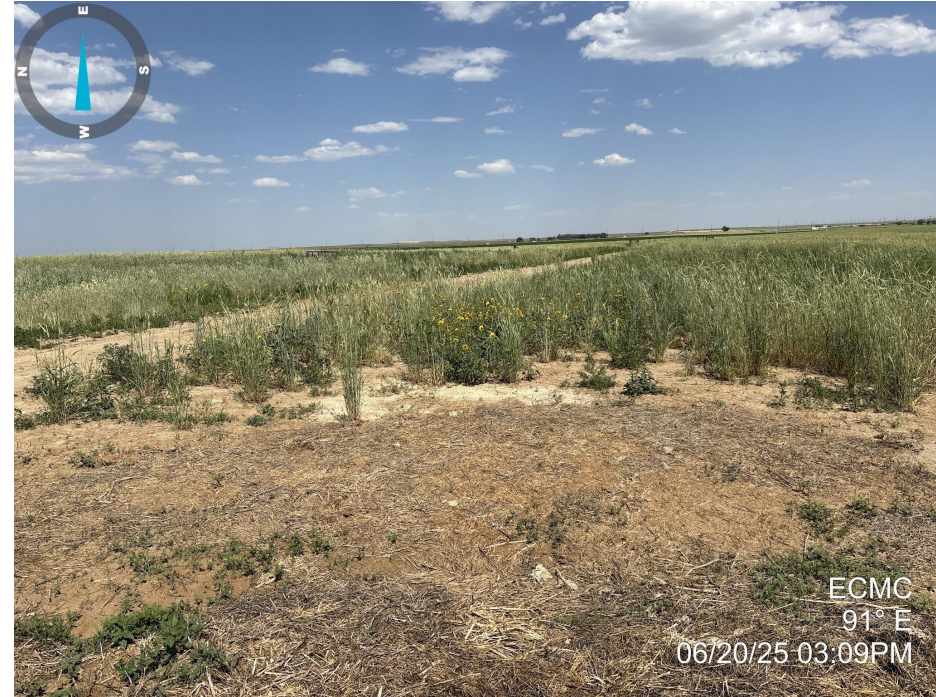
Photo 2. Photo taken from the multi-well location, facing East. See comments under Photo 1.

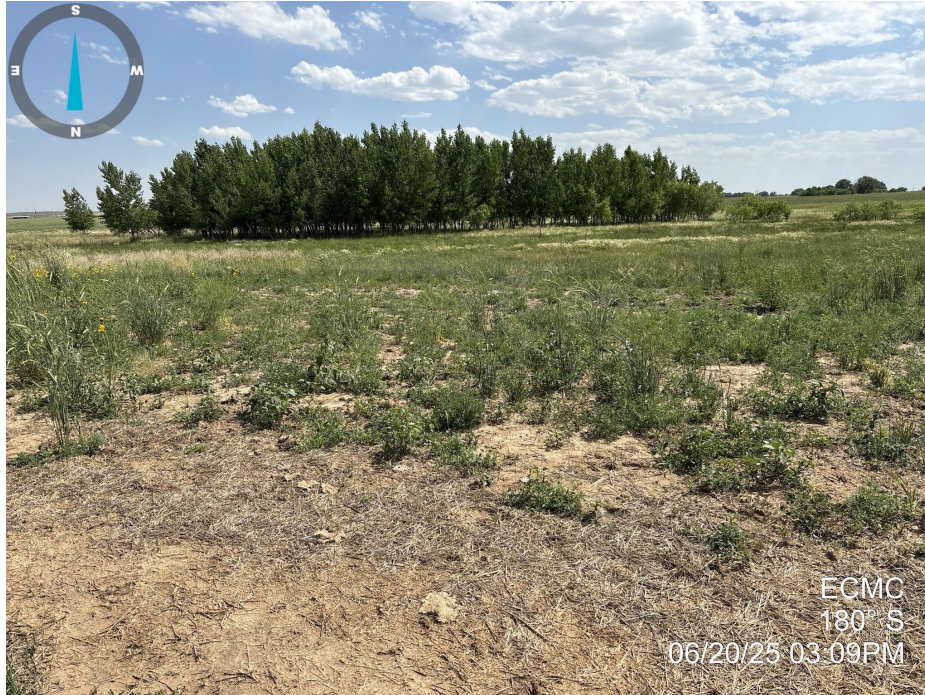
Photo 3. Photo taken from the multi-well location, facing South. See comments under Photo 1.

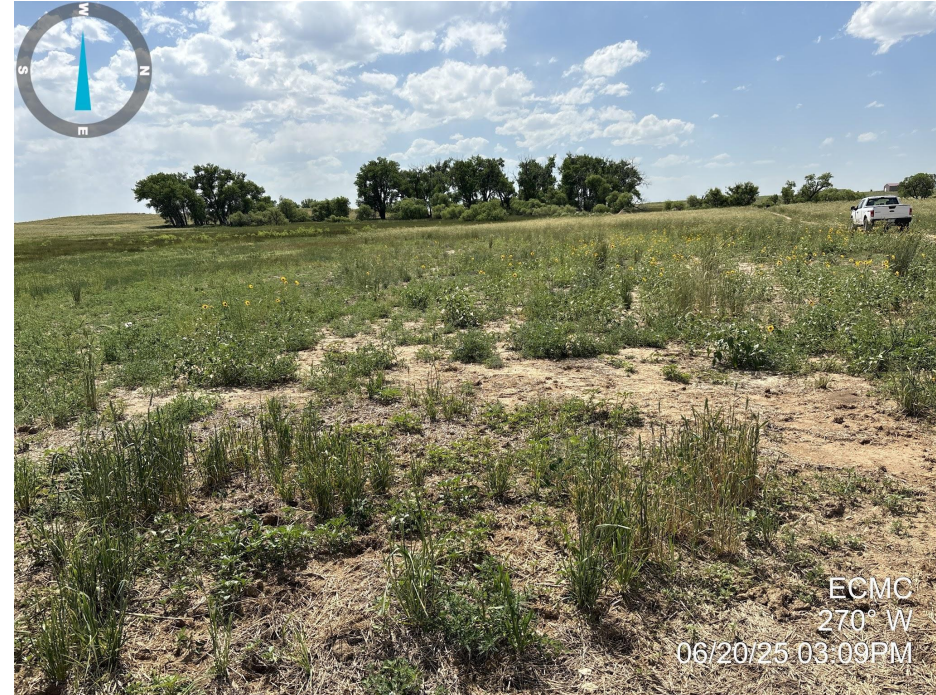
Photo 4. Photo taken from the multi-well location, facing West. See comments under Photo 1.

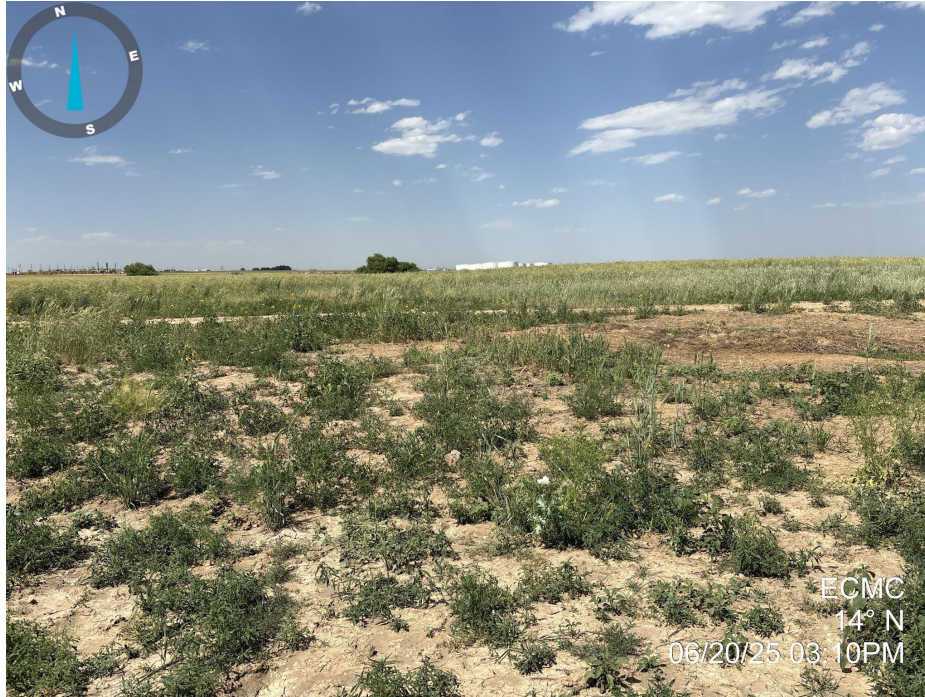
Photo 5. Photo taken of the multi-well location, facing North. Photo illustrates that vegetation has not established to Rule 1004 standards.

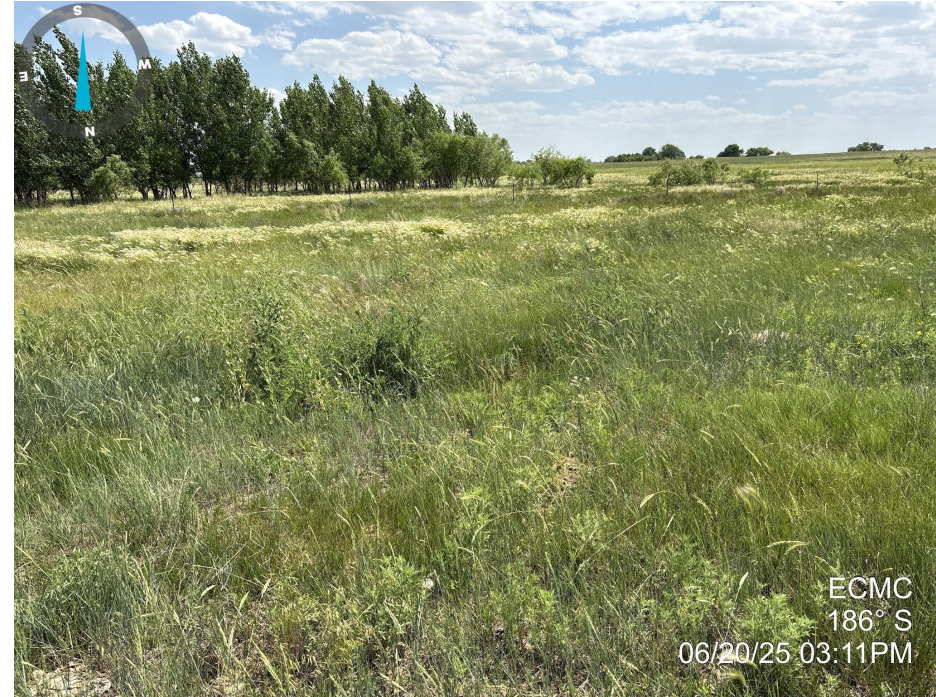
Photo 6. Photo taken of the reference area, located south of the location, facing south. Photo illustrates perennial grass vegetation.
