# Final Reclamation Inspection

Operator: NOBLE ENERGY INC - 100322

Location ID: 420221

Inspection Photos  
Location Name: DECHANT/H36-24 TANK  
Location ID: 420221

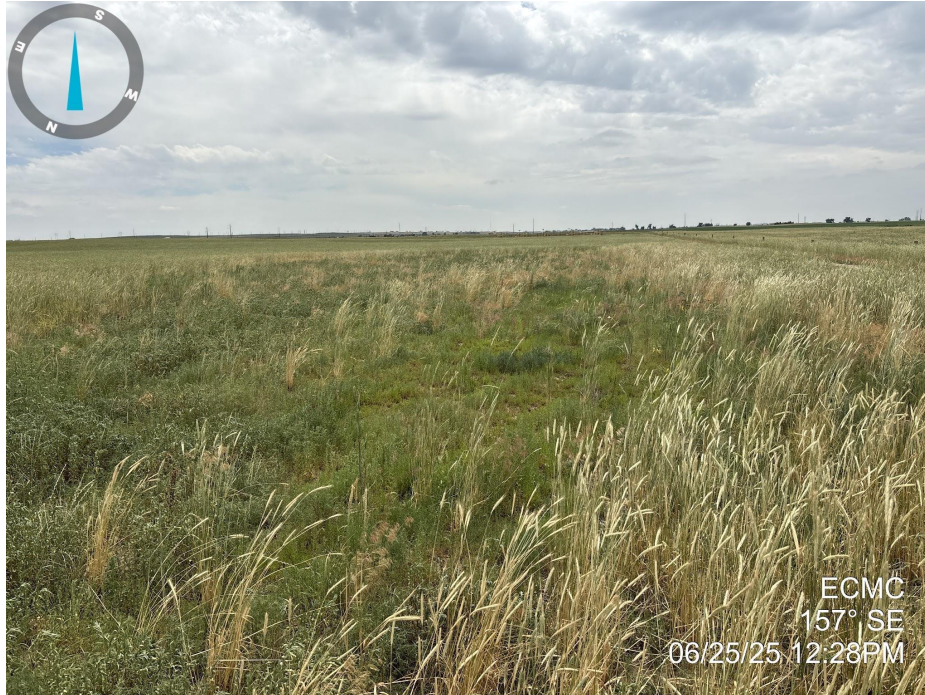
**Photo 1.** Photo taken from the tank battery location, facing southeast. Photo illustrates that final reclamation activities have taken place, but vegetation establishment does not meet Rule 1004 standards. Bare ground and weedy annual vegetation, including cheatgrass (*Bromus tectorum*), a List C Noxious Weed species, were observed across the location.

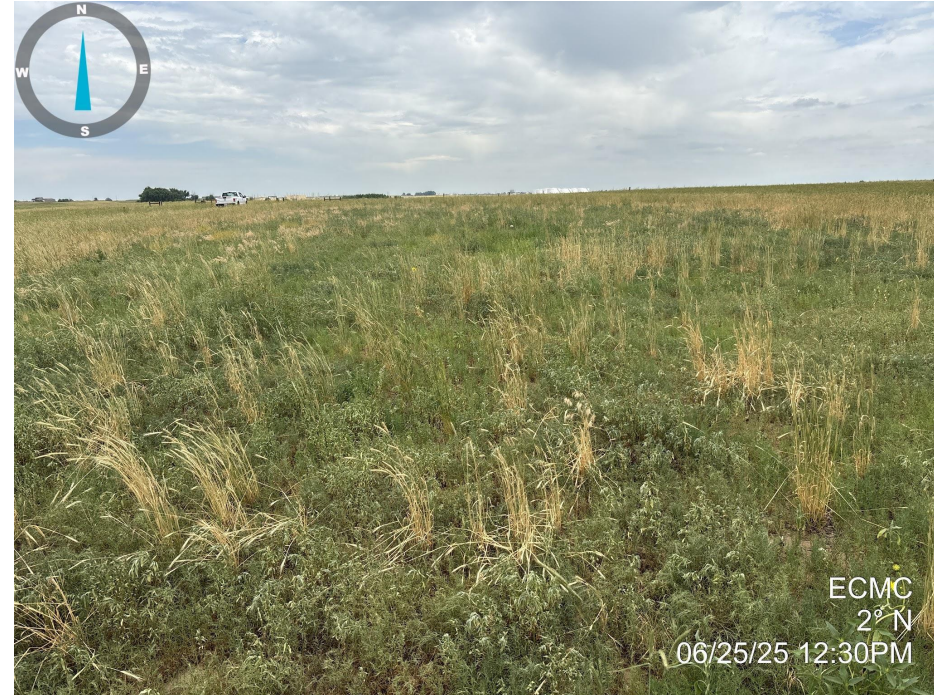
**Photo 2.** Photo taken from the tank battery location, facing north. See comments under Photo 1.

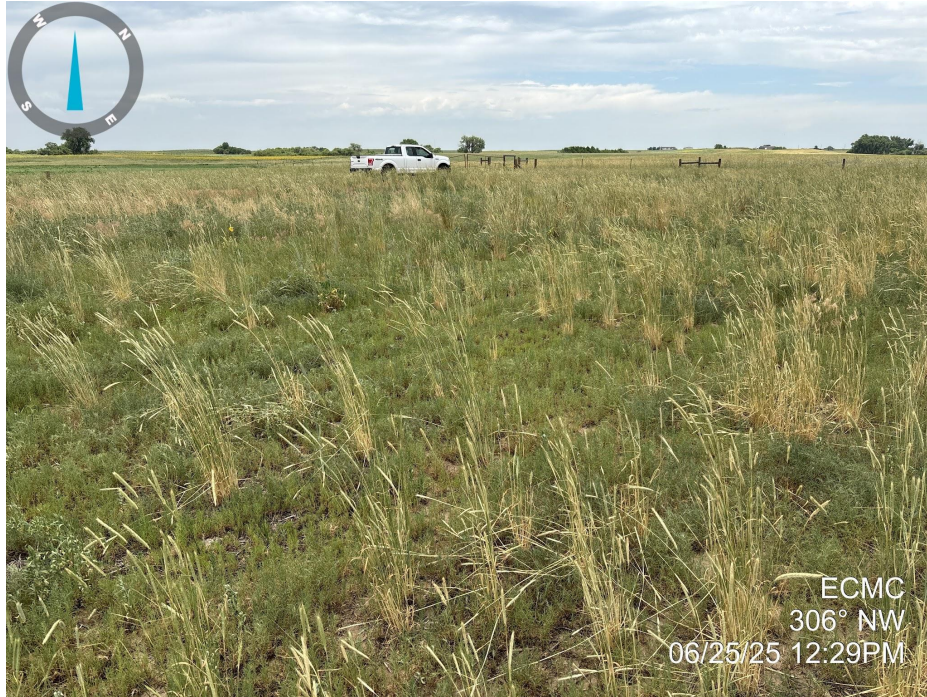
**Photo 3.** Photo taken of the tank battery location, facing northwest. See comments under Photo 1.

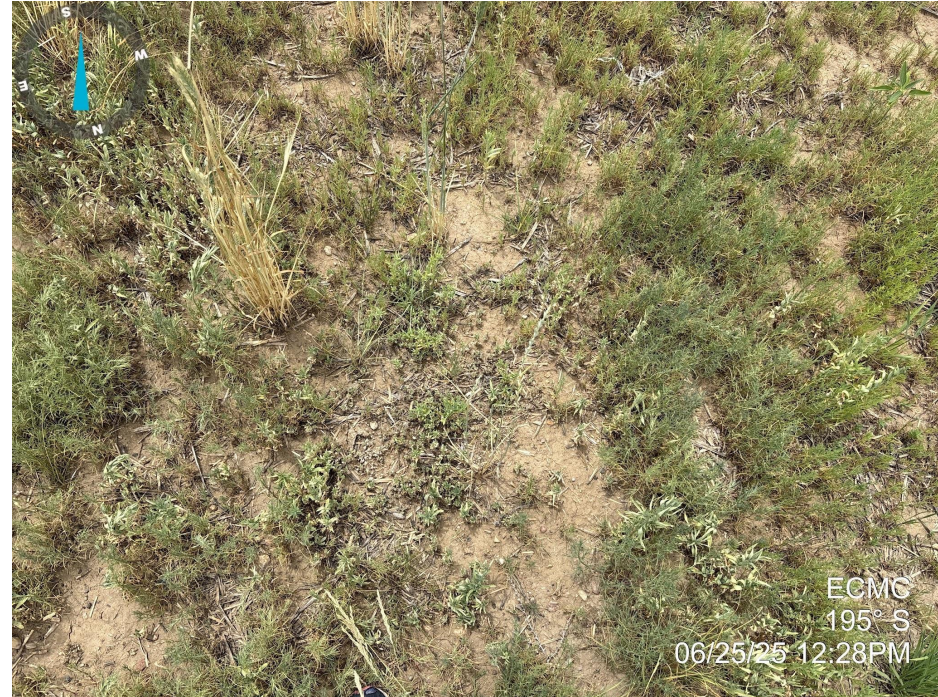
**Photo 4.** Photo taken of ground cover at the tank battery location. Photo illustrates patches of bare ground and weedy annual vegetation.

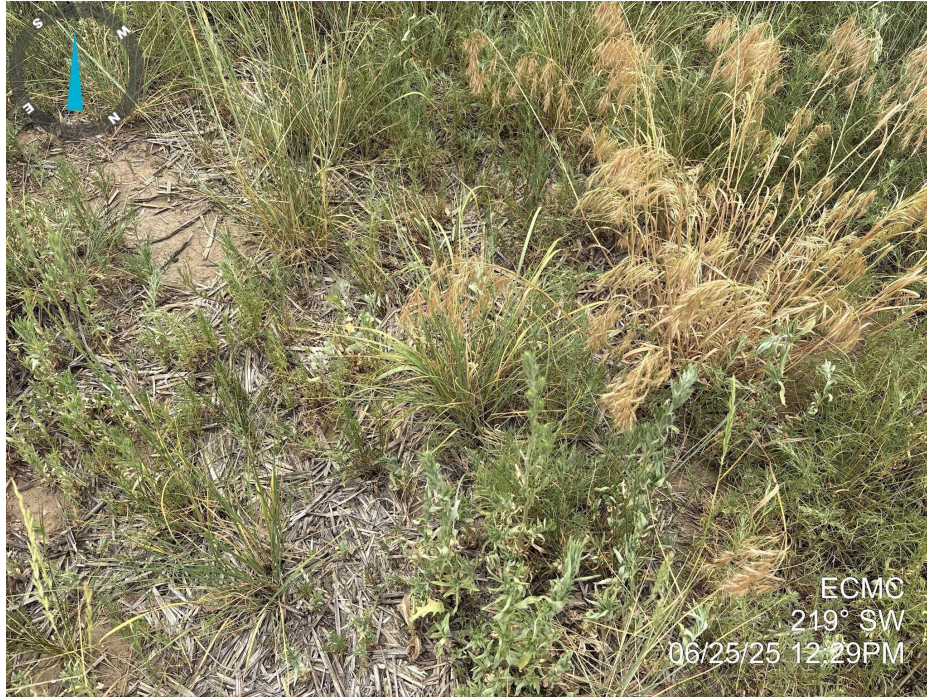
**Photo 5.** Photo taken of ground cover at the tank battery location. Photo illustrates cheatgrass (*Bromus tectorum*), a List C Noxious Weed species, which was observed across the location.

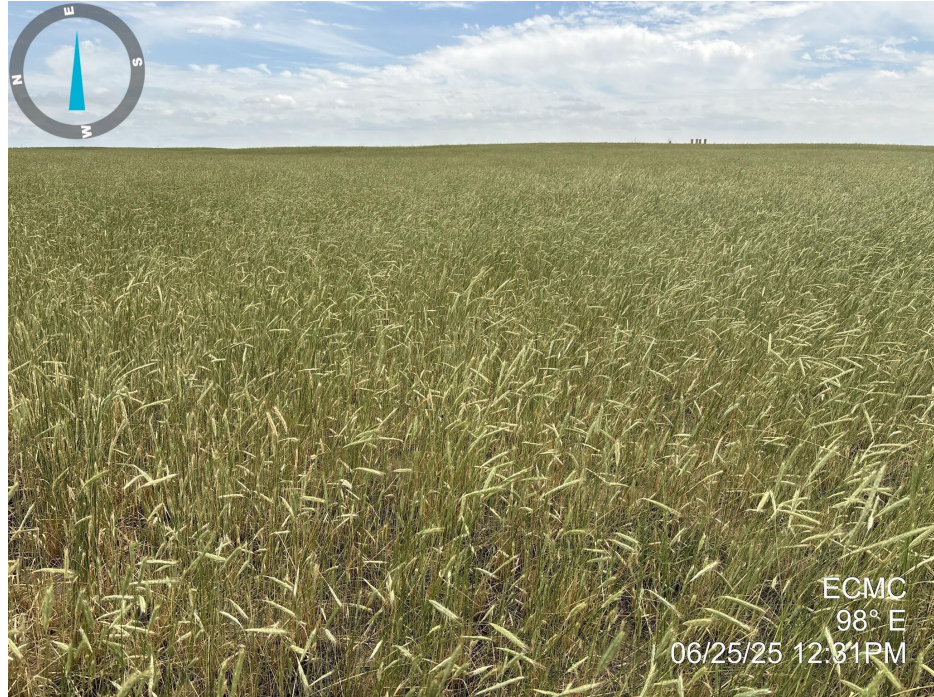
**Photo 6.** Photo taken of the reference area to the tank battery location, located south of the location, facing east. Photo illustrates rye cropland.
