Final Reclamation Inspection

Operator: NOBLE ENERGY INC - 100322

Location ID: 328692

Location Name: DECHANT STATE #H36-20D

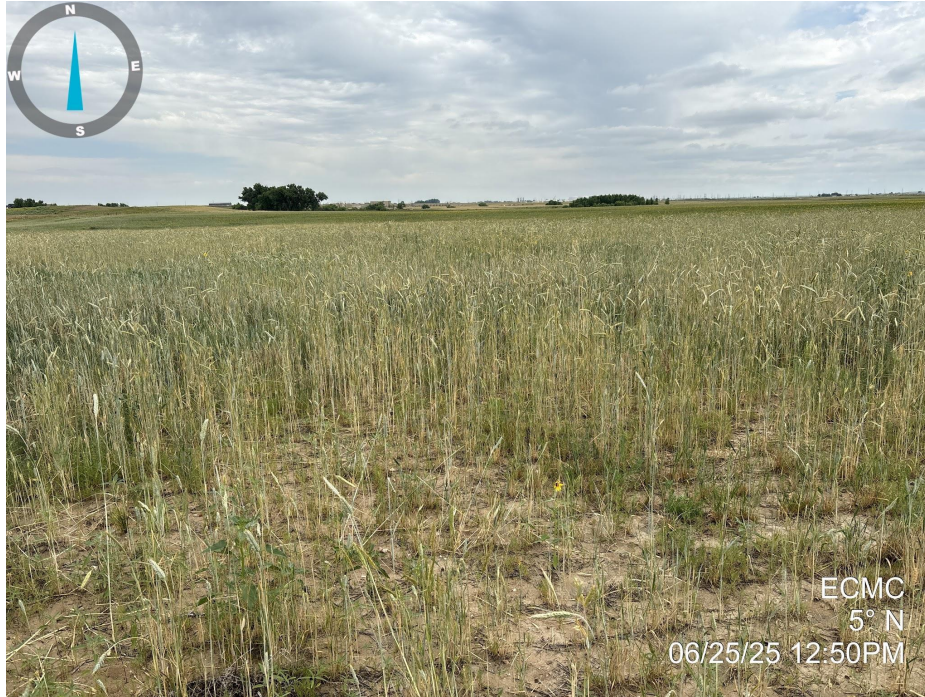
Photo 1. Photo taken from the multi-well location, facing North. Photo illustrates that final reclamation activities have taken place, with evidence of drill row seeding, but vegetation establishment does not meet Rule 1004 standards.

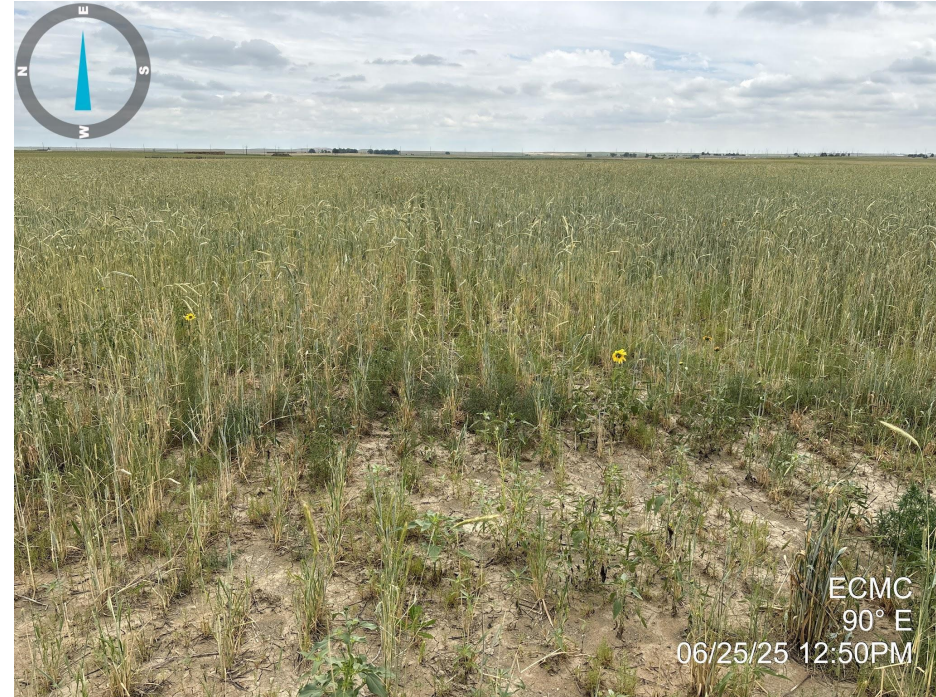
Photo 2. Photo taken from the multi-well location, facing East. See comments under Photo 1.

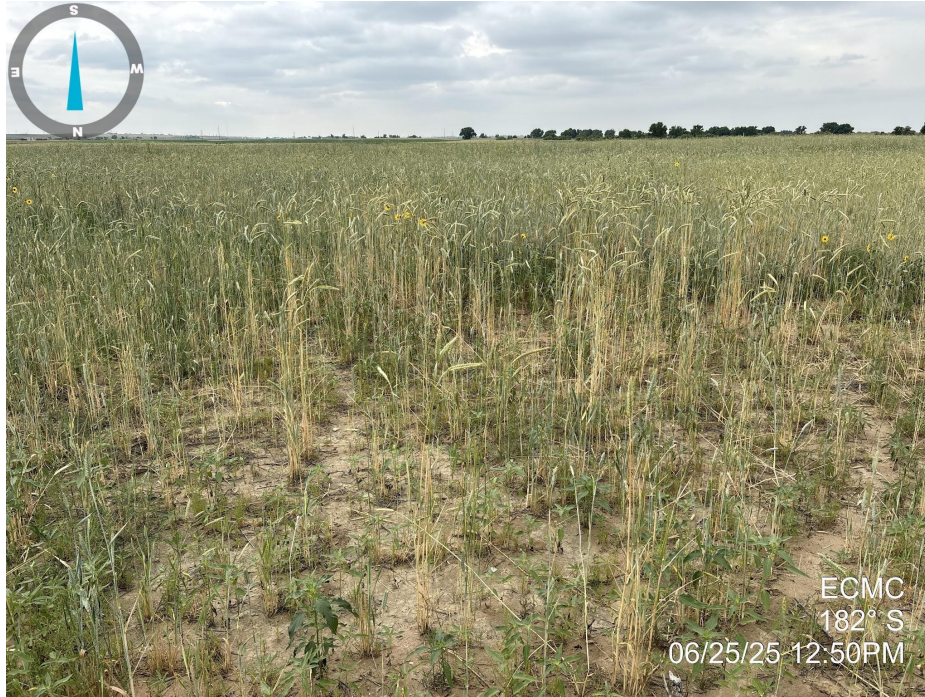
Photo 3. Photo taken from the multi-well location, facing South. See comments under Photo 1.

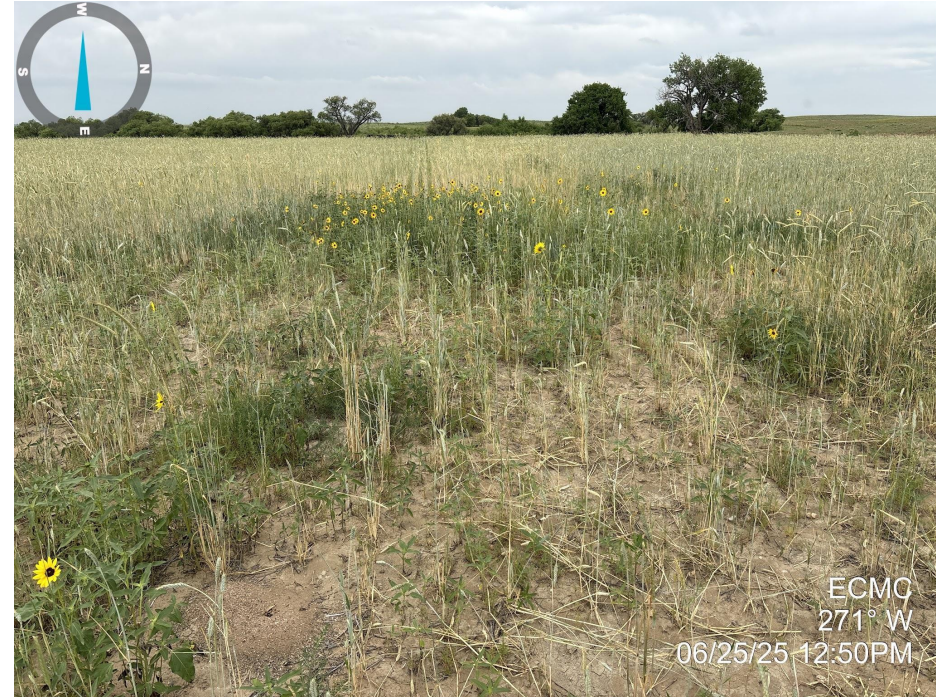
Photo 4. Photo taken from the multi-well location, facing West. See comments under Photo 1.

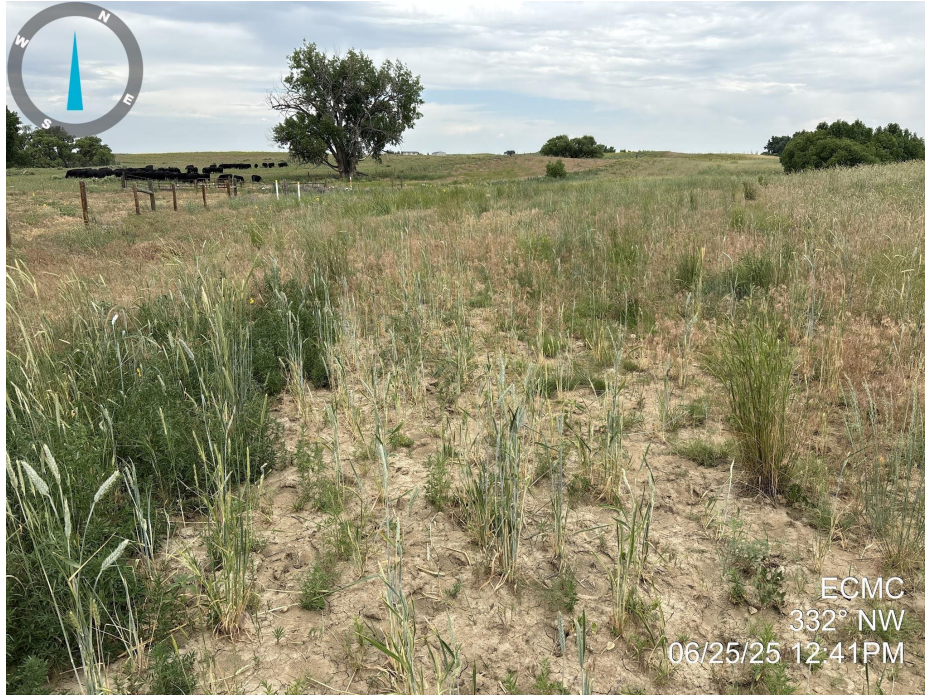
Photo 5. Photo taken of the access road to the multi-well location, facing northwest. Photo illustrates that final reclamation activities have taken place, with evidence of drill row seeding, but vegetation has not established to Rule 1004 standards. Weedy annual vegetation, including cheatgrass (*Bromus tectorum*), a List C Noxious Weed species, was observed along the road.

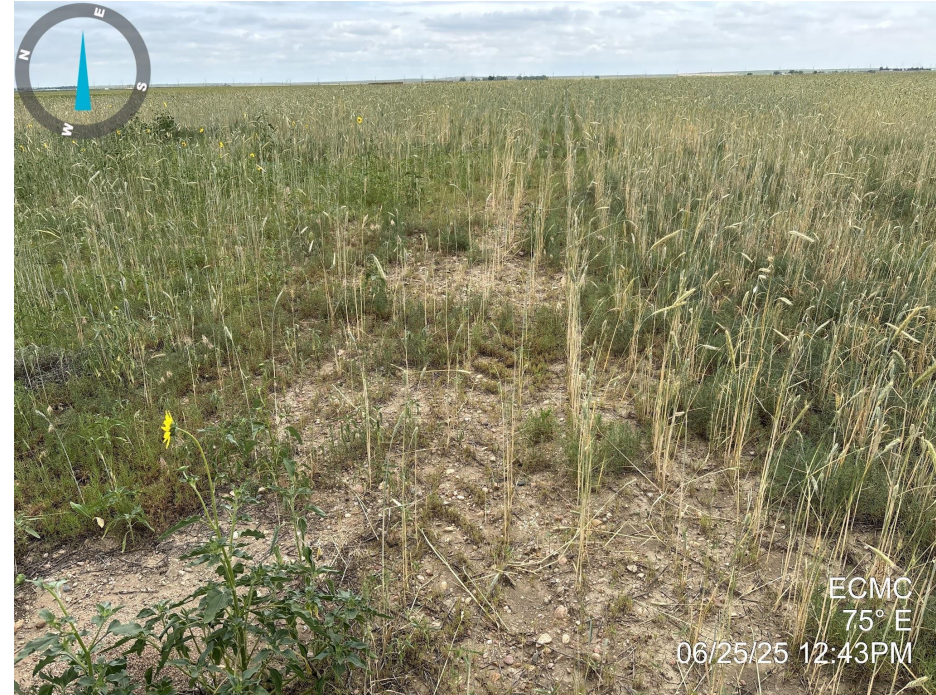
Photo 6. Photo taken of the access road to the multi-well location, facing east. Photo illustrates that gravel remains along this portion of the access road.

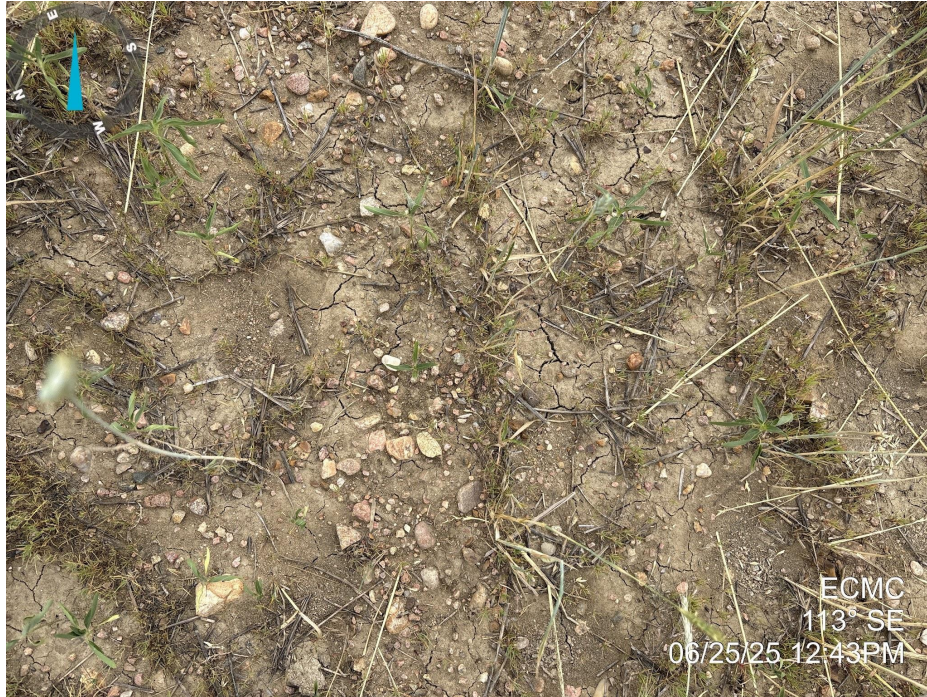
Photo 7. Photo taken of ground cover at the access road. Photo illustrates gravel that remains on a portion of the access road.

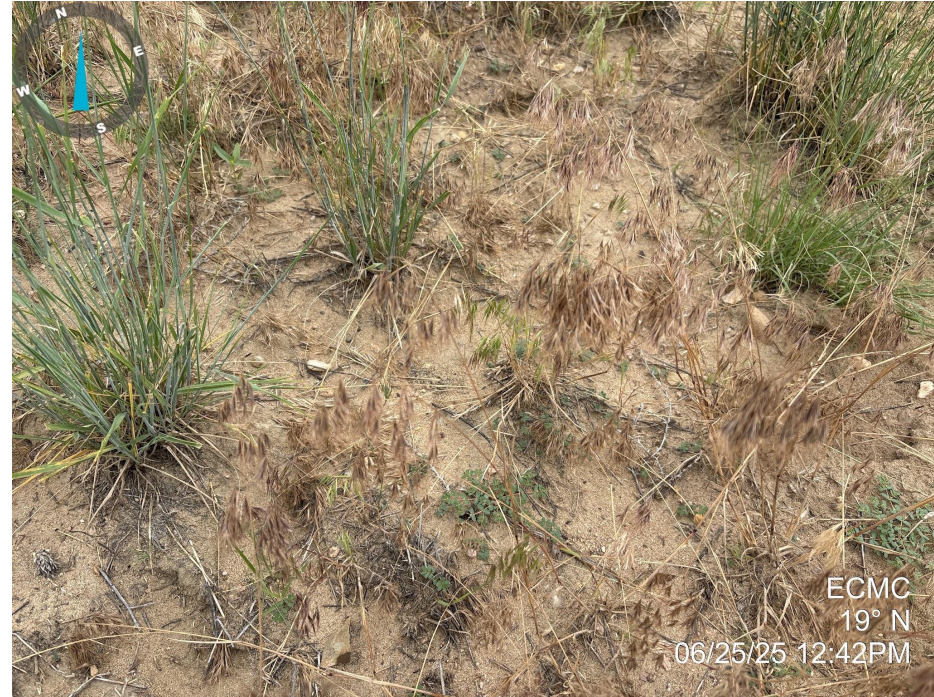
Photo 8. Photo taken of vegetation cover at the access road. Photo illustrates weedy annual vegetation, including cheatgrass (*Bromus tectorum*), a List C Noxious Weed species.

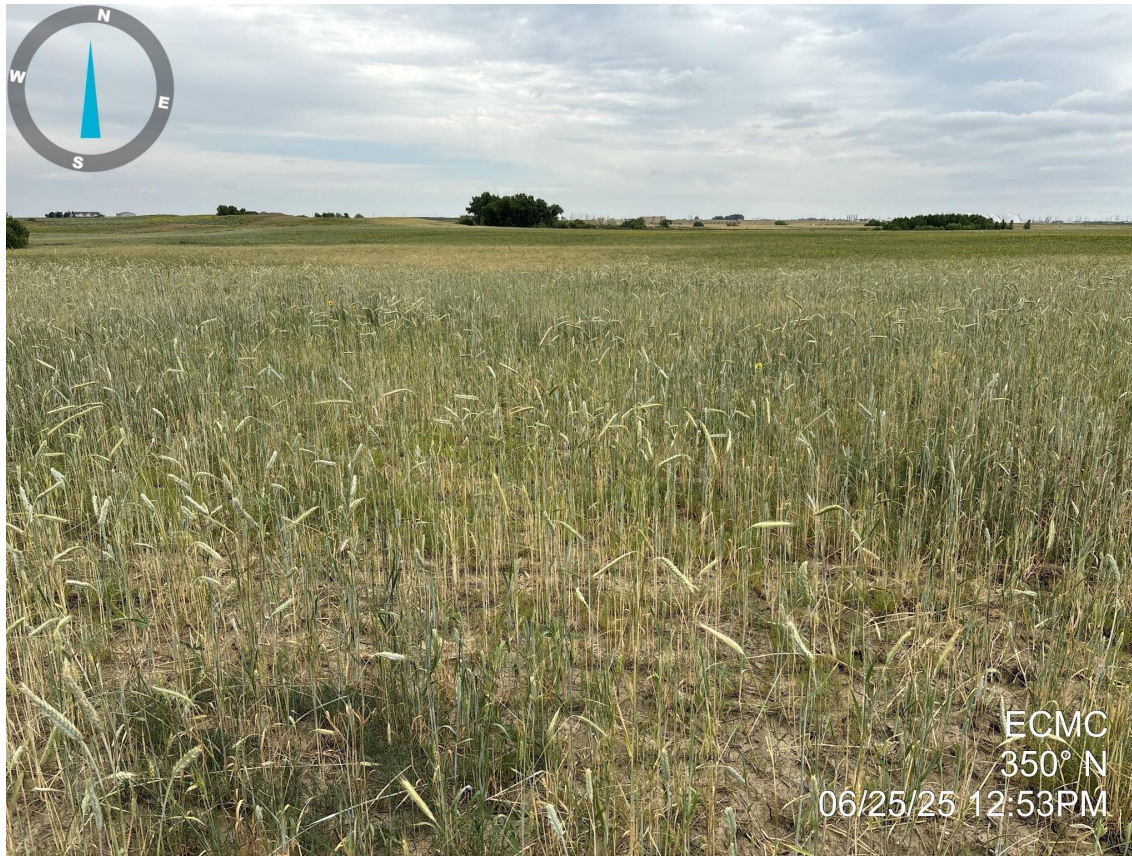
Photo 9. Photo taken of reference area to the multi-well location, east of the location, facing north. Photo illustrates rye cropland.
