Final Reclamation Inspection

Operator: NOBLE ENERGY INC - 100322

Location ID: 420219

Inspection Photos
Location Name: DECHANT STATE #H36-11
Location ID: 420219

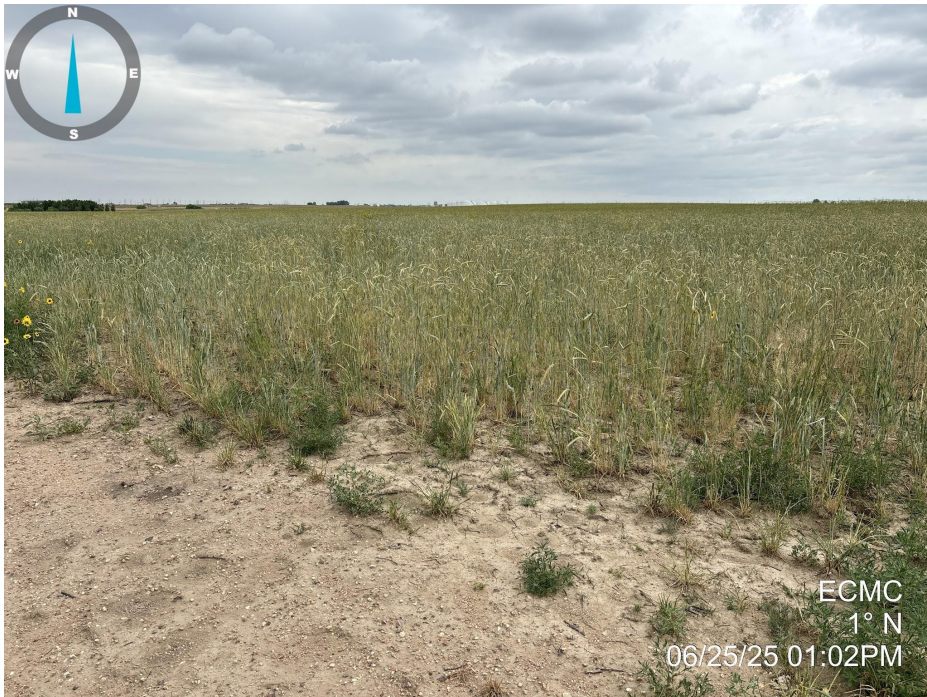
Photo 1. Photo taken from the multi-well location, facing North. Photo illustrates that final reclamation activities have taken place, but vegetation has not established to Rule 1004 standards. The location is adjacent to an access road.

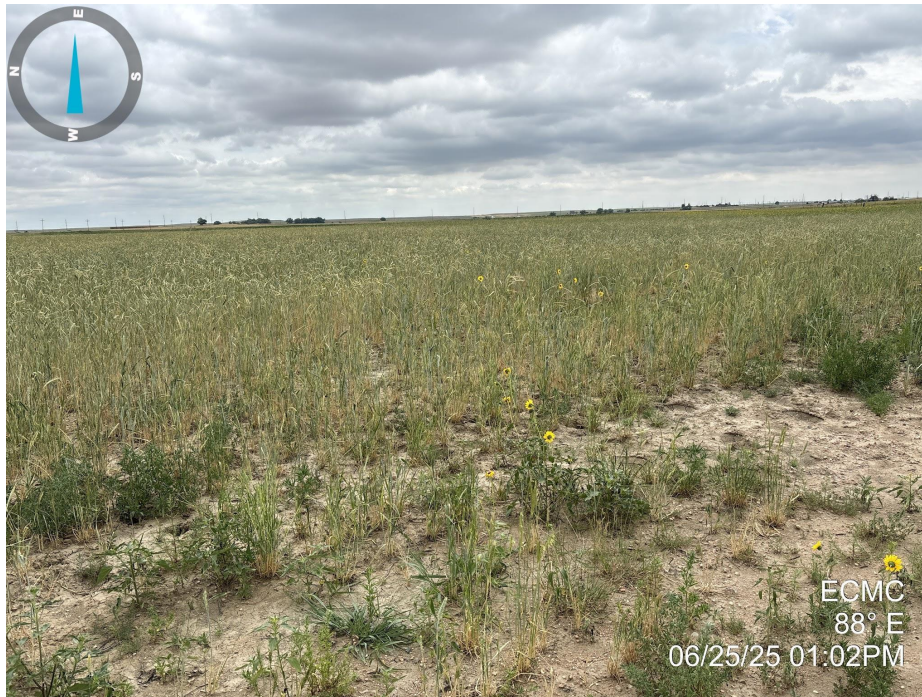
Photo 2. Photo taken from the multi-well location, facing East. See comments under Photo 1.

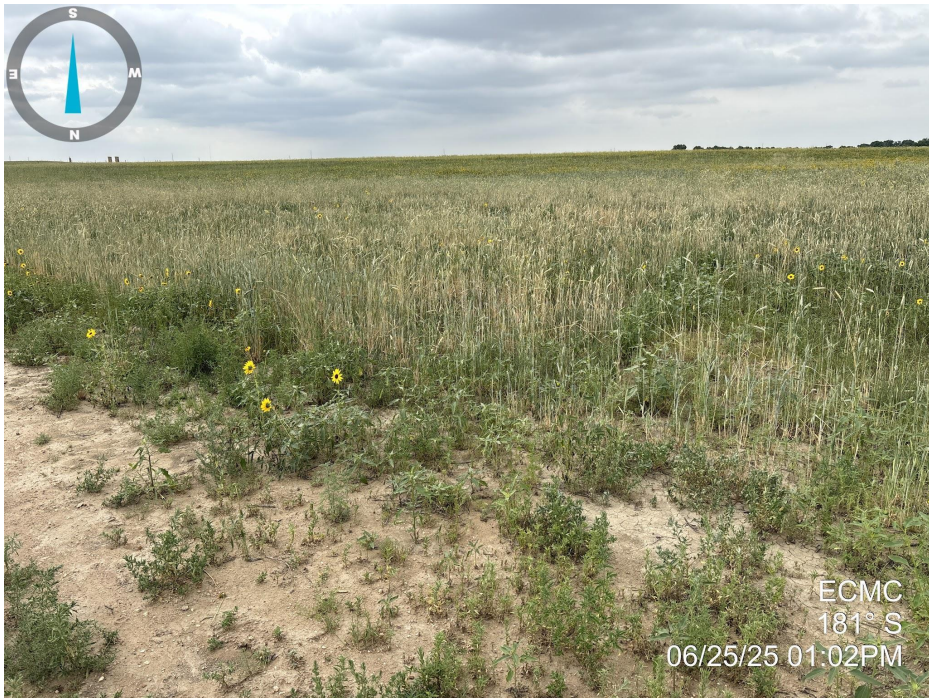
Photo 3. Photo taken from the multi-well location, facing South. See comments under Photo 1.

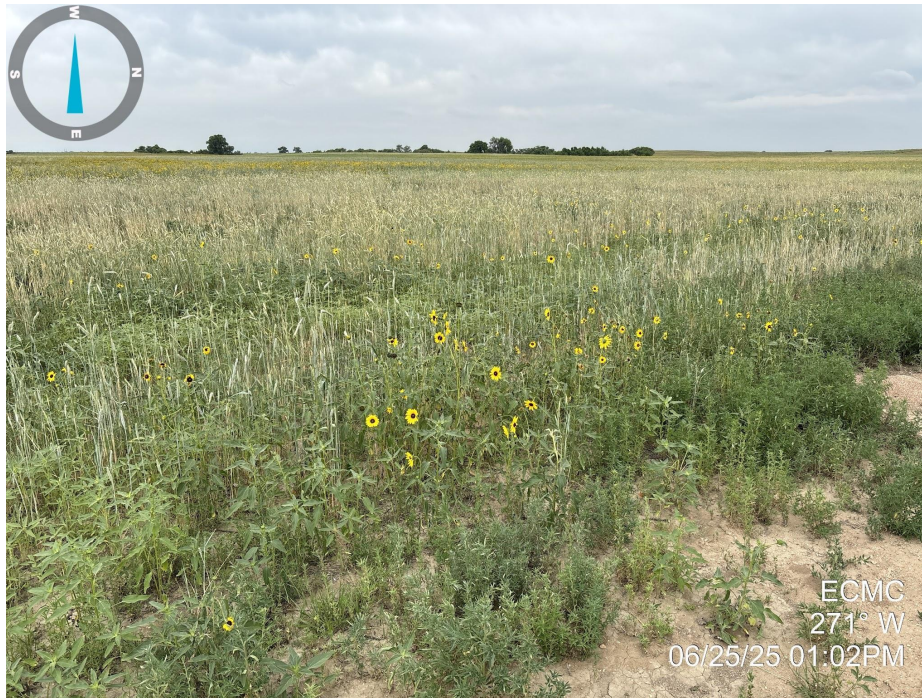
Photo 4. Photo taken from the multi-well location, facing West. See comments under Photo 1.

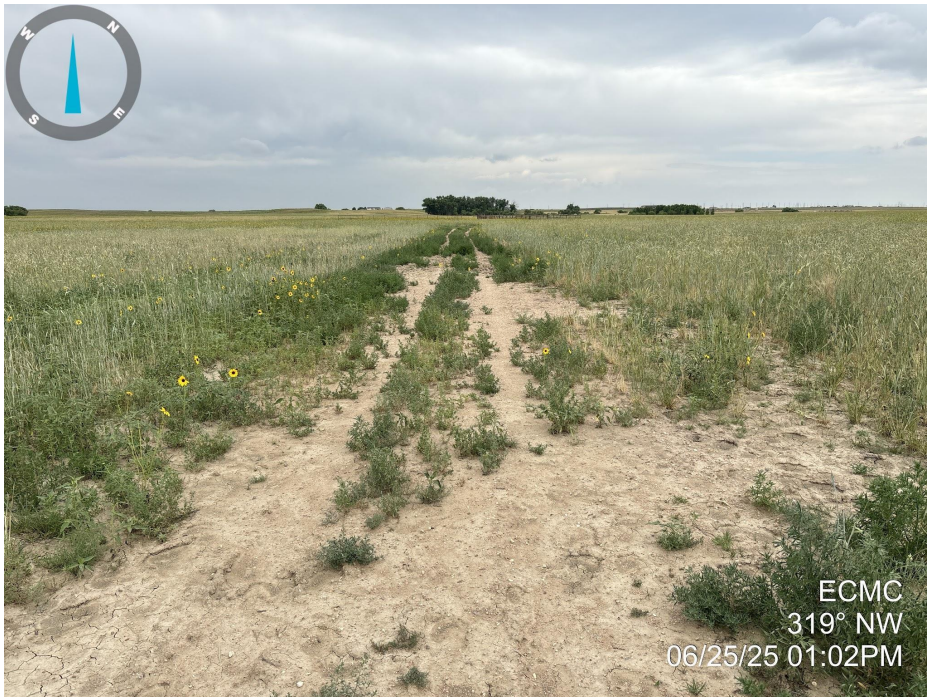
Photo 5. Photo taken of the multi-well location, facing northwest. Photo illustrates the location is adjacent to an access road in use by the landowner. Final reclamation does not meet Rule 1004 standards as bare ground remains at the well location along the northeastern portion of the access road.

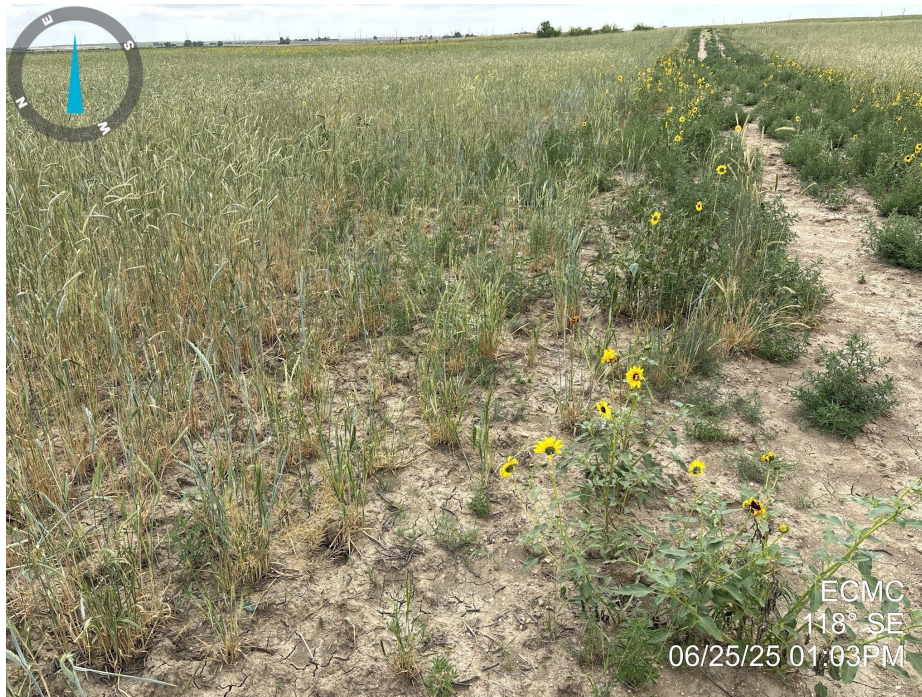
Photo 6. Photo taken of the reference area for the well location, southeast of the location, facing southeast. Photo illustrates annual vegetation adjacent to the access road and rye cropland.
