# Final Reclamation Inspection

Operator: NOBLE ENERGY INC - 100322

Location ID: 317694

Inspection Photos  
Location Name: DECHANT #H36-24  
Location ID: 317694

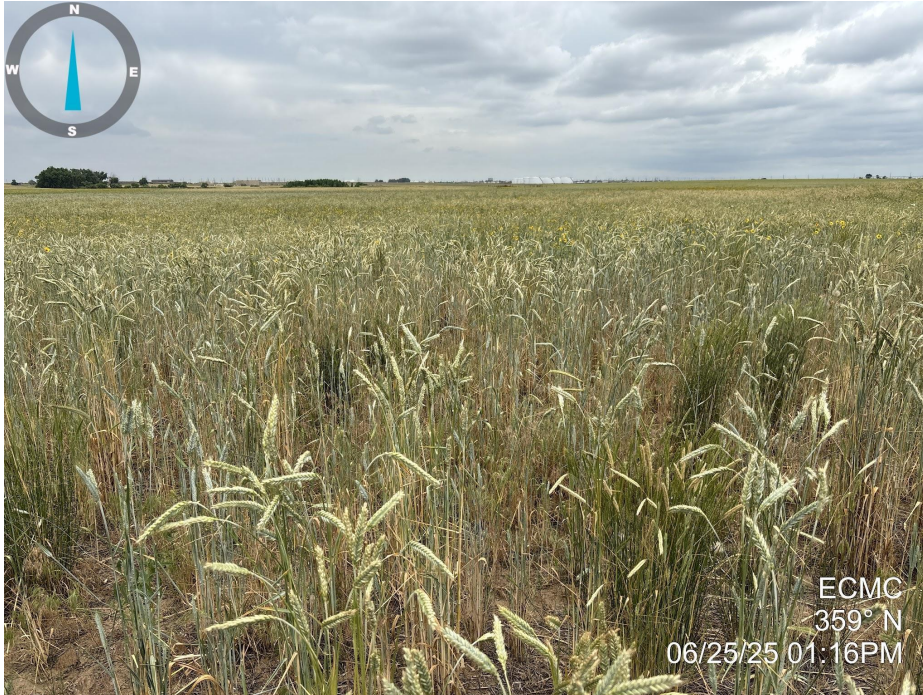
**Photo 1.** Photo taken from the multi-well location, from well API# 123-07590 (SPIKE STATE GWS H #36-11J), facing North. Photo illustrates that final reclamation activities have taken place, but weedy annual vegetation, including cheatgrass (*Bromus tectorum*), was observed across the location.

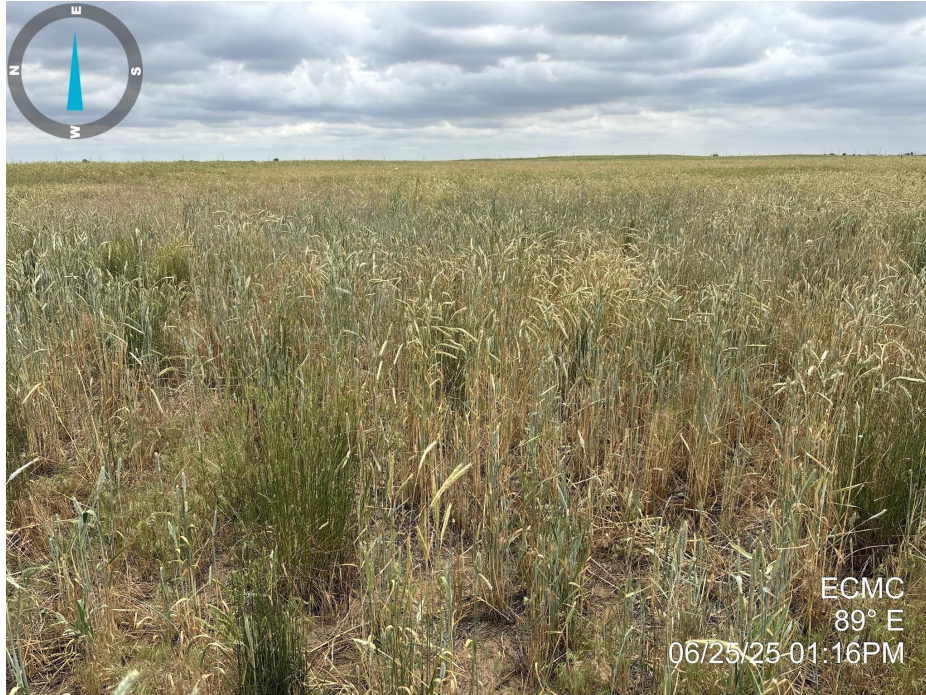
**Photo 2.** Photo taken from the multi-well location, from well API# 123-07590 (SPIKE STATE GWS H #36-11J), facing East. See comments under Photo 1.

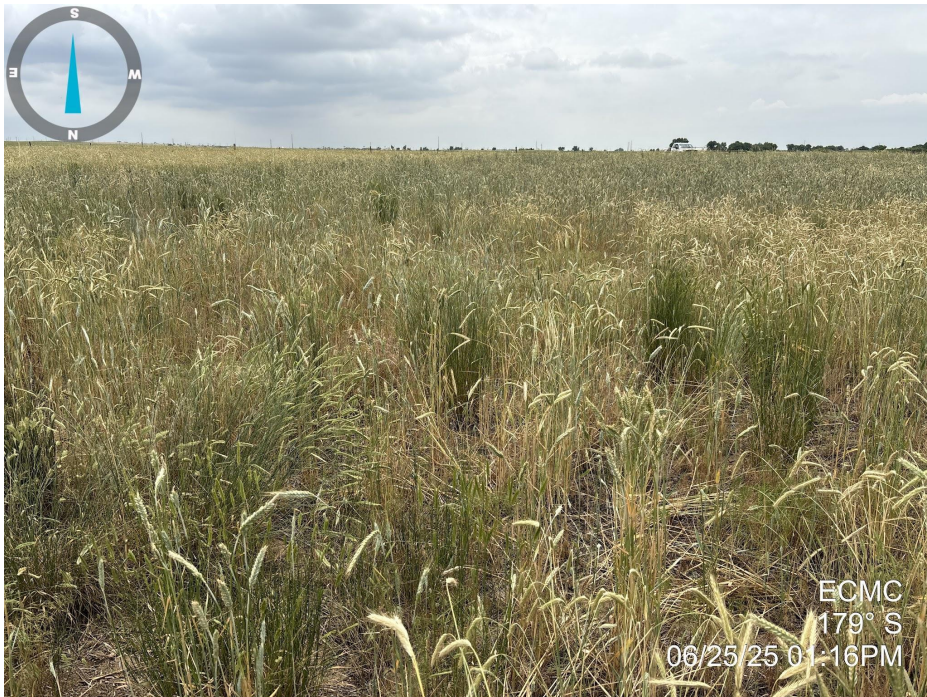
**Photo 3.** Photo taken from the multi-well location, from well API# 123-07590 (SPIKE STATE GWS H #36-11J), facing South. See comments under Photo 1.

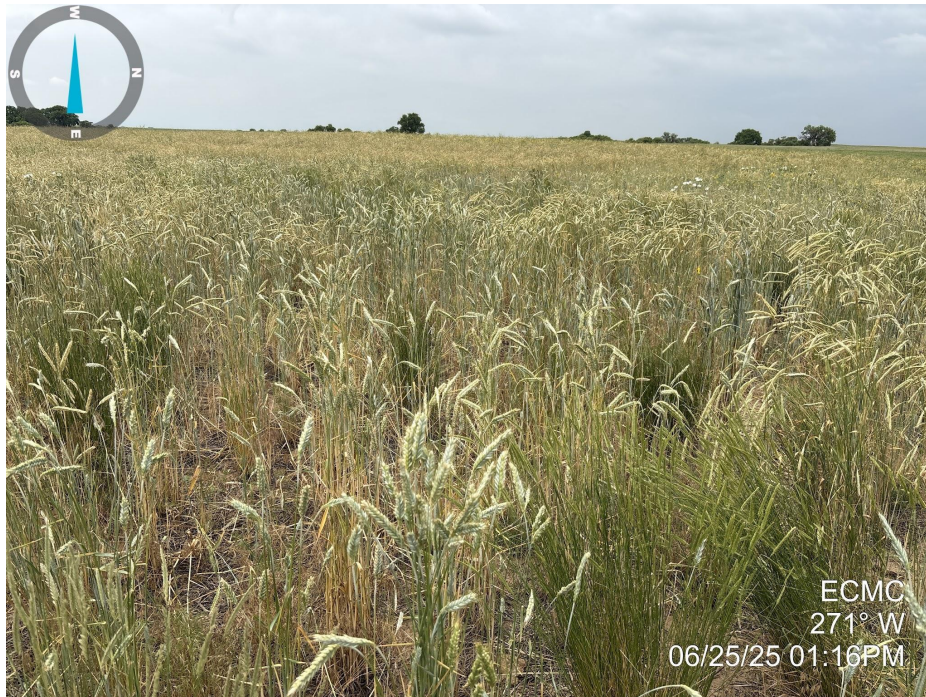
**Photo 4.** Photo taken from the multi-well location, from well API# 123-07590 (SPIKE STATE GWS H #36-11J), facing West. See comments under Photo 1.

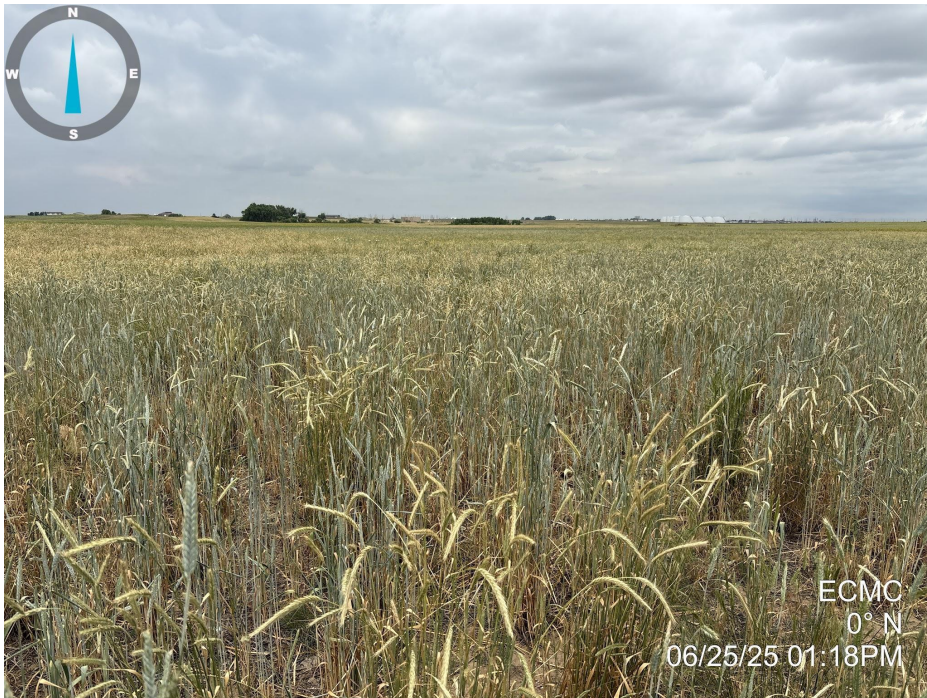
**Photo 5.** Photo taken from the multi-well location, from well API# 123-35254 (DECHANT STATE #H36-33D), facing North. See comments under Photo 1.

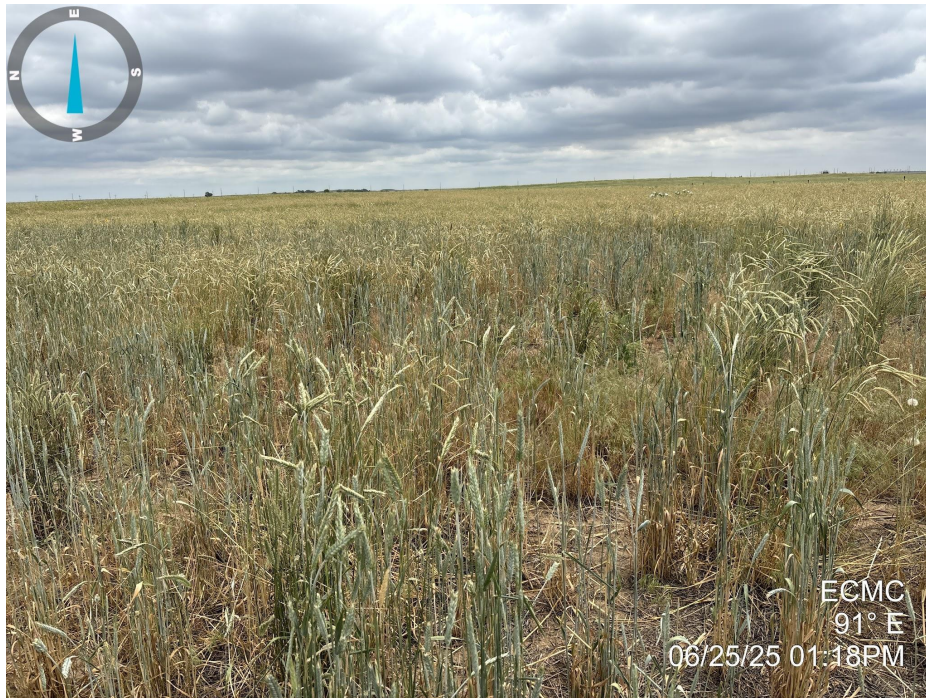
**Photo 6.** Photo taken from the multi-well location, from well API# 123-35254 (DECHANT STATE #H36-33D), facing East. See comments under Photo 1.

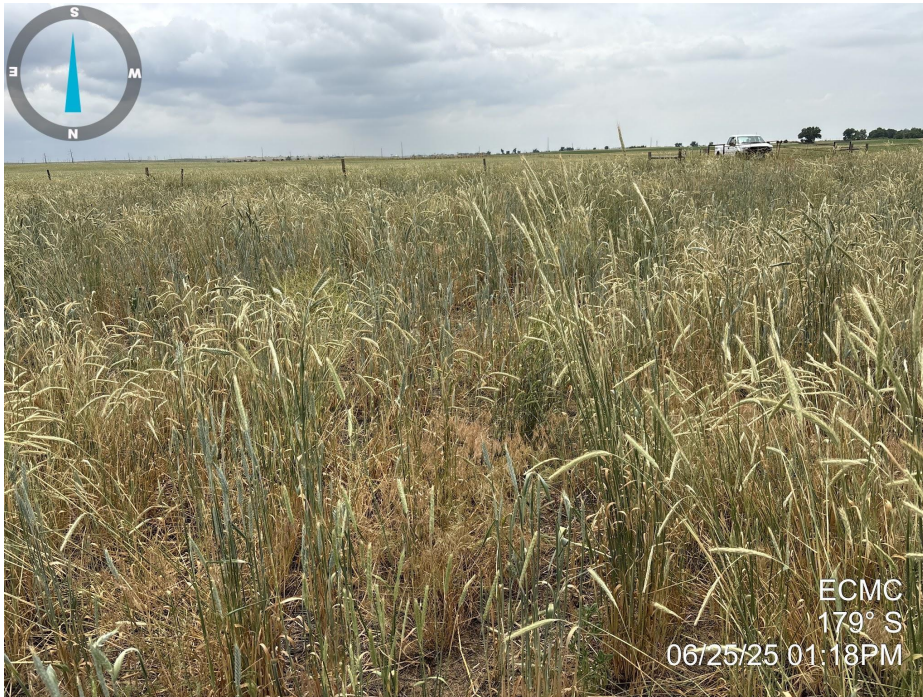
**Photo 7.** Photo taken from the multi-well location, from well API# 123-35254 (DECHANT STATE #H36-33D), facing South. See comments under Photo 1.

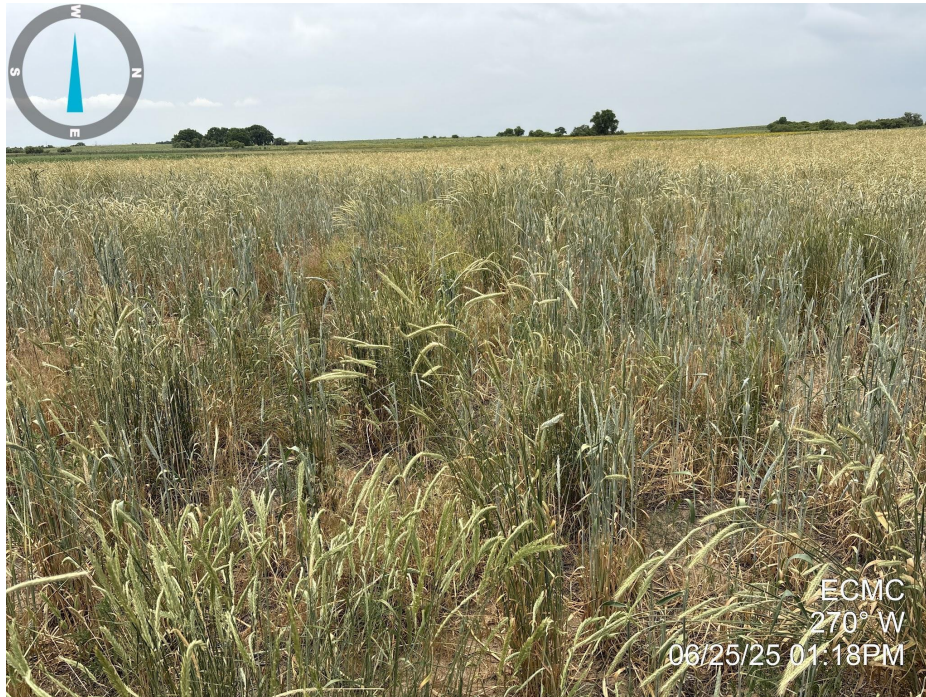
**Photo 8.** Photo taken from the multi-well location, from well API# 123-35254 (DECHANT STATE #H36-33D), facing West. See comments under Photo 1.

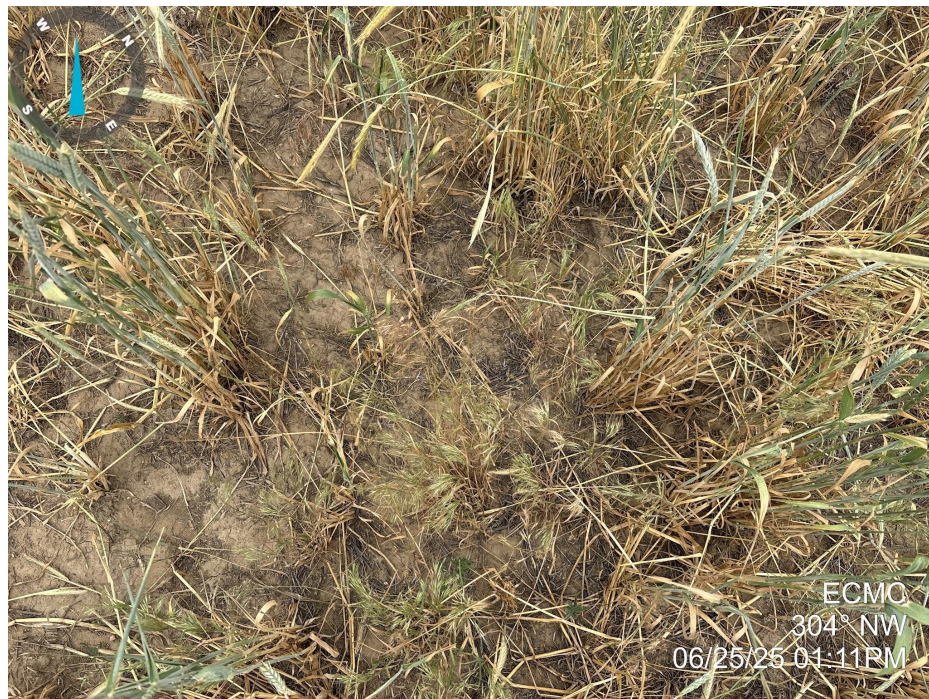
**Photo 9.** Photo taken of ground cover at the location. Photo illustrates cheatgrass (*Bromus tectorum*), a List C Noxious Weed species.

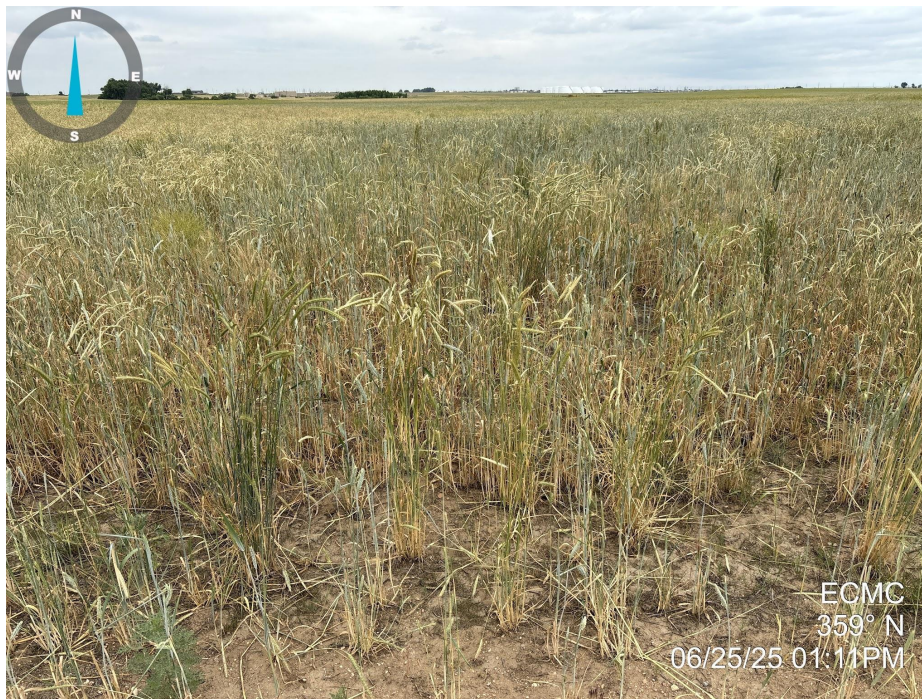
**Photo 10.** Photo taken of the access road to the well location. Photo illustrates final reclamation activities have taken place, but weedy annual vegetation, including cheatgrass (*Bromus tectorum*), was observed across the location.

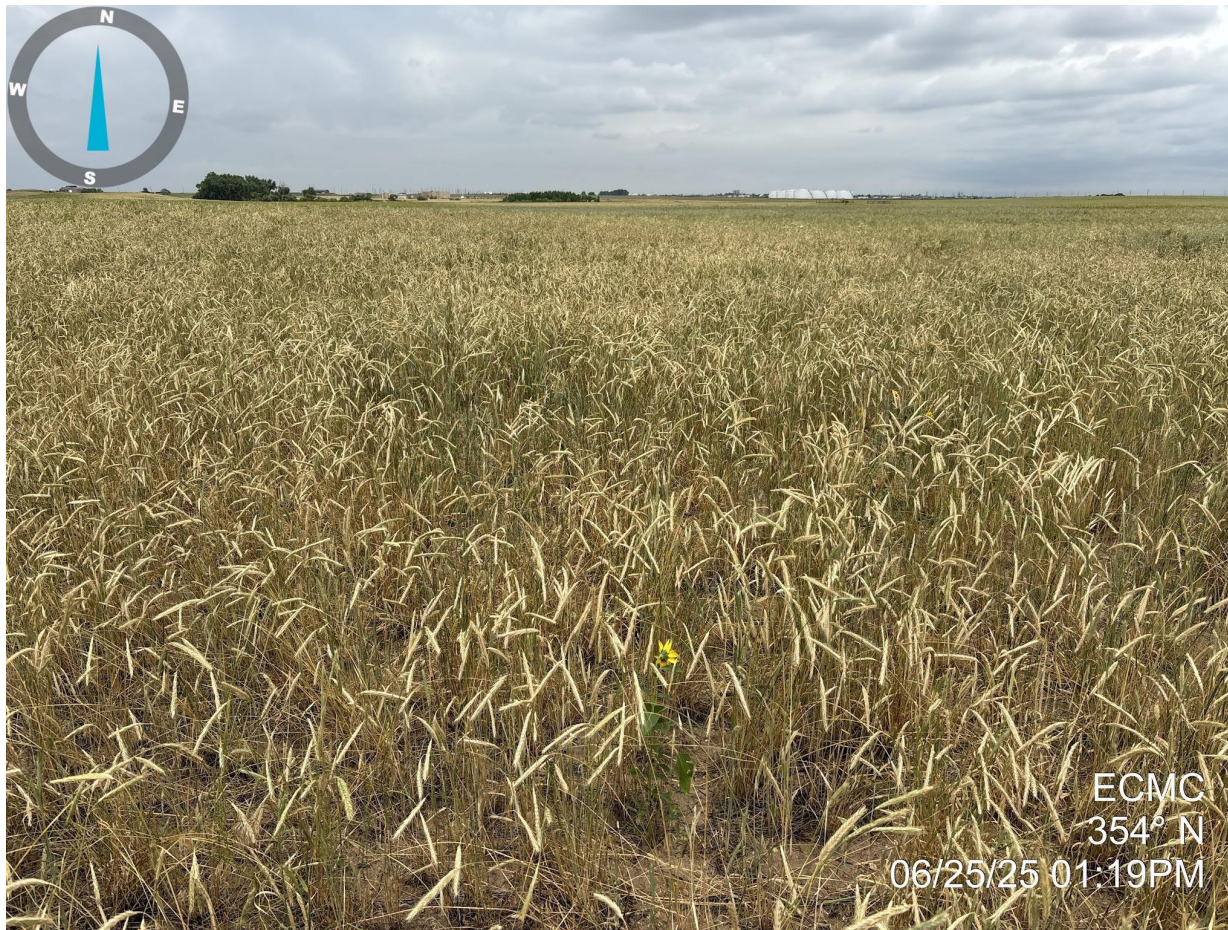
**Photo 11.** Photo taken of the reference area to the multi-well location, west of the location, facing north. Photo illustrates rye cropland.
