**Subject: Release Investigation Field Activities  
Garden Gulch 3 – Produced Water Release  
Logan Mesa  
Garfield County, Colorado**

## SOIL SAMPLING ACTIVITIES – GARDEN GULCH 3

**FIGURE 1**  
**SITE LOCATION MAP**  
**GARDEN GULCH 3**  
**LOT 2 SEC 7-T6S-R96W**  
**GARFIELD COUNTY, COLORADO**  
**QB ENERGY LLC**

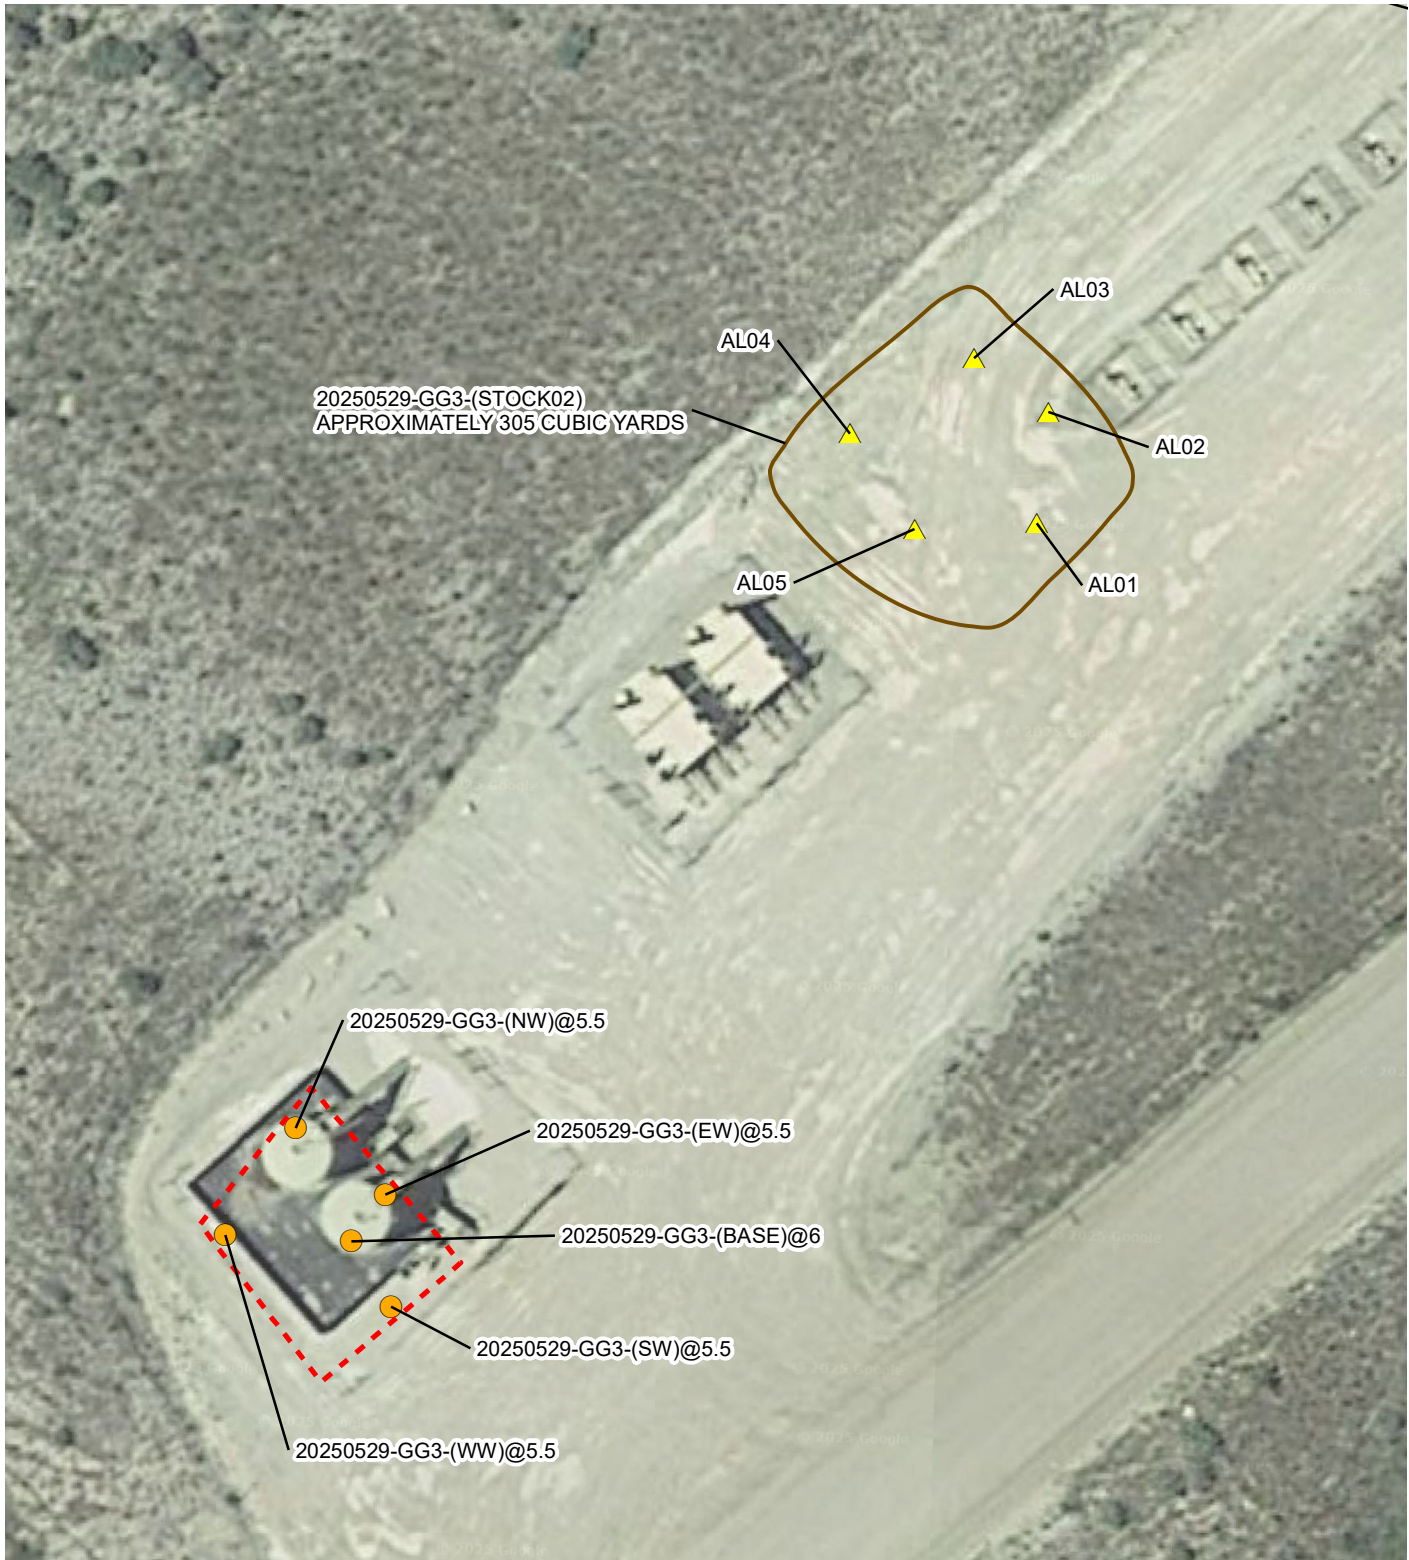
**FIGURE 2**  
**SAMPLE LOCATION MAP**  
**GARDEN GULCH 3**  
**LOT 2 SEC 7-T6S-R96W**  
**GARFIELD COUNTY, COLORADO**  
**QB ENERGY LLC**

In total, six confirmation soil samples were submitted to Elevation Diagnostics (Elevation) of Aurora, Colorado for laboratory analysis of the full ECMC Table 915-1 suite of analytes. All soil analytical results were evaluated under ECMC Residential Soil Screening Level Concentrations (RSSLCs). The confirmation soil sample locations and excavation and stockpile extents were mapped using a handheld Trimble® R1 Global Positioning System (GPS) receiver and are depicted on the attached Figure 2. A photographic log of the sampling activities is included in Enclosure A.

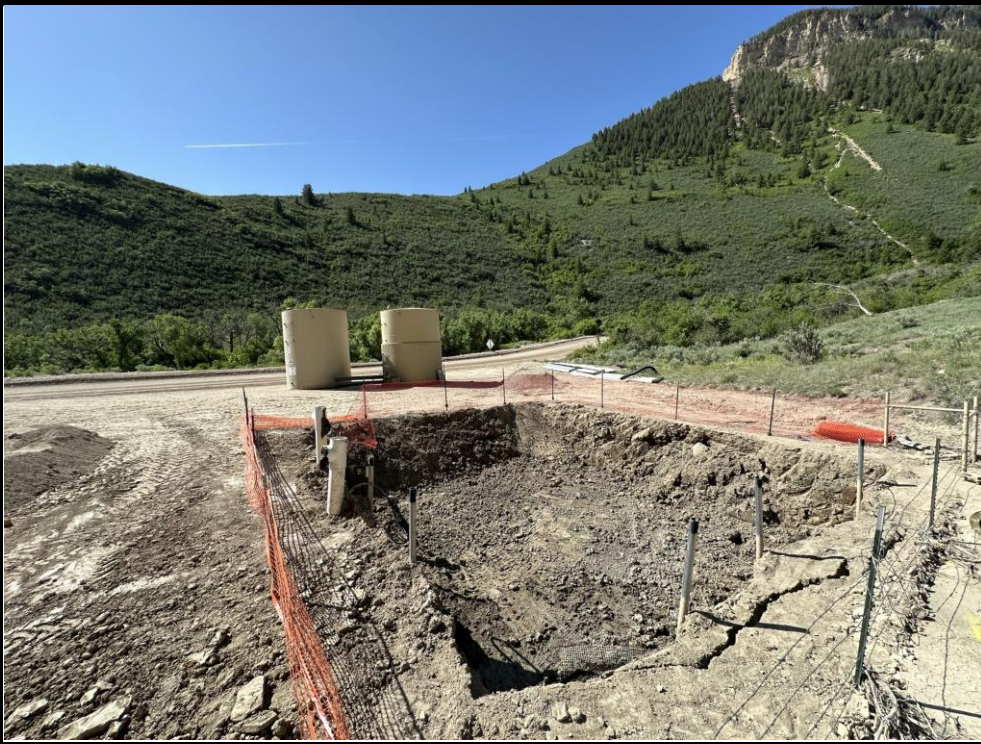
| Photo No. | Date | |
|---|---|---|
| 1 | 5/29/2025 | |

| Photo No. | Date | |
|---|---|---|
| Excavation overview<br>View Southeast | | |

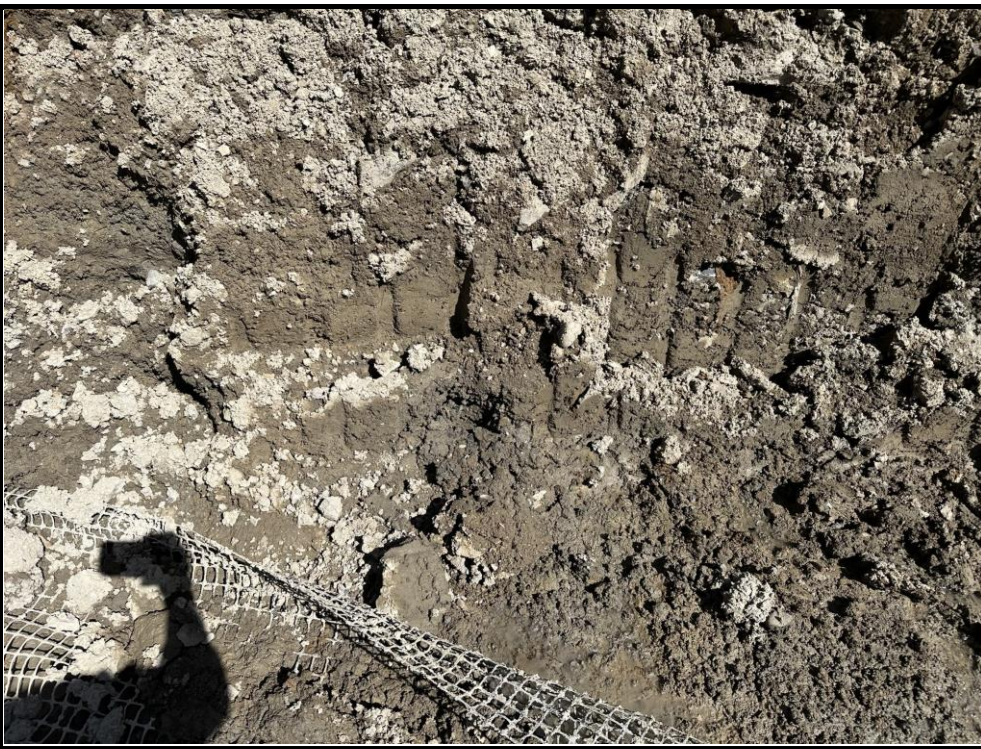
| Photo No. | Date | |
|---|---|--|
| 2 | 5/29/2025 | |

| Sample ID | PID (ppm) | Field Observations | Laboratory Analysis |
|---|---|---|---|
| 20250529-GG3-(NW)@5.5 | 1.5 | Hydrocarbon Odor / Staining | Full Table 915-1 Suite |

| Photo No. | Date | |
|---|---|--|
| 20250529-GG3-(NW)@5.5<br>View Northwest | | |

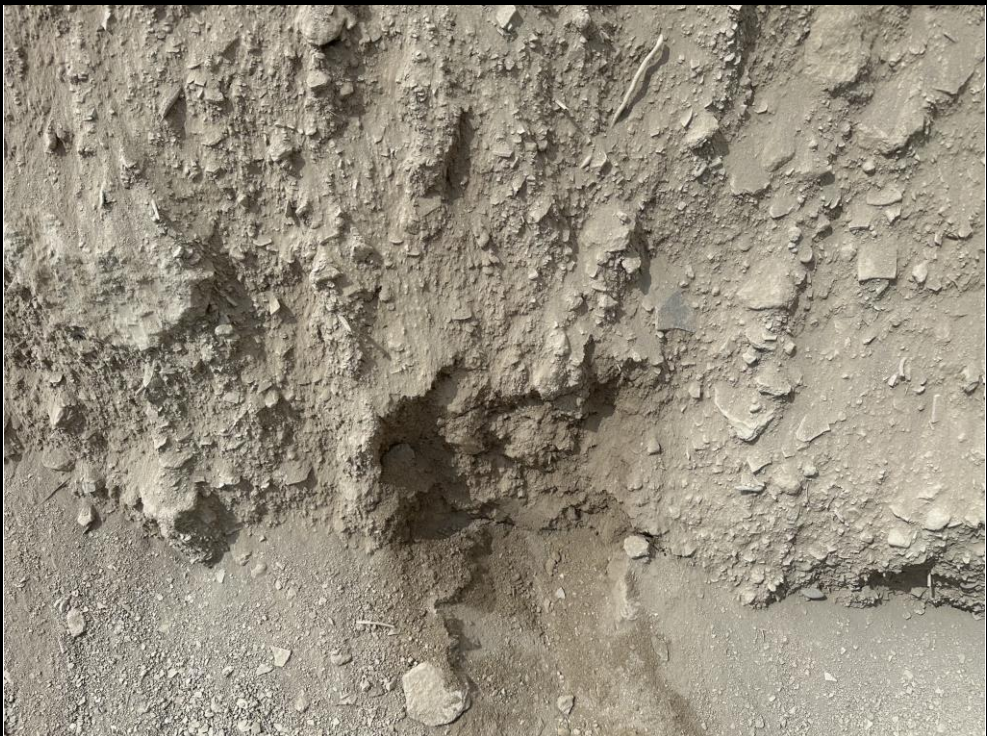
| Photo No. | Date | |
|---|---|--|
| 10 | 5/29/2025 | |

| Photo No. | Date | |
|---|---|--|
| 20250529-GG3-(STOCK01)<br>Aliquot 3<br>View Southeast | | |

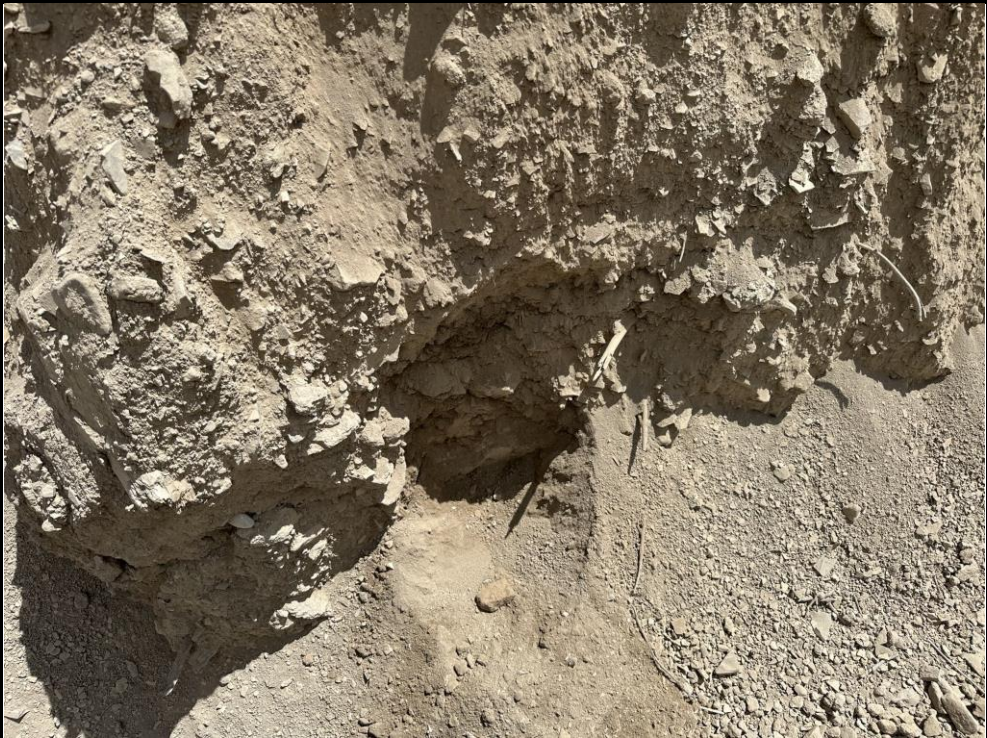
| <b>Photo No.</b> | <b>Date</b> | |
|---|---|---|
| 11 | 5/29/2025 | |

| <b>Photo No.</b> | <b>Date</b> | |
|---|---|---|
| 20250529-GG3-(STOCK01)<br>Aliquot 4<br>View North | | |

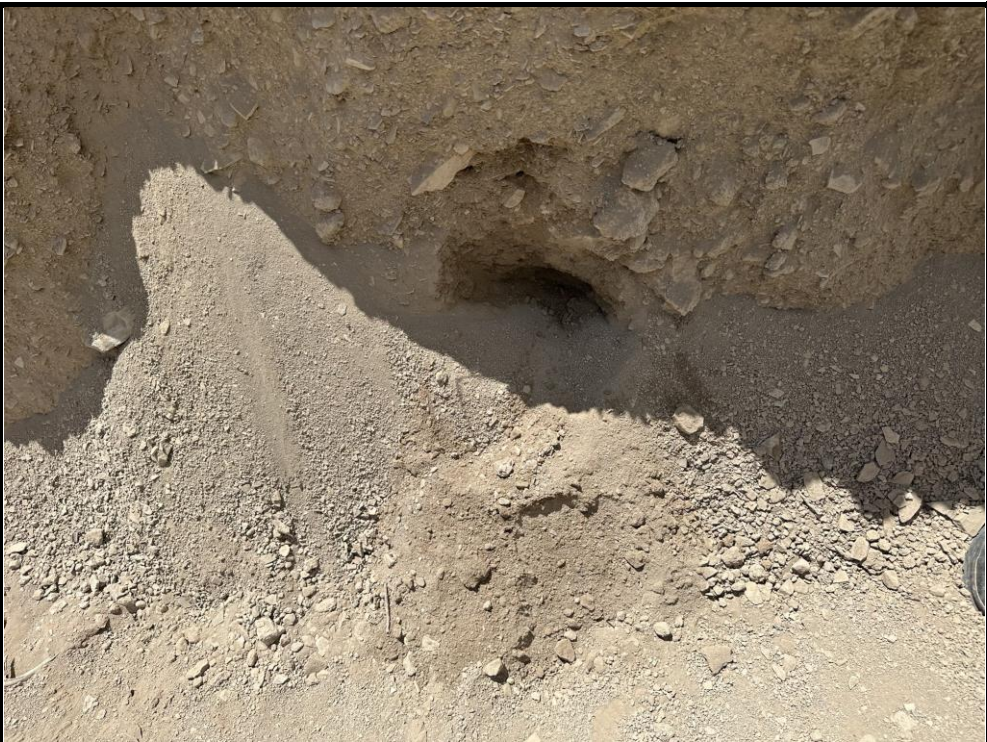
| <b>Photo No.</b> | <b>Date</b> | |
|--|---|--|
| 12 | 5/29/2025 | |

| <b>Photo No.</b> | <b>Date</b> | |
|--|---|--|
| 20250529-GG3-(STOCK01)<br>Aliquot 5<br>View East | | |

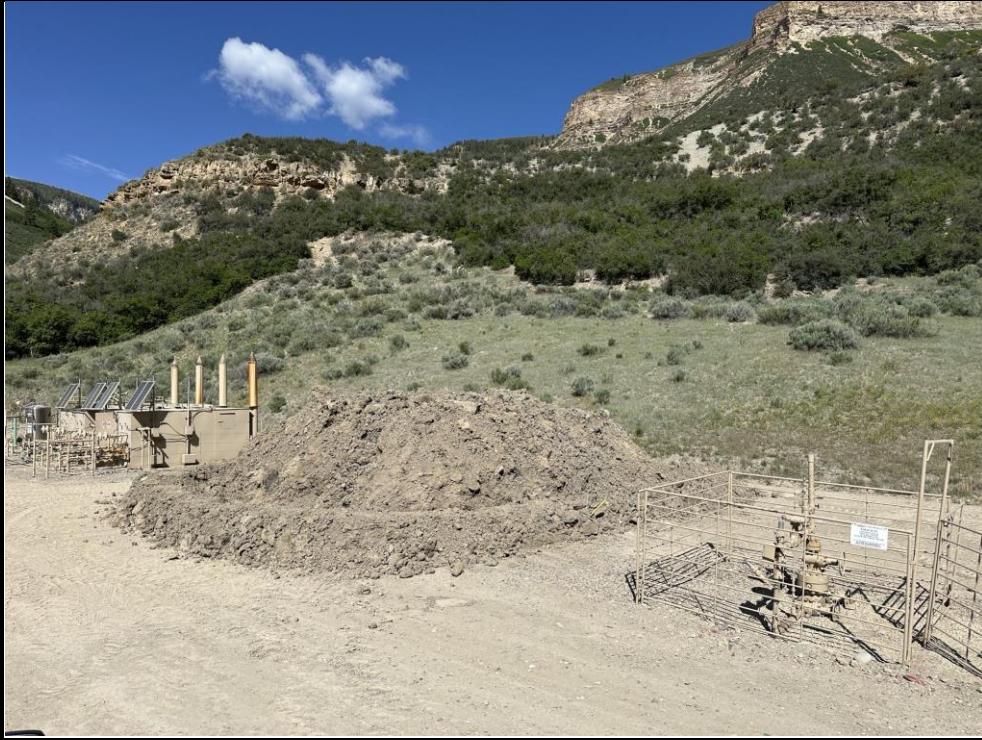
| Photo No. | Date | |
|--|---|---|
| 13 | 5/29/2025 | |

| Sample ID | PID (ppm) | Field Observations | Laboratory Analysis |
|---|---|---|---|
| 20250529-GG3-(STOCK02) | 2.5 | Hydrocarbon Odor / Staining | Full Table 915-1 Suite |

| Photo No. | Date | |
|--|---|---|
| 20250529-GG3-(STOCK02)<br>Overview<br>View Southwest | | |

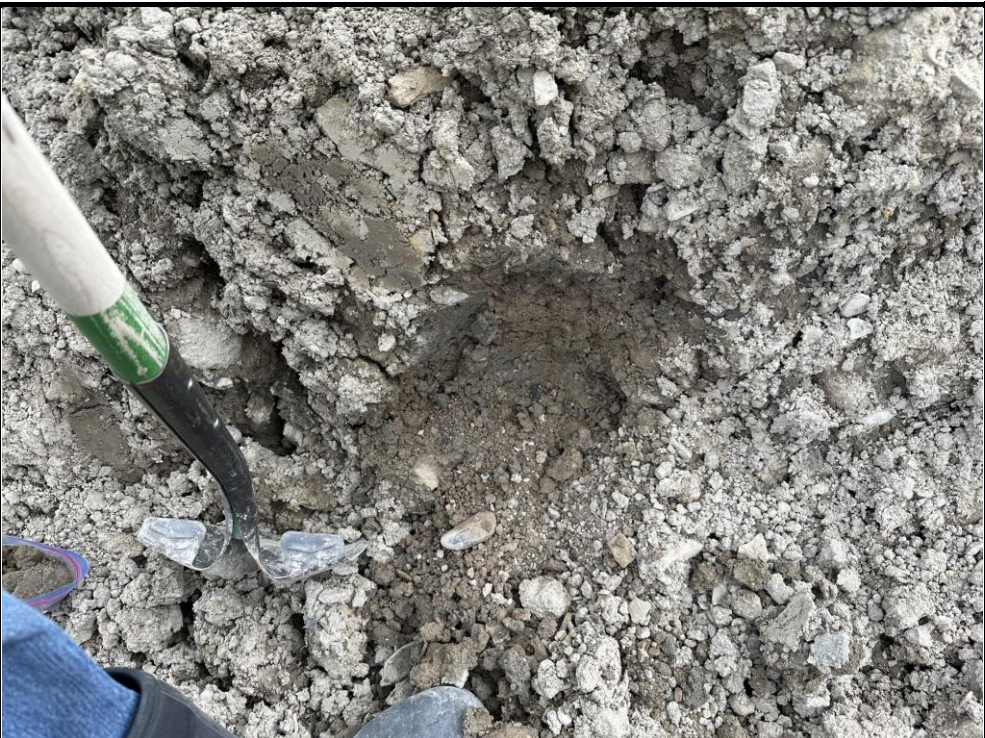
| Photo No. | Date | |
|---|---|--|
| 18 | 5/29/2025 | |

| Photo No. | Date | |
|---|---|--|
| 20250529-GG3-(STOCK02)<br>Aliquot 5<br>View Northeast | | |
