Inspection Photos

Operator: LARAMIE ENERGY LLC #10433

Location ID: 312666

Inspection Doc: 718100642

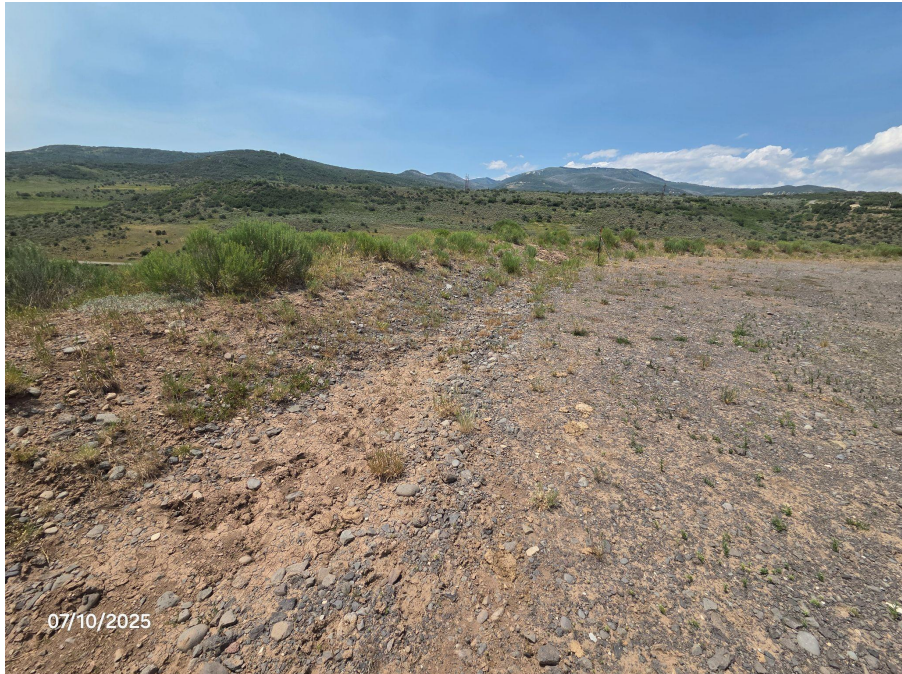
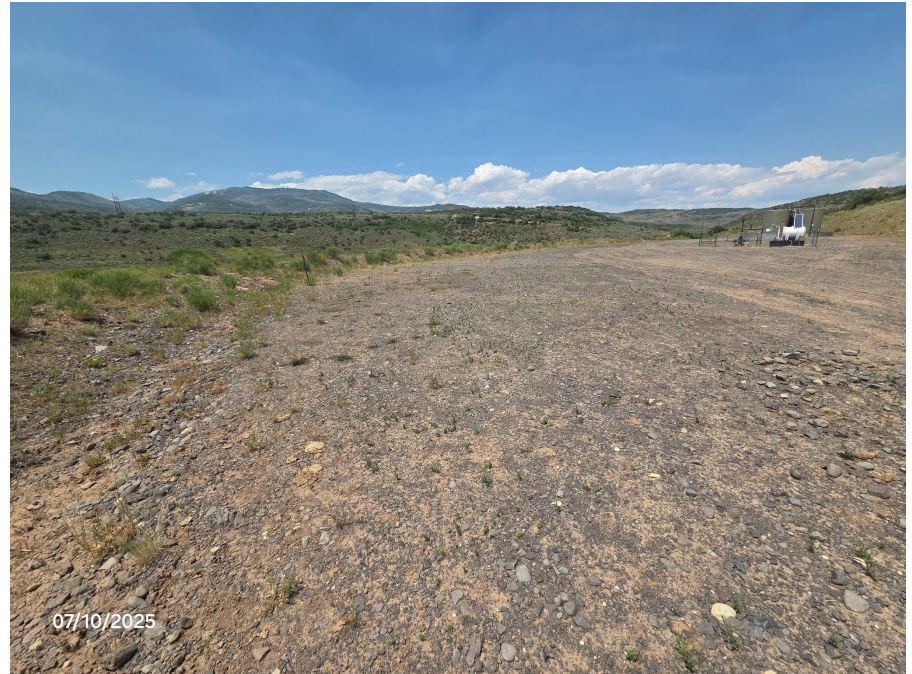
Photo 1: Photos 1-2 taken from the south end of the Location. Photos provide an overview from west, northwest, northeast to east.

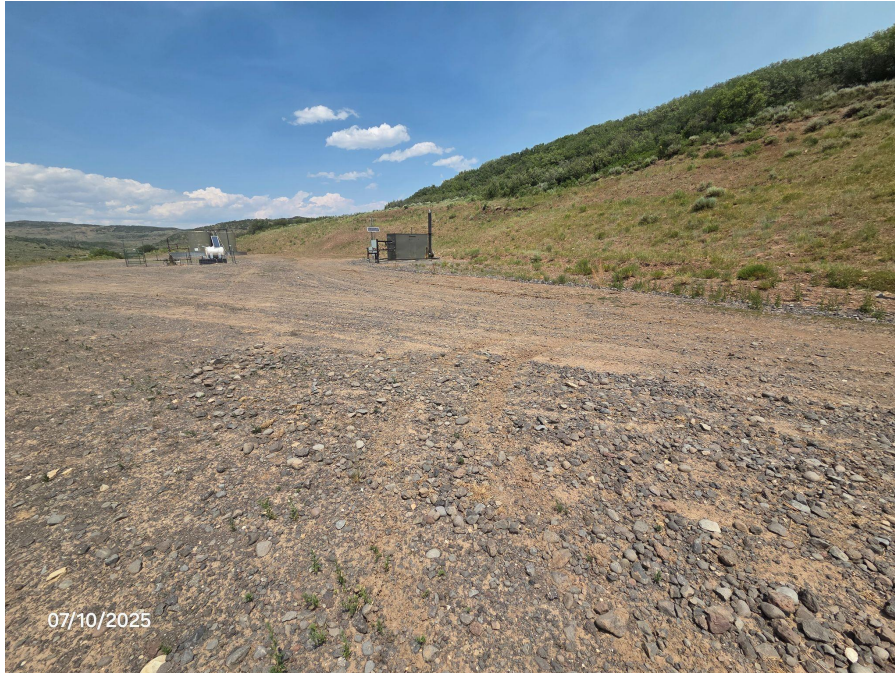
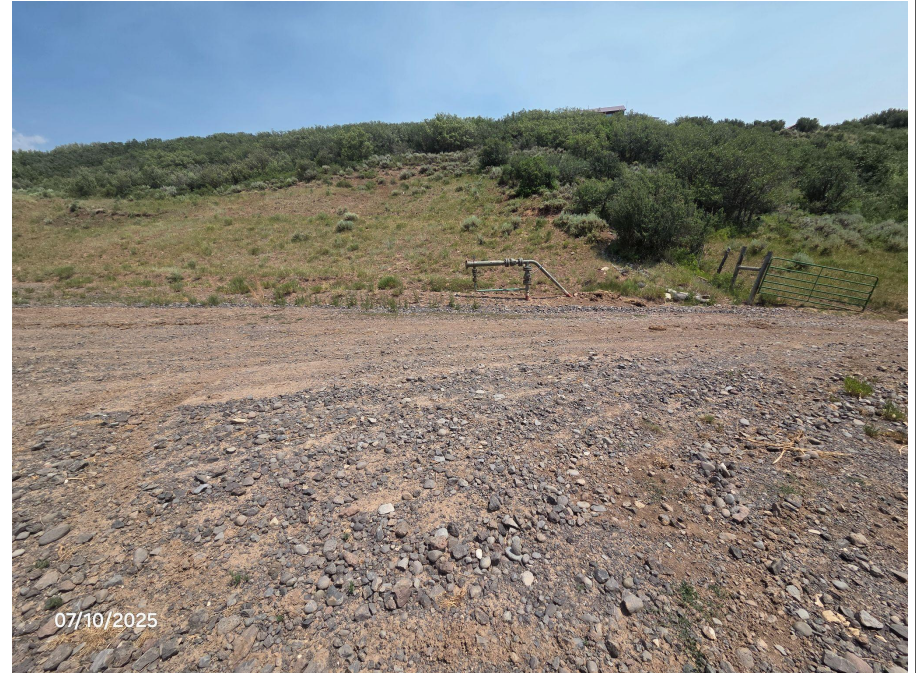
Photo 2: See comments under photo 1.

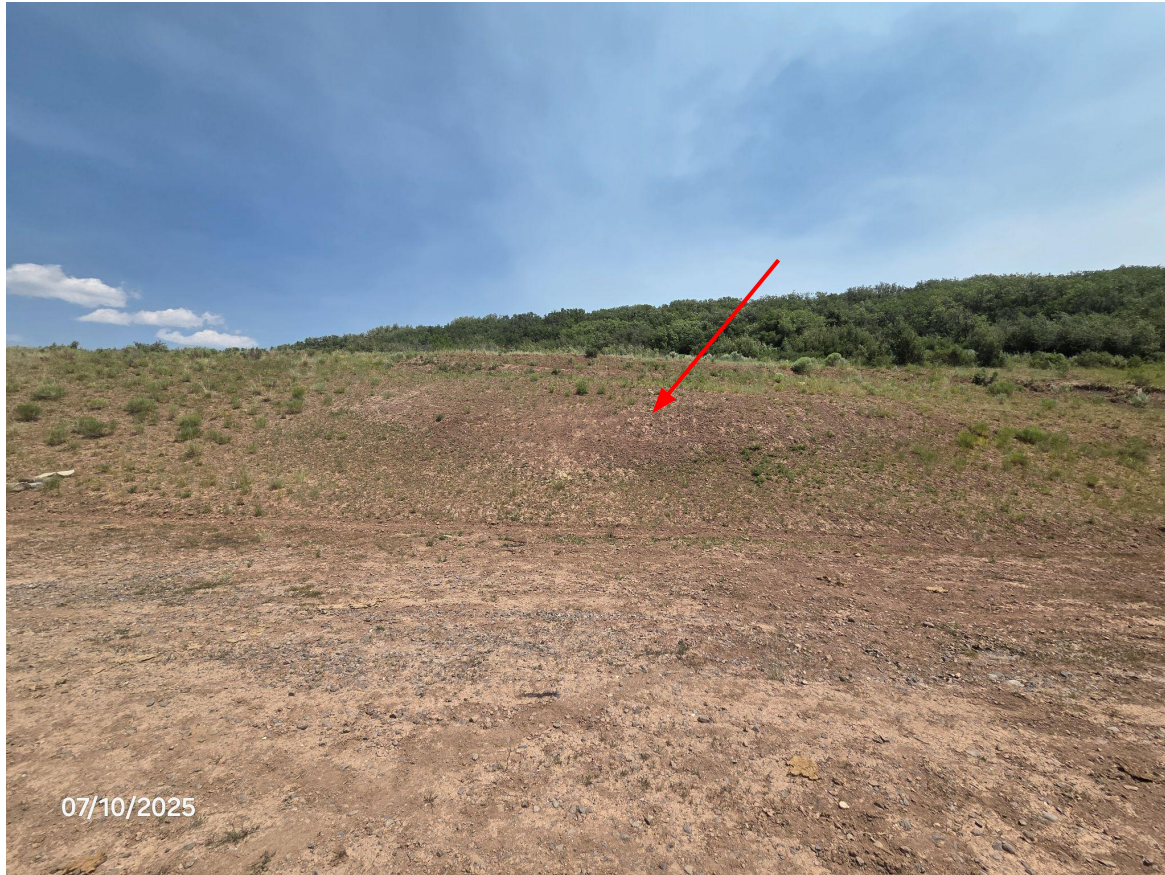
Photo 3: Photo shows cut slopes on the east end of the Location. There are areas of the slopes where perennial vegetative establishment does not appear to be progressing towards 1003 uniform standards- additional seeding efforts are advised

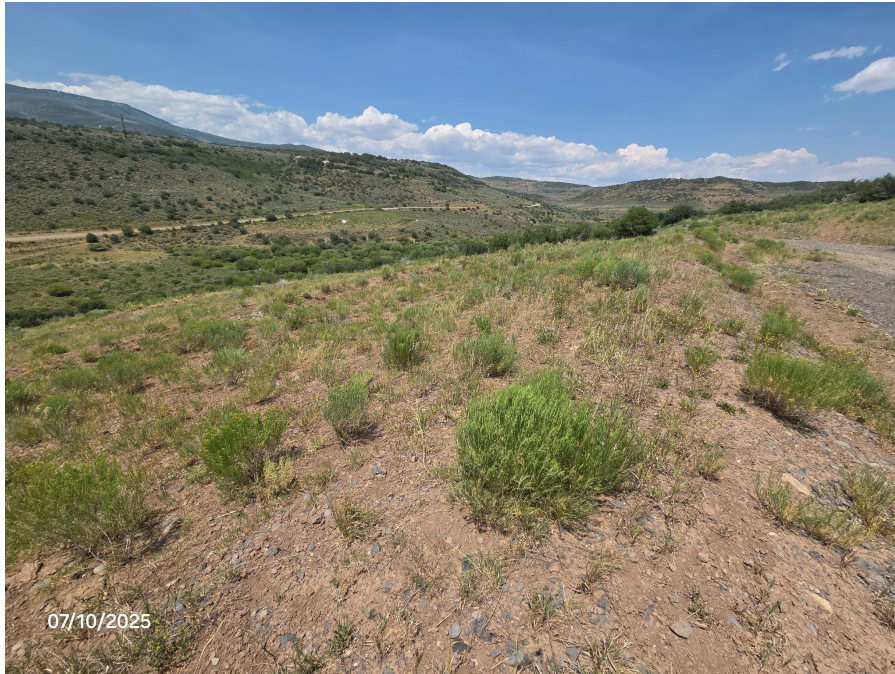
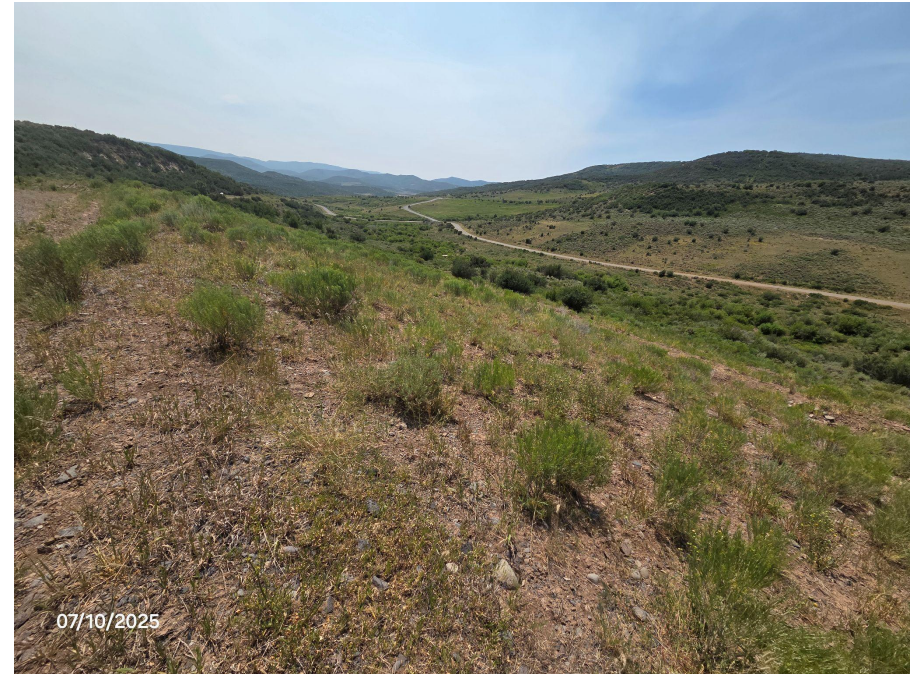
Photo 4: Photos taken from the interim areas on the west end of the Location. Reclamation is progressing towards 1003 standards within these areas.

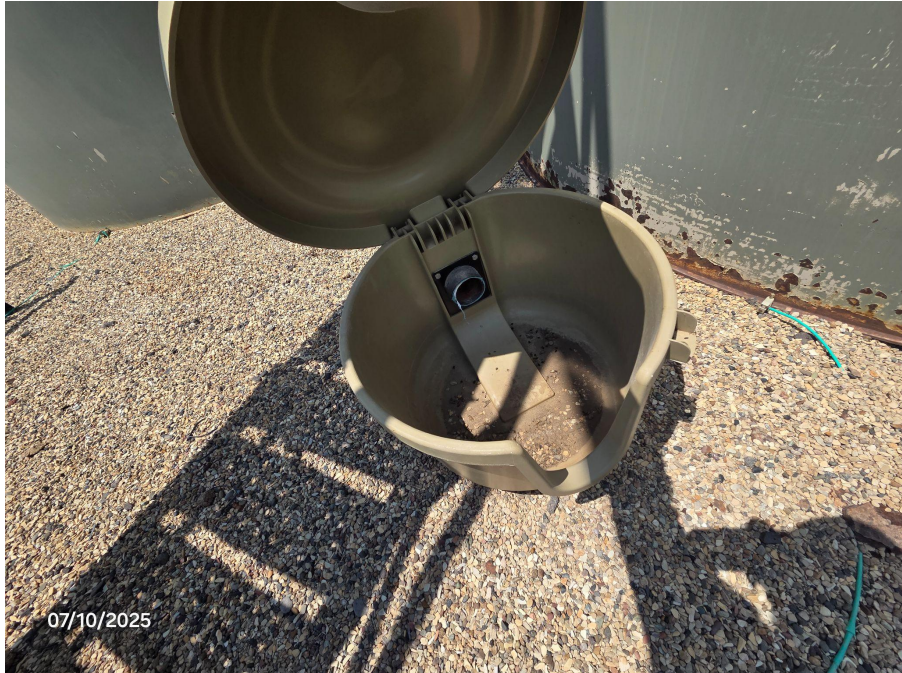
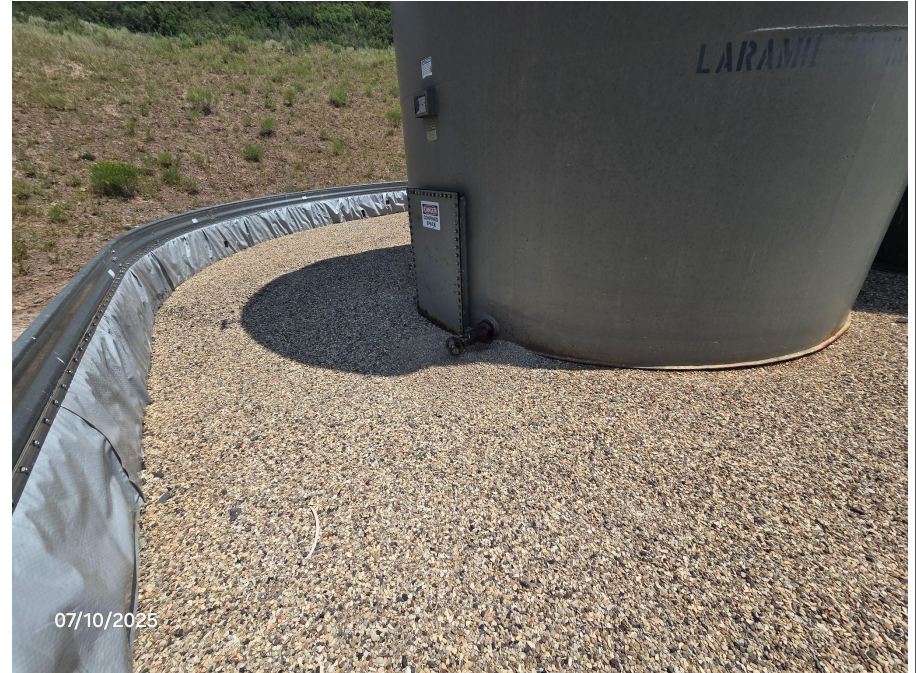
Photo 5: Photos taken from the battery facility. Photos show lines at tanks missing cap/plug.
