Flowline Closure Checklist

COGCC Rule 911.a.(4) Environmental Site Closure Assessment Field Form

Additional Attachments:		Tank Battery Closure		Wellhead Closure 08/30/2022		Pit Closure		Partially Buried Vault Closure
Site Name & COGCC Facility Number: Baker State B #36-11 ID: #249626		Date: February 20, 2025			Remediation Project #: 20766			
Associated Wells:		Age of Site: 11/3/1993			Number of Photos Attached: 20

TABLE 1
FIELD DATA SUMMARY TABLE
NOBLE 100322
BAKER STATE B #36-11, WELD COUNTY, COLORADO
REM # 20766

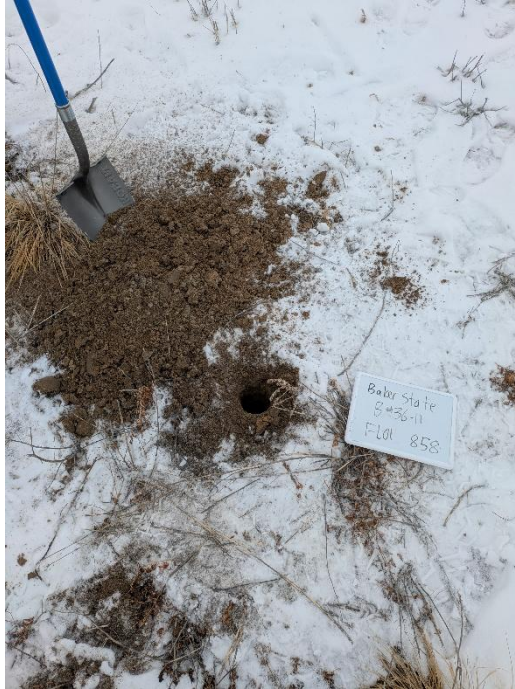
Photo:
1

Description:
FL01@6', no odor/no staining

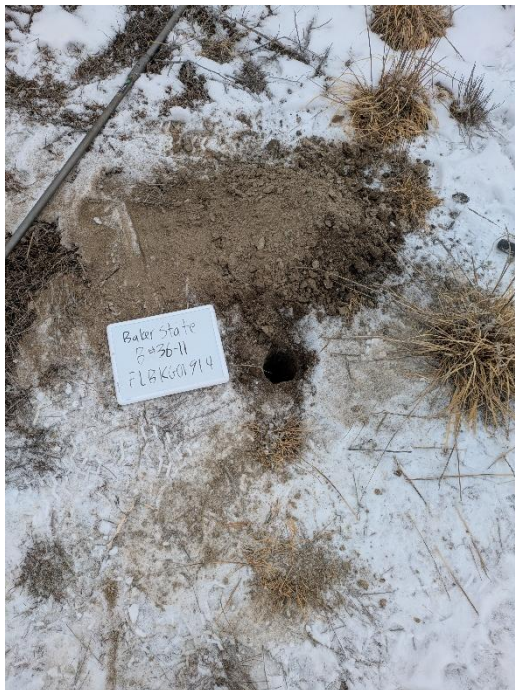
Photo:
2

Description:
FL01BKG01@4', no odor/no staining

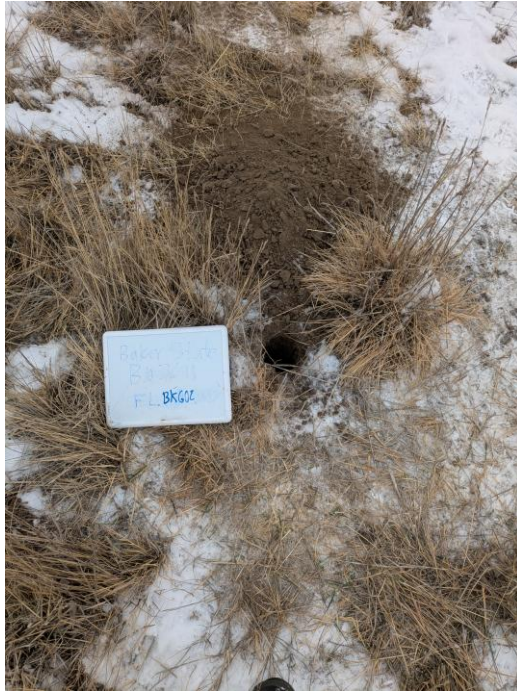
Photo: 3	Date: 02/17/2025	Description: FL01BKG02@4', no odor/no staining
--------------------	----------------------------	--

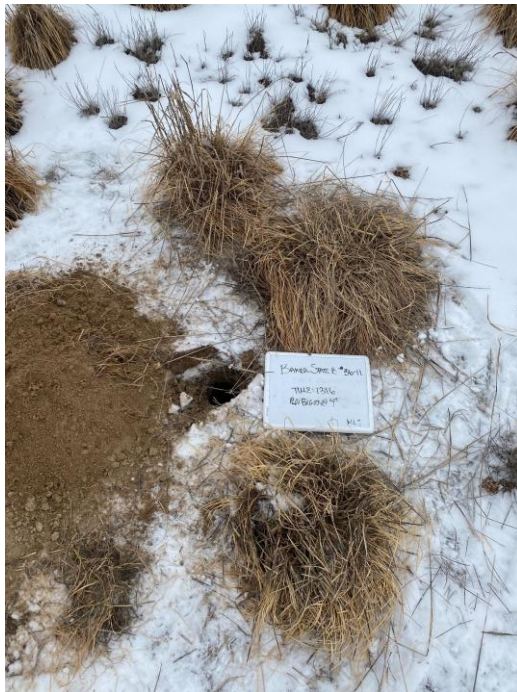
Photo: 4	Date: 02/17/2025	Description: FL01BKG03@4', no odor/no staining
--------------------	----------------------------	--

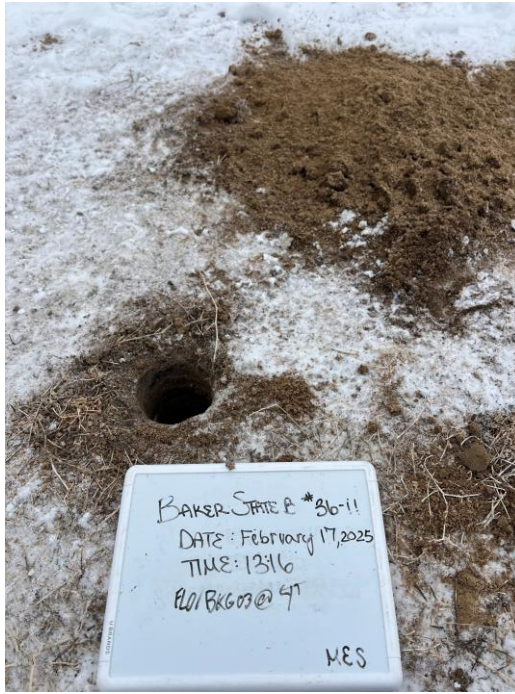
Photo: 5	Date: 02/17/2025	Description: FL01BKG03@4', no odor/no staining
--------------------	----------------------------	--

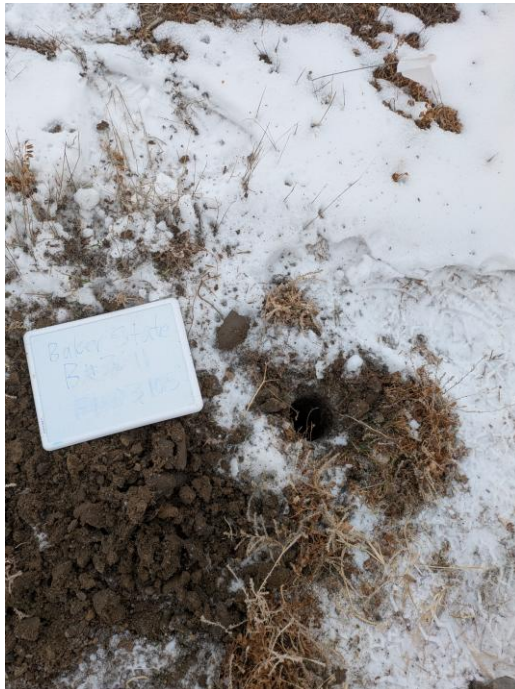
Photo: 6	Date: 02/17/2025	Description: FL03@4', no odor/no staining
--------------------	----------------------------	---

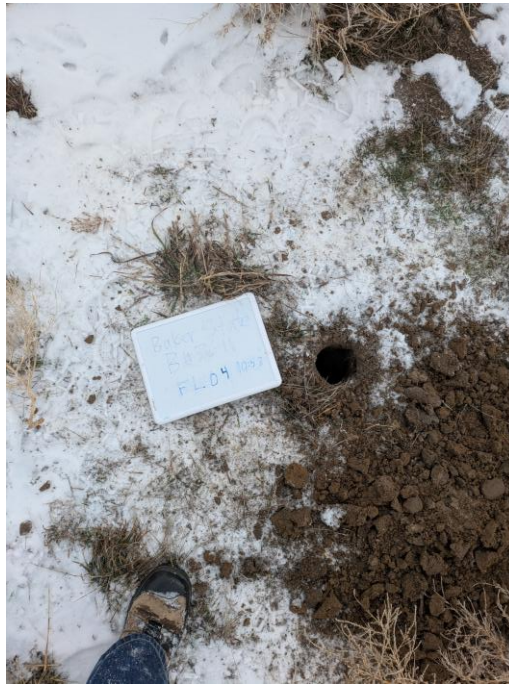
Photo:
7

Description:
FL04@4', no odor/no staining

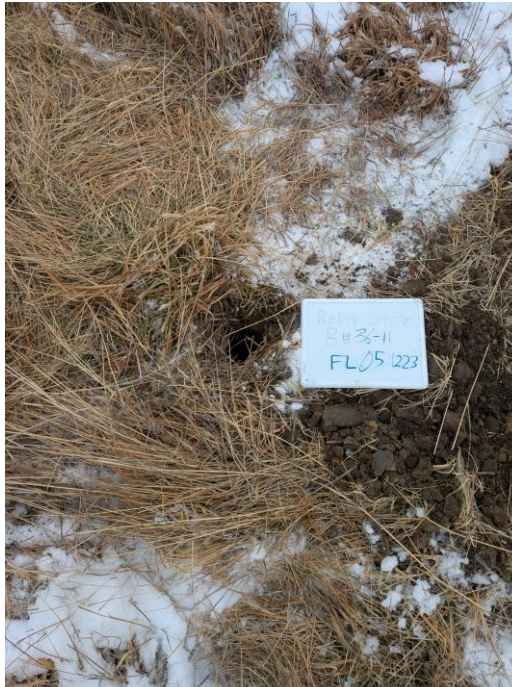
Photo:
8

Description:
FL05@4', no odor/no staining

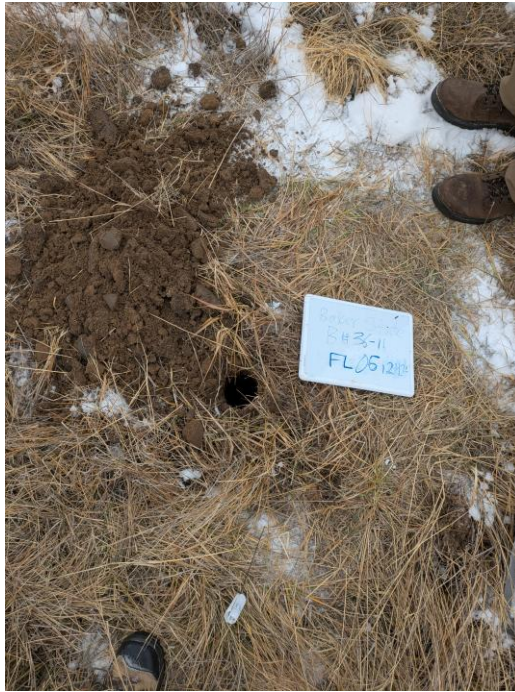
Photo: 9	Date: 02/17/2025	Description: FL06@4', no odor/no staining
--------------------	----------------------------	---

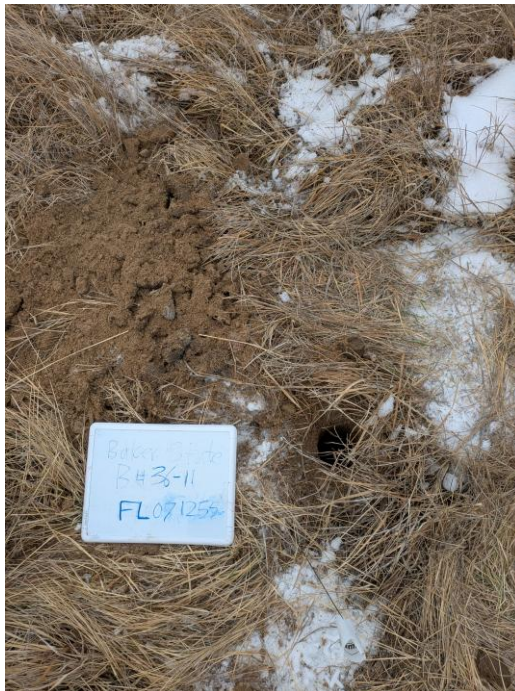
Photo: 10	Date: 02/17/2025	Description: FL07@4', no odor/no staining
---------------------	----------------------------	---

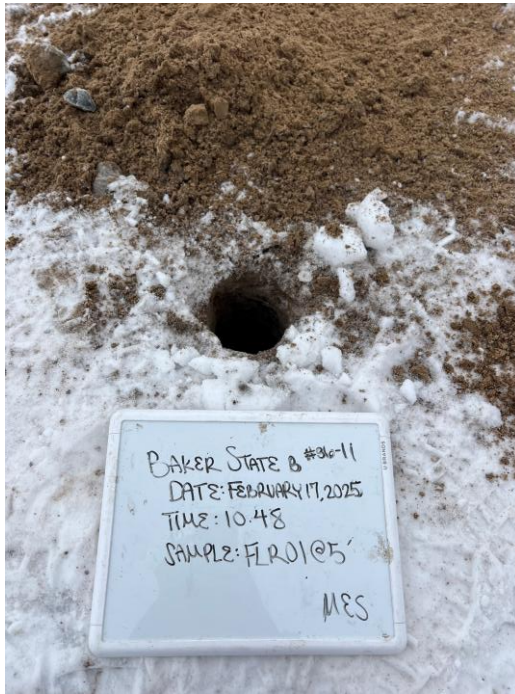
Photo: 11	Date: 02/17/2025	Description: FLR01@5', no odor/no staining
---------------------	----------------------------	--

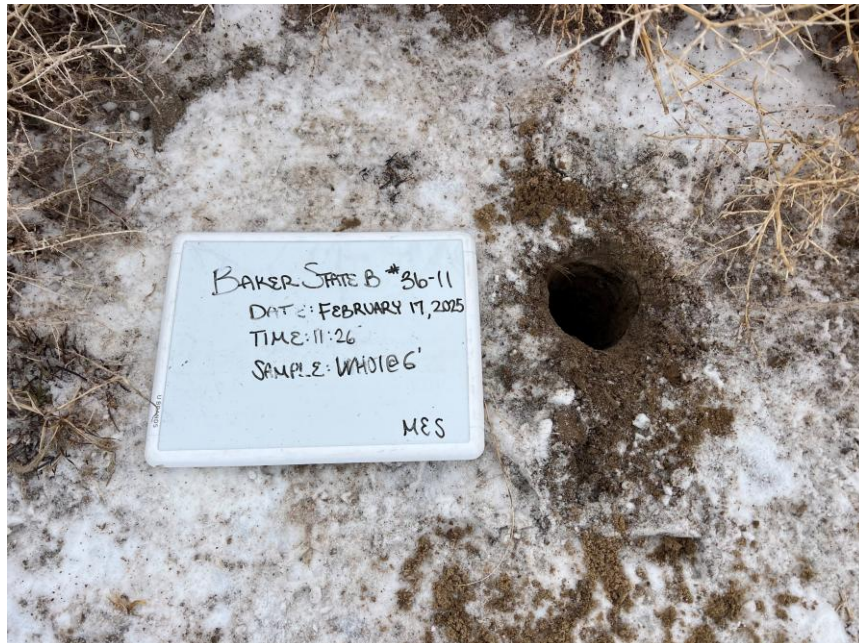
Photo: 12	Date: 02/17/2025	Description: WH01@6', no odor/no staining
---------------------	----------------------------	---

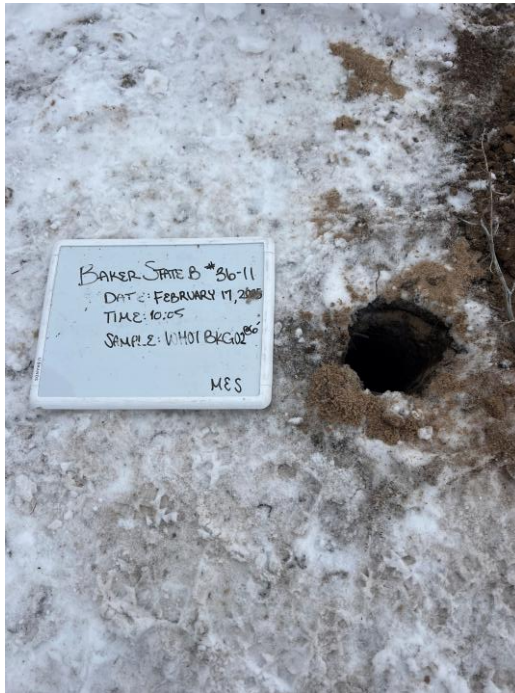
Photo: 13	Date: 02/17/2025	Description: WH01BKG02@6', no odor/no staining
---------------------	----------------------------	--

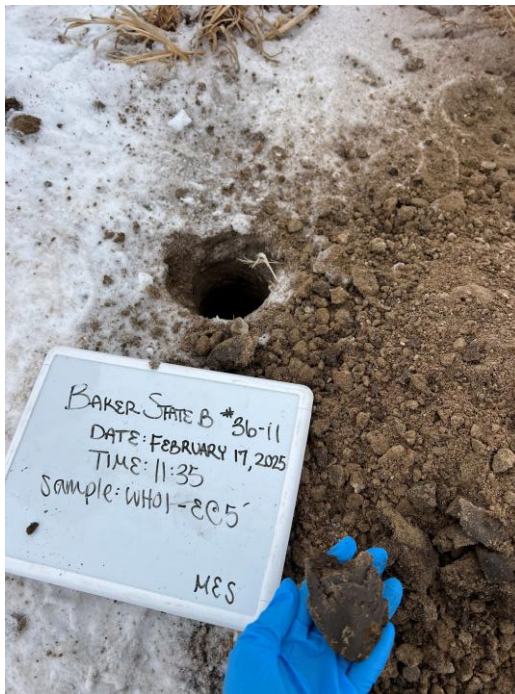
Photo: 14	Date: 02/17/2025	Description: WH01-E@5', no odor/no staining
---------------------	----------------------------	---

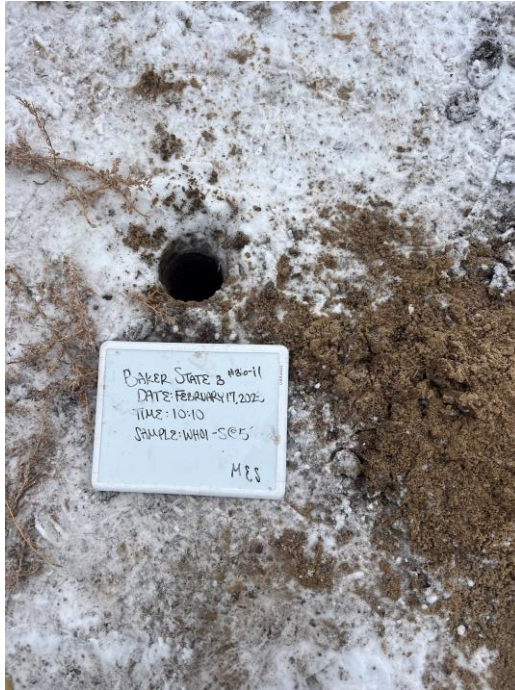
Photo: 15	Date: 02/17/2025	Description: WH01-S@5', no odor/no staining
---------------------	----------------------------	---

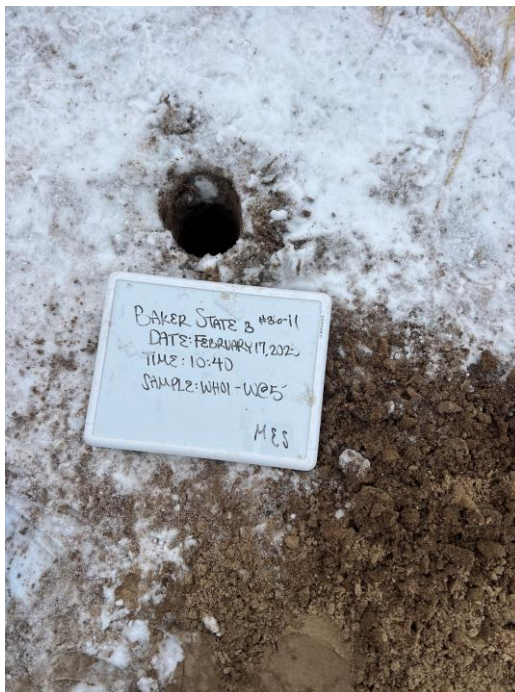
Photo: 16	Date: 02/17/2025	Description: WH01-W@5', no odor/no staining
---------------------	----------------------------	---

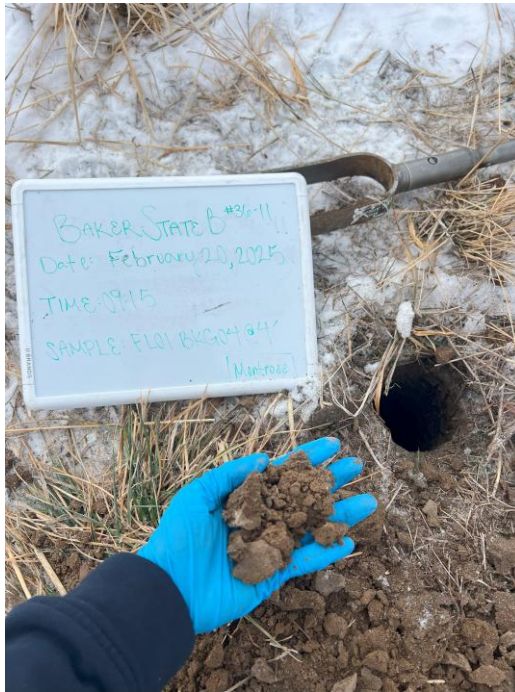
Photo: 17	Date: 02/20/2025	Description: FLBKG04@4', no odor/no staining
---------------------	----------------------------	--

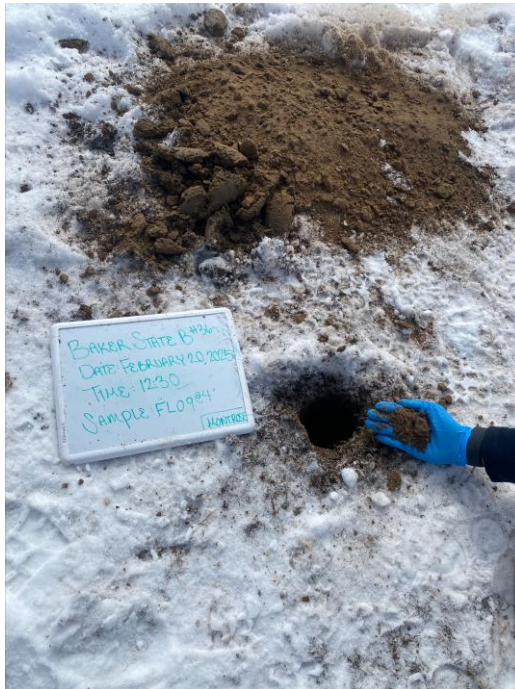
Photo: 18	Date: 02/20/2025	Description: FL09@4', no odor/no staining
---------------------	----------------------------	---

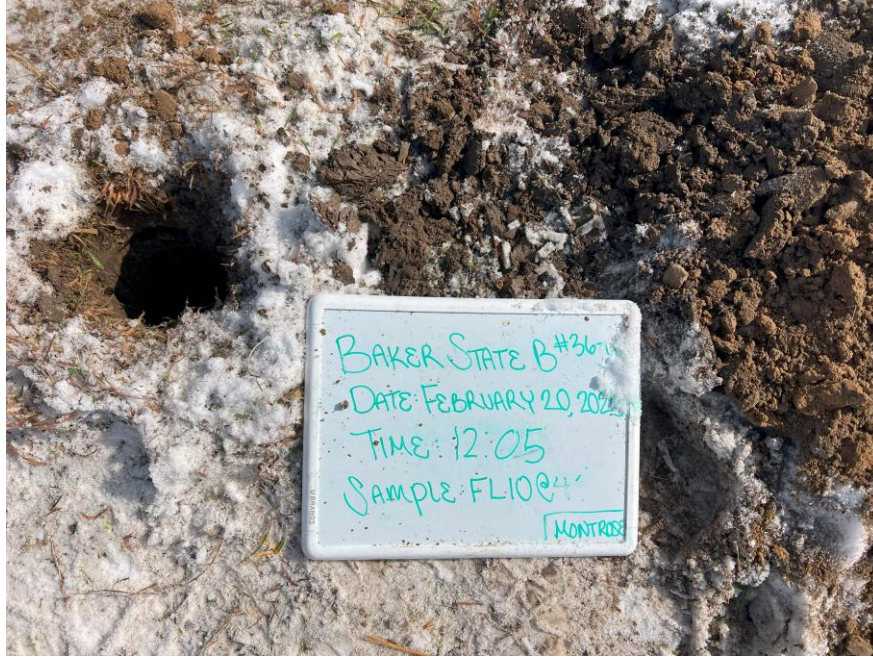
Photo: 19	Date: 02/20/2025	Description: FL10@4', no odor/no staining
---------------------	----------------------------	---

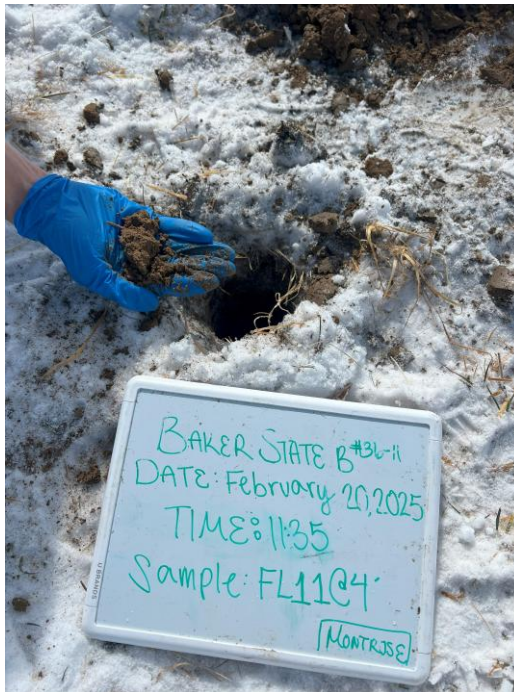
Photo: 20	Date: 02/20/2025	Description: FL11@4', no odor/no staining
---------------------	----------------------------	---

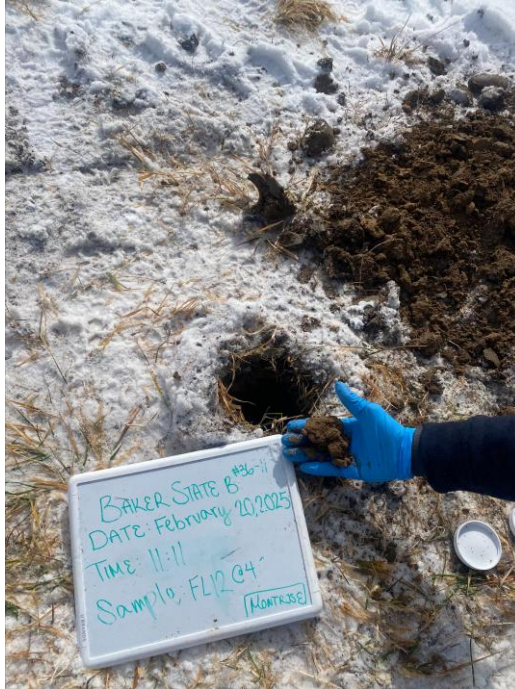
Photo: 21	Date: 02/20/2025	Description: FL12@4', no odor/no staining
---------------------	----------------------------	---

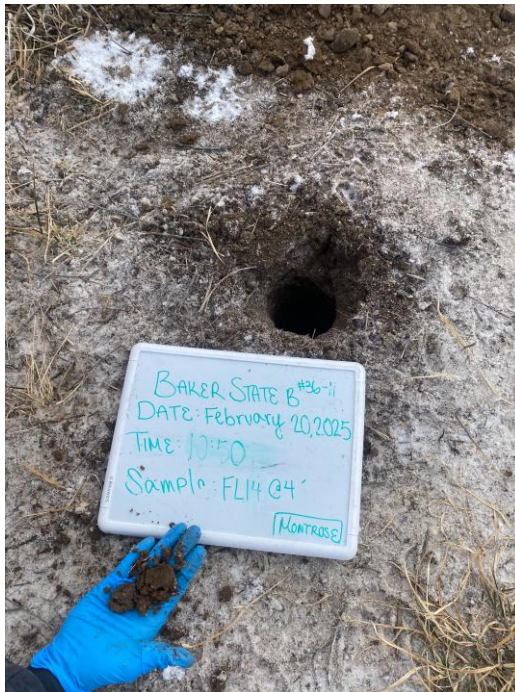
Photo: 22	Date: 02/20/2025	Description: FL14@4', no odor/no staining
---------------------	----------------------------	---

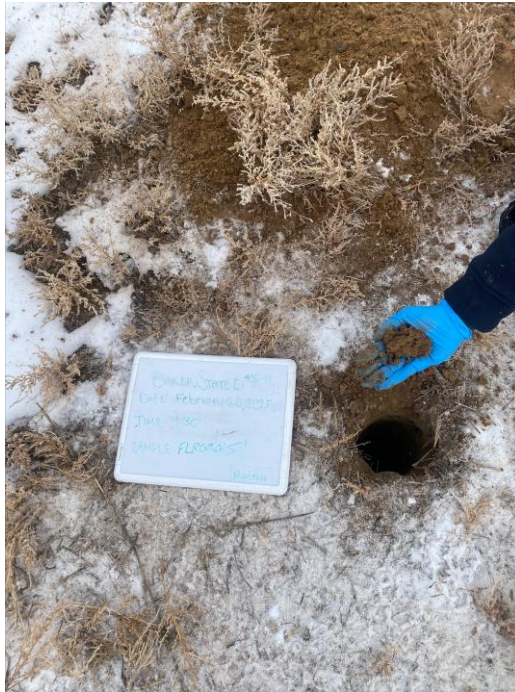
Photo: 23	Date: 02/20/2025	Description: FLR02@5', no odor/no staining
---------------------	----------------------------	--
