Operator: AXIS Exploration

Location Name: Sabo 22-19 4 TB

Loc ID: 460776

Inspection: 713602311

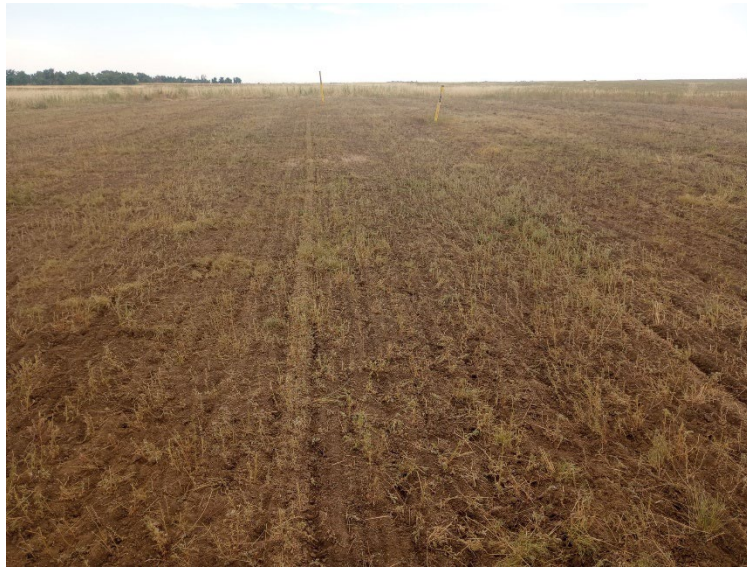
Exhibit A

CA: The former tank battery location is not reclaimed. There are undesirable weeds and areas that are bare of vegetation. Soils need to be cross ripped to at least 18 inches and decompacted. The location needs to be reseeded to establish a perennial vegetation cover that reflects reference area levels. Comply with 1004 Rules

CA Resolution: Operator has addressed vegetation issues in order to comply with Rule 1004.
