Report of Work Completed – Tank Valve Release

| ECMC Location Name (ID) | SHIDELER FEDERAL-67S93W/26SESE (334232) |
| Operator Location Name | P26W |
| ECMC Remediation Project | 23856 |

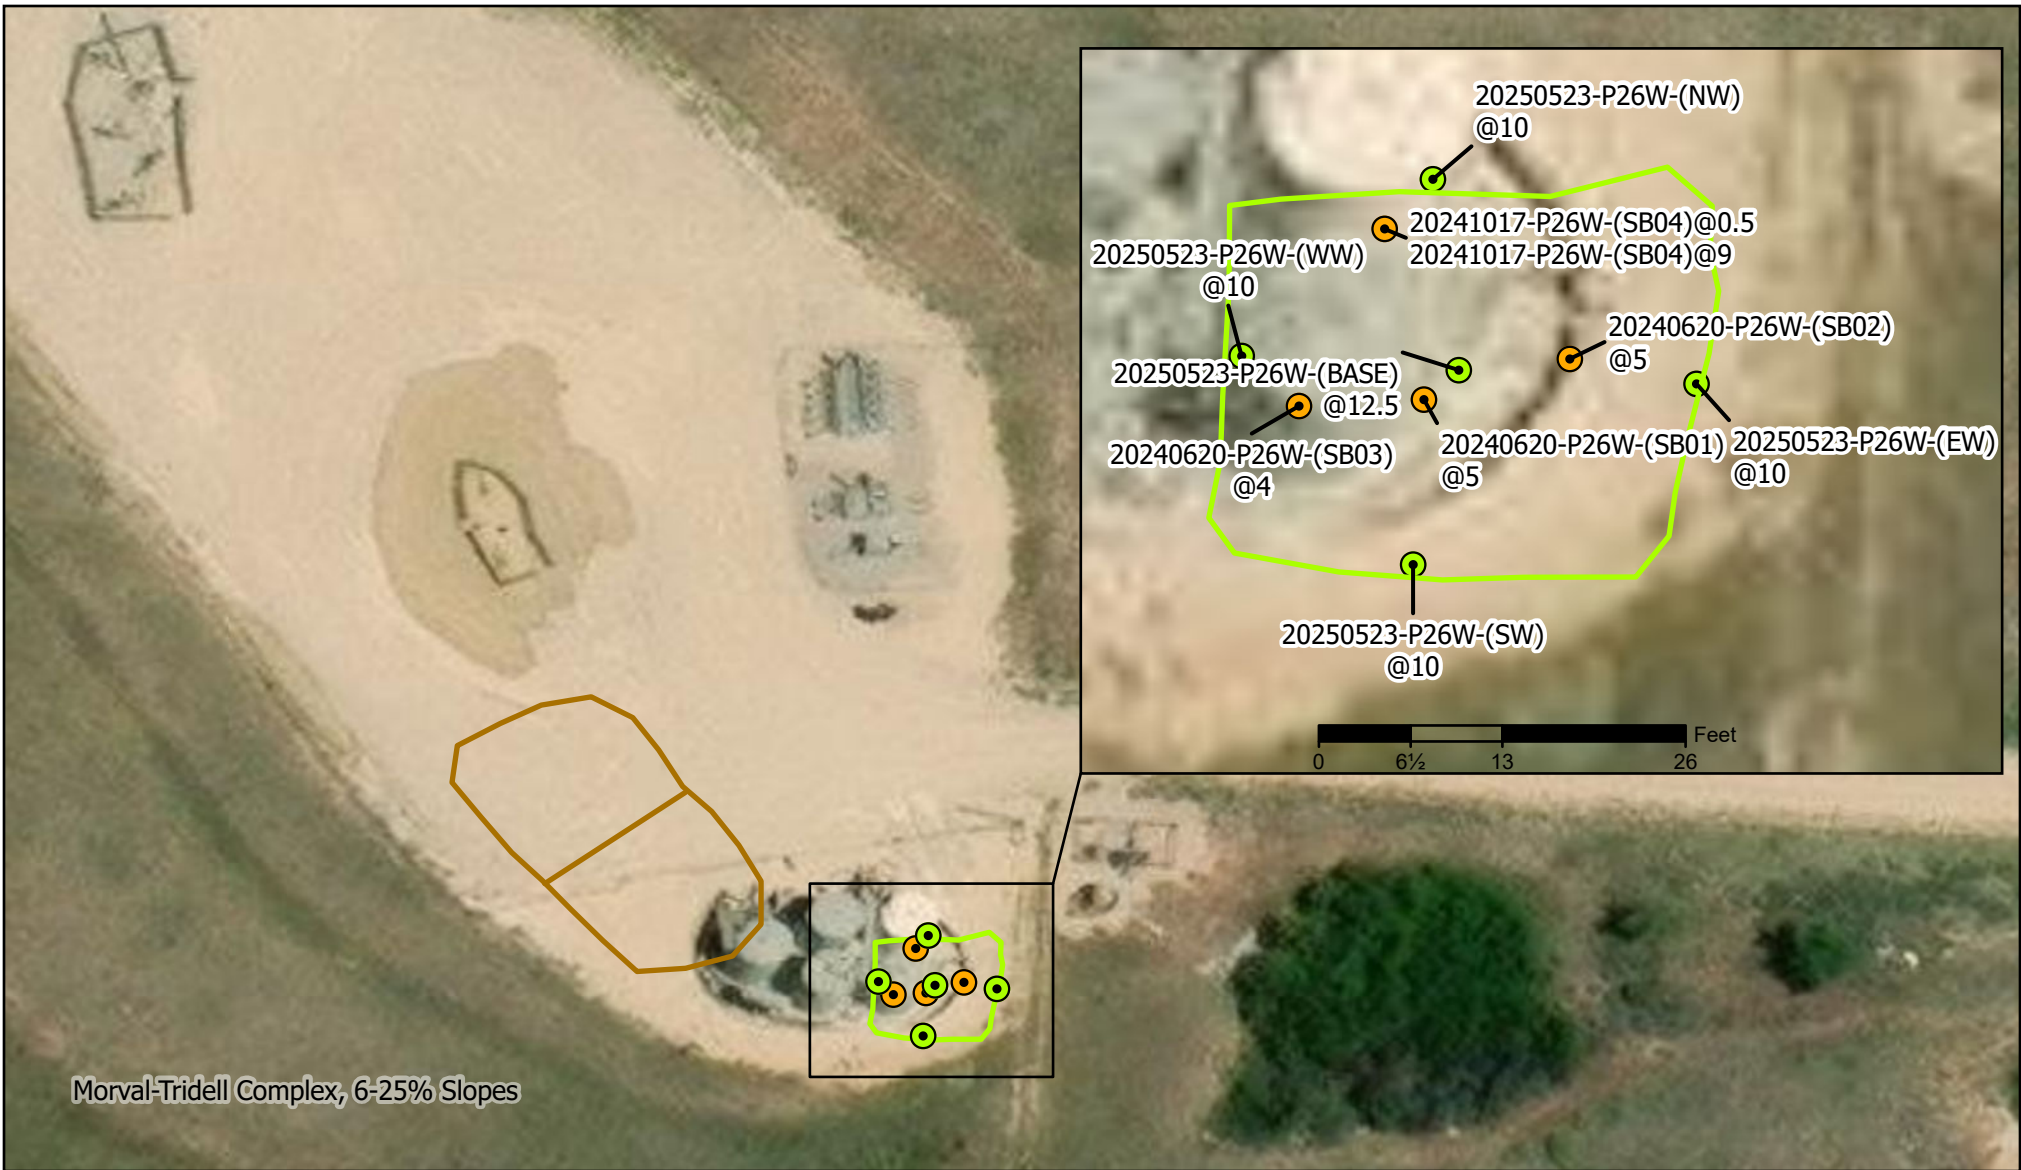
Site Diagram - Site Investigation

Soil Samples
-

Soil Borings
-

Excavation Extent
-

Stockpile Extent

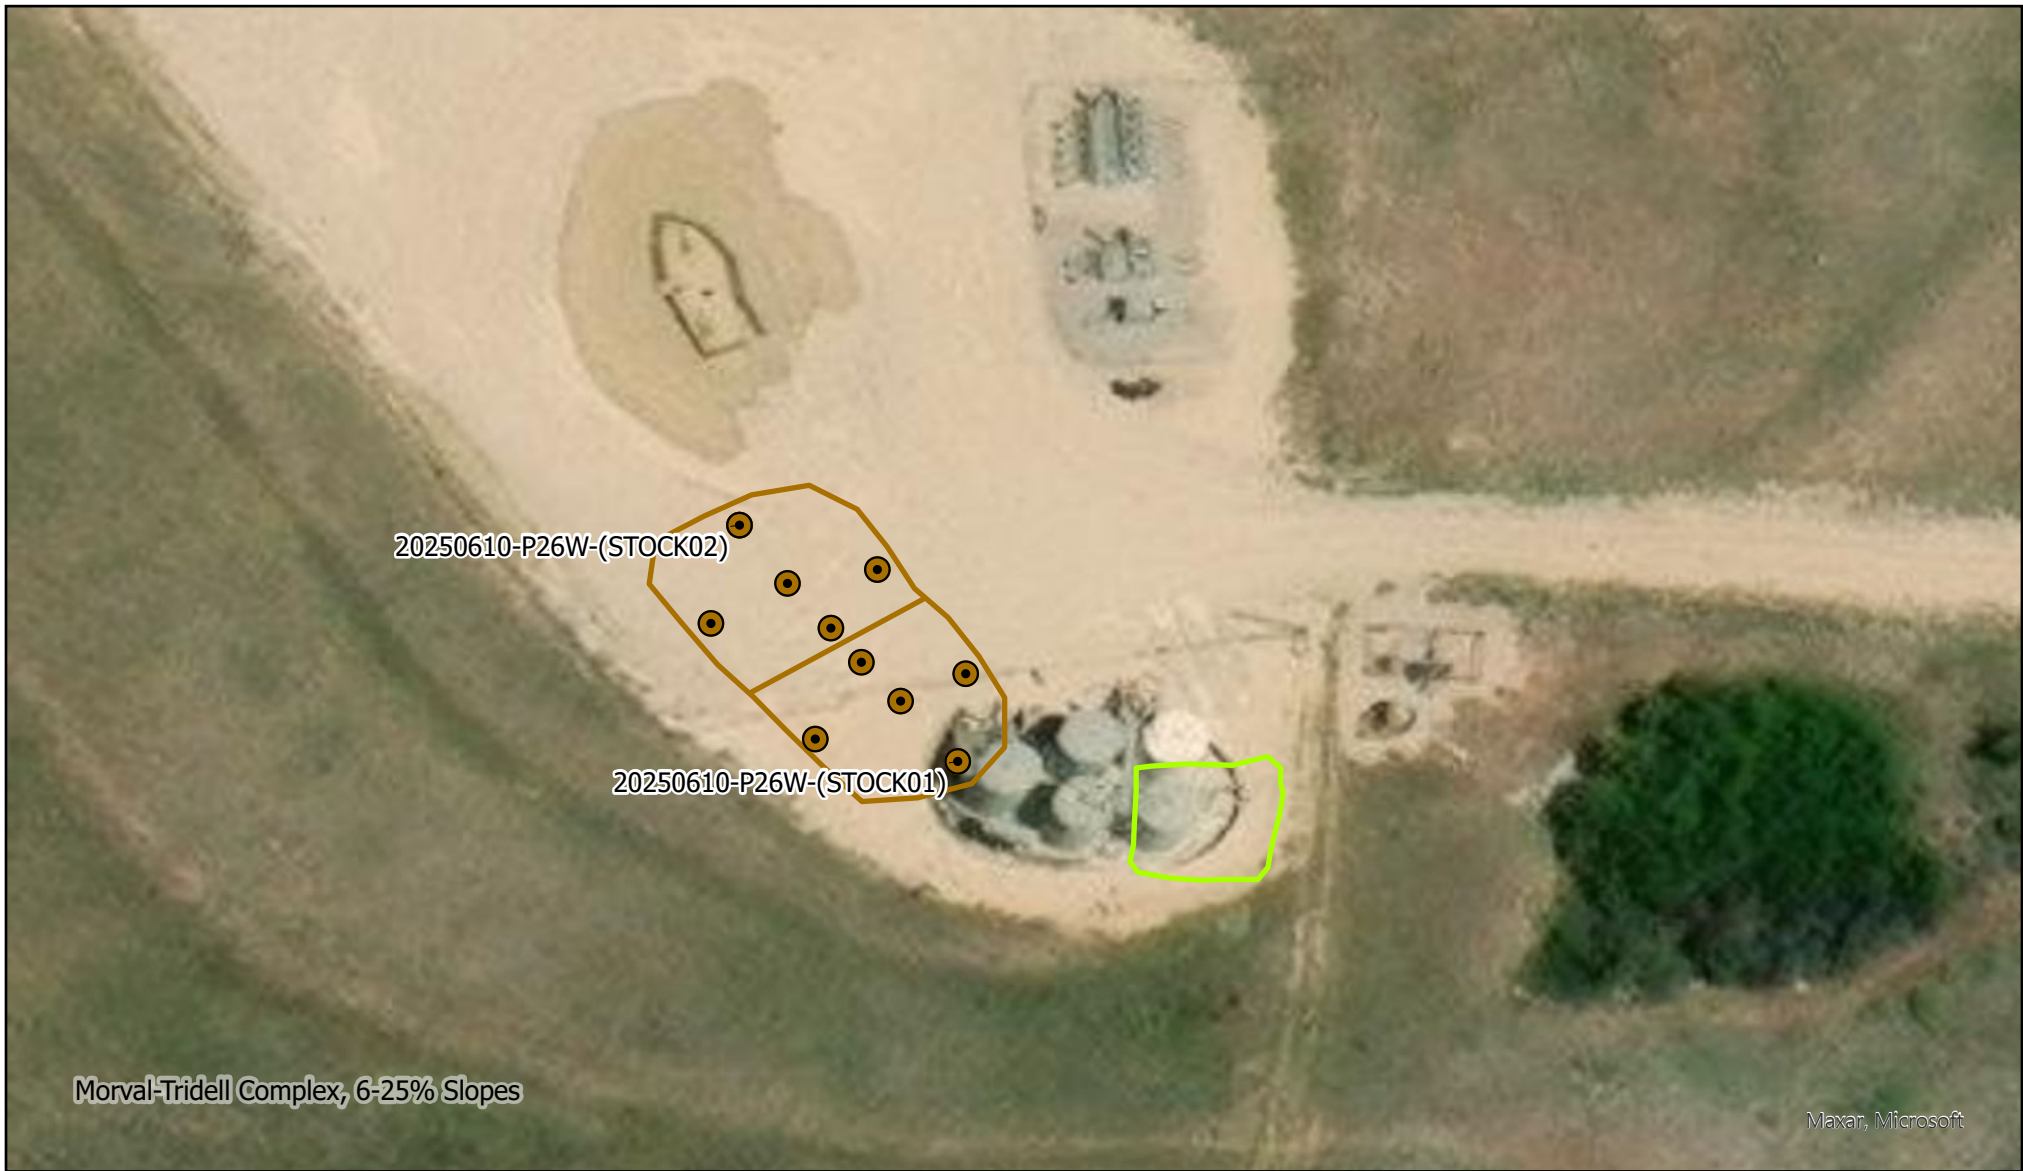
Site Diagram - Stockpile Samples

Stockpile Samples
-

Excavation Extent
-

Stockpile Extent

Field screening PID measurements range from 0.5 to 1.5 ppm. Laboratory analysis of the stockpile samples indicates that concentrations of arsenic exceeding RSSL range from 4.83 to 5.06 mg/kg.

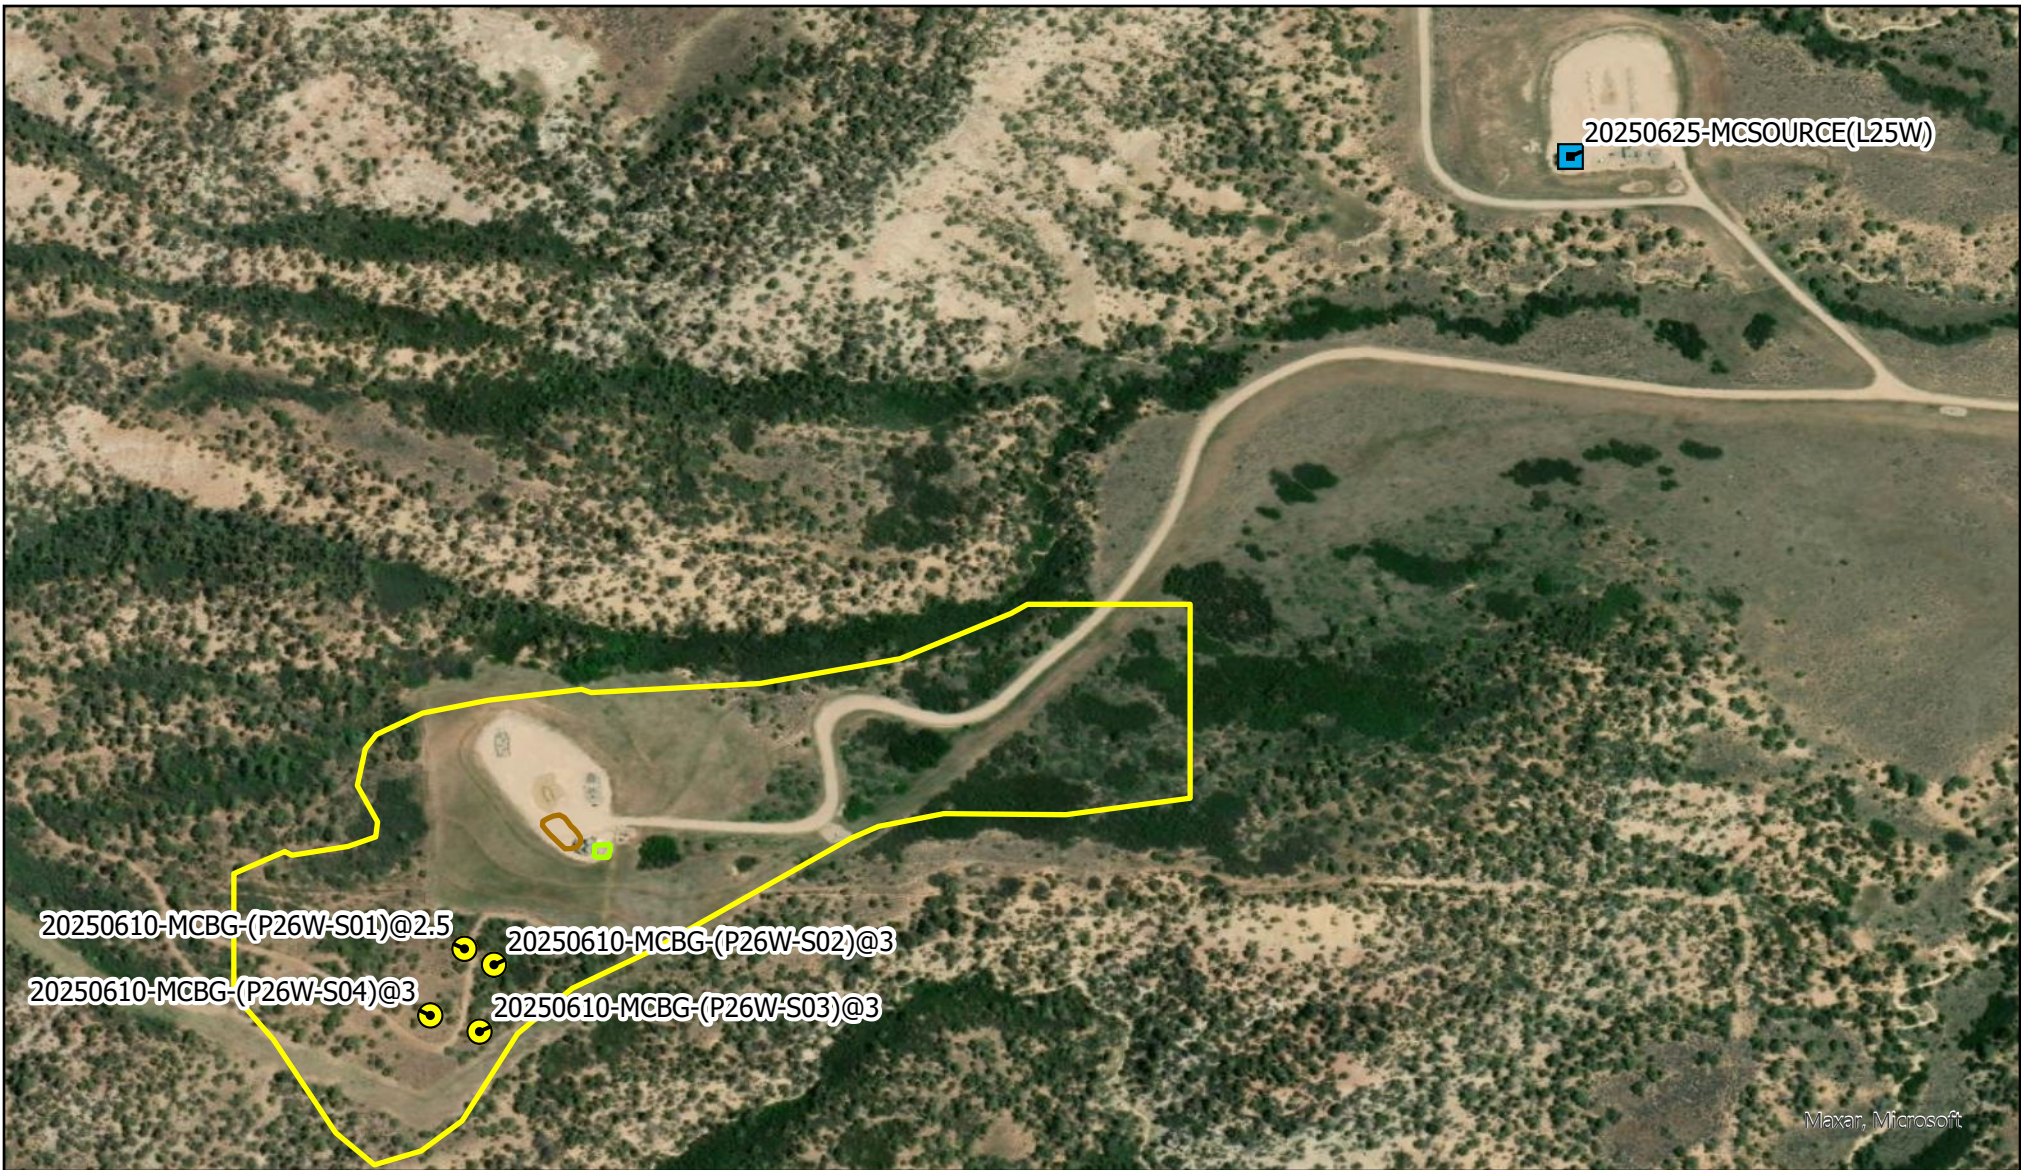
Site Overview - Supporting Samples

Background Soil Samples
-

Source Sample
-

NRSC Soil Survey: Morval-Tridell Complex, 6-25% Slopes

Laboratory analysis of the background samples indicates that concentrations of arsenic exceeding RSSL range from 4.33 to 5.16 mg/kg.

Analytical results from the source characterization sample indicate values of pH at 8.19 and arsenic of 0.00278 milligrams per liter (mg/L).

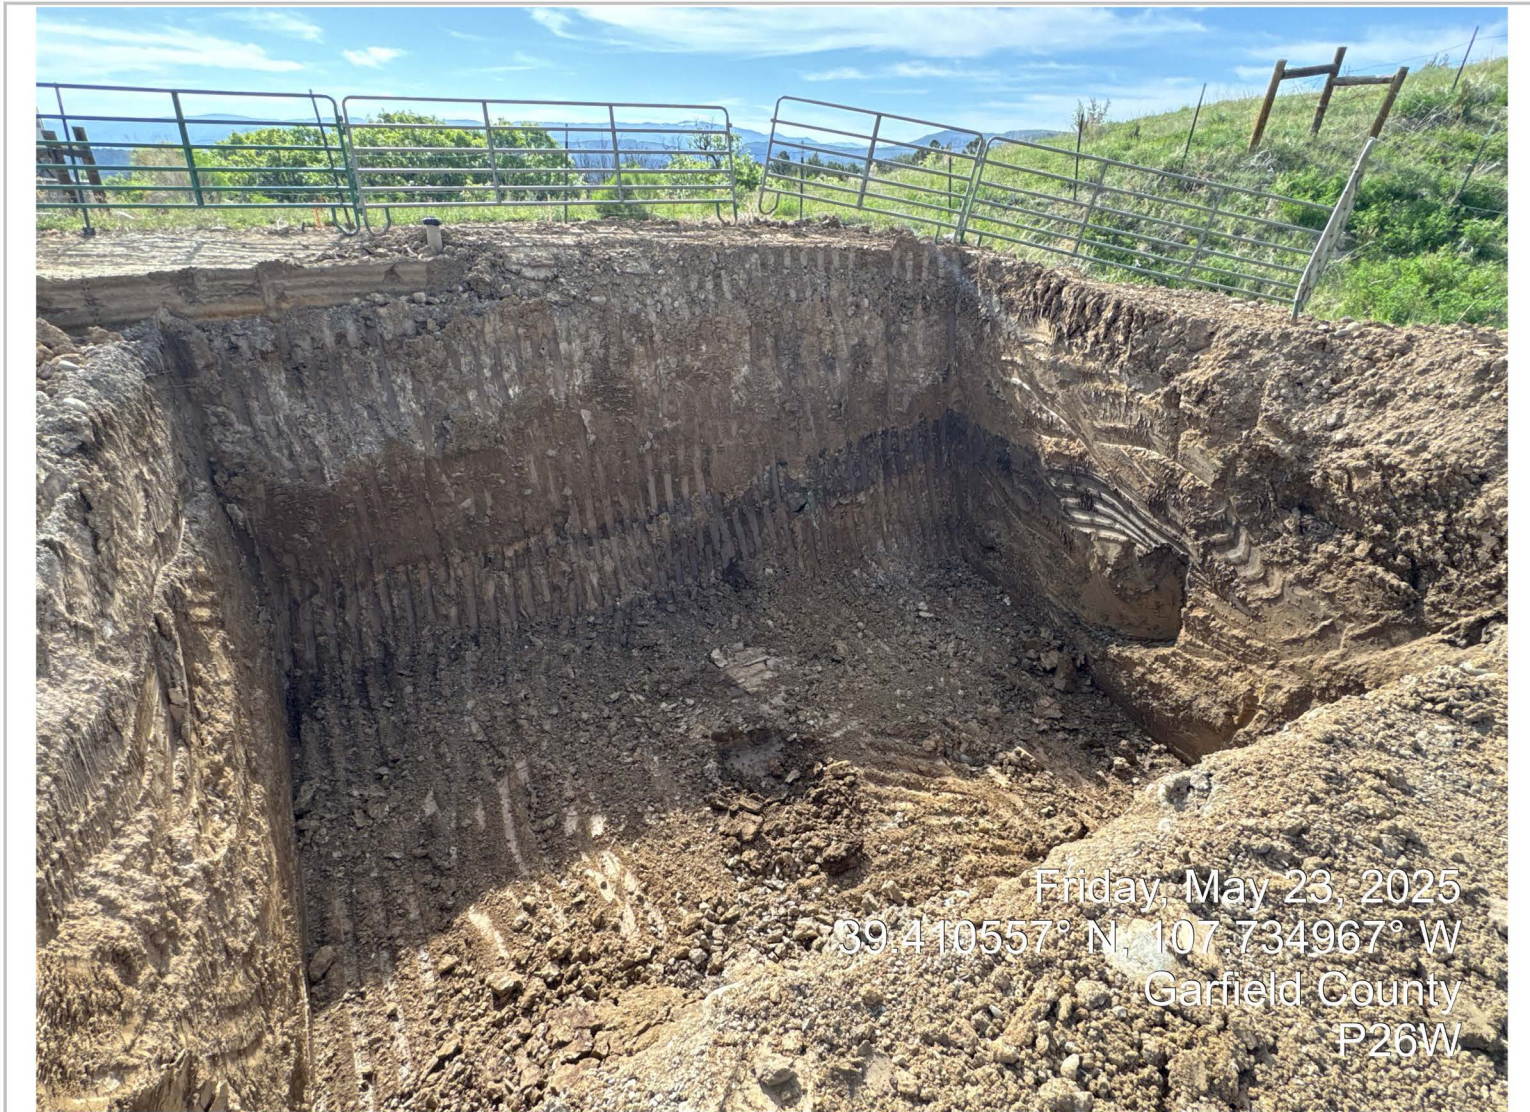
Excavation 05/23/2025: View East

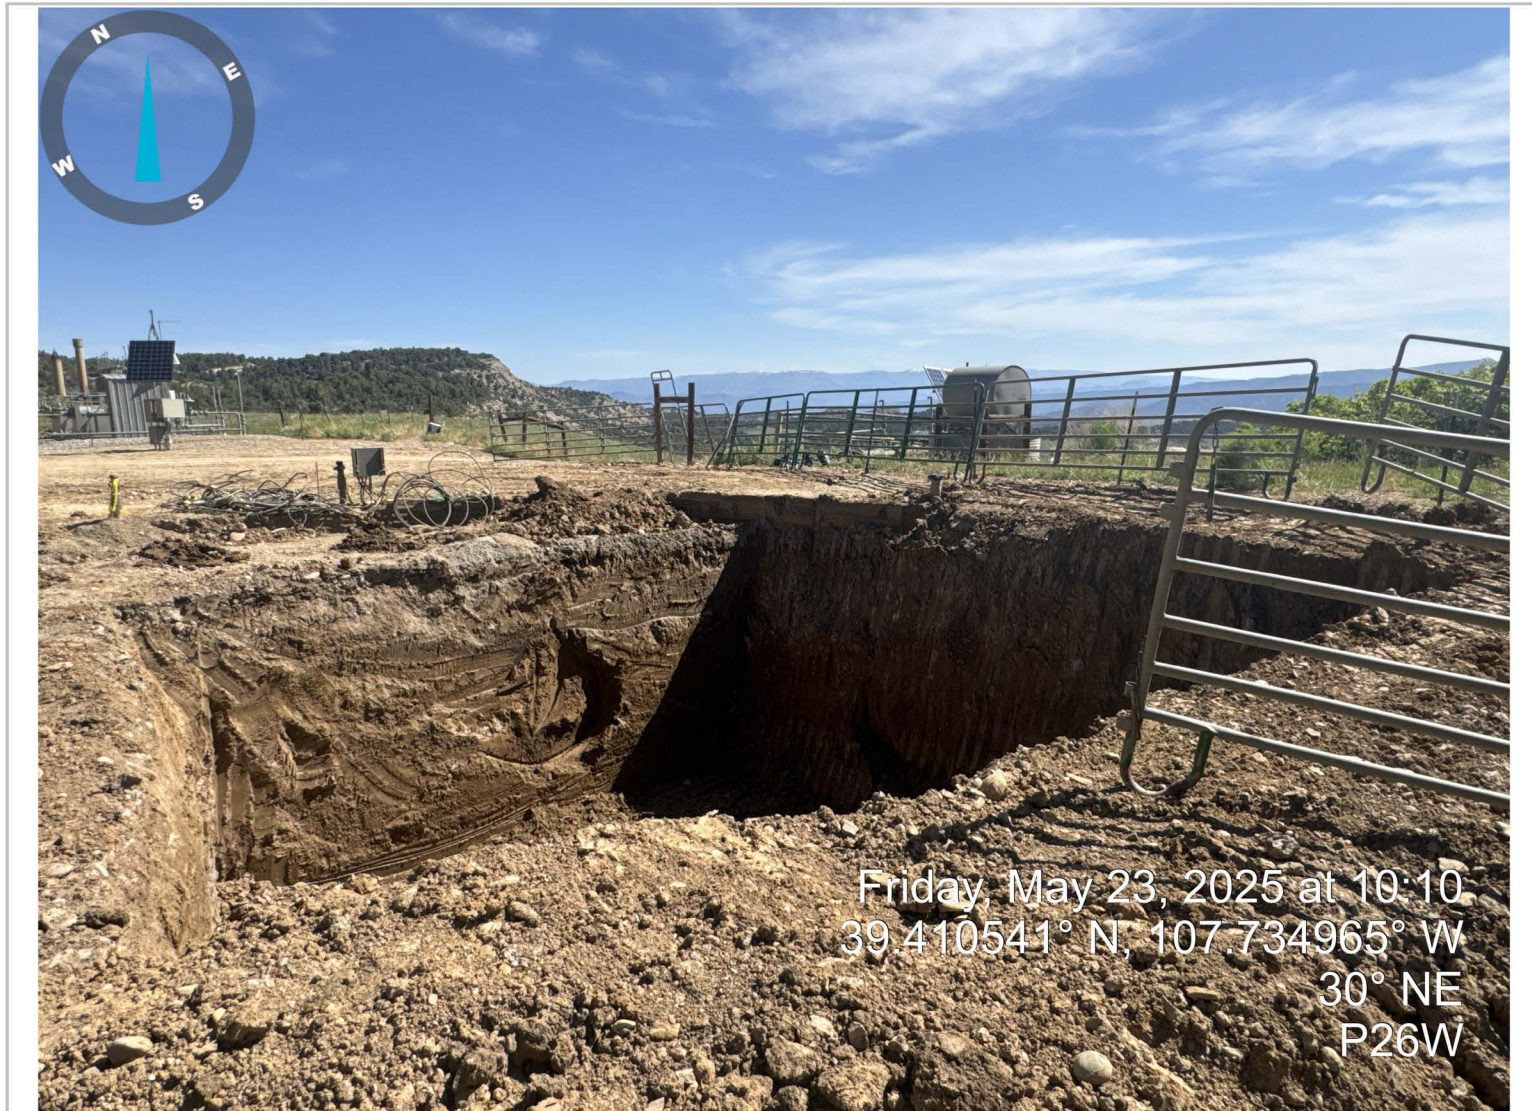
Excavation 05/23/2025: View Northeast

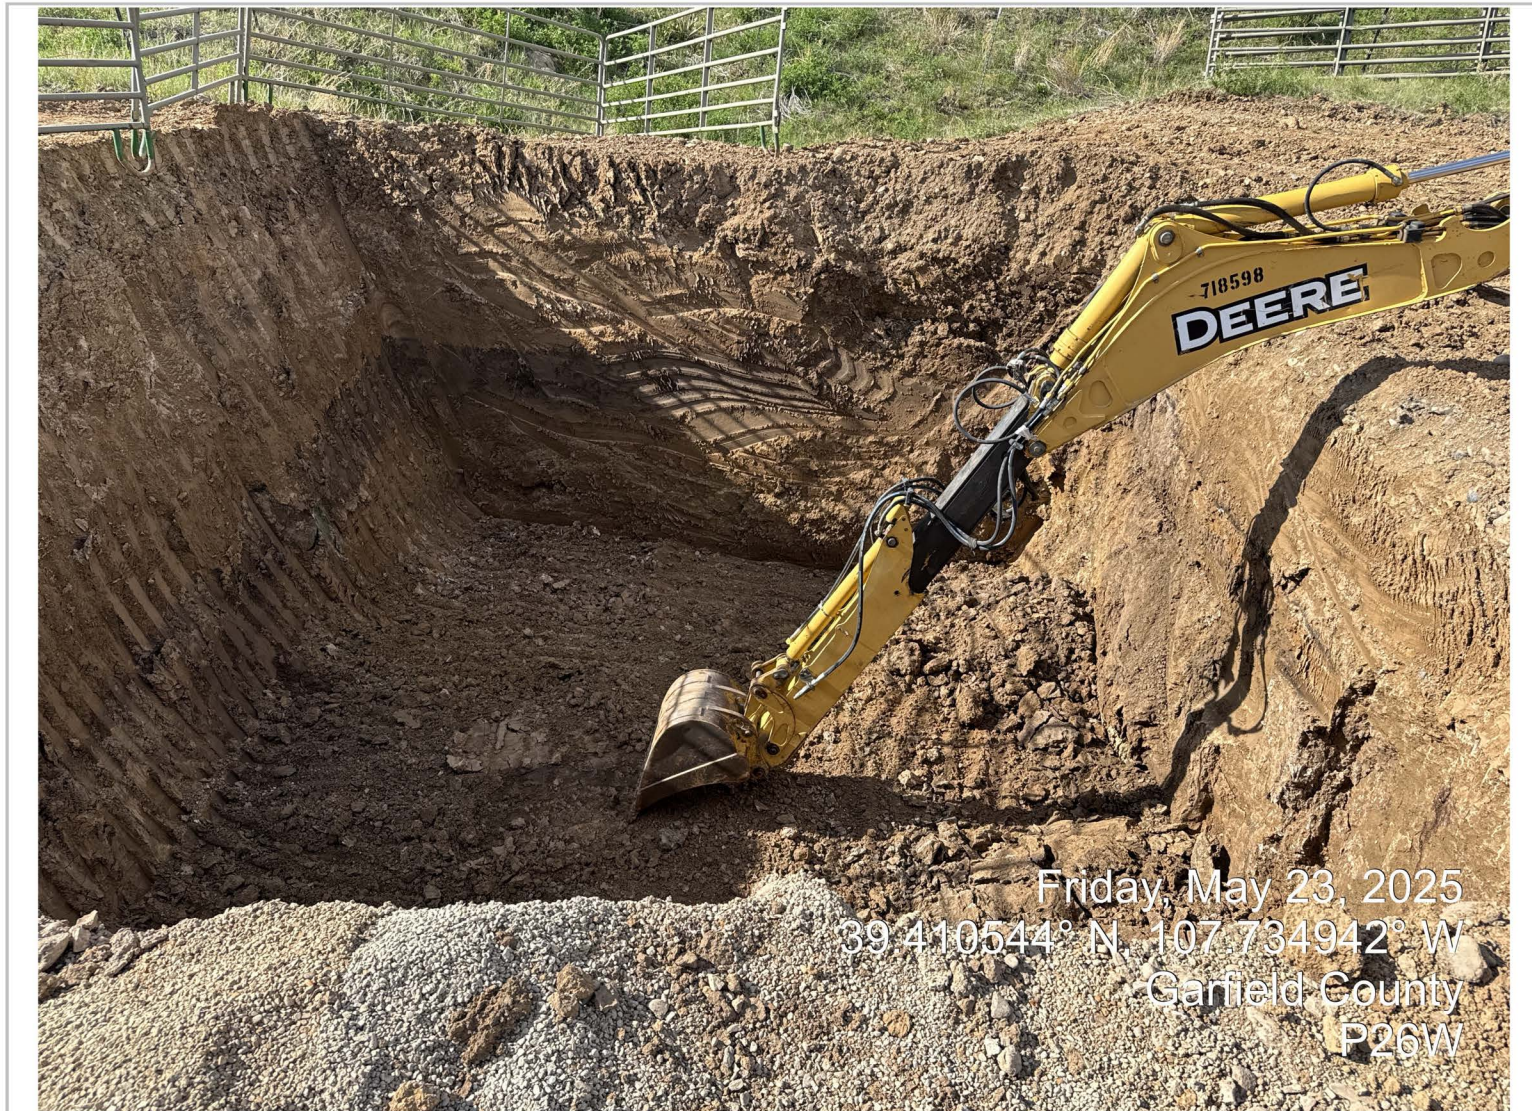
20250523-P26W-(BASE)@12.5: View South

| Analyte | | | | EC | SAR | pH | HWS Boron | Arsenic | Barium | Cadmium | Chromium VI | Copper | Lead | Nickel | Selenium | Silver | Zinc |
|---|---|---|---|---|---|---|---|---|---|---|---|---|---|---|---|---|---|
| 20250523-P26W-(BASE)@12.5 | Excavation | 05/23/2025 | 4803 | | 2.96 | 8.55 | | 6.65 | | | < 0.080 | | | | | | |

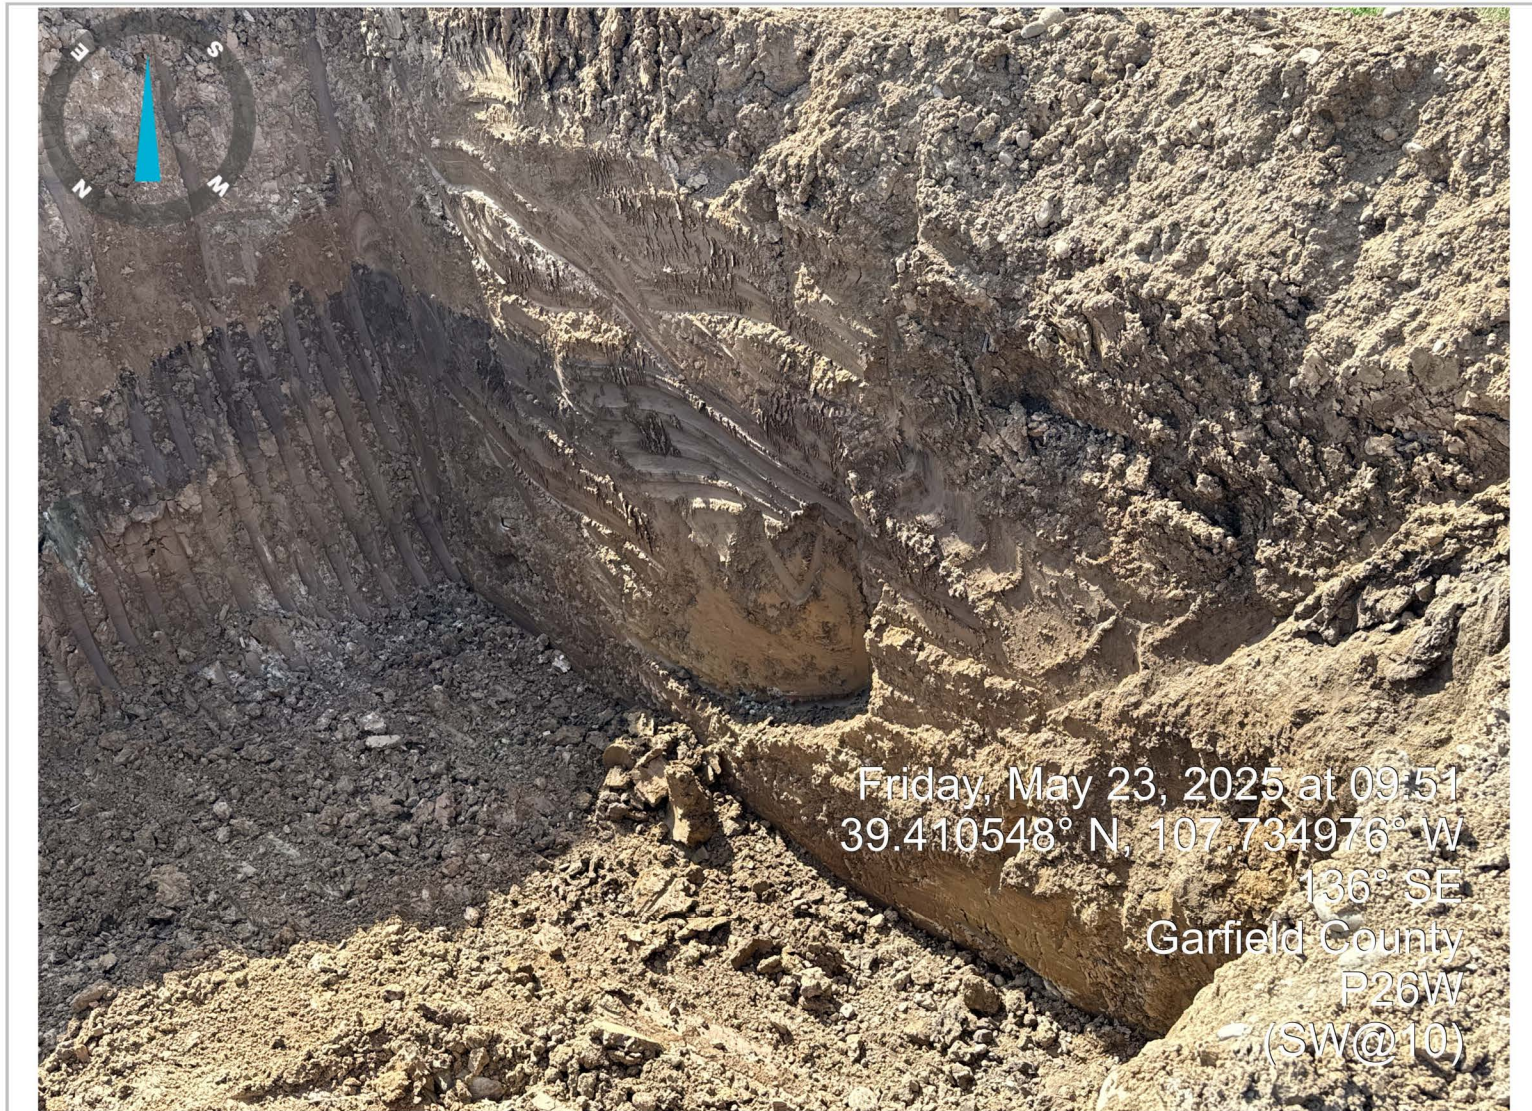
20250523-P26W-(SW)@10: View Southeast

| Analyte | | | | EC | SAR | pH | HWS Boron | Arsenic | Barium | Cadmium | Chromium VI | Copper | Lead | Nickel | Selenium | Silver | Zinc |
|---|---|---|---|---|---|---|---|---|---|---|---|---|---|---|---|---|---|
| 20250523-P26W-(SW)@10 | Excavation | 05/23/2025 | 4803 | | 3.26 | 8.65 | | 7.36 | | | 0.08 | | | | | | |

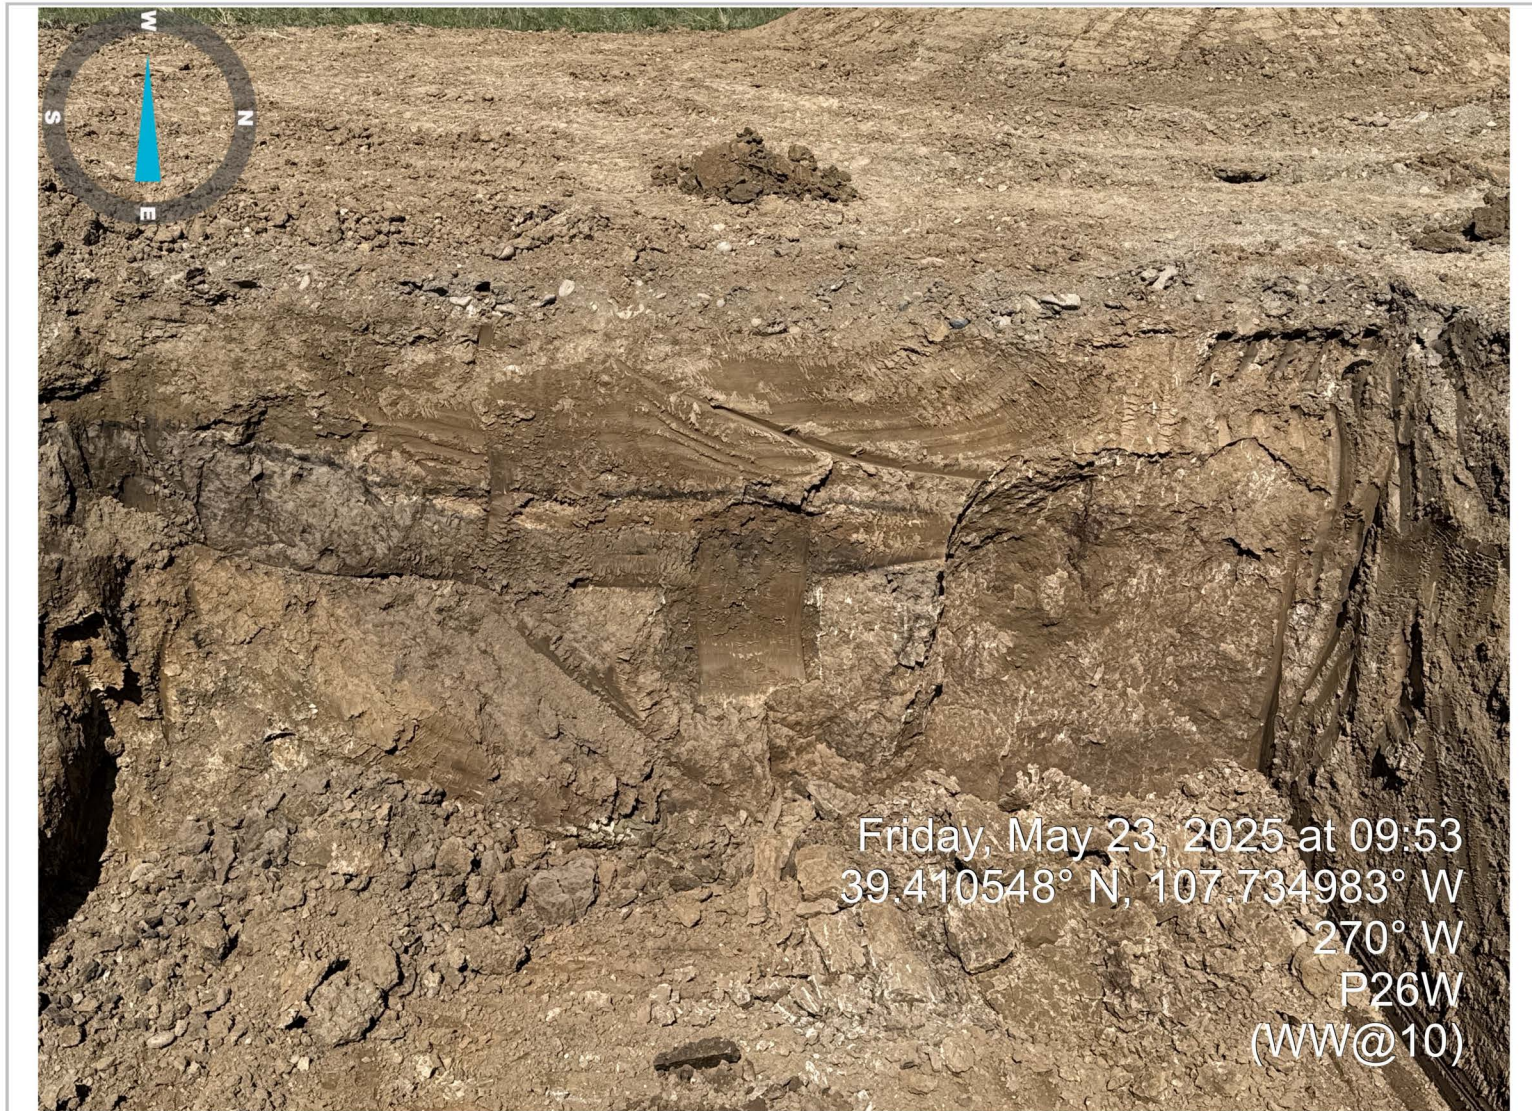
20250523-P26W-(WW)@10: View West

| Analyte | | | | EC | SAR | pH | HWS Boron | Arsenic | Barium | Cadmium | Chromium VI | Copper | Lead | Nickel | Selenium | Silver | Zinc |
|---|---|---|---|---|---|---|---|---|---|---|---|---|---|---|---|---|---|
| 20250523-P26W-(WW)@10 | Excavation | 05/23/2025 | 4803 | | 4.15 | 8.99 | | 5.08 | | | < 0.080 | | | | | | |

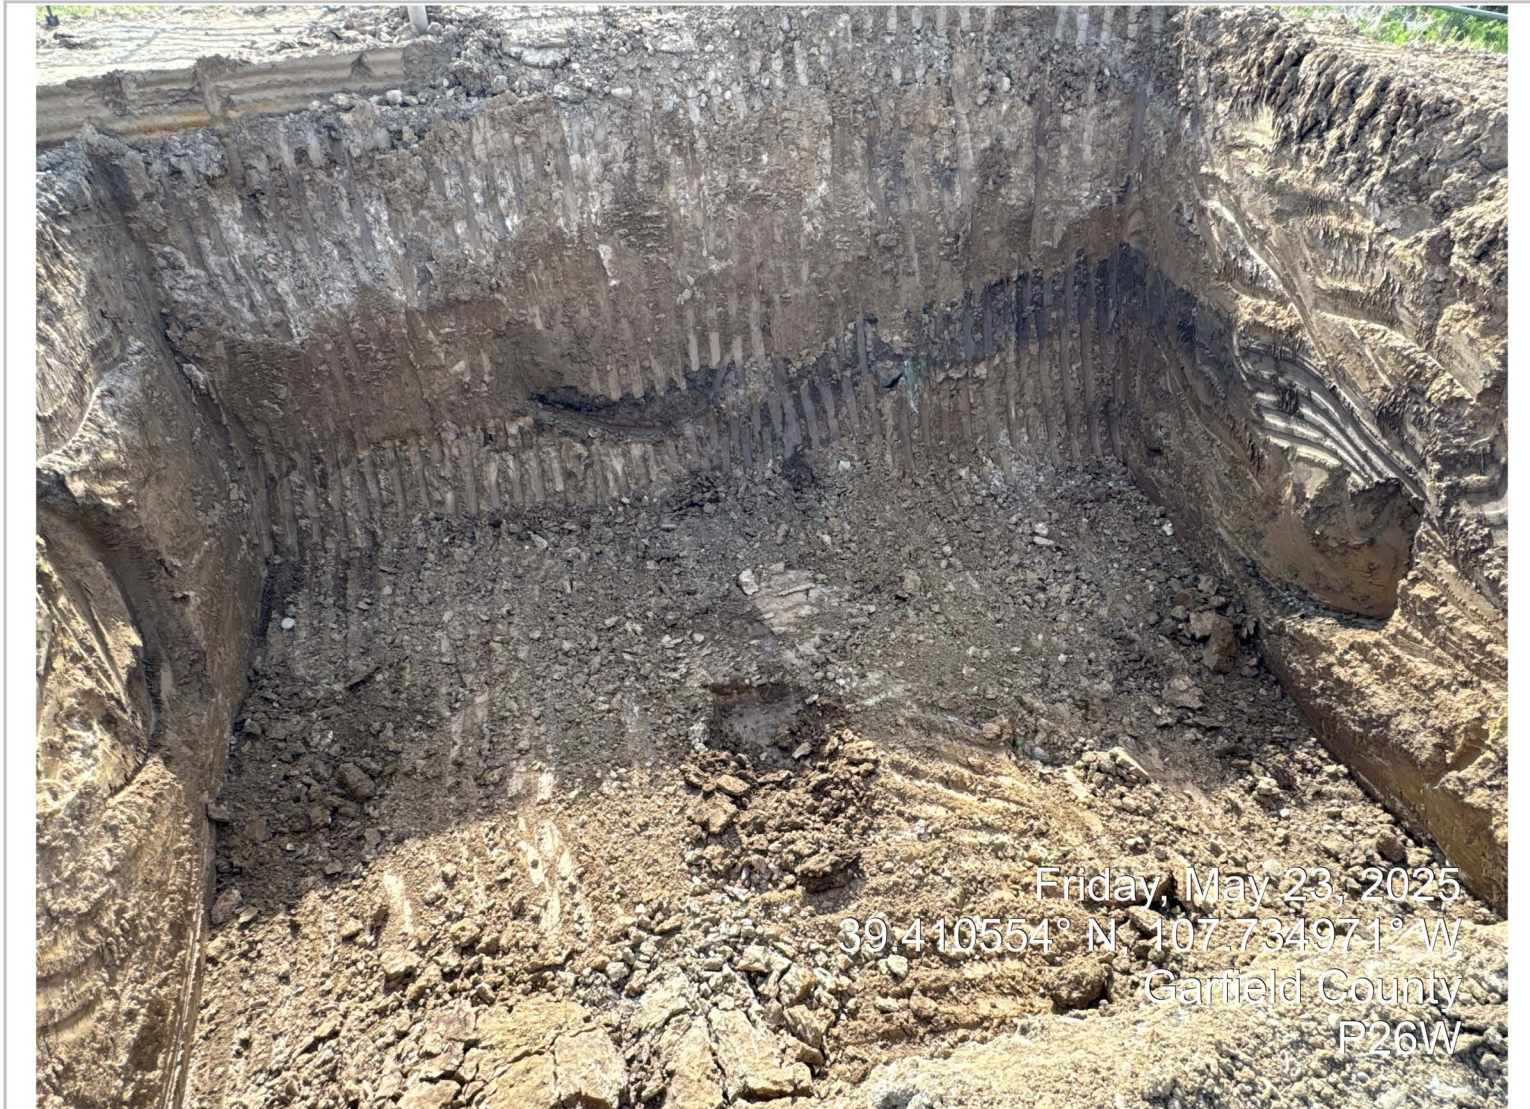
20250523-P26W-(EW)@10: View East

| Analyte | | | | EC | SAR | pH | HWS Boron | Arsenic | Barium | Cadmium | Chromium VI | Copper | Lead | Nickel | Selenium | Silver | Zinc |
|---|---|---|---|---|---|---|---|---|---|---|---|---|---|---|---|---|---|
| 20250523-P26W-(EW)@10 | Excavation | 05/23/2025 | 4803 | | 4.27 | 8.80 | | 3.99 | | | 0.08 | | | | | | |

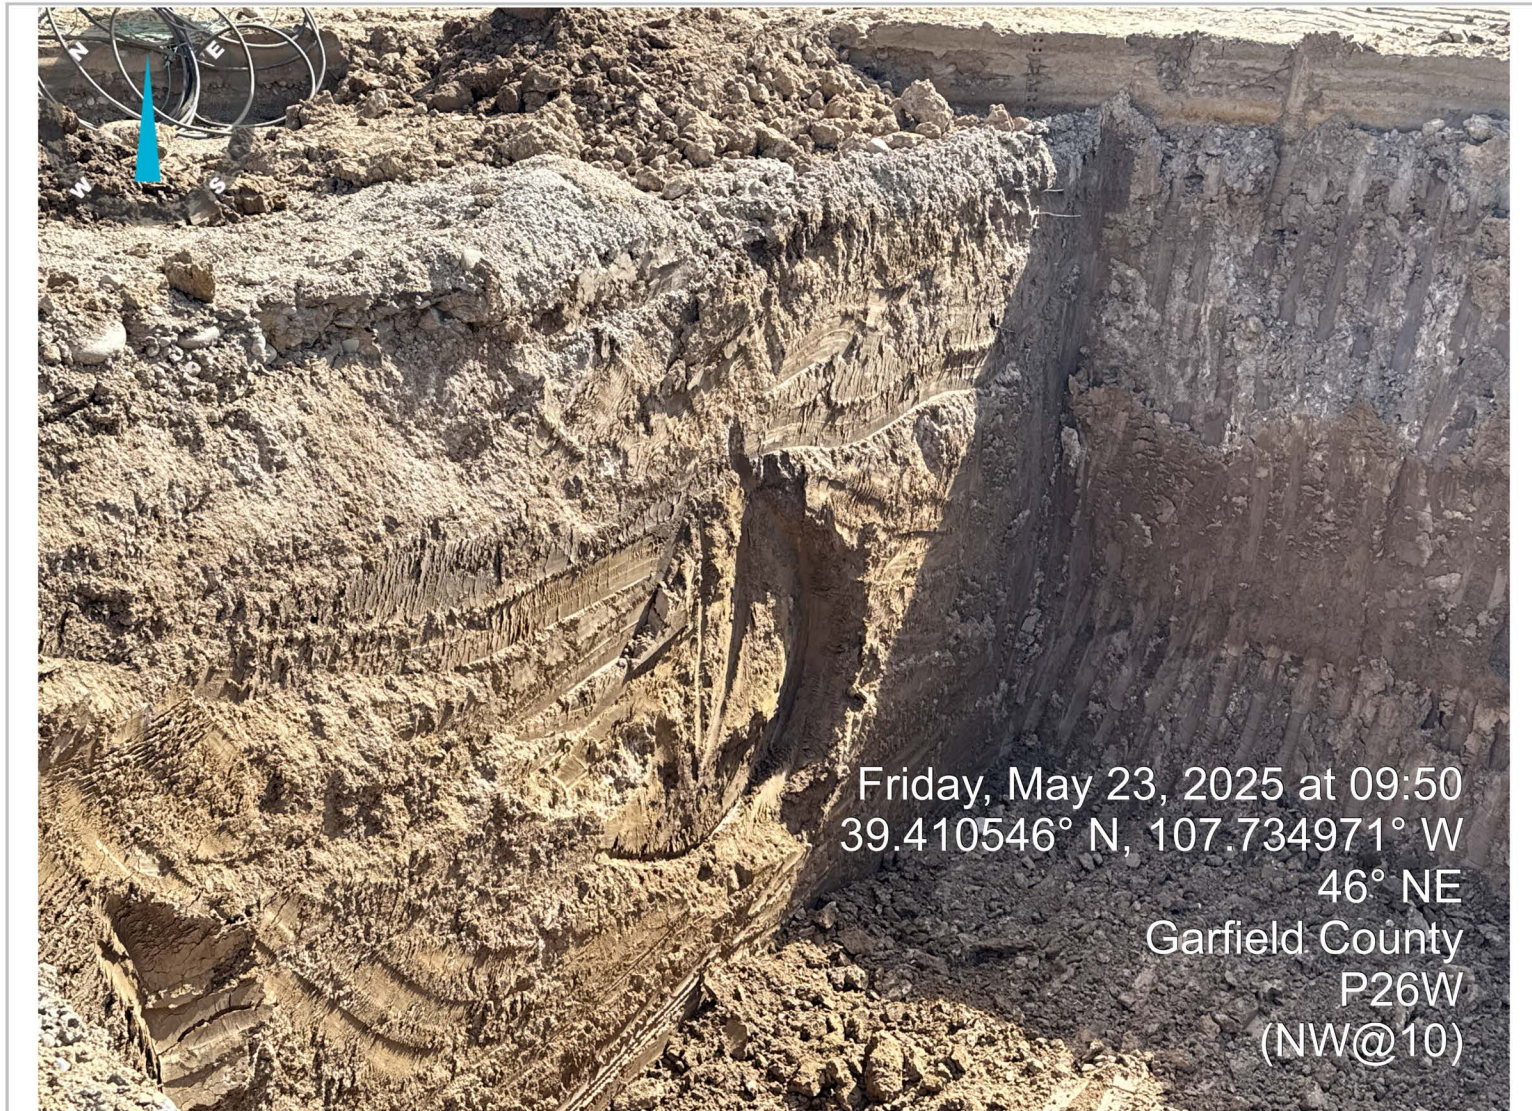
20250523-P26W-(NW)@10: View Northeast

| Analyte | | | | EC | SAR | pH | HWS Boron | Arsenic | Barium | Cadmium | Chromium VI | Copper | Lead | Nickel | Selenium | Silver | Zinc |
|---|---|---|---|---|---|---|---|---|---|---|---|---|---|---|---|---|---|
| 20250523-P26W-(NW)@10 | Excavation | 05/23/2025 | 4803 | | 4.20 | 8.54 | | 5.80 | | | < 0.080 | | | | | | |

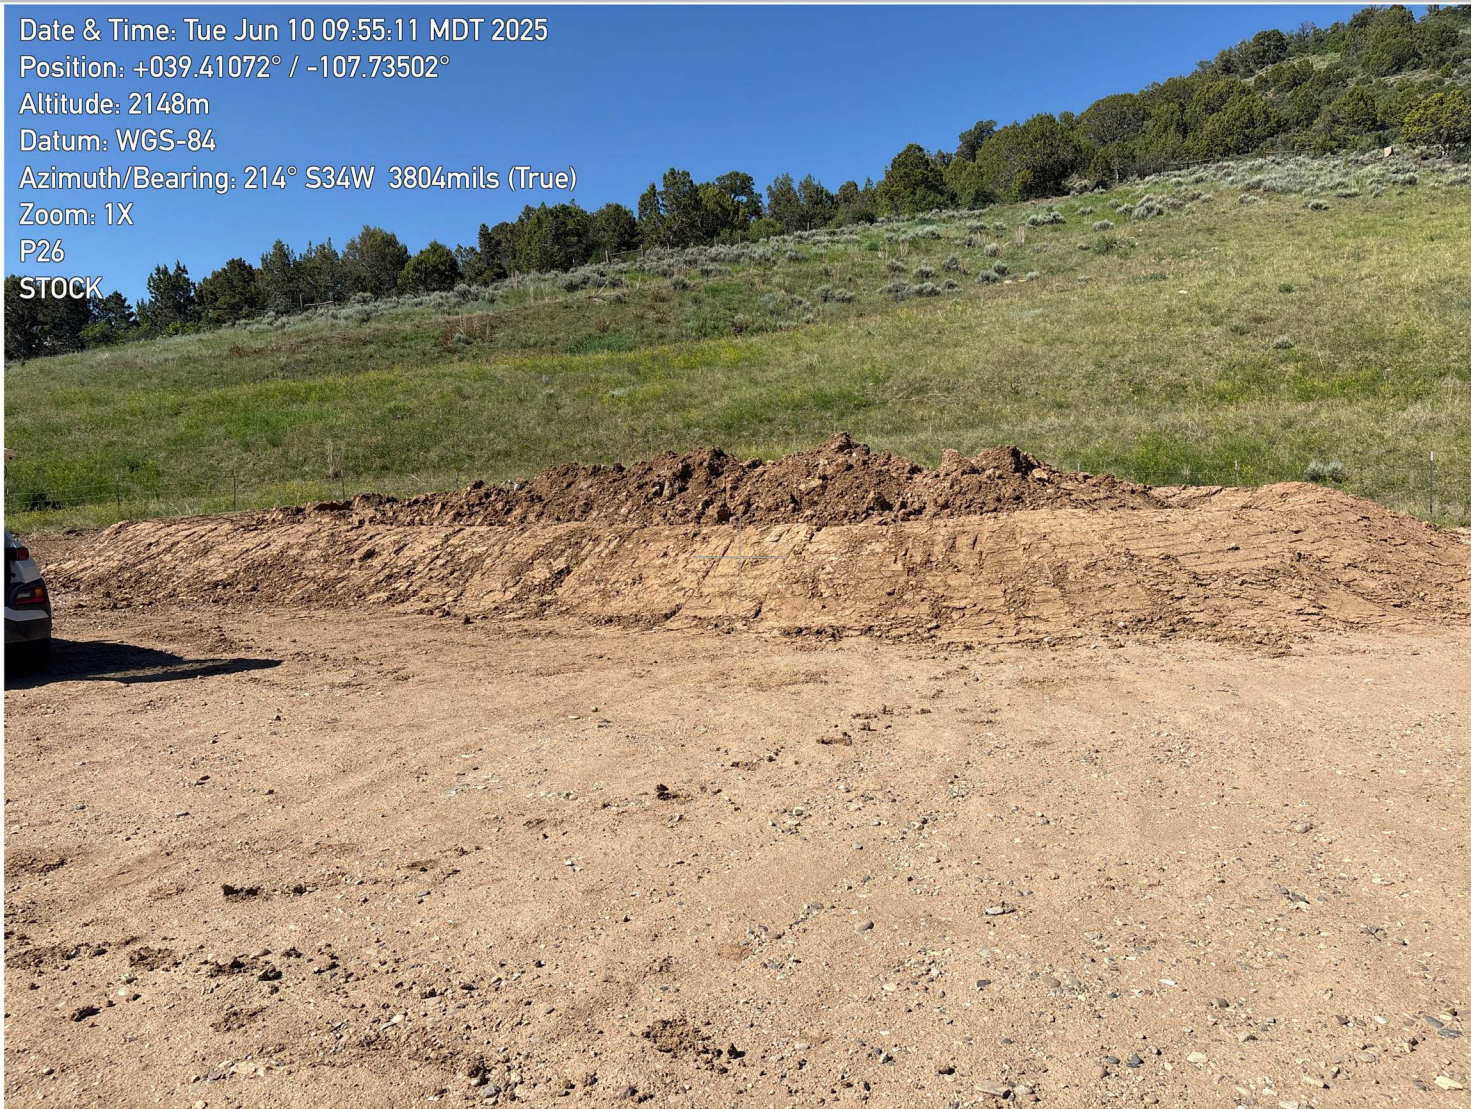
Stockpile 06/10/2025: View Southwest

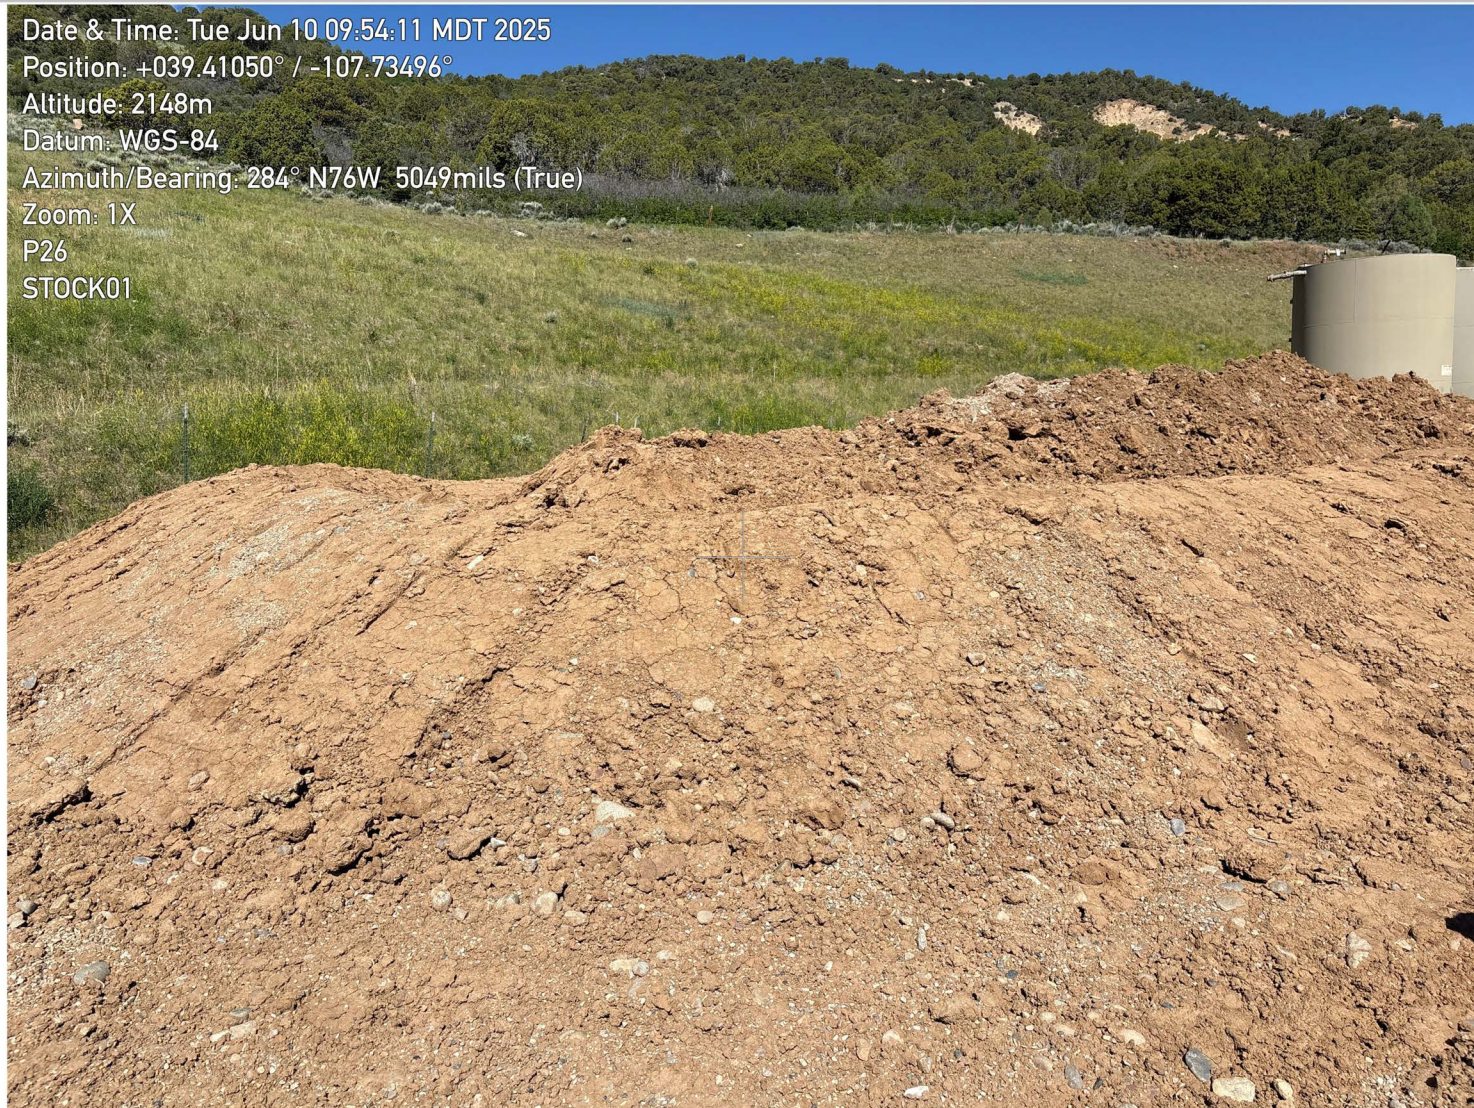
20250610-P26W-(STOCK01): View Northwest

| Analyte | | | | EC | SAR | pH | HWS Boron | Arsenic | Barium | Cadmium | Chromium VI | Copper | Lead | Nickel | Selenium | Silver | Zinc |
|---|---|---|---|---|---|---|---|---|---|---|---|---|---|---|---|---|---|
| 20250610-P26W-(STOCK01) | Stockpile | 06/10/2025 | 5102 | | 4.59 | 8.28 | | 4.83 | | | < 0.080 | | | | | | |
