Report of Work Completed – Tank Valve Release

| ECMC Location Name (ID) | SHIDELER FEDERAL-67S93W/26SESE (334232) |
| Operator Location Name | P26W |
| ECMC Remediation Project | 23856 |

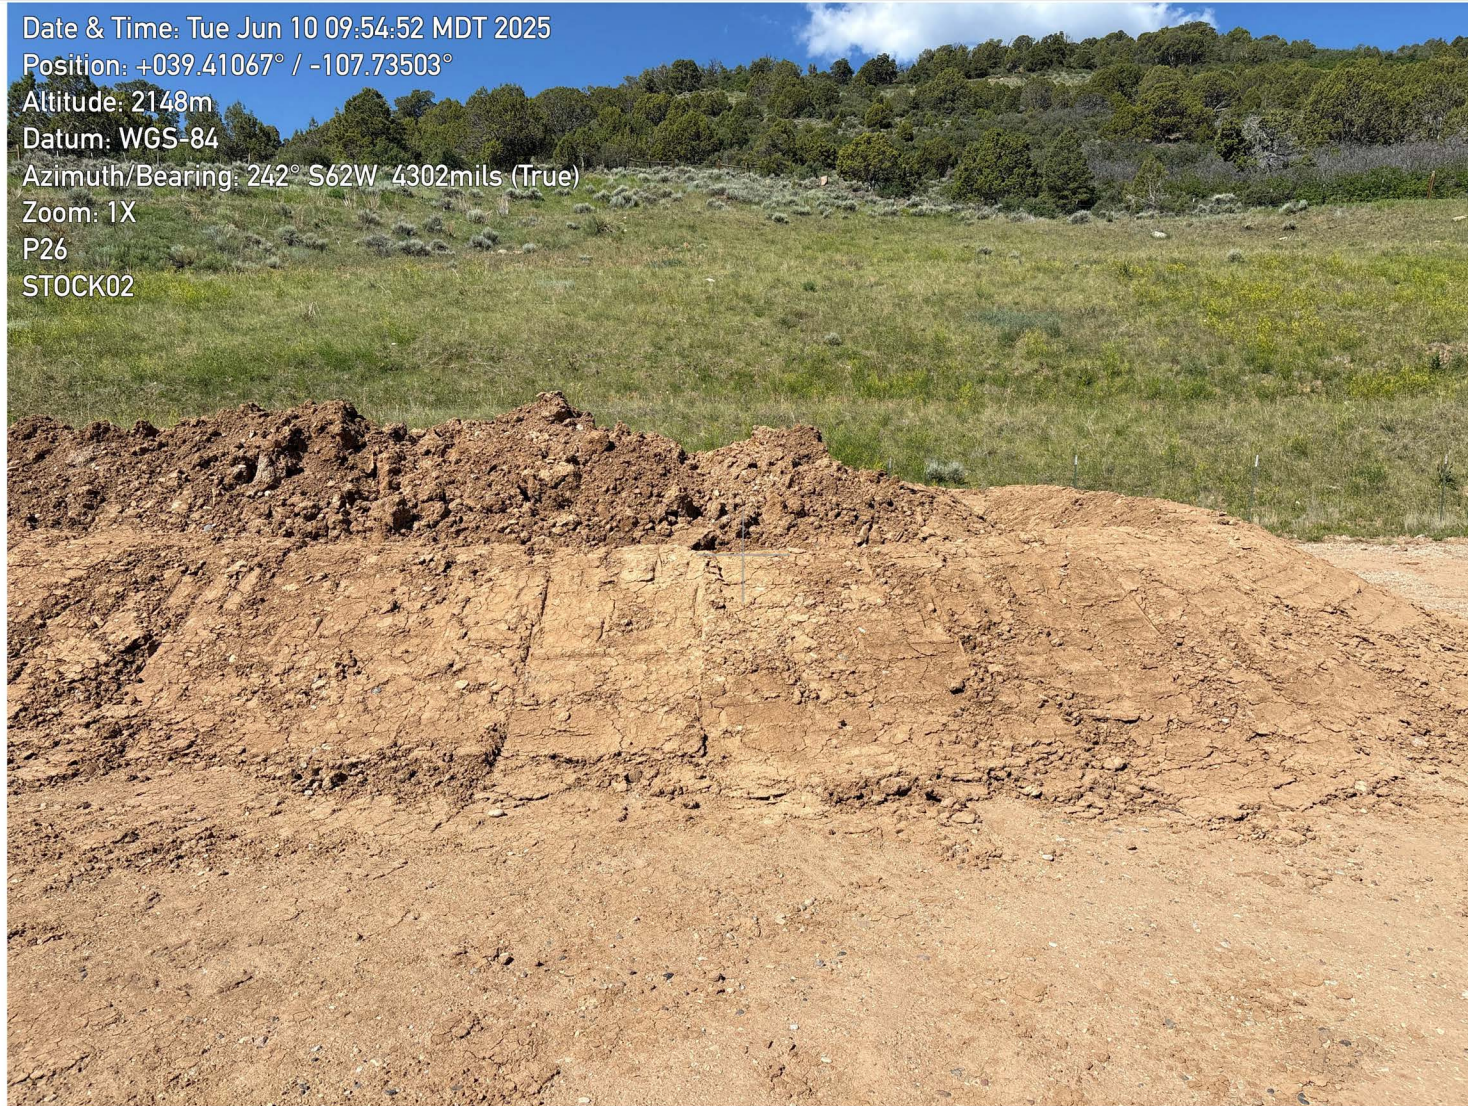
20250610-P26W-(STOCK02): View Southwest

| Analyte | | | | EC | SAR | pH | HWS Boron | Arsenic | Barium | Cadmium | Chromium VI | Copper | Lead | Nickel | Selenium | Silver | Zinc |
|---|---|---|---|---|---|---|---|---|---|---|---|---|---|---|---|---|---|
| 20250610-P26W-(STOCK02) | Stockpile | 06/10/2025 | 5102 | | 4.88 | 8.30 | | 5.06 | | | 0.08 | | | | | | |
