Subject: **Excavation Report**
 Kerbs K 20-6
 API # 05-123-20597
 SENW Sec. 20, T4N, R66W
 Weld County, Colorado
 Fremont Project No. C024-125
 Remediation #23578

EXCAVATION REPORT

NOBLE ENERGY INC.

KERBS K 20-6

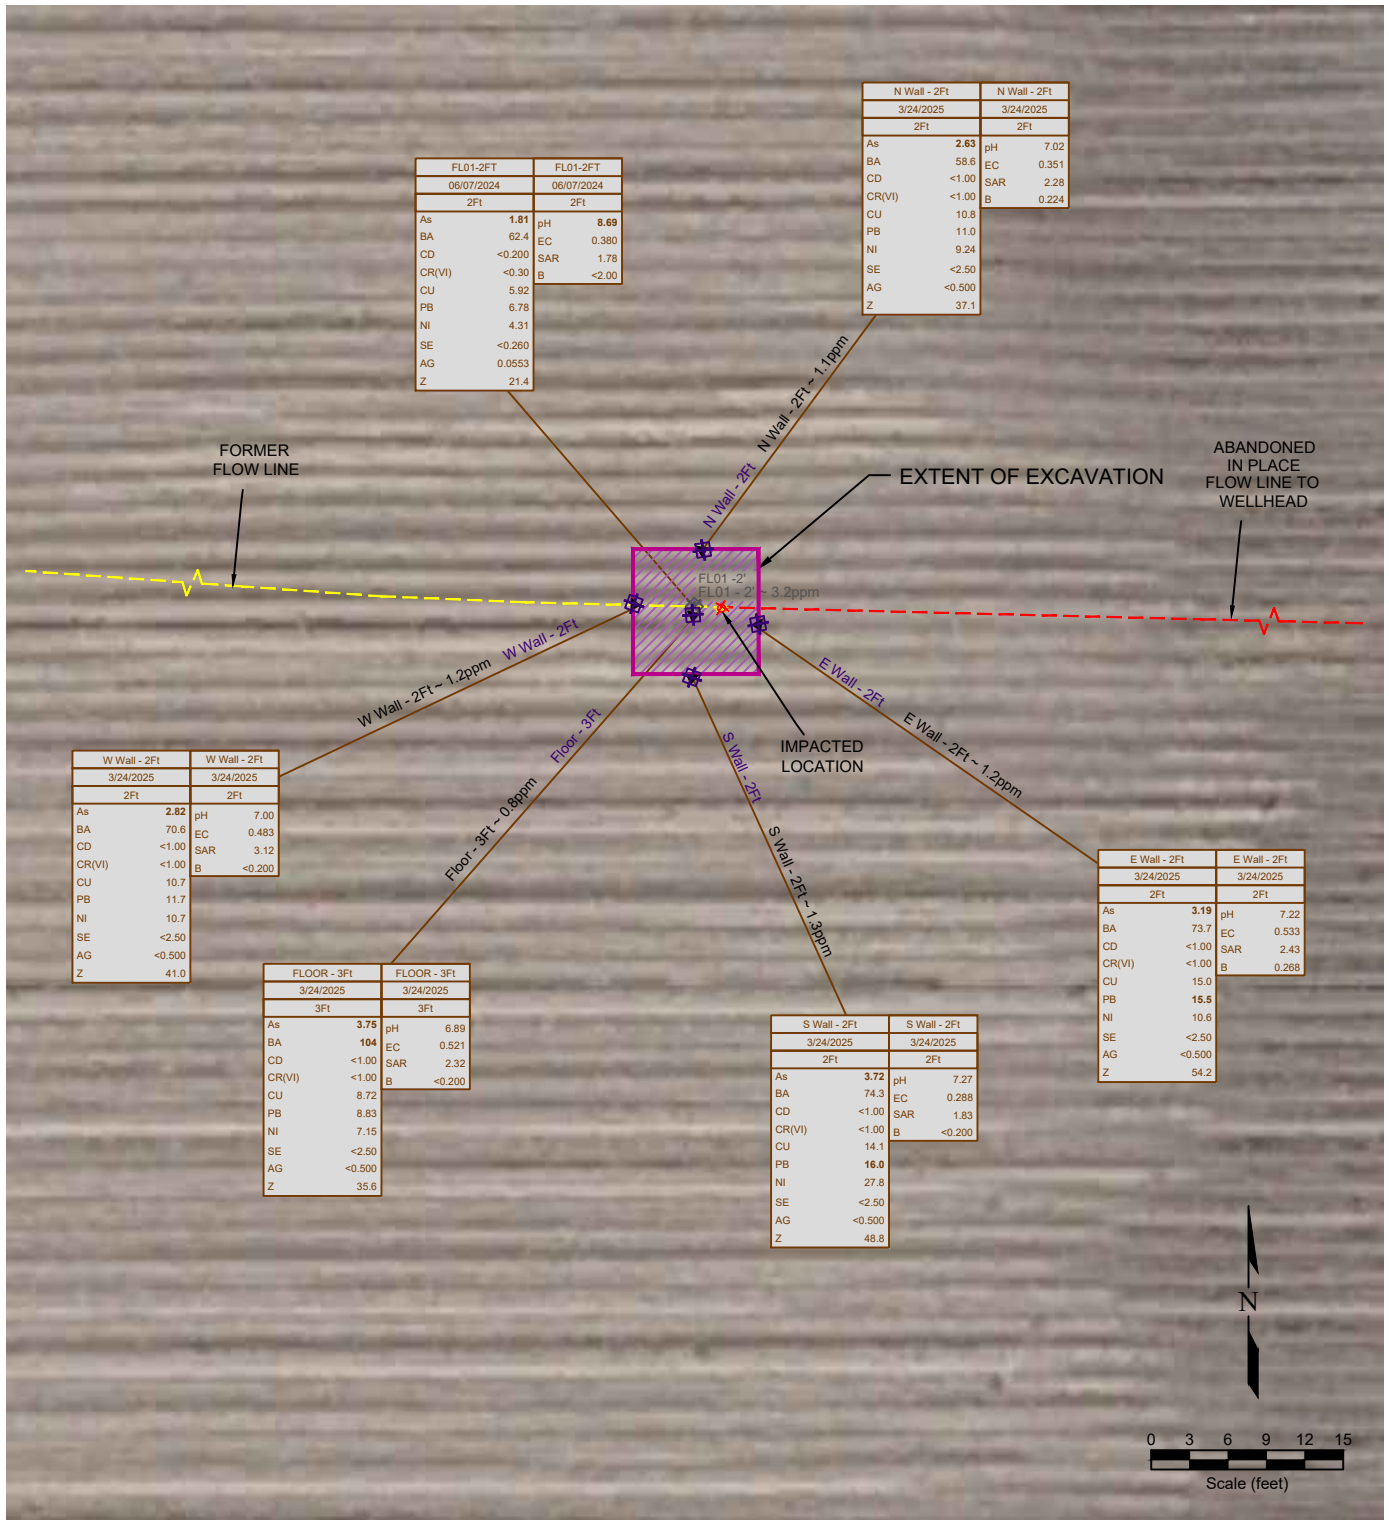
Figure 4

However, exceedances of certain metal constituents were observed. One sample collected from the excavation floor at a depth of three feet (FLOOR – 3ft) exceeded the ECMC Table 915-1 PGSSLs for barium. Two sidewall samples (S Wall – 2ft and E Wall – 2ft) exceeded PGSSLs for lead, and one sample (S Wall – 2ft) exceeded the PGSSLs for nickel. Additionally, all collected samples exceeded the Residential Soil Screening Levels (RSSLs) for arsenic. Background samples obtained from native soils adjacent to the excavation at depths of two and three feet also exceeded ECMC Table 915-1 PGSSLs for arsenic and barium, suggesting these exceedances may be representative of naturally occurring background conditions.

With respect to the PGSSL exceedances for lead and nickel, the operator proposes to resample the original sidewall locations (S Wall - 2ft and E Wall - 2ft) at the same depths where the elevated concentrations were initially observed. Resampled soil will be analyzed for the full Table 915-1 analyte suite. If the resampling results are compliant with applicable Table 915-1 PGSSLs, Noble will submit a request for a No Further Action (NFA) determination, supported by background data to justify any persistent elevated concentrations.

Alternatively, if exceedances of lead or nickel persist and cannot be attributed to native soil conditions through background soil characterization, Noble will collect a minimum of five additional samples to delineate the horizontal and vertical extent of impacts. If necessary, remedial alternatives will be evaluated to address any in situ exceedances of metals that are not attributable to background and that exceed the applicable ECMC Table 915-1 standards.
