# Final Reclamation Inspection

Location ID: 328318

Inspection Document #: 718800529

Inspection Photos  
Location Name: CANNON #H 35-09  
Location ID: 328318

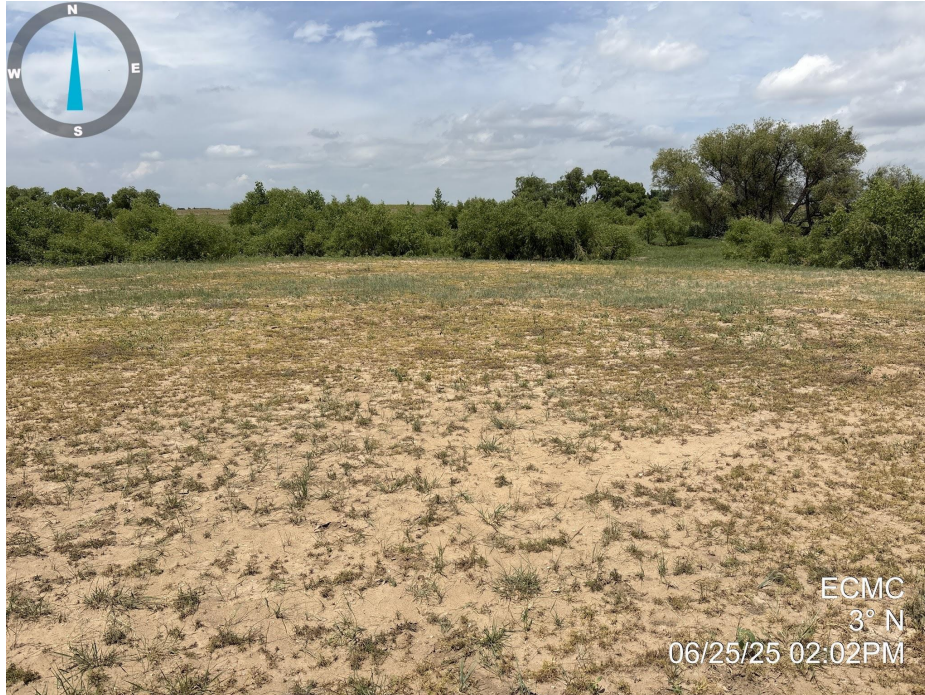
**Photo 1.** Photo taken from the well location, facing North. Photo illustrates that final reclamation activities have taken place, with evidence of drill row seeding, but vegetation has not established to Rule 1004 standards.

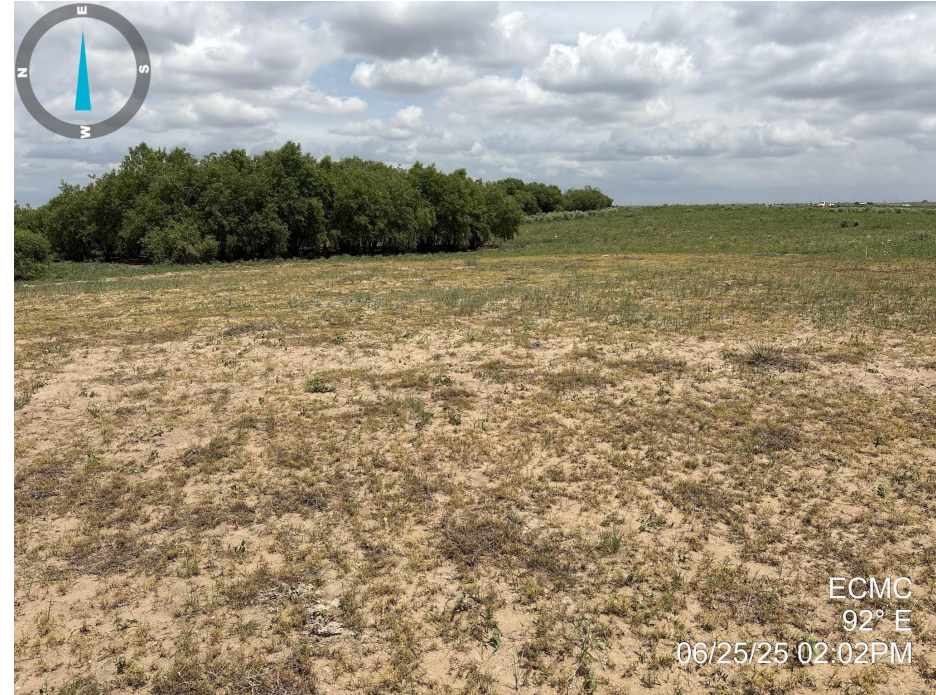
**Photo 2.** Photo taken from the well location, facing East. See comments under Photo 1.

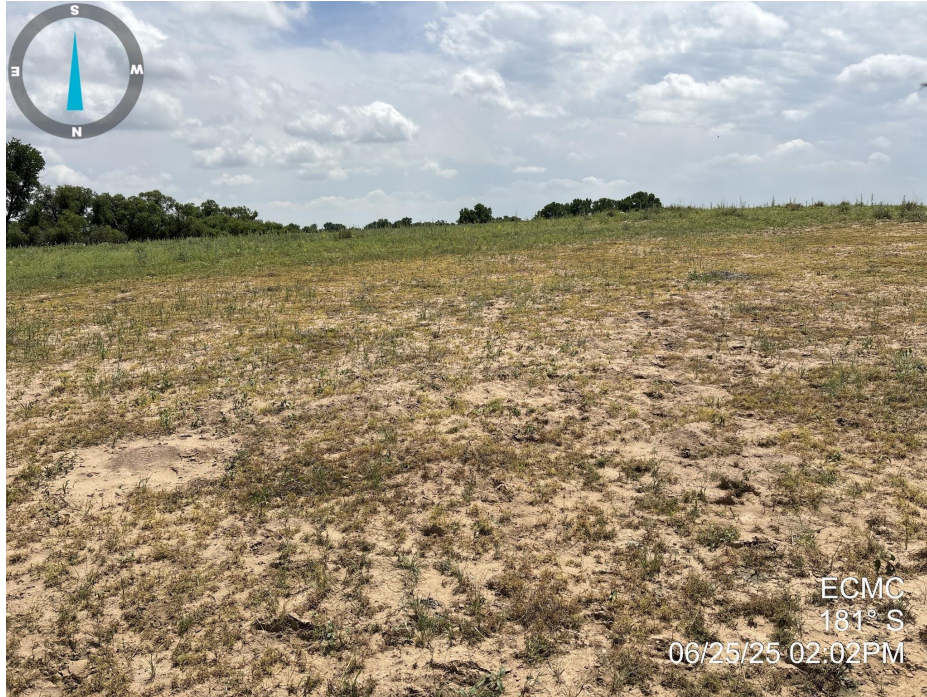
**Photo 3.** Photo taken from the well location, facing South. See comments under Photo 1.

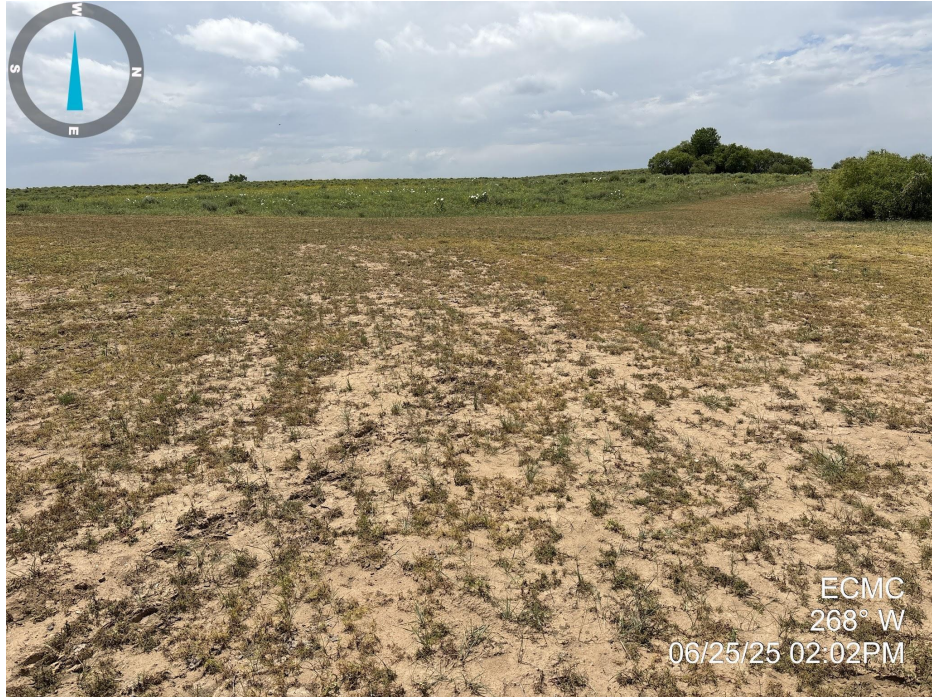
**Photo 4.** Photo taken from the well location, facing West. See comments under Photo 1.

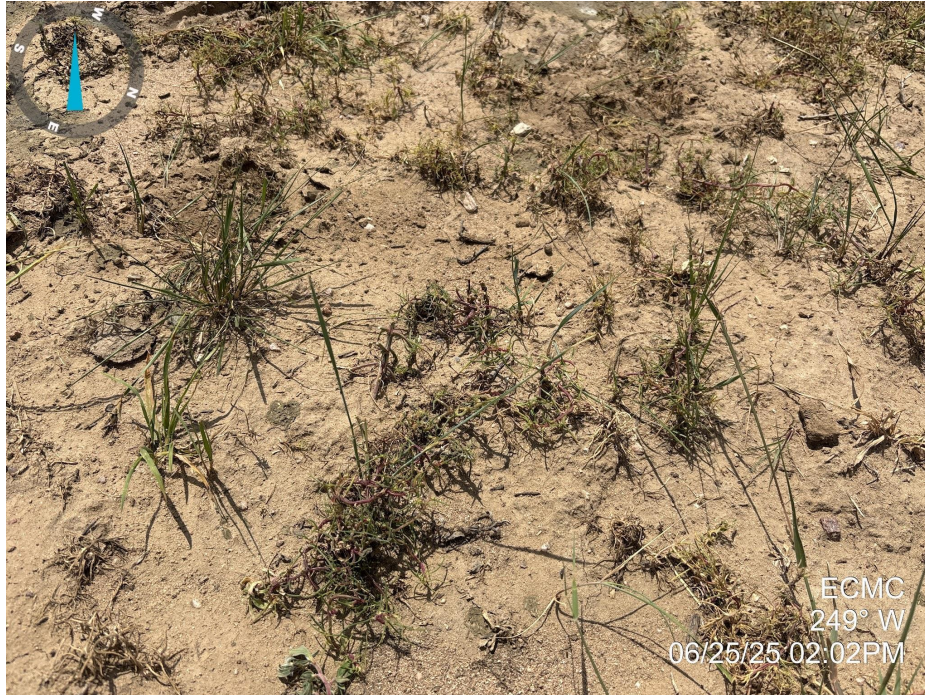
**Photo 5.** Photo taken of ground cover at the location. Photo illustrates bare ground and weedy annual vegetation, including russian thistle (*Salsola tragus*).

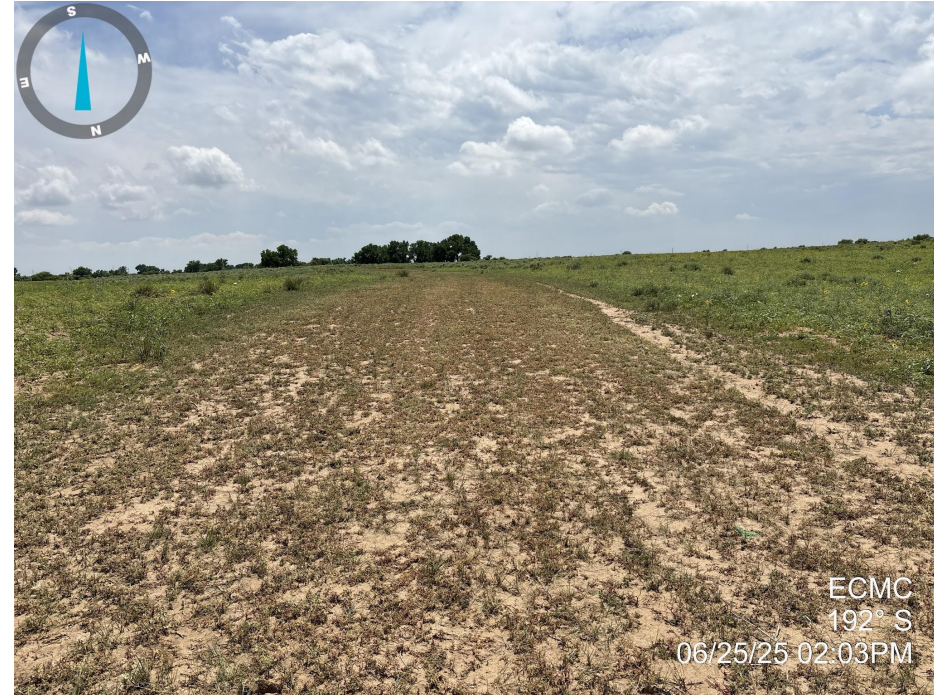
**Photo 6.** Photo taken of the access road to the well location, facing south. Photo illustrates that final reclamation activities have taken place, but vegetation has not established to Rule 1004 standards and the site is dominated by russian thistle (*Salsola tragus*).

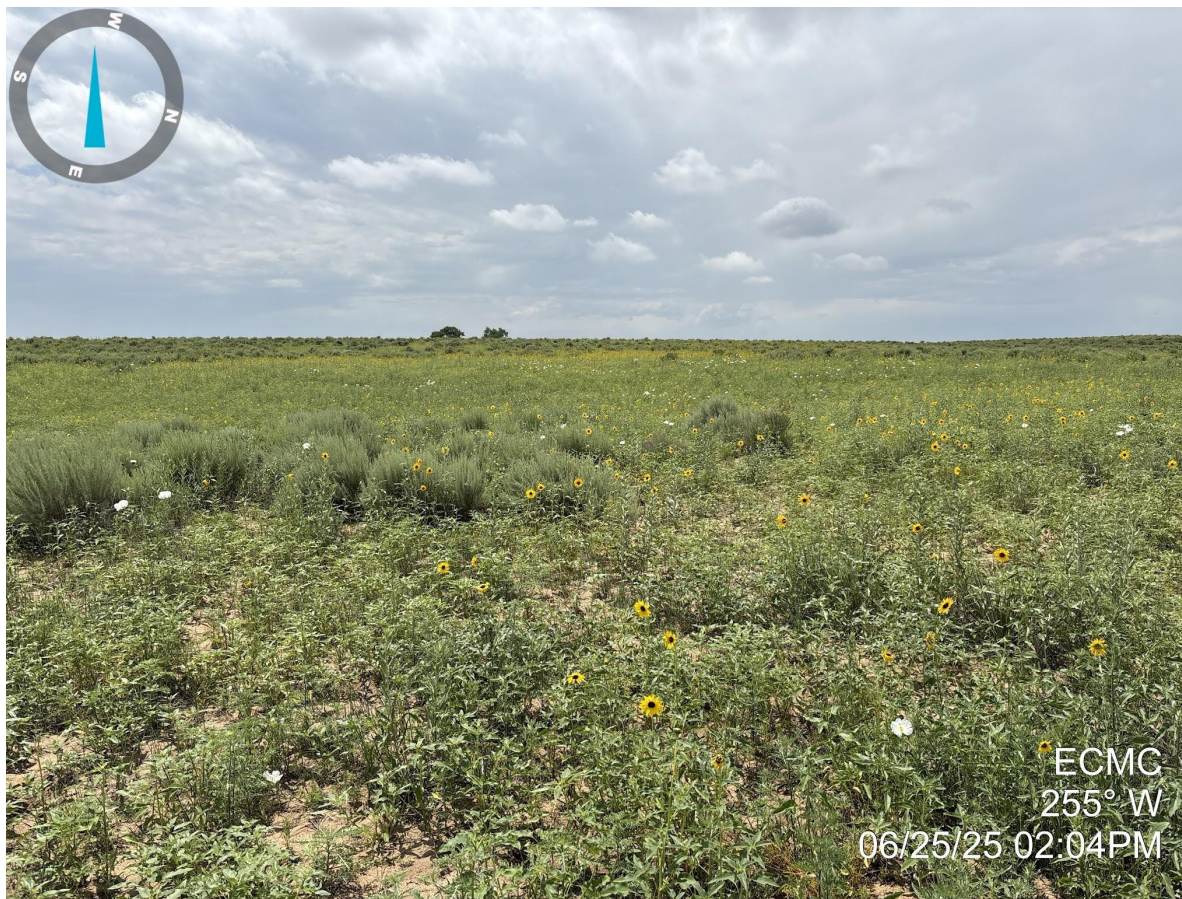
**Photo 7.** Photo taken of the reference area to the well location, northwest of the location, facing west. Photo illustrates the site is dominated by sand sagebrush (*Artemisia filifolia*), prairie sunflower (*Helianthus petiolaris*), and thistle poppy (*Argemone polyanthemus*).
