Musick-McClintock 5 (Spill ID 481685/REM 23556)

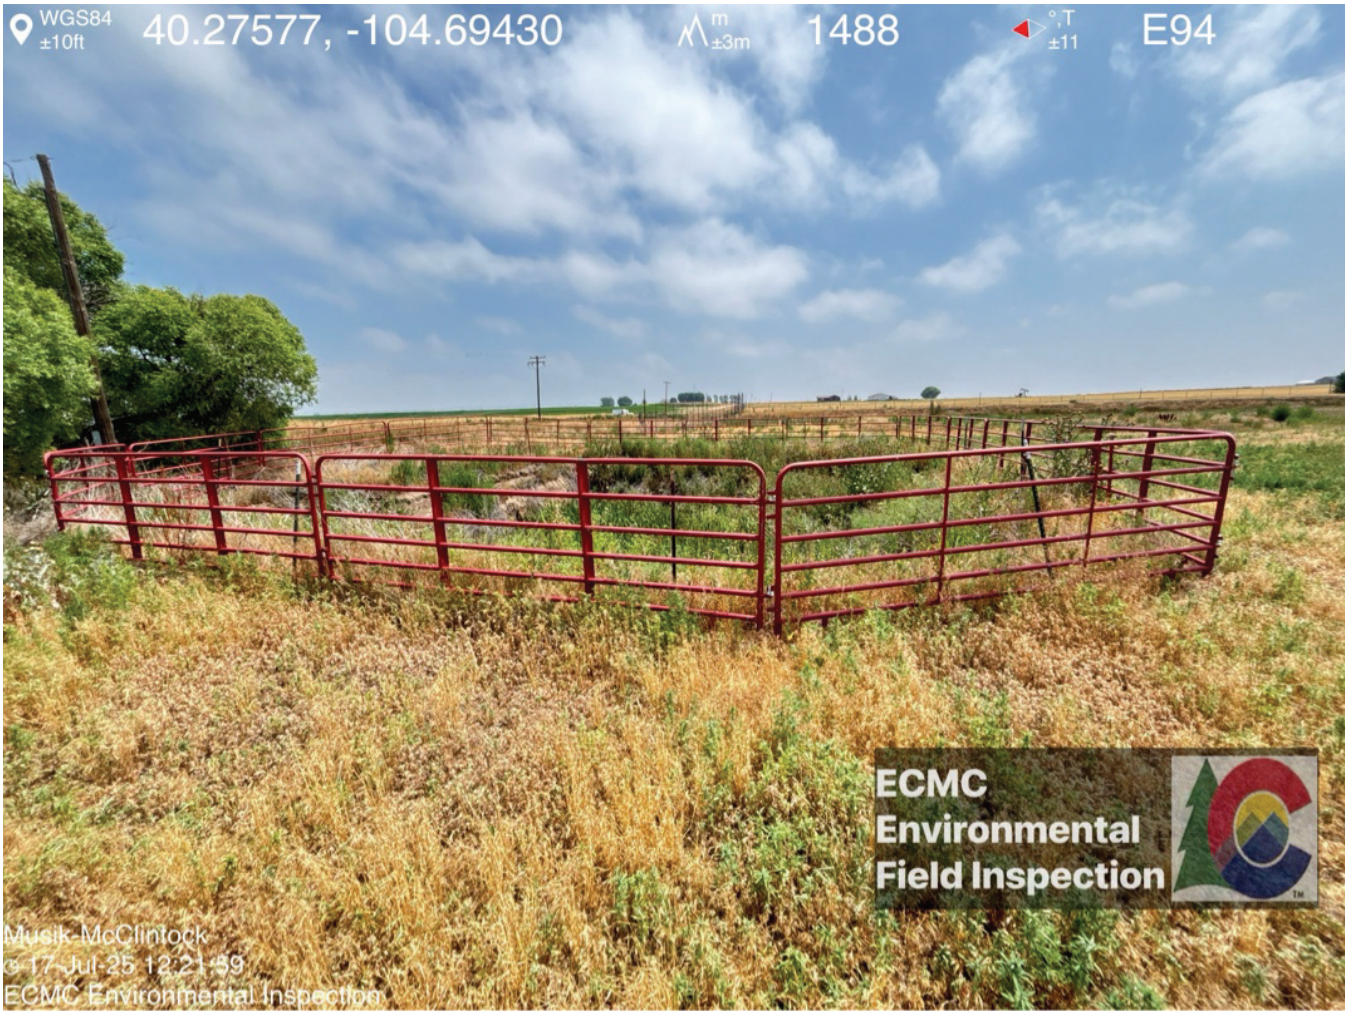
Musick-McClintock 5 (Spill ID 481685/REM 23556)
Approximately 60'x50'x12' (LxWxD) remedial excavation remains open
-Cattle fencing has been installed around the open excavation
-Weeds/vegetation throughout the area disturbed by site investigation and remediation activities and throughout the open excavation

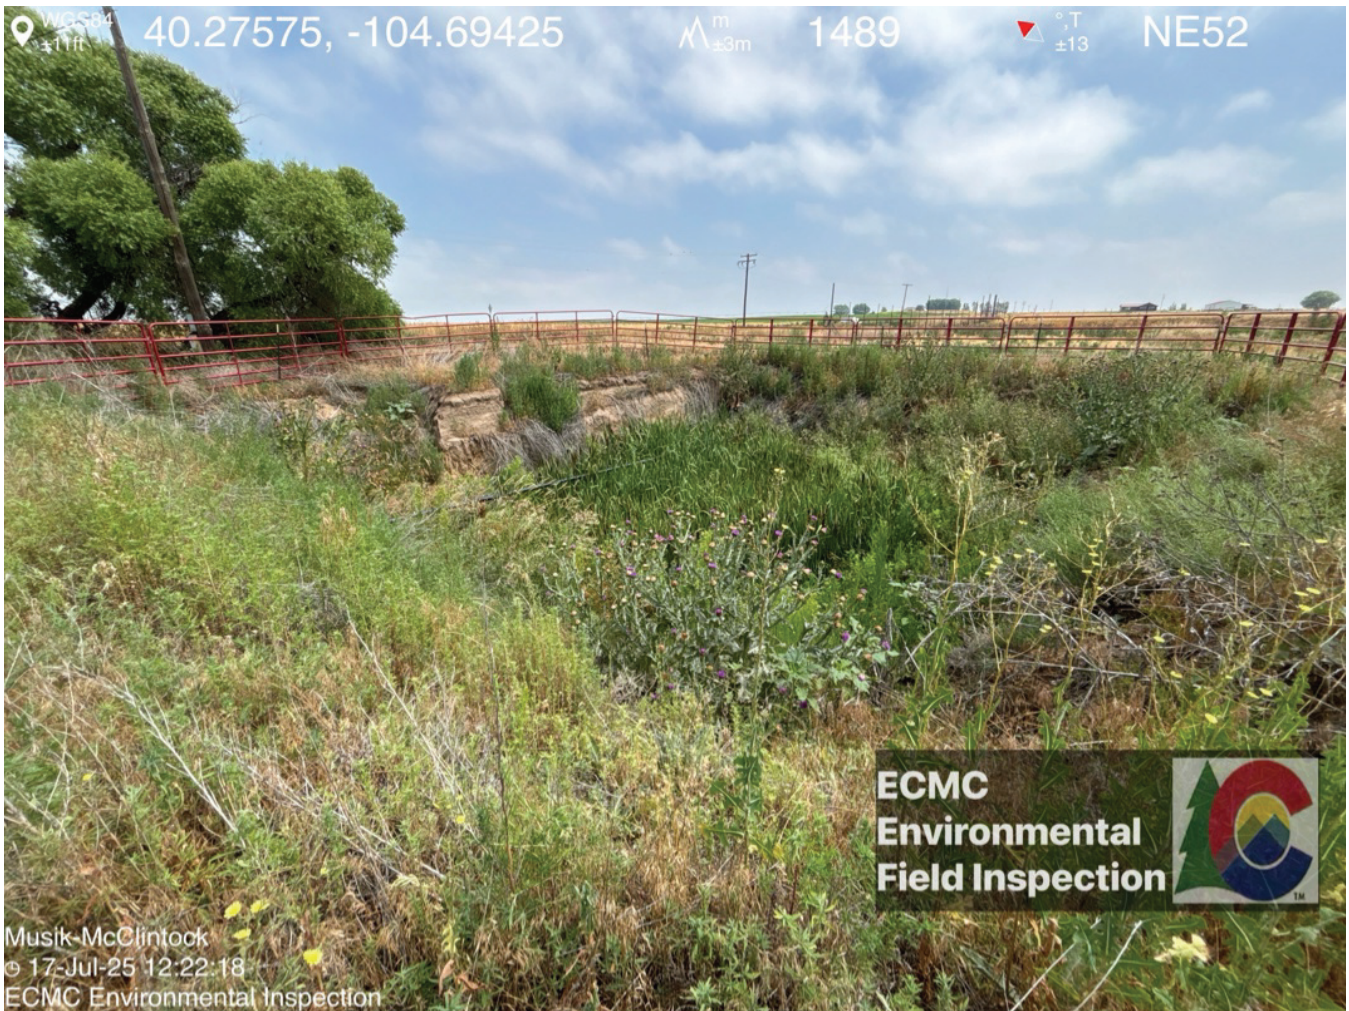
Approximately 60'x50'x12' (LxWxD) remedial excavation remains open

-Cattle fencing has been installed around the open excavation

-Weeds/vegetation throughout the area disturbed by site investigation and remediation activities and throughout the open excavation

-Flowline exposed within the open excavation

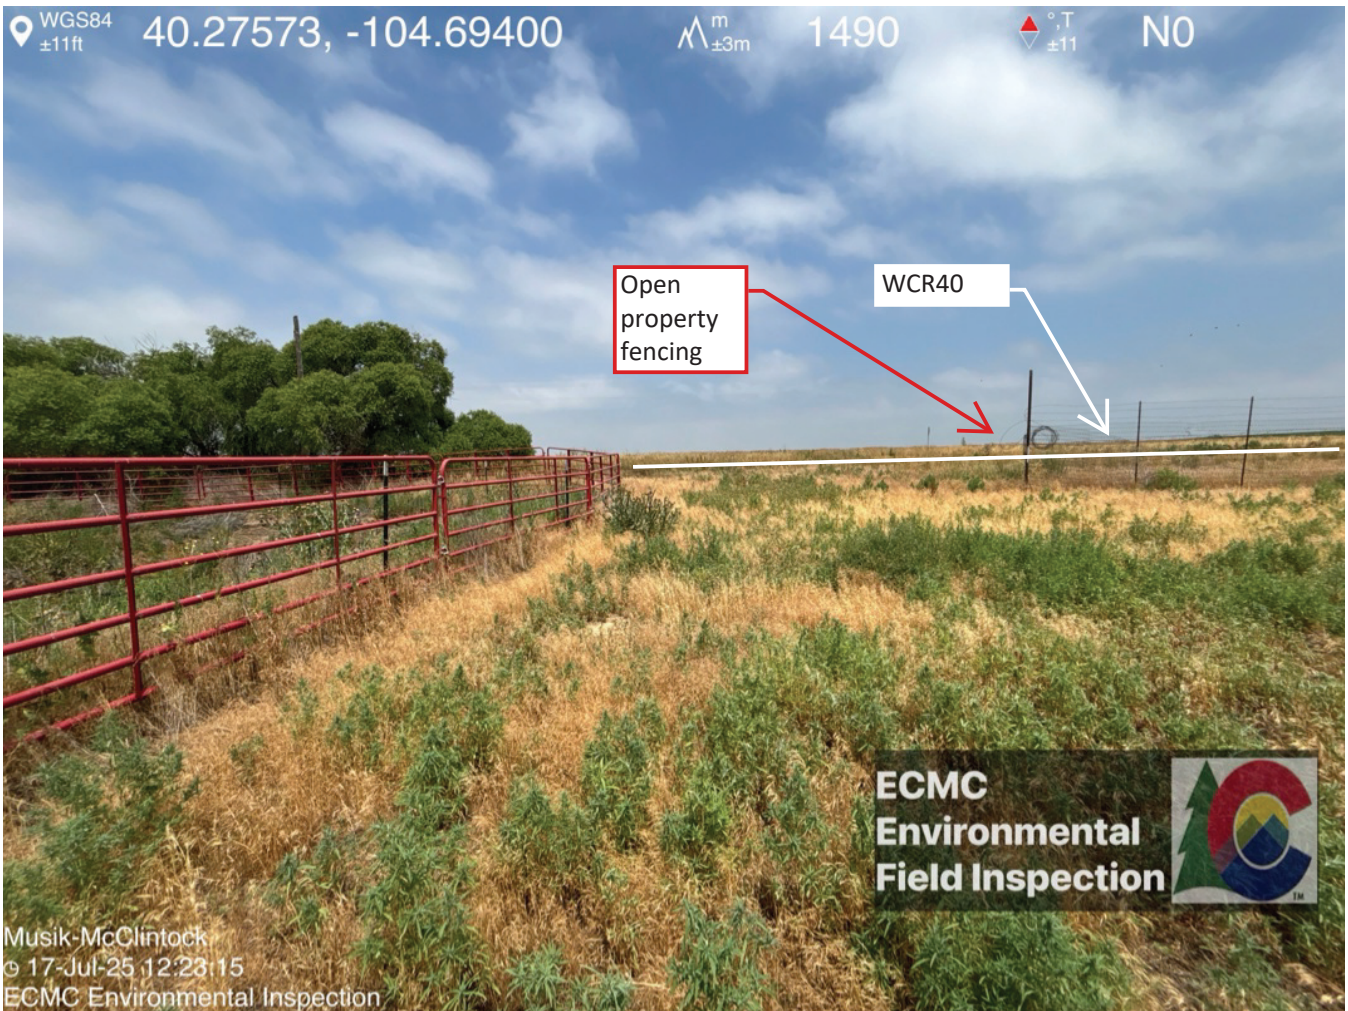
Musick-McClintock 5 (Spill ID 481685/REM 23556)

- Approximately 60'x50'x12' (LxWxD) remedial excavation remains open
- Cattle fencing has been installed around the open excavation
- Weeds/vegetation throughout the area disturbed by site investigation and remediation activities and throughout the open excavation
- Spill is located adjacent to Weld County Road 40
- Property fencing to the north and NE of the excavation has been removed and remains open

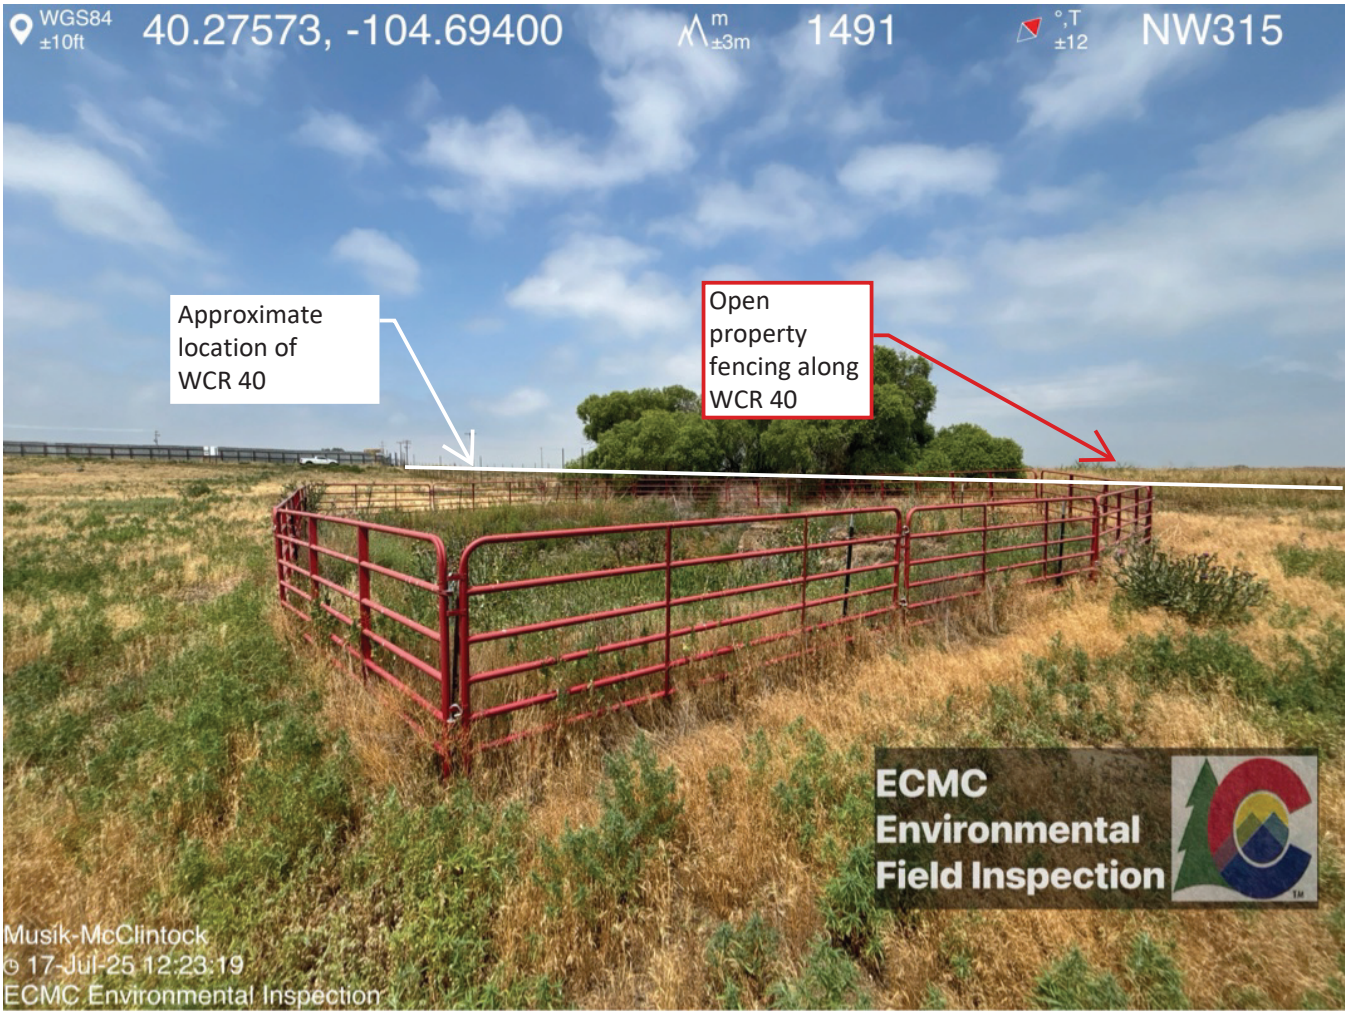
Musick-McClintock 5 (Spill ID 481685/REM 23556)

- Approximately 60'x50'x12' (LxWxD) remedial excavation remains open
- Cattle fencing has been installed around the open excavation
- Weeds/vegetation throughout the area disturbed by site investigation and remediation activities and throughout the open excavation
- Spill is located adjacent to Weld County Road 40
- Property fencing to the north and NE of the excavation has been removed and remains open

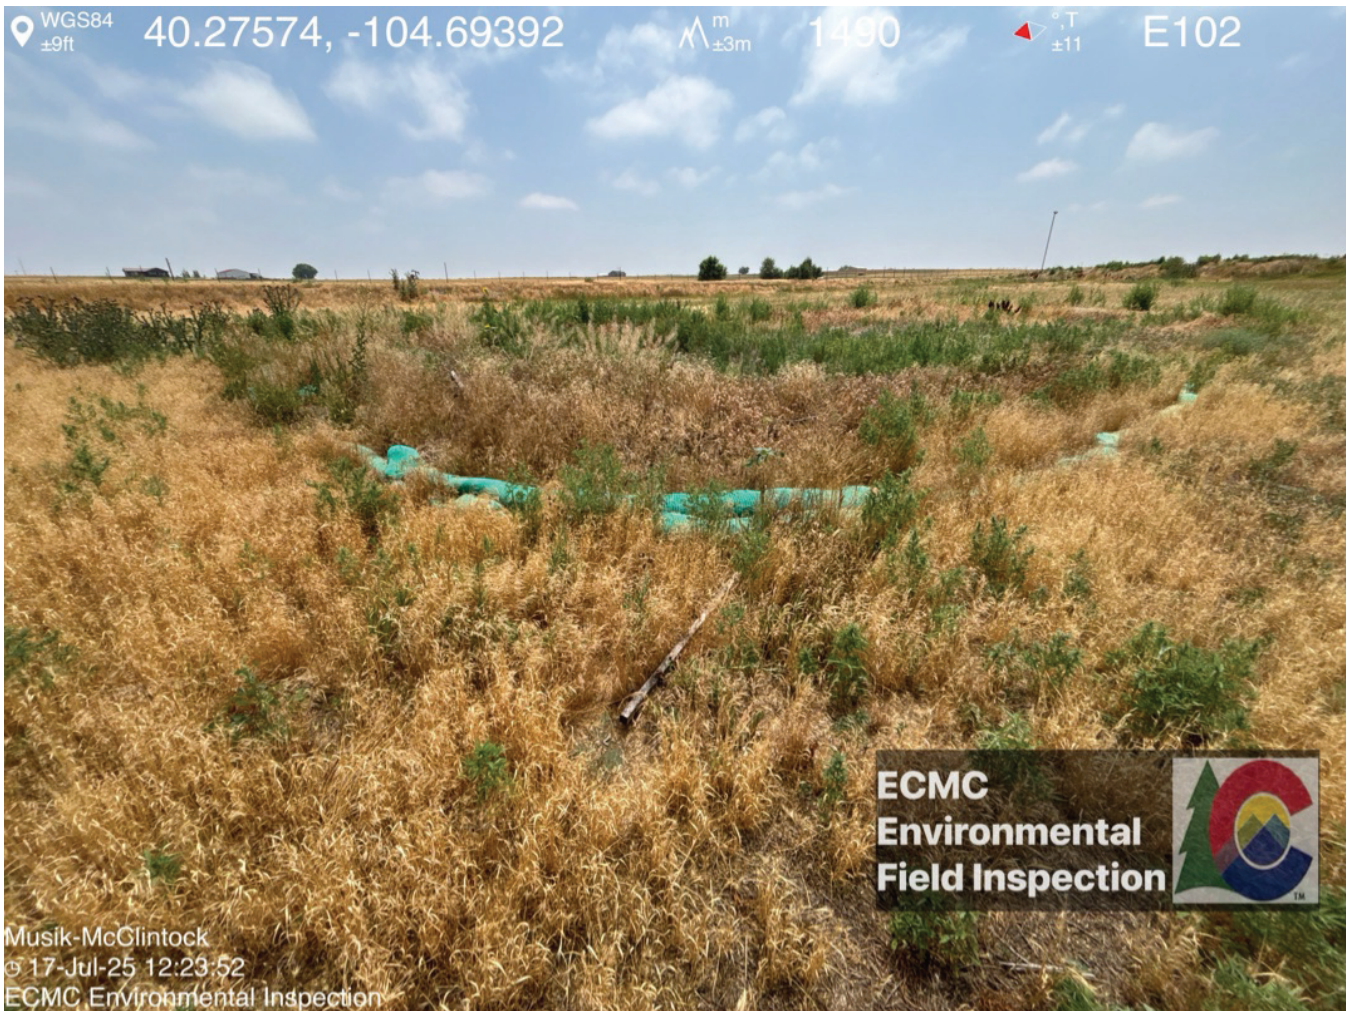
Musick-McClintock 5 (Spill ID 481685/REM 23556)

-Wattles around the E&P waste stockpile (approximately 70'x35') need to be replaced.

“Contaminated” signage previously observed (See FIR Doc #689501335 & 702700147) at the stockpile has been removed; however, the E&P waste stockpile remains and is now overgrown with weeds.
