# Inspection Photos

**Operator:** FULCRUM ENERGY OPERATING- #10805

**Location ID:** 324749

Inspection Photos  
Location Name: Buffalo Ditch 1-32H Pad  
Location ID: 324749

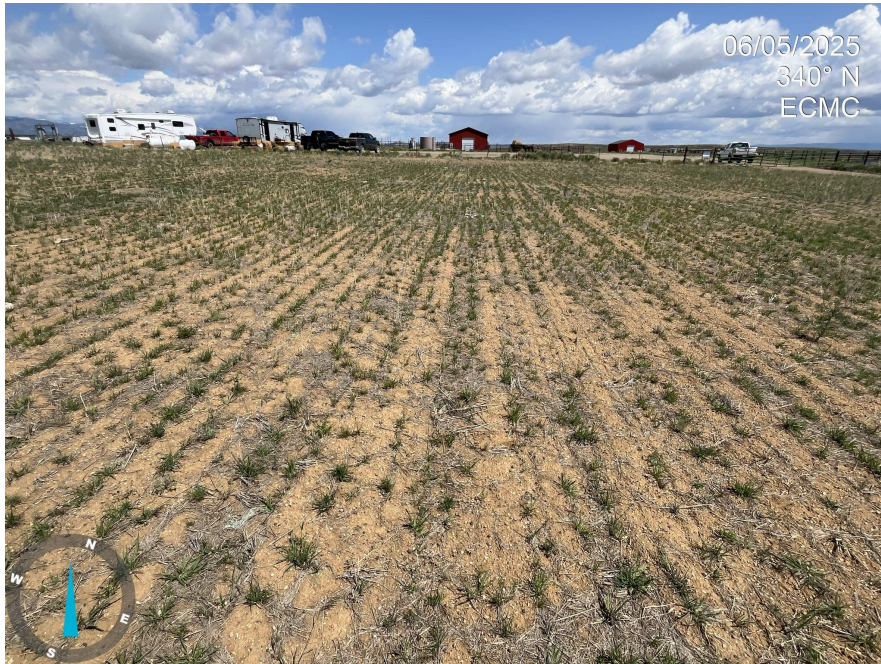
**Photo 1-4.** Photos taken at the center of the previous Location disturbance, facing north, east, south, and southwest. It is unclear if gravel removal and compaction alleviation has occurred. It is apparent that seeding efforts were conducted.

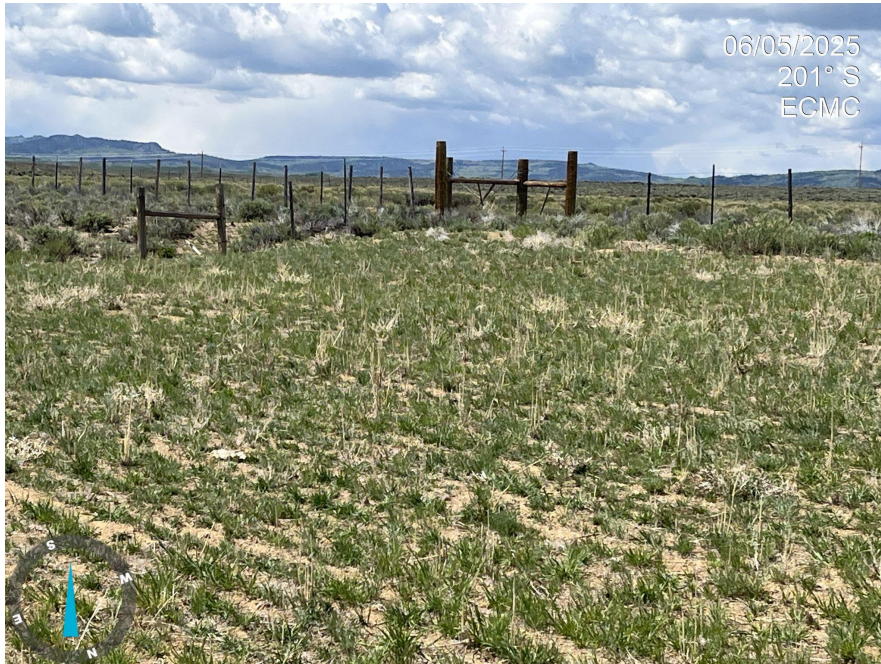
**Photo 5.** Photo taken at the southwestern portion of the Location, facing south, illustrating vegetation growth, primarily observed sagebrush, Russian Thistle and Brome species.

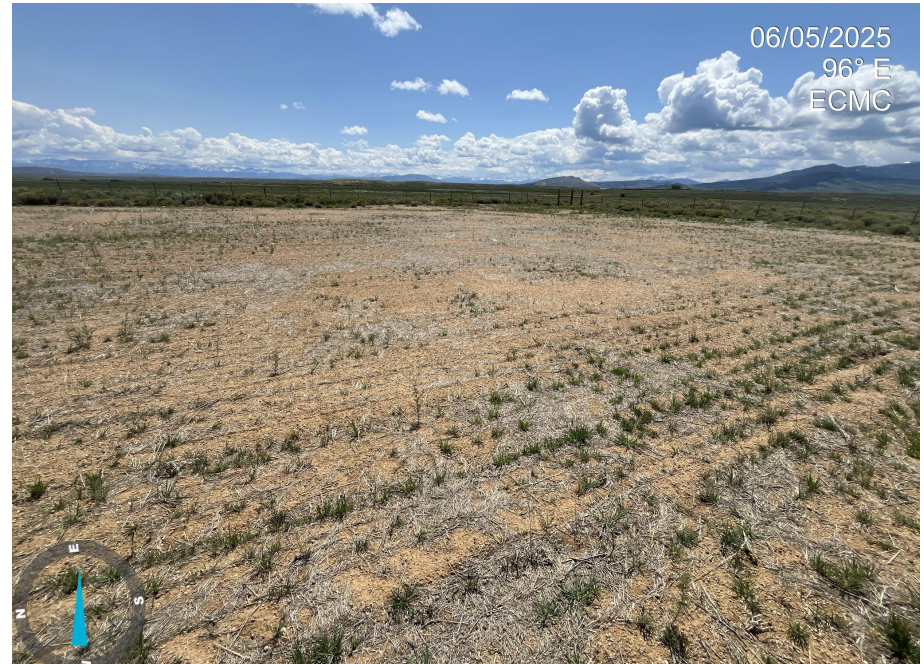
**Photo 6.** Photo taken of the east portion of the Location, facing east, showing bare areas without vegetation growth.

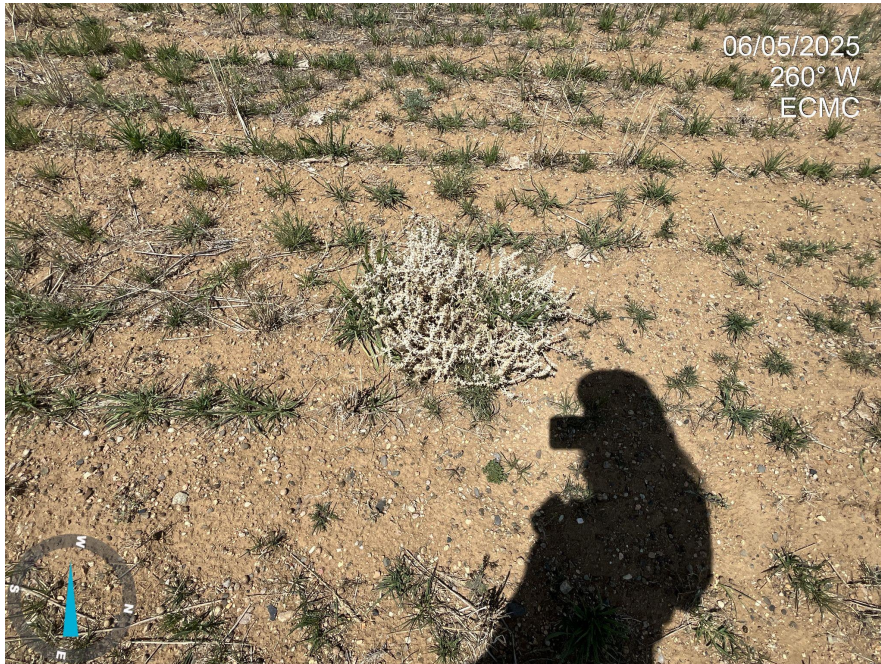
**Photo 7.** Photo taken illustrating undesirable plant species (e.g., Russian Thistle).

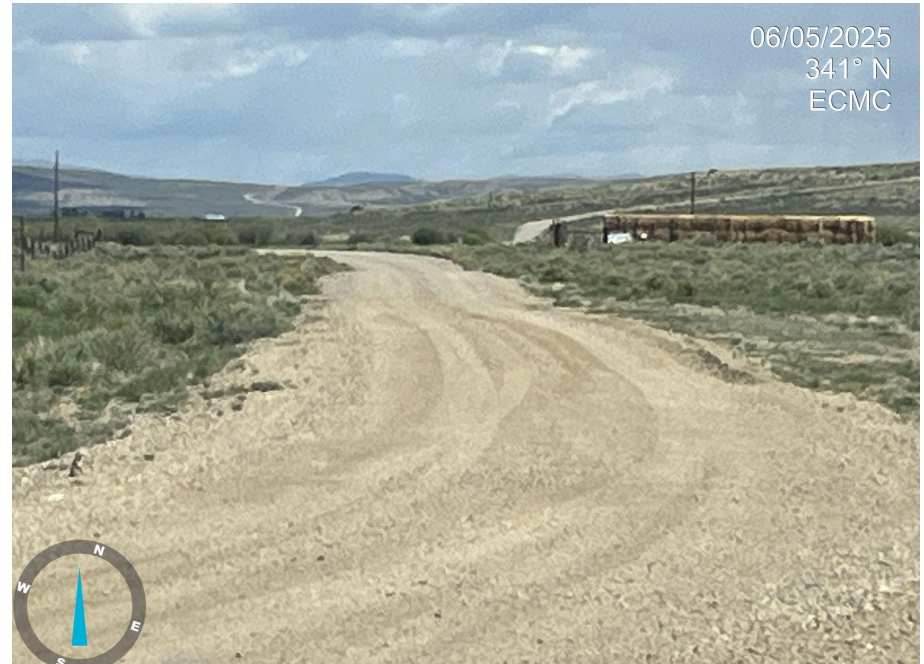
**Photo 8.** Photo taken of the access road, facing north. A portion of the access road to this location and the access road to the Buffalo Ditch 2-32H Location (ID: 324750) remain unreclaimed.

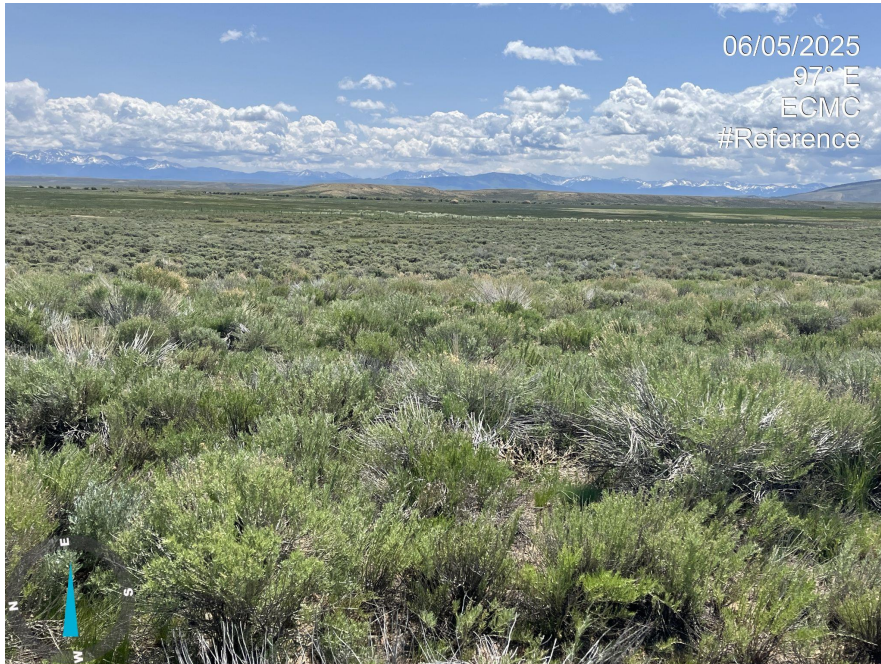
**Photo 9.** Photos 9-10 taken east of the Location, facing east. Photo illustrates the reference area vegetation, primarily sagebrush and rabbitbrush.
