Inspection Photos

Operator: BONANZA CREEK ENERGY OPERATING
LLC- #8960

Location ID: 324618

Inspection Photos
Location Name: Mccallum Unit # 64 Pad
Location ID: 324618

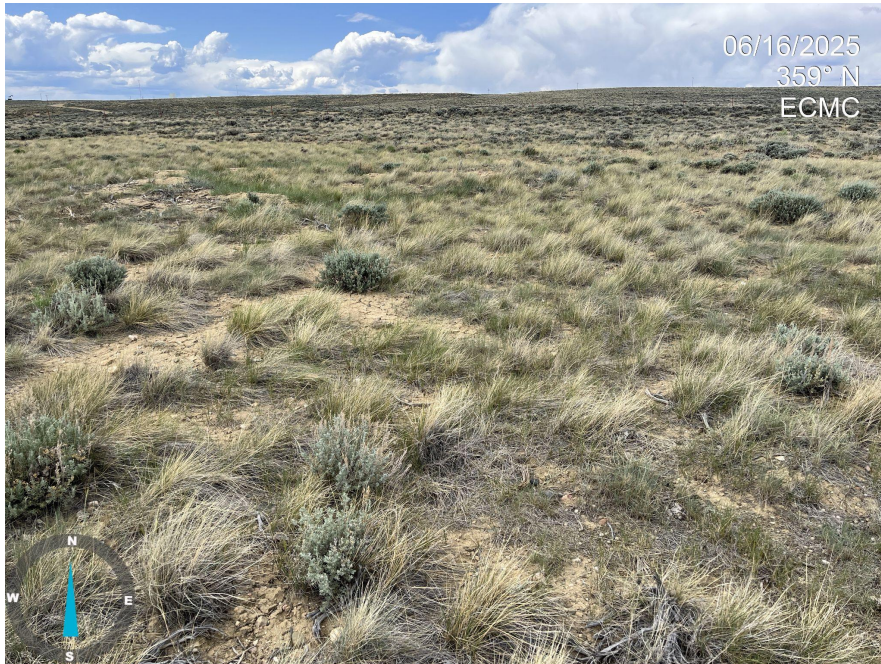
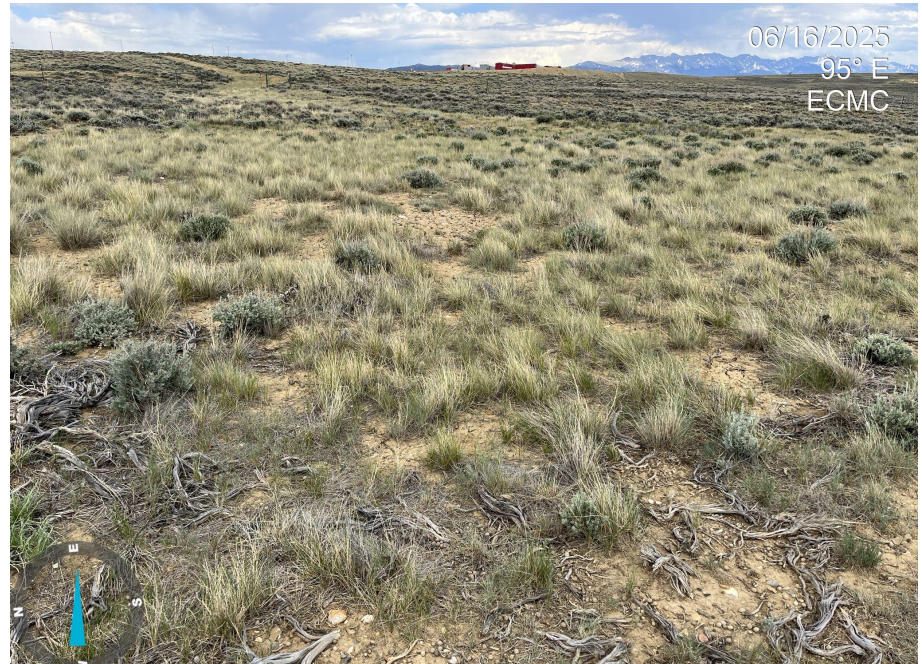
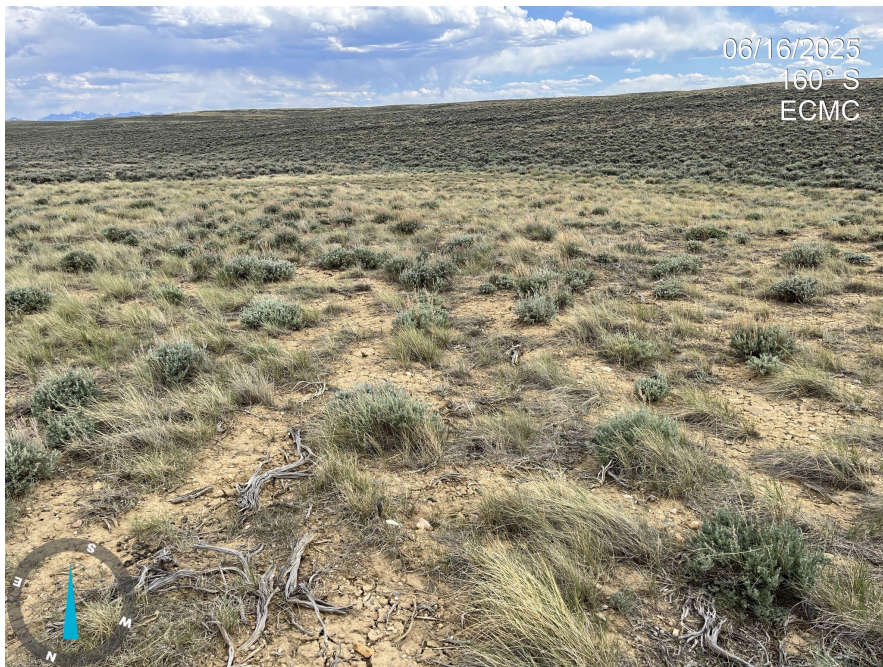
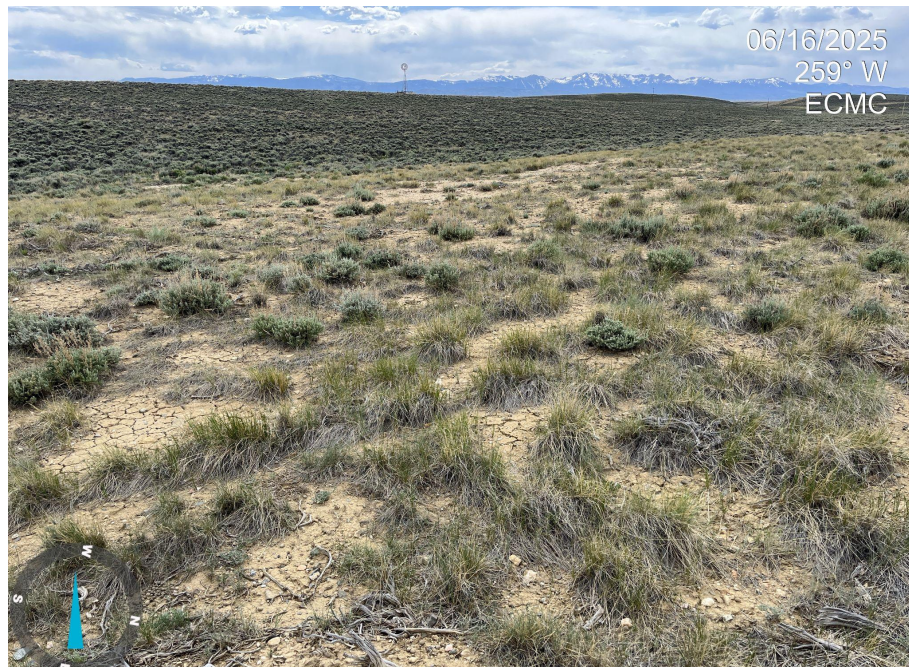
Photo 1. Photo taken from the center of the previous disturbance, facing north, east, south, and west. Vegetation has reached 80% of the reference area and is primarily sagebrush and *Hilaria jamesii*.

Photo 2. See comments under Photo 1.

Photo 3. See comments under Photo 1.

Photo 4. See comments under Photo 1.

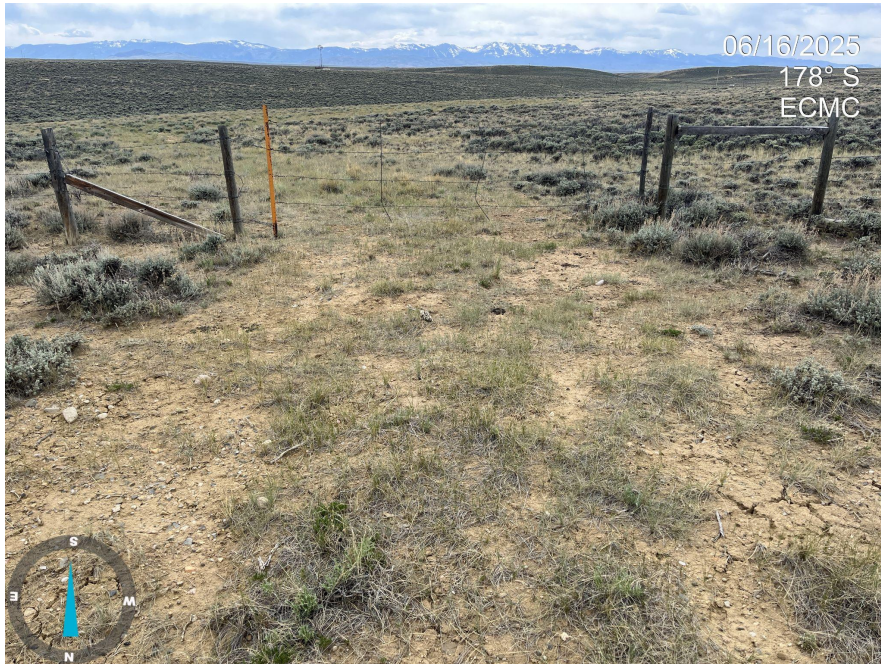
Photo 5. Photo taken from the entrance to the Location, facing south. Fence remains around the pad.

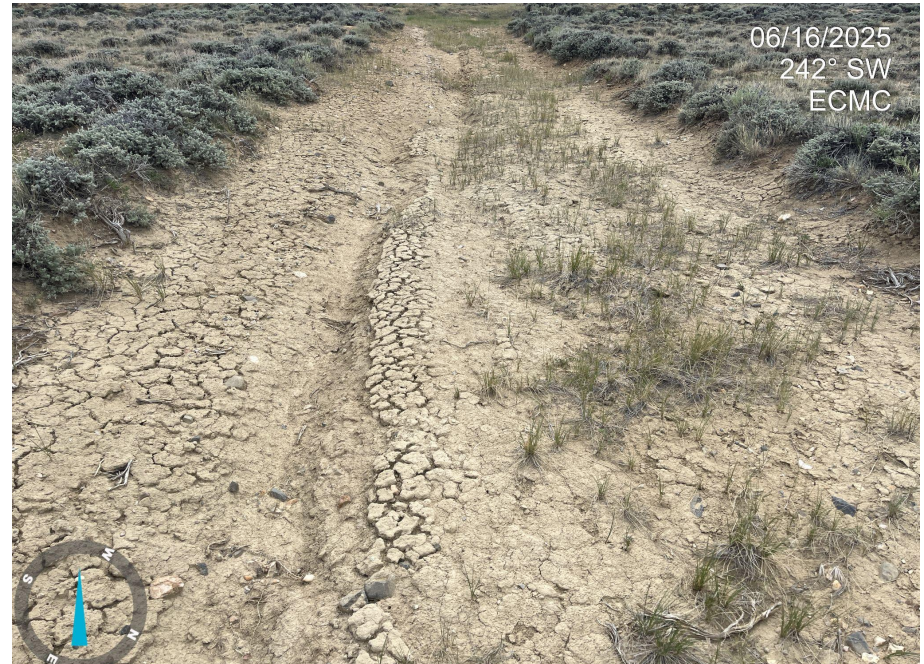
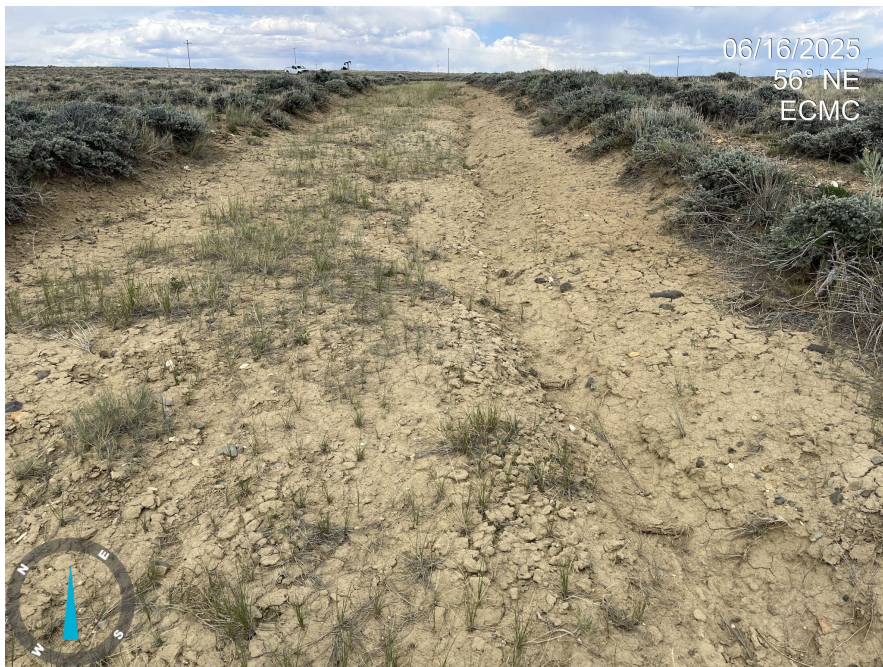
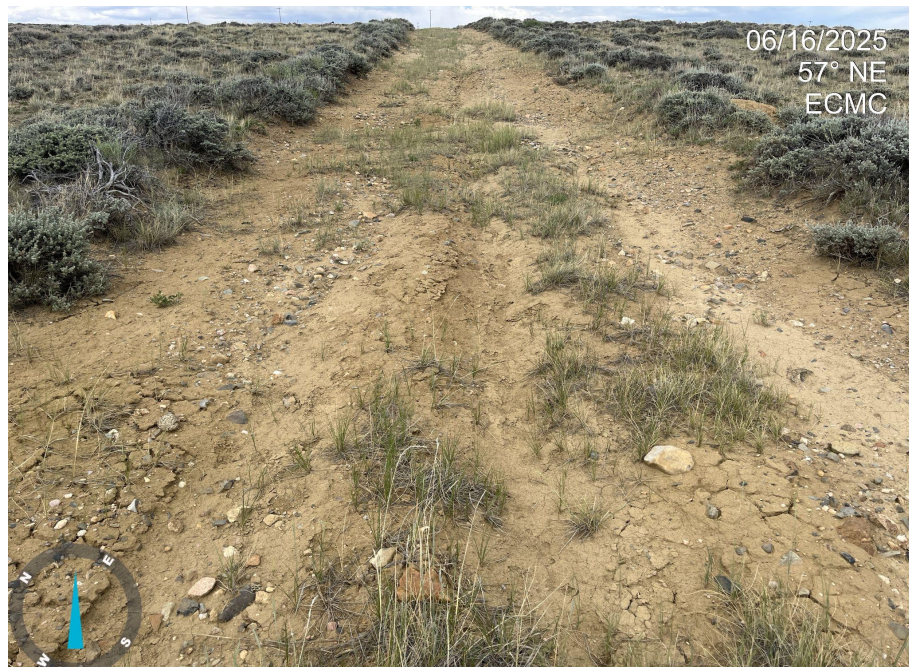
Photo 6. Photos 6-8 taken of the access road, illustrating that the access road is experiencing erosion, primarily in the portion closest to the pad entrance.

Photo 7. See comments under Photo 6.

Photo 8. See comments under Photo 6.

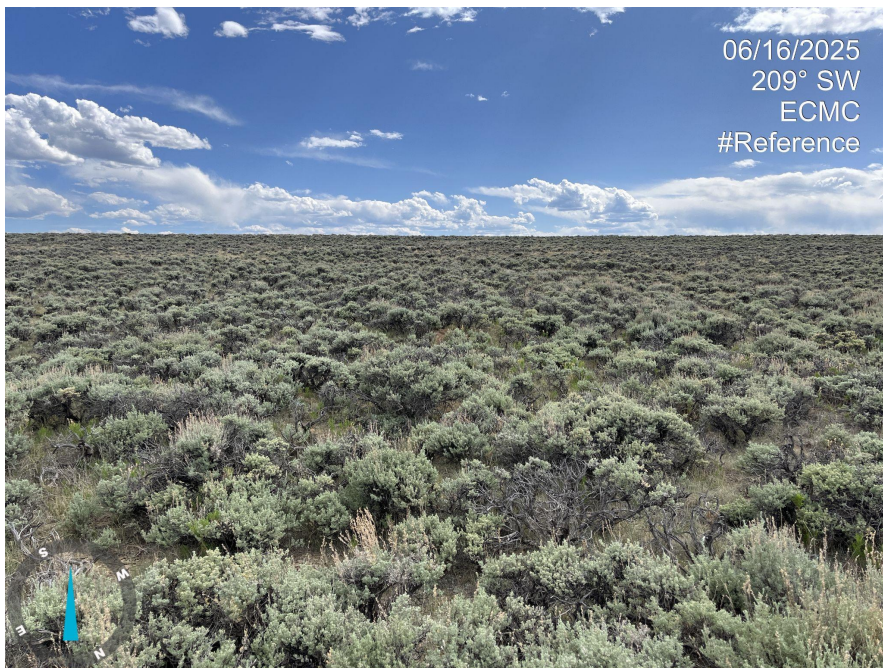
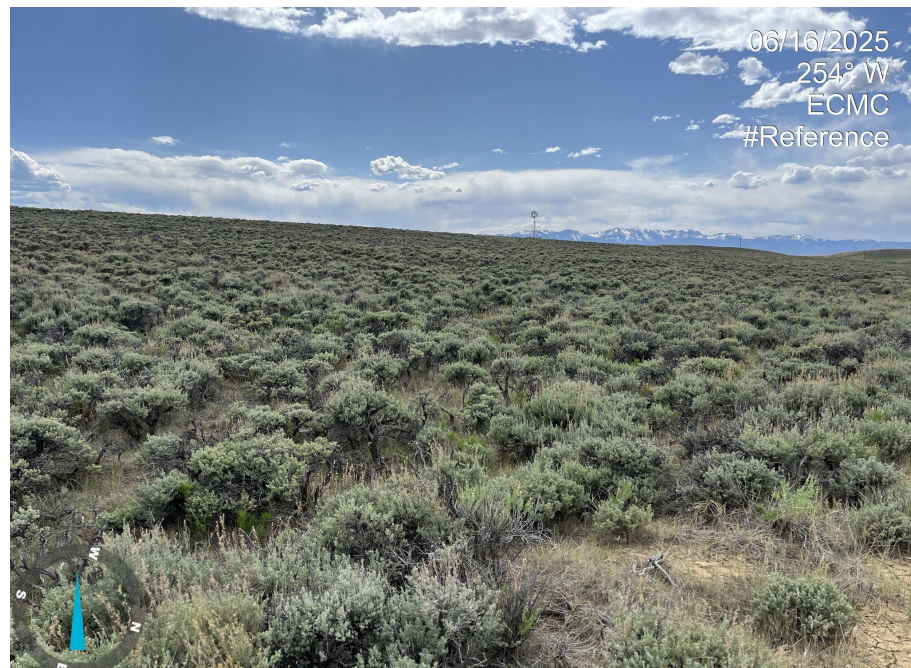
Photo 9. Photos 9-10 taken of the reference area vegetation, illustrating primarily sagebrush vegetation.

Photo 10. See comments under Photo 9.
