Final Reclamation Inspection

Operator: NOBLE ENERGY INC - 100322

Location ID: 418266

Inspection Photos
Location Name: CANNON H #35-22X
Location ID: 418266

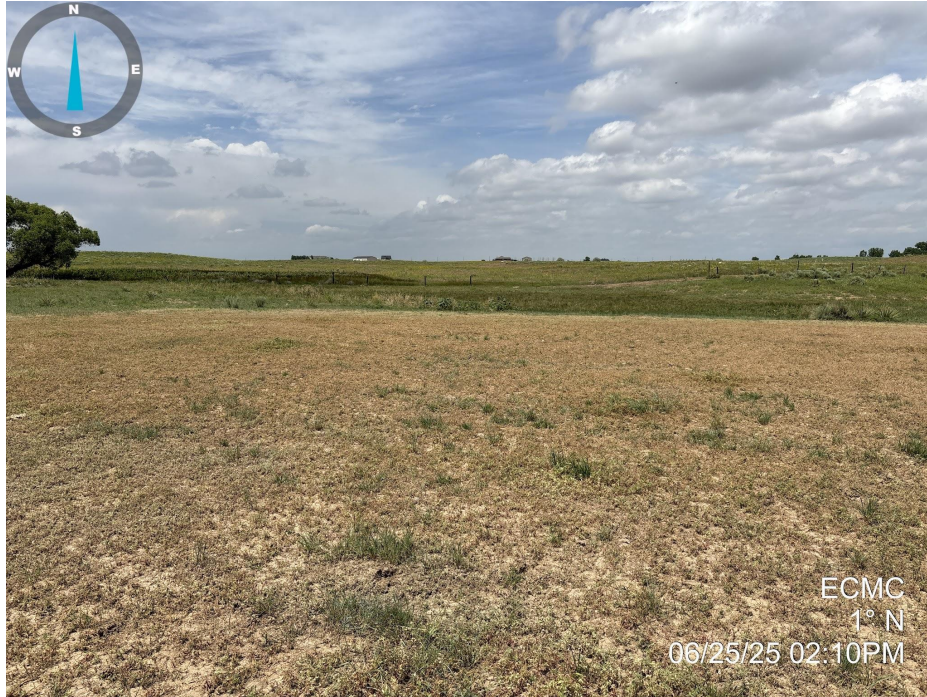
Photo 1. Photo taken from the well location, facing North. Photo illustrates that final reclamation activities have taken place, with evidence of drill row seeding, but vegetation has not established to Rule 1004 standards.

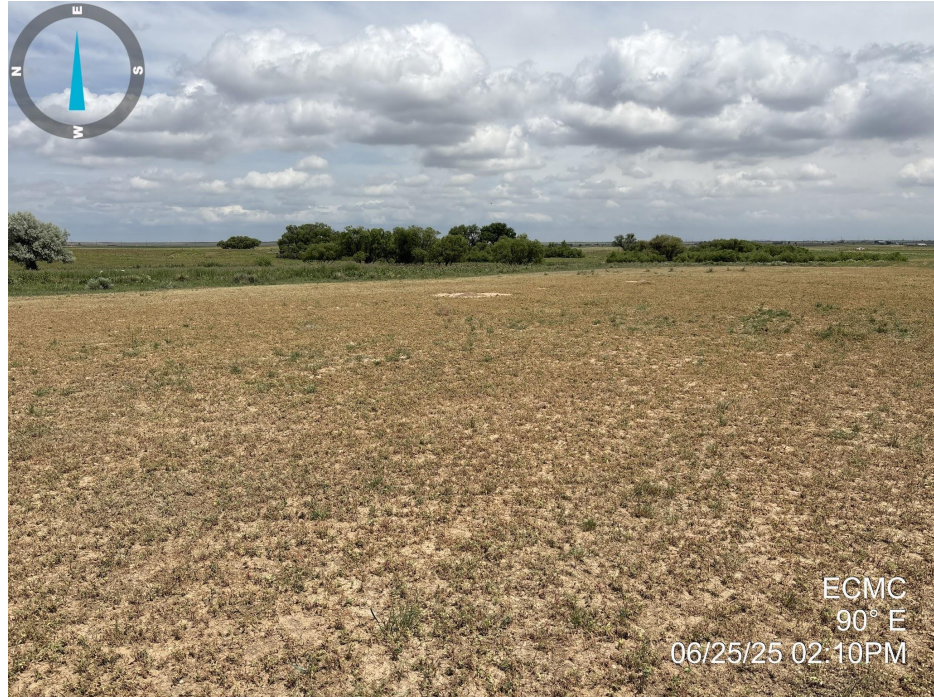
Photo 2. Photo taken from the well location, facing East. See comments under Photo 1.

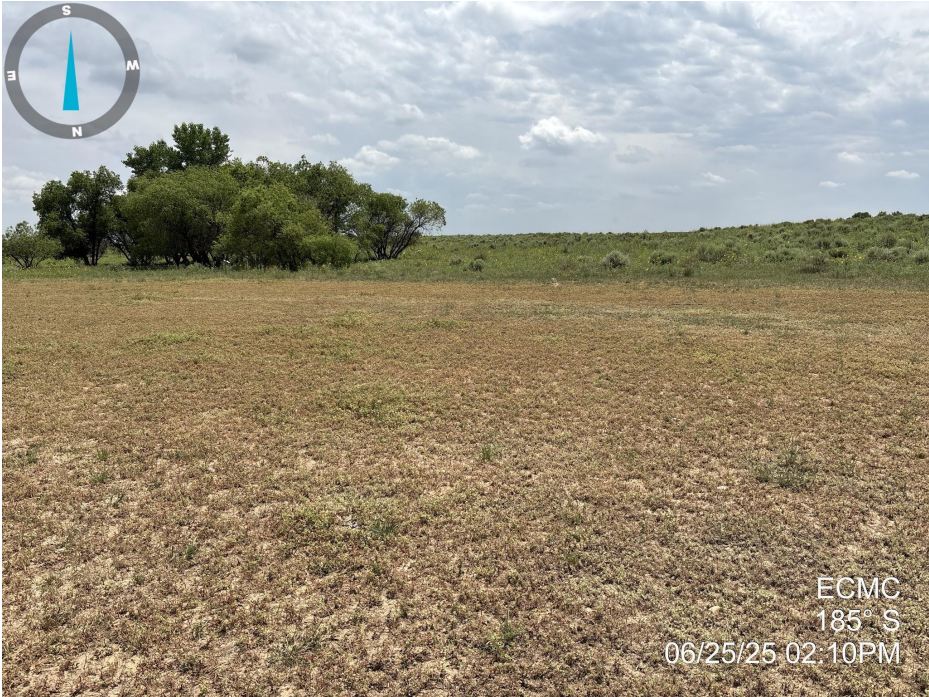
Photo 3. Photo taken from the well location, facing South. See comments under Photo 1.

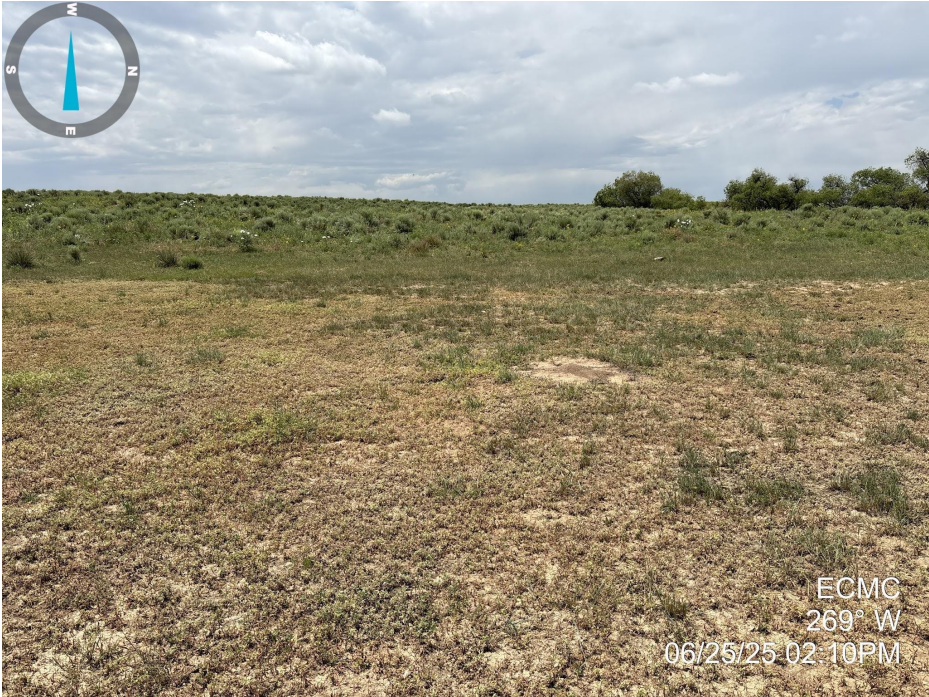
Photo 4. Photo taken from the well location, facing West. See comments under Photo 1.

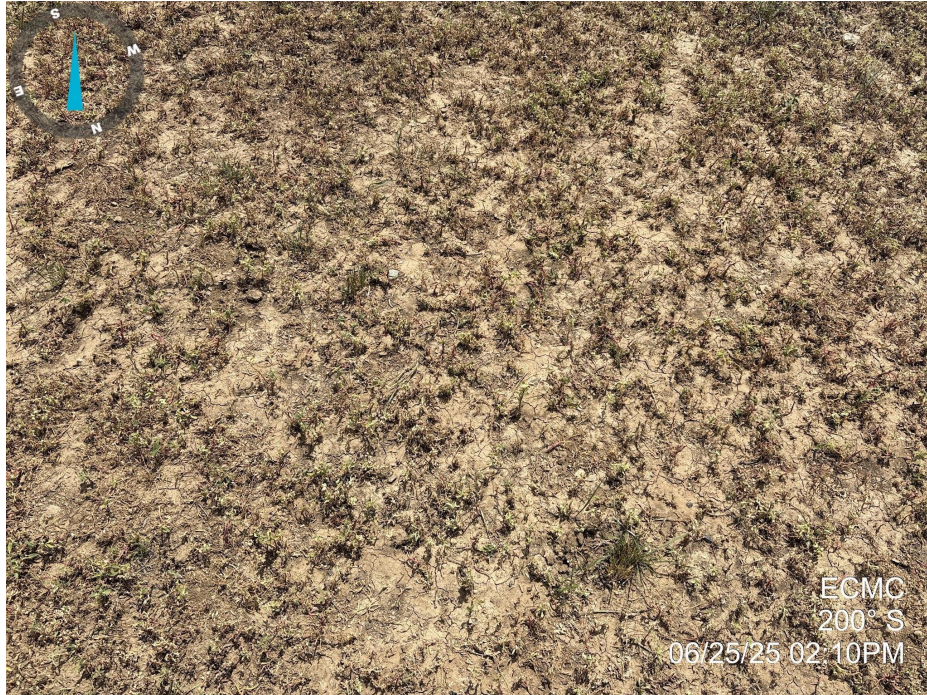
Photo 5. Photo taken of ground cover at the location. Photo illustrates weedy annual vegetation, including russian thistle (*Salsola tragus*).

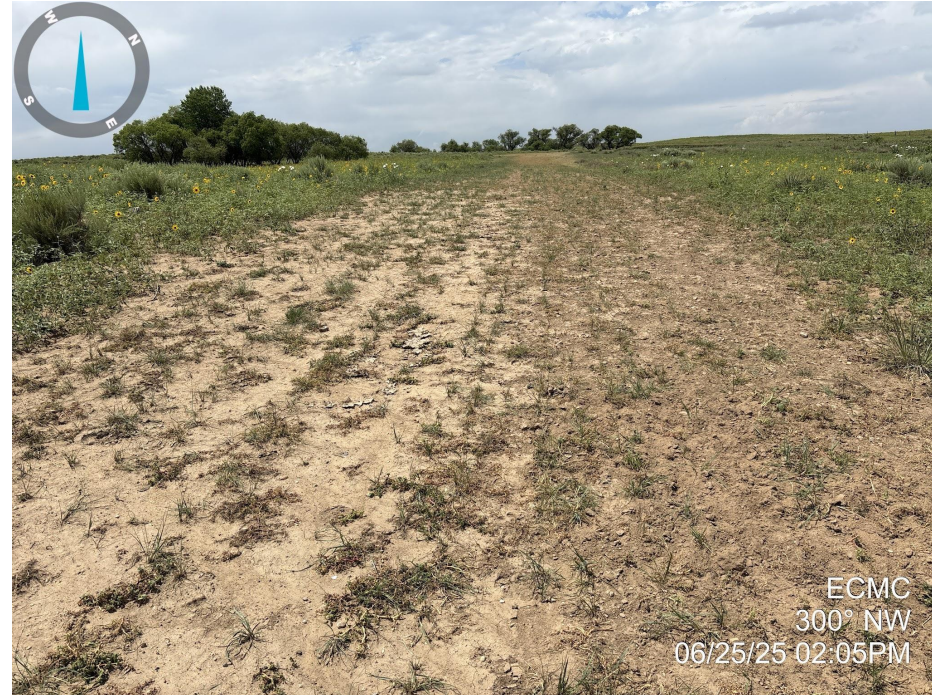
Photo 6. Photo taken of the access road to the well location, facing northwest. Photo illustrates that final reclamation activities have taken place, but vegetation has not established to Rule 1004 standards and the site is dominated by russian thistle (*Salsola tragus*).

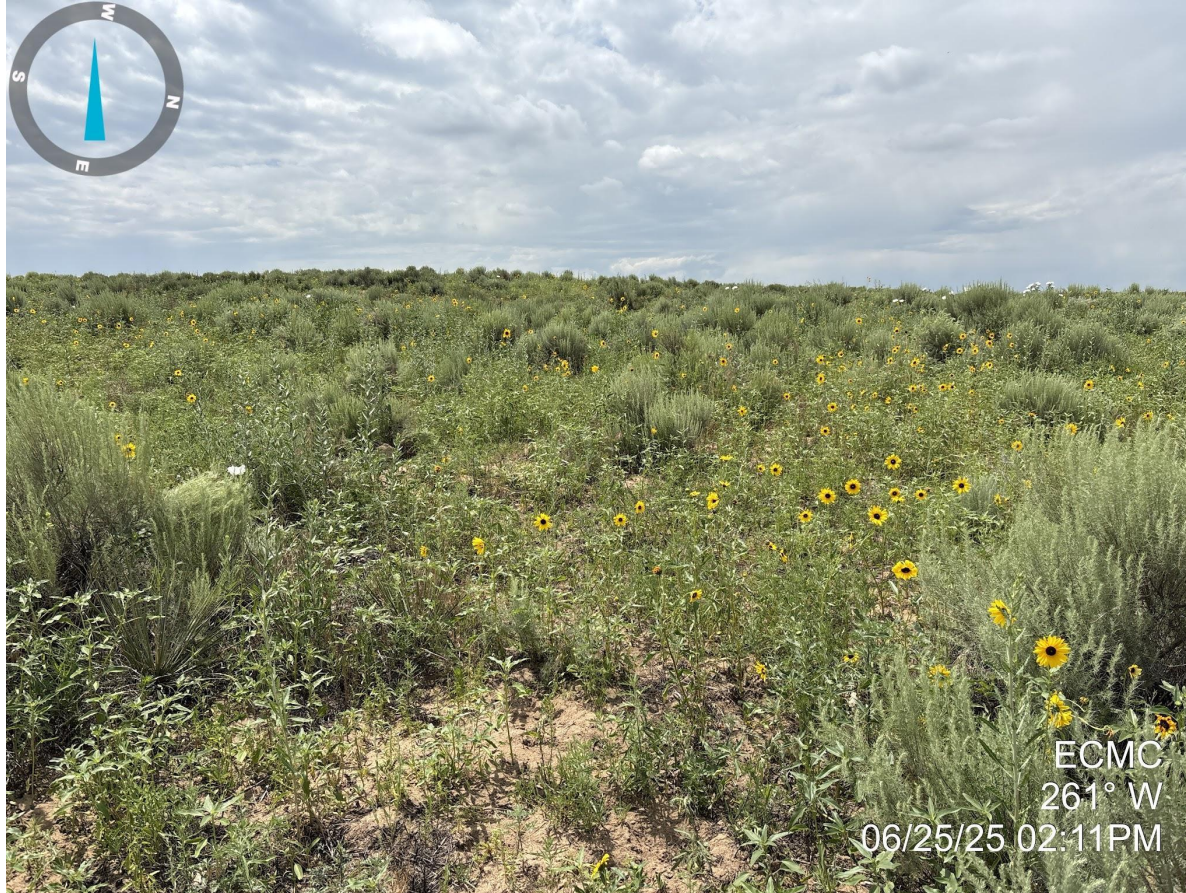
Photo 7. Photo taken of the reference area to the well location, south of the location, facing west. Photo illustrates the site is dominated by sand sagebrush (*Artemisia filifolia*) and prairie sunflower (*Helianthus petiolaris*).
