Final Reclamation Inspection

Operator: NOBLE ENERGY INC - 100322

Location ID: 328319

Inspection Photos
Location Name: CANNON #H 35-10
Location ID: 328319

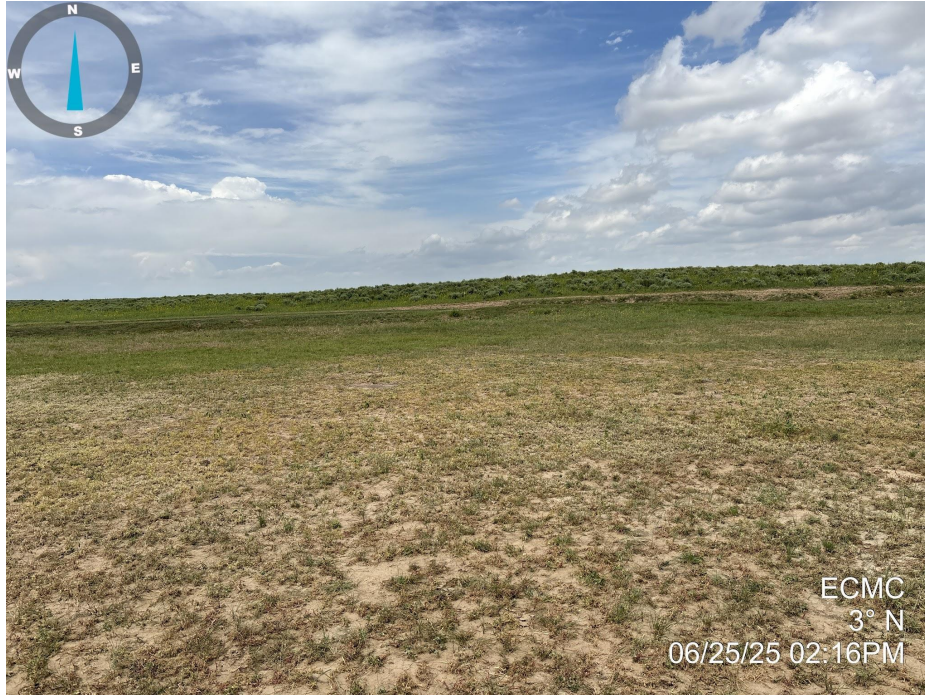
Photo 1. Photo taken from the well location, facing North. Photo illustrates that final reclamation activities have taken place, with evidence of drill row seeding, but vegetation has not established to Rule 1004 standards.

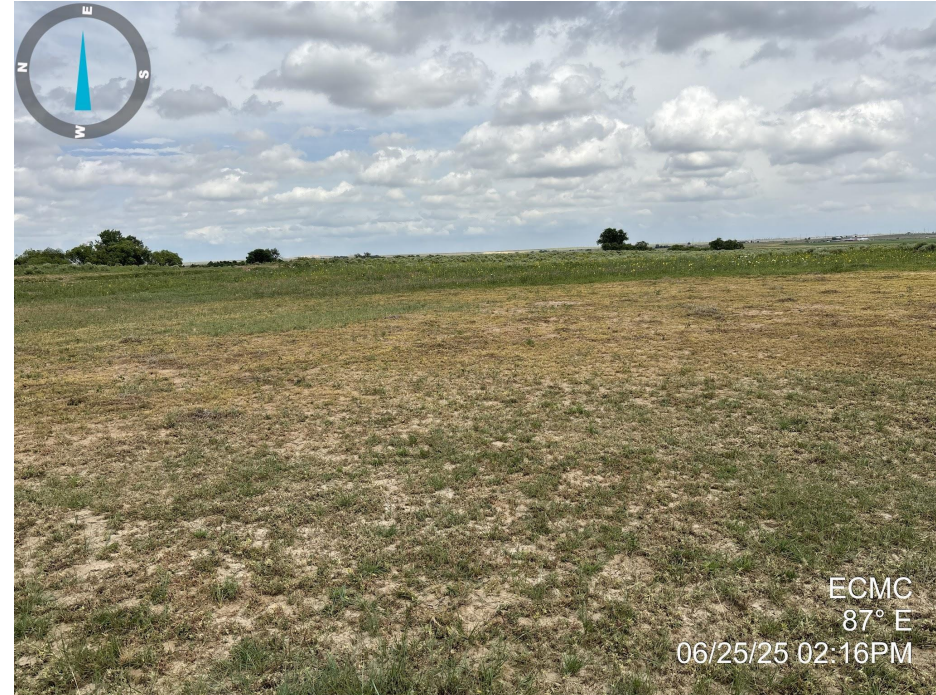
Photo 2. Photo taken from the well location, facing East. See comments under Photo 1.

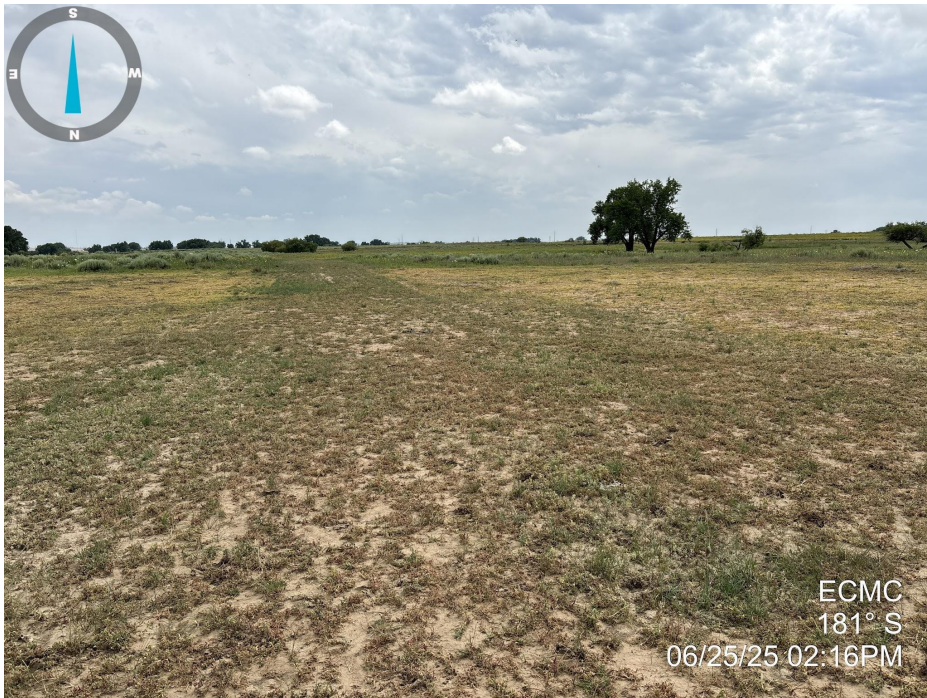
Photo 3. Photo taken from the well location, facing South. See comments under Photo 1.

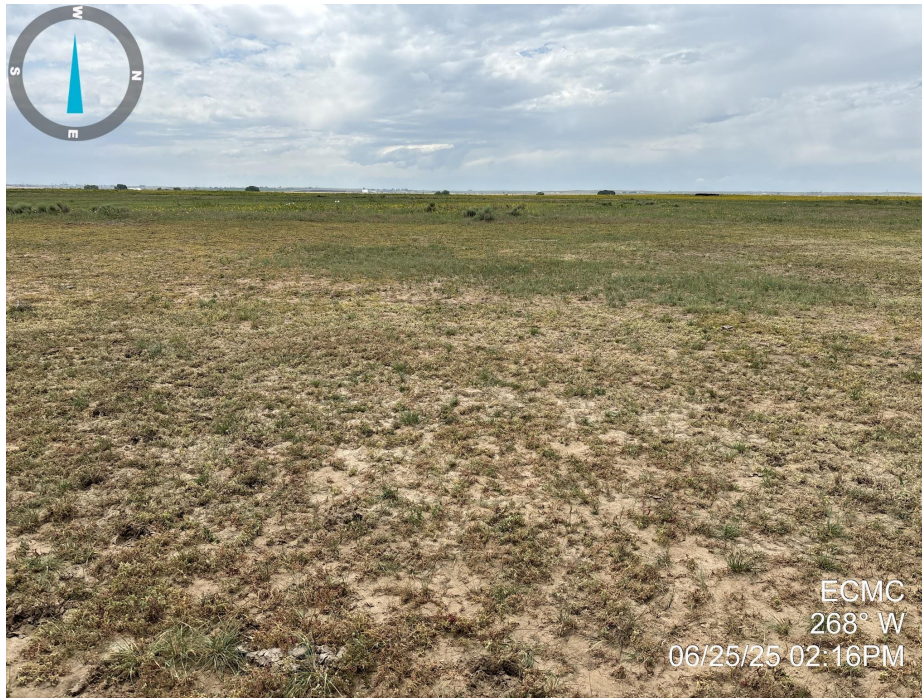
Photo 4. Photo taken from the well location, facing West. See comments under Photo 1.

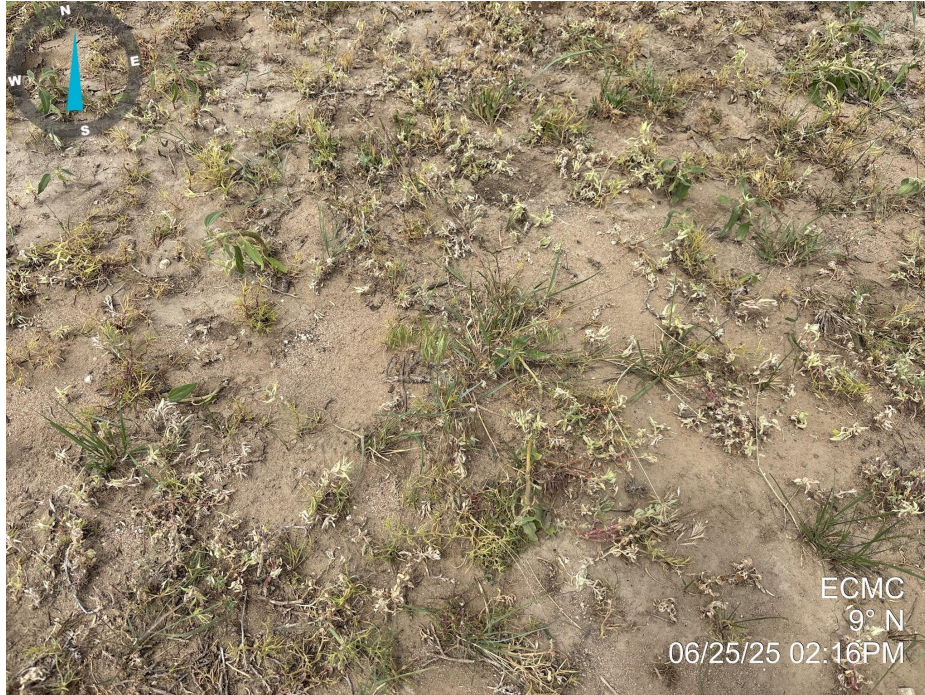
Photo 5. Photo taken of ground cover at the location. Photo illustrates weedy annual vegetation, including russian thistle (*Salsola tragus*).

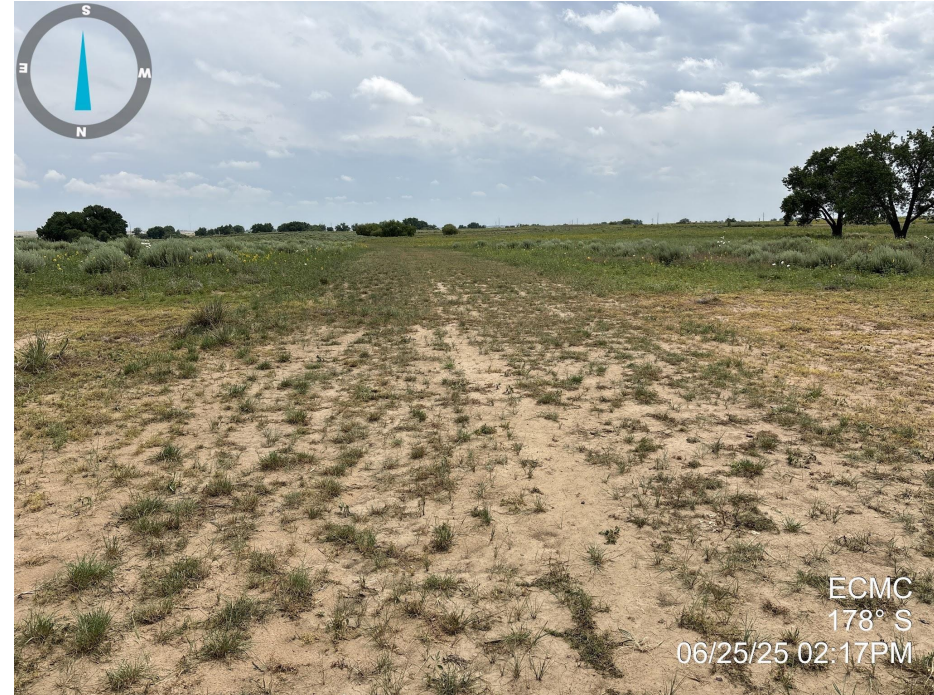
Photo 6. Photo taken of the access road to the well location, facing south. Photo illustrates that final reclamation activities have taken place, but vegetation has not established to Rule 1004 standards.

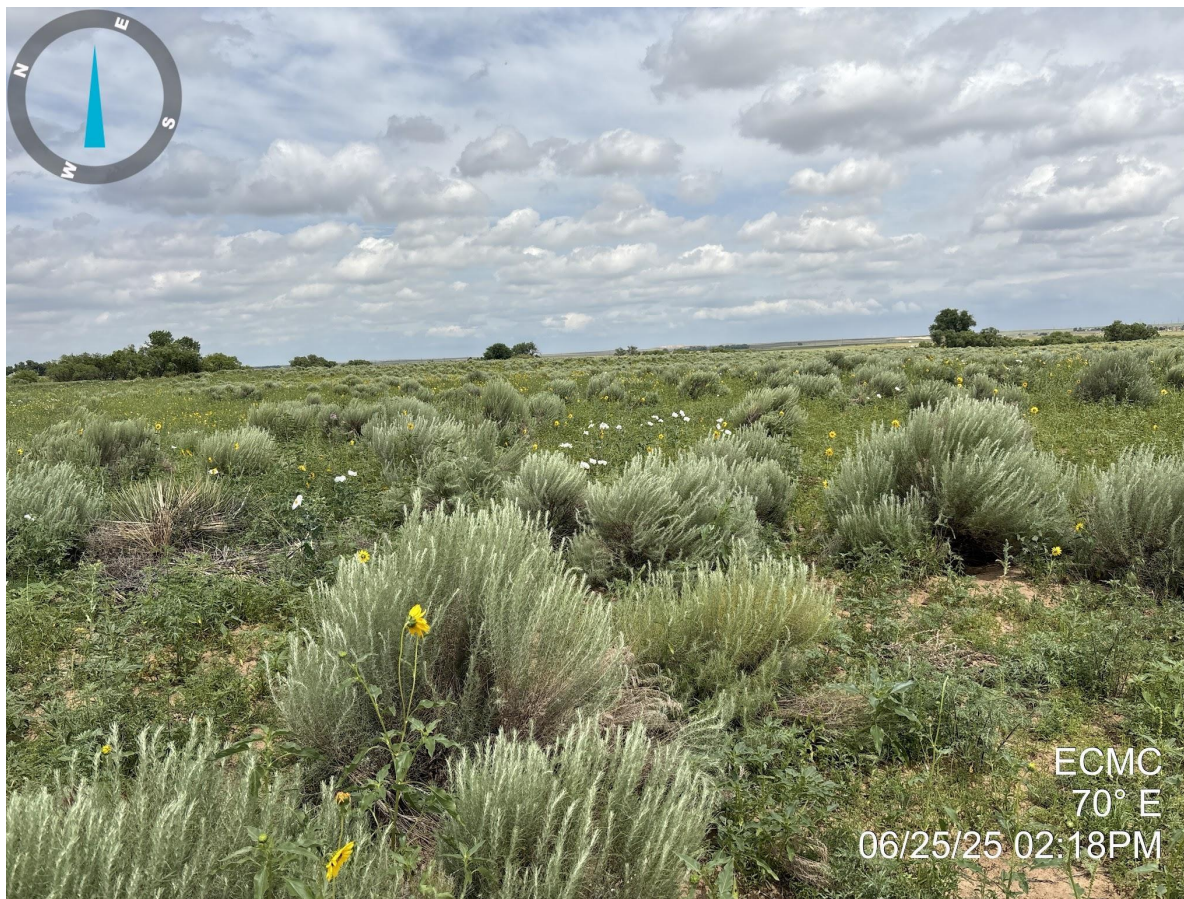
Photo 7. Photo taken of the reference area to the well location, south of the location, facing east. Photo illustrates the site is dominated by sand sagebrush (*Artemisia filifolia*) and prairie sunflower (*Helianthus petiolaris*).
