Final Reclamation Inspection

Operator: NOBLE ENERGY INC - 100322

Location ID: 417509

Inspection Photos
Location Name: CANNON #X02-27
Location ID: 417509

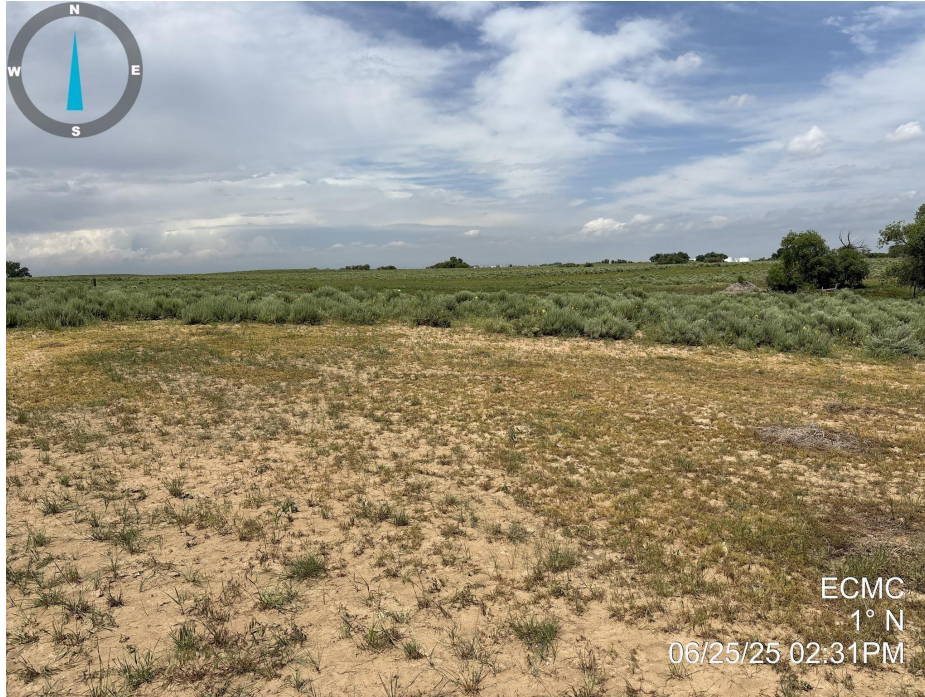
Photo 1. Photo taken from the well location, facing North. Photo illustrates that final reclamation activities have taken place, with evidence of drill row seeding, but vegetation has not established to Rule 1004 standards.

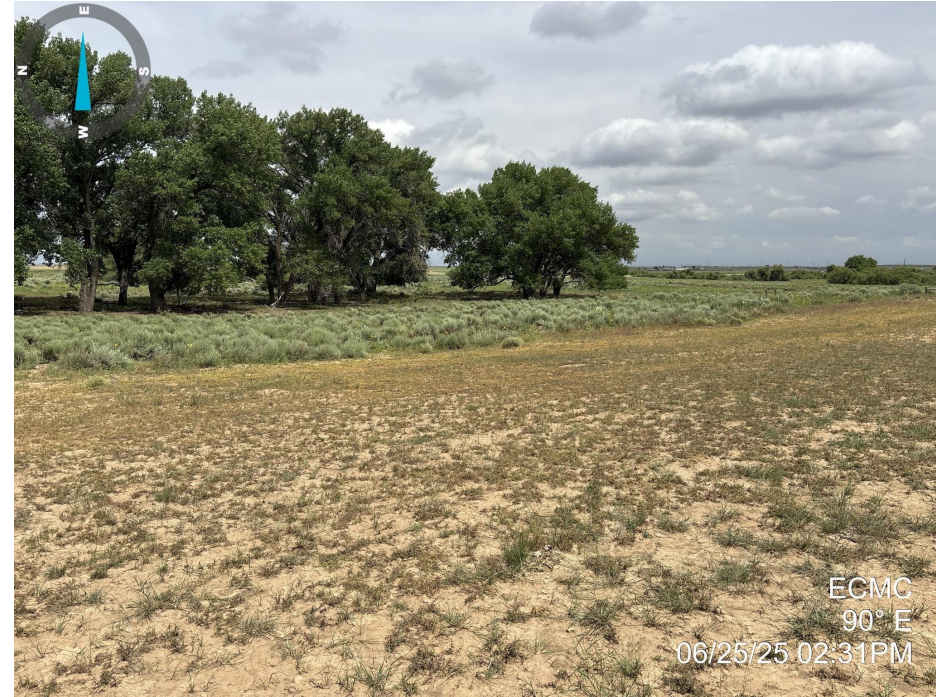
Photo 2. Photo taken from the well location, facing East. See comments under Photo 1.

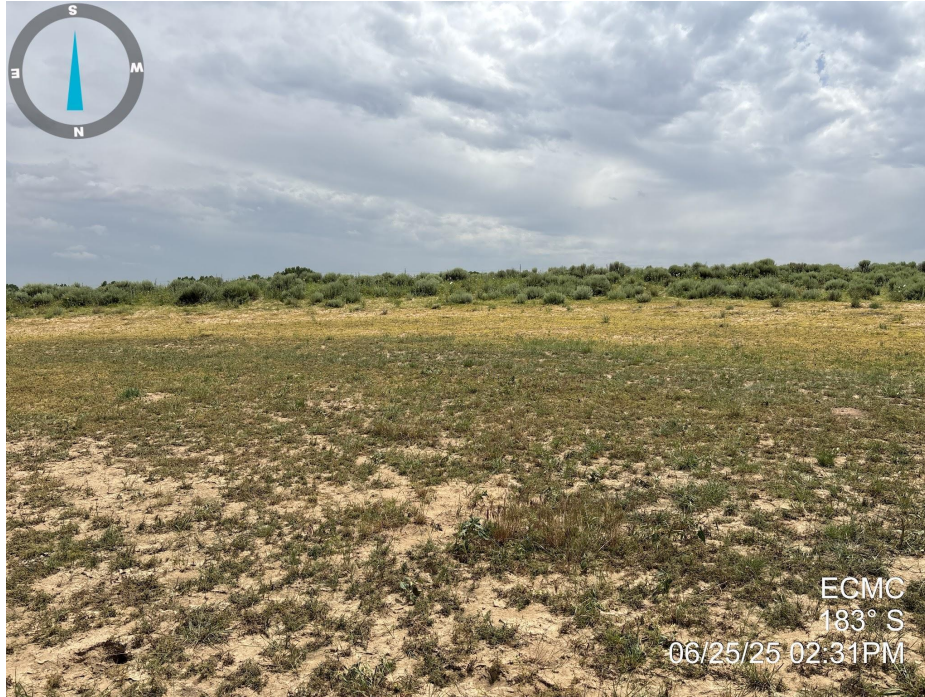
Photo 3. Photo taken from the well location, facing South. See comments under Photo 1.

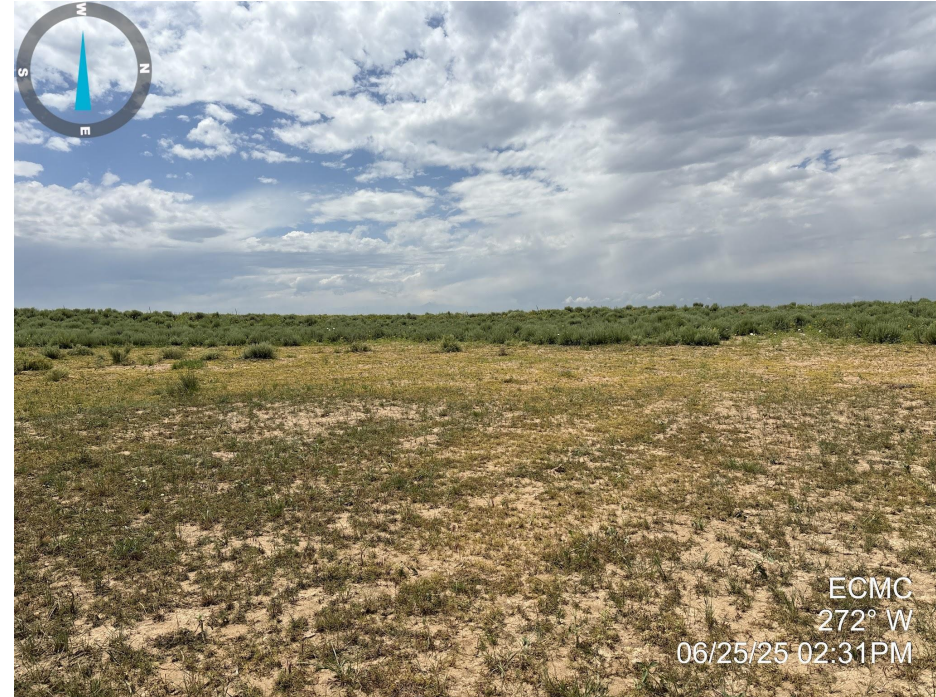
Photo 4. Photo taken from the well location, facing West. See comments under Photo 1.

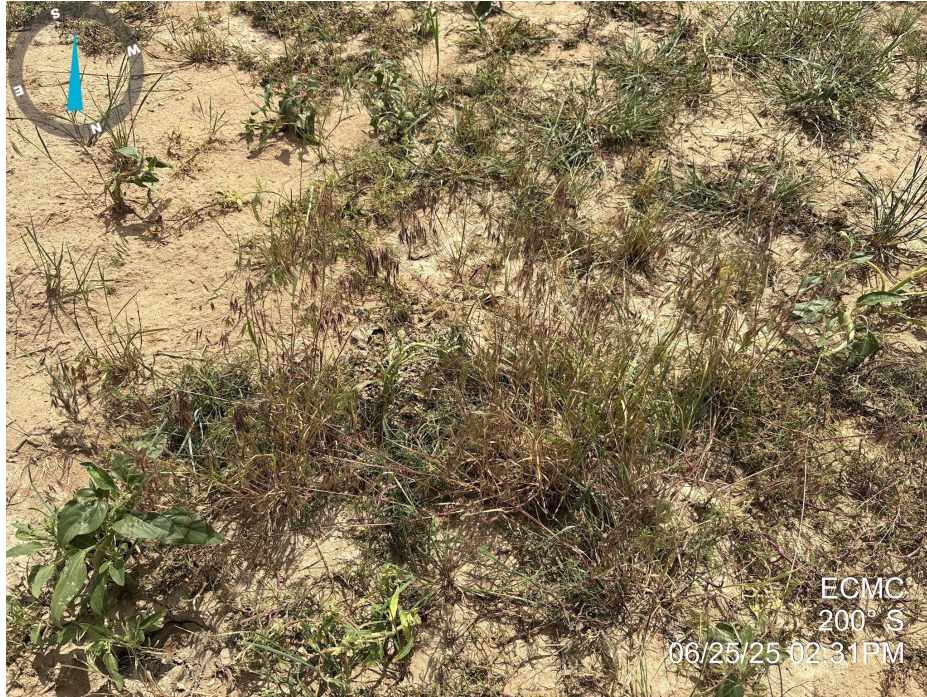
Photo 5. Photo taken of ground cover at the location. Photo illustrates weedy annual vegetation, including cheatgrass (*Bromus tectorum*), a List C Noxious Weed species.

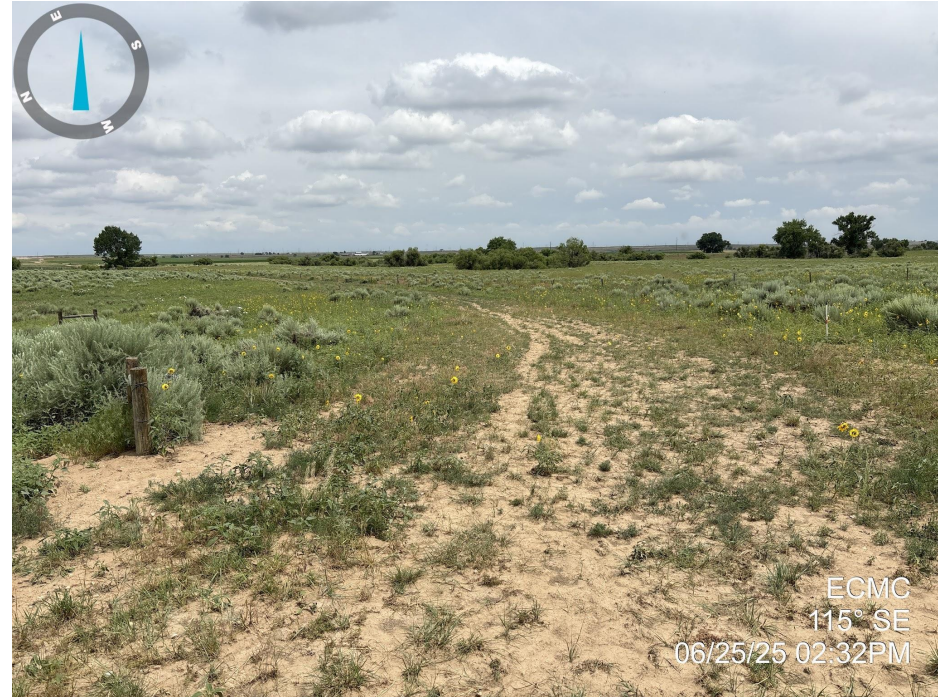
Photo 6. Photo taken of the access road to the well location, facing southeast. Photo illustrates that final reclamation activities have taken place, but vegetation has not established to Rule 1004 standards.

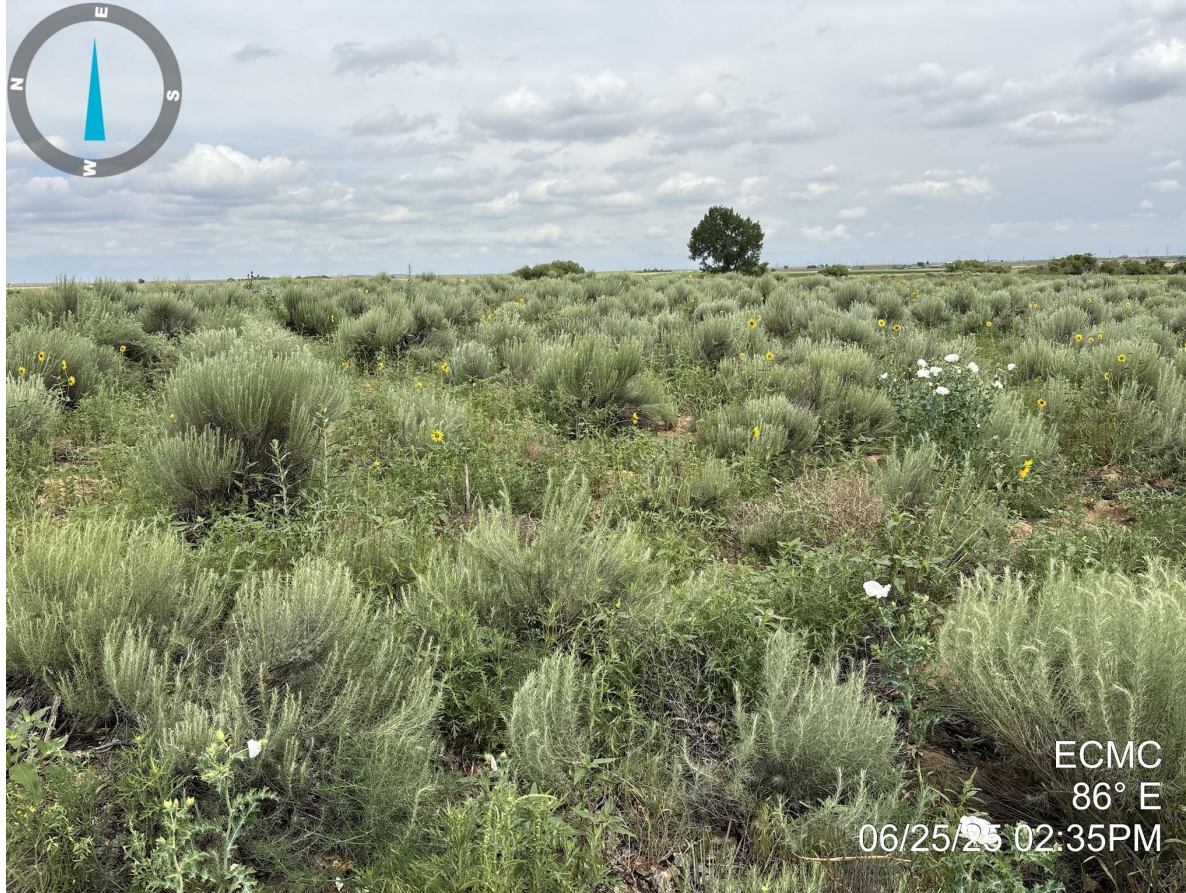
Photo 7. Photo taken of the reference area to the well location, east of the location, facing east. Photo illustrates the site is dominated by sand sagebrush (*Artemisia filifolia*), prairie sunflower (*Helianthus petiolaris*), and thistle poppy (*Argemone polyanthemus*).
