# Construction and Stormwater Inspection

June 27, 2025

Operator: EXTRACTION OIL & GAS INC - 10459

Inspection Photos  
Location Name: T-Bone/XOG-28 Pad  
Location ID: 489258

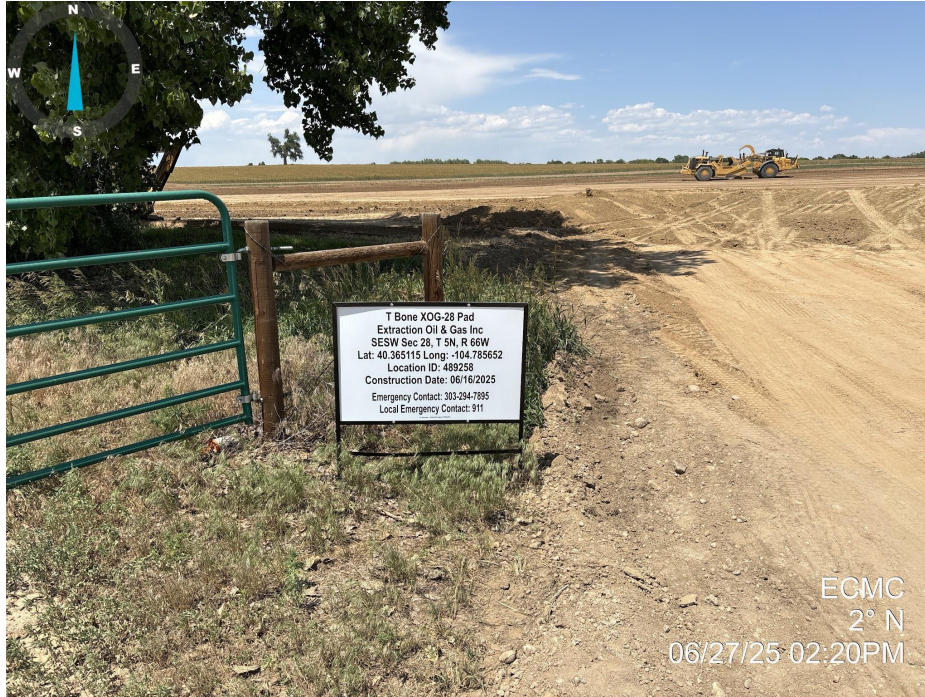
**Photo 1.** Photo taken from the entrance to the location. Photo illustrates the Operator sign. No mailbox or permits were observed at the time of this inspection.

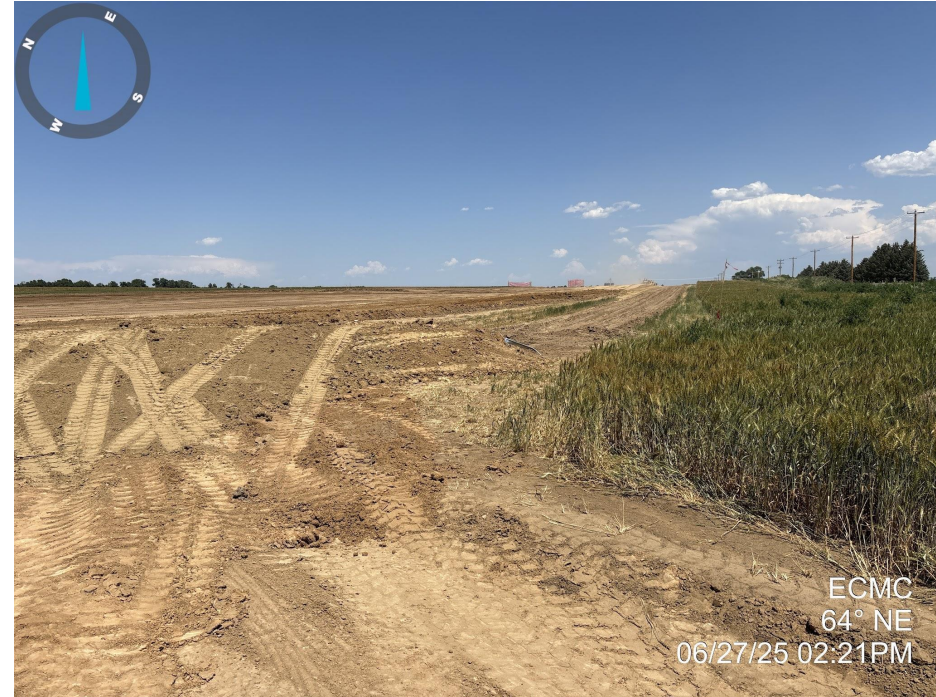
**Photo 2.** Photo taken of the entrance to the location, facing northeast. Photo illustrates that ditch and berm BMPs have not been installed along the perimeter of the location.

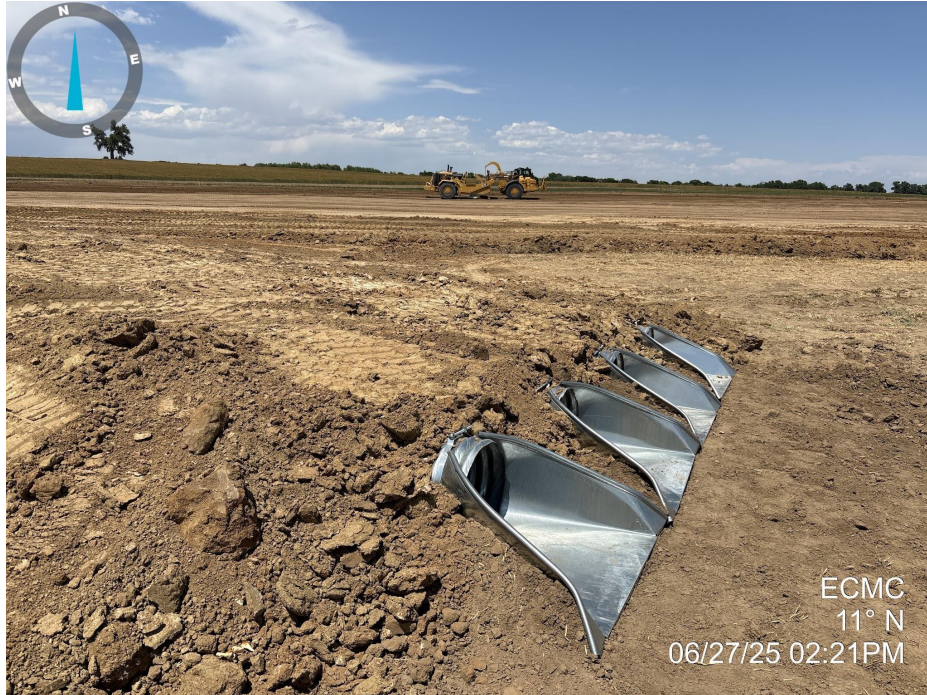
**Photo 3.** Photo taken from the southern perimeter of the location, facing north. Photo illustrates culverts have been installed near the southwestern entrance to the location.

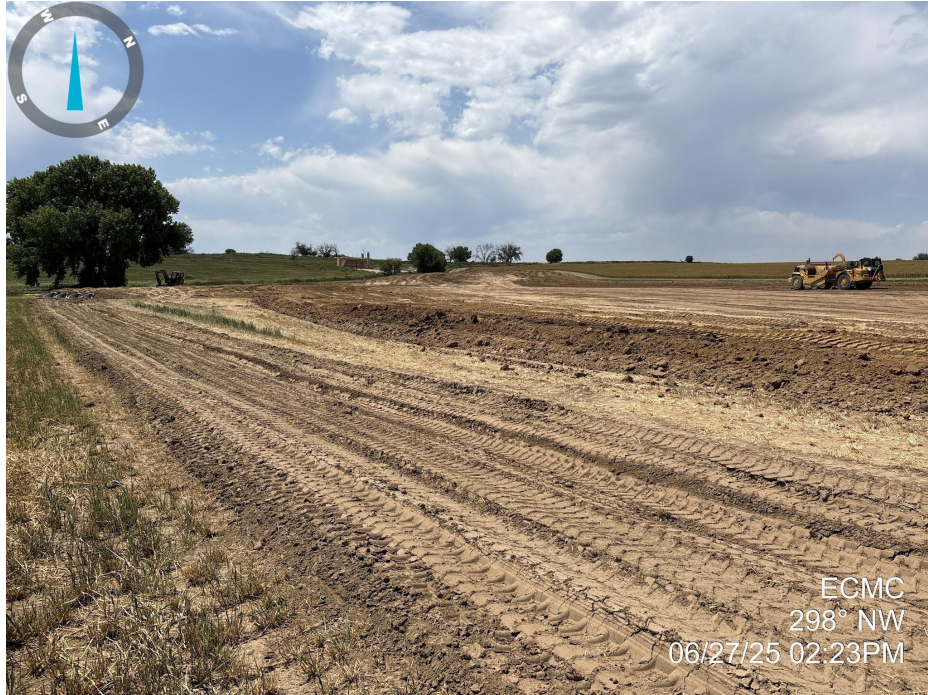
**Photo 4.** Photo taken from the southern perimeter of the location, facing northwest. Photo illustrates the operator is in the process of stabilizing the working pad surface.

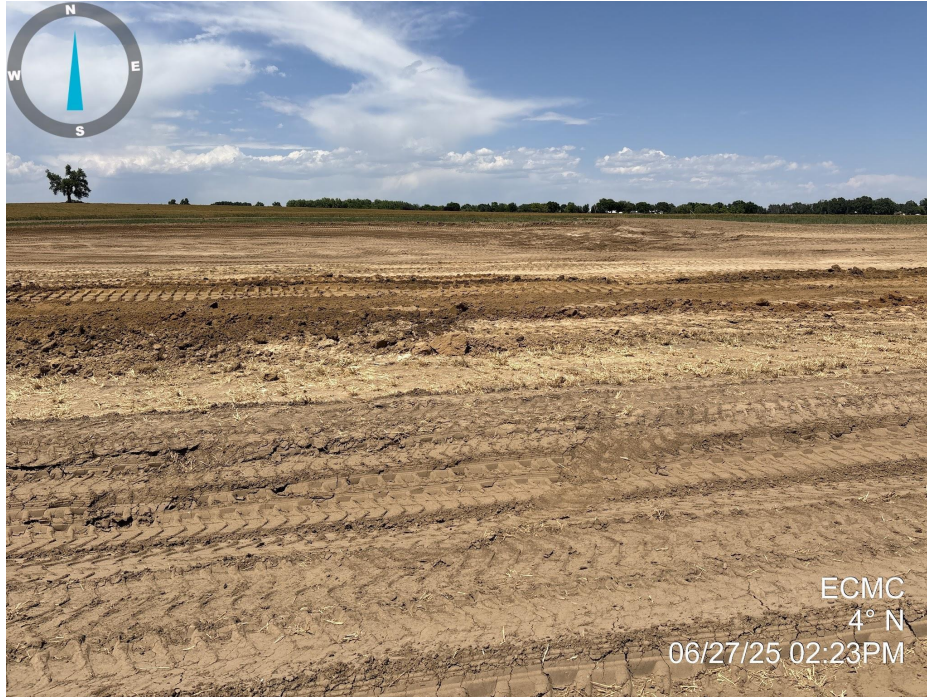
**Photo 5.** Photo taken of the southern perimeter of the location, facing north. See comments under Photo 4.

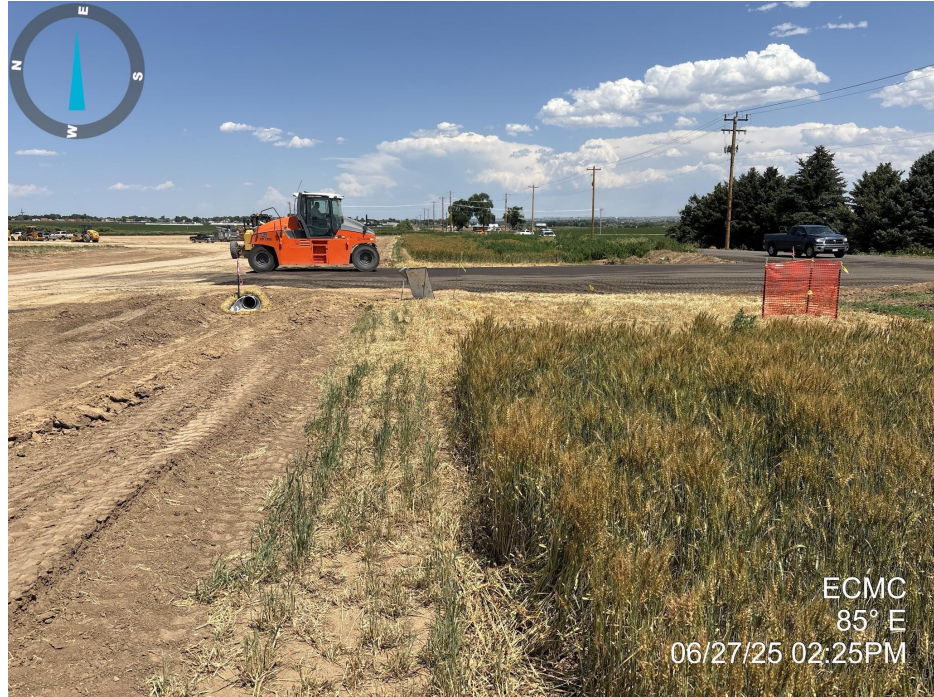
**Photo 6.** Photo taken of the eastern entrance to the location along the southern perimeter. Photo illustrates a culvert has been installed and the operator was in the process of stabilizing the entrance with road base.

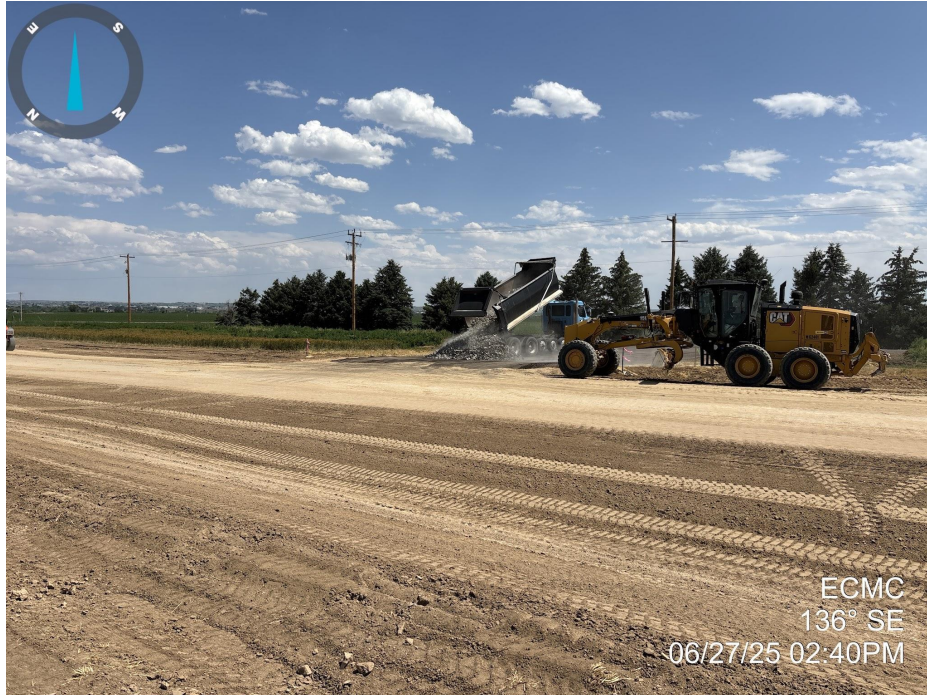
**Photo 7.** Photo taken of the eastern entrance to the location along the southern perimeter. Photo illustrates that at the time of this inspection rock was being installed to create a vehicle tracking pad.

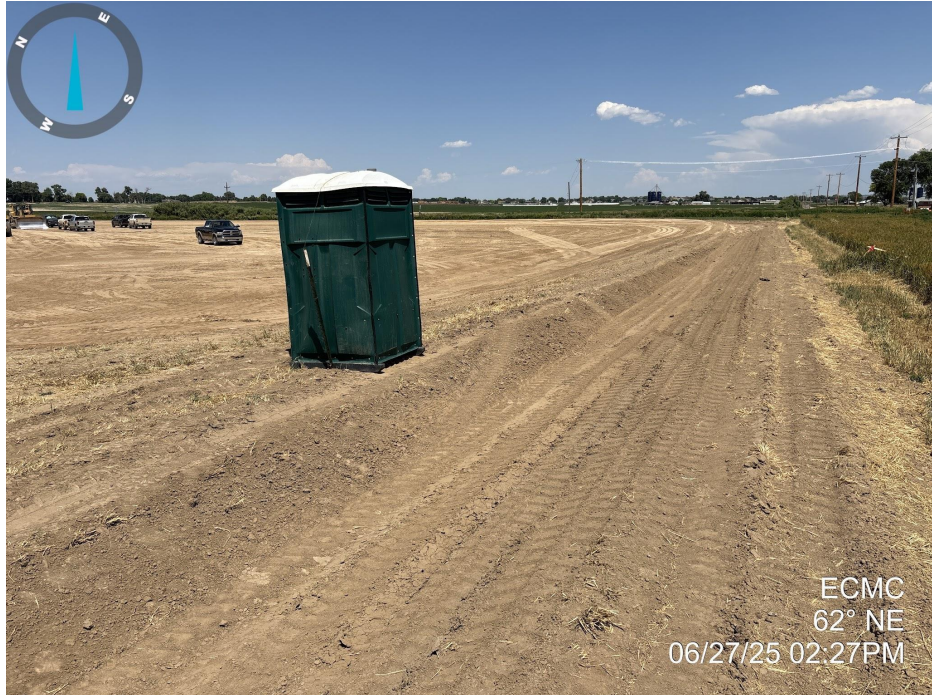
**Photo 8.** Photo taken from southeastern perimeter of the location, facing northeast. Photo illustrates a porta potty has been stabilized per best management practices. The operator is in the process of installing a ditch and berm along this portion of the location.

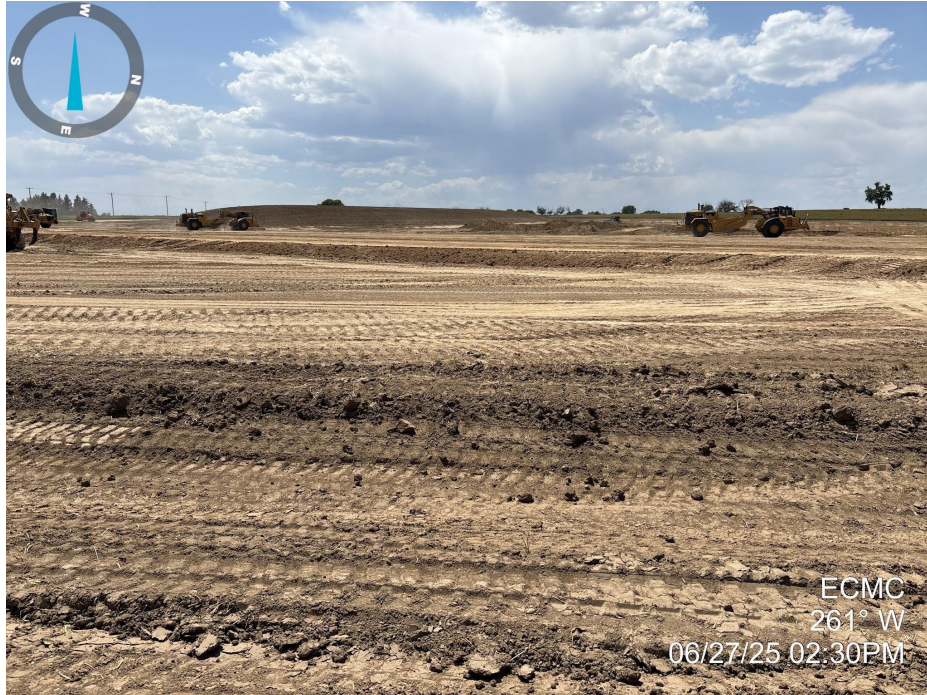
**Photo 9.** Photo taken from the eastern portion of the location. Photo illustrates the operator is in the process of stabilizing the working pad surface.

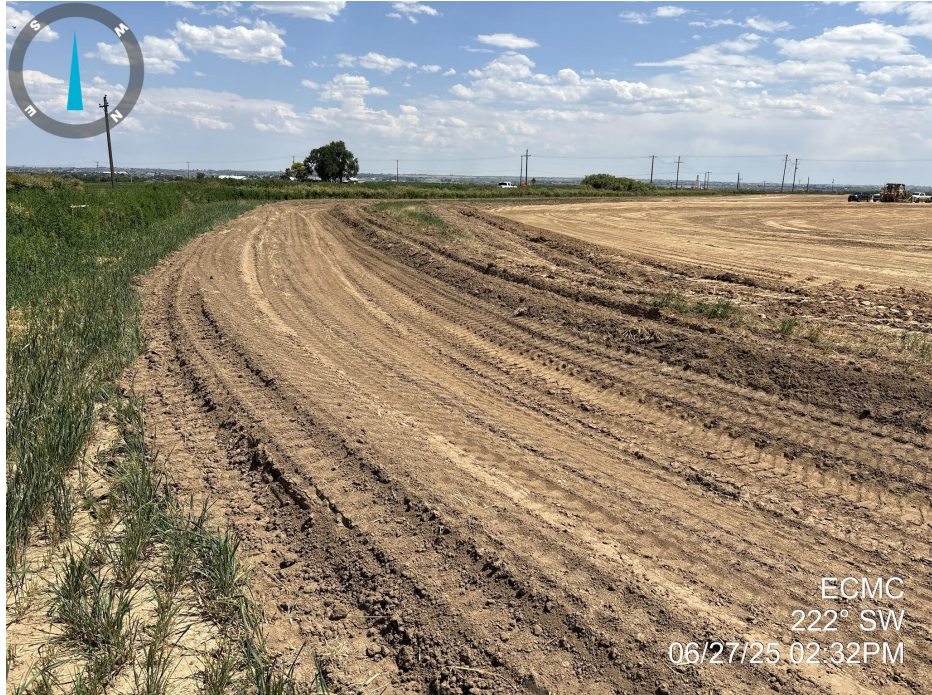
**Photo 10.** Photo taken from the northeastern portion of the location, facing southwest. See comments under Photo 9.

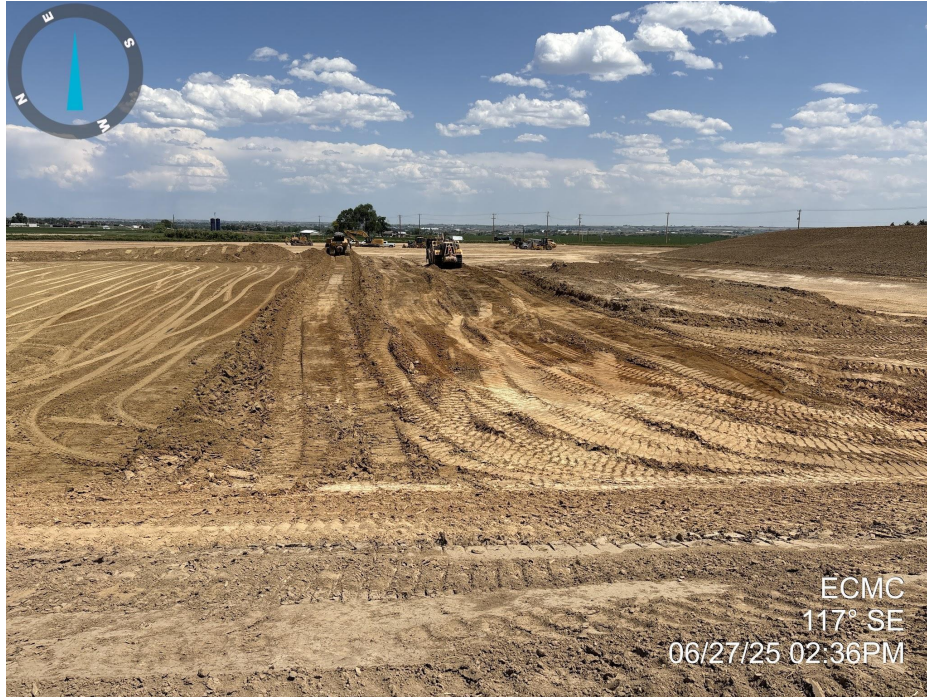
**Photo 11.** Photo taken from the northern perimeter of the site, facing southeast. See comments under Photo 9.

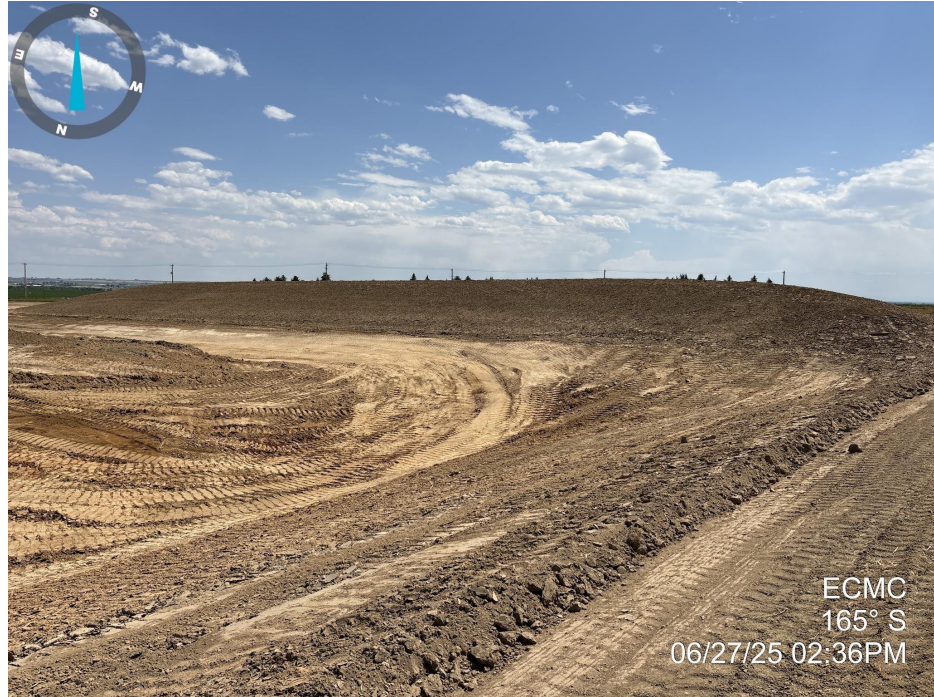
**Photo 12.** Photo taken of the topsoil stockpile. Photo illustrates the operator has not yet stabilized the stockpile.

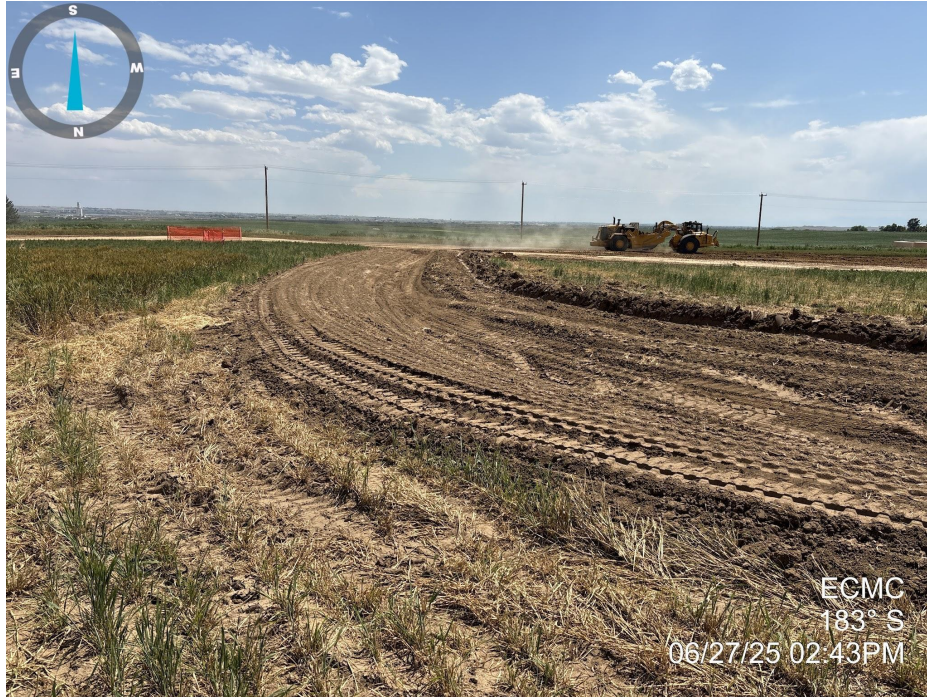
**Photo 13.** Photo taken of the southwestern portion of the location, facing south. See comments under Photo 9.

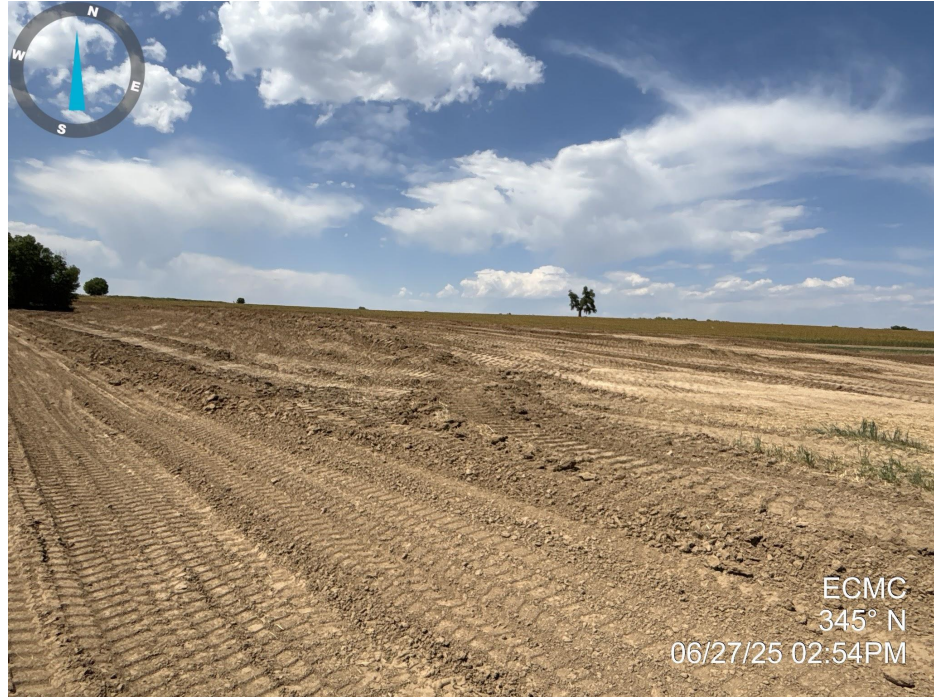
**Photo 14.** Photo taken of the southwestern portion of the location, facing north. See comments under Photo 9.
