## Inspection/Audit Photos

Location Name: TEP ROCKY MOUNTAIN LLC CLOUGH RWF 22-14 Pad

Location # 335853

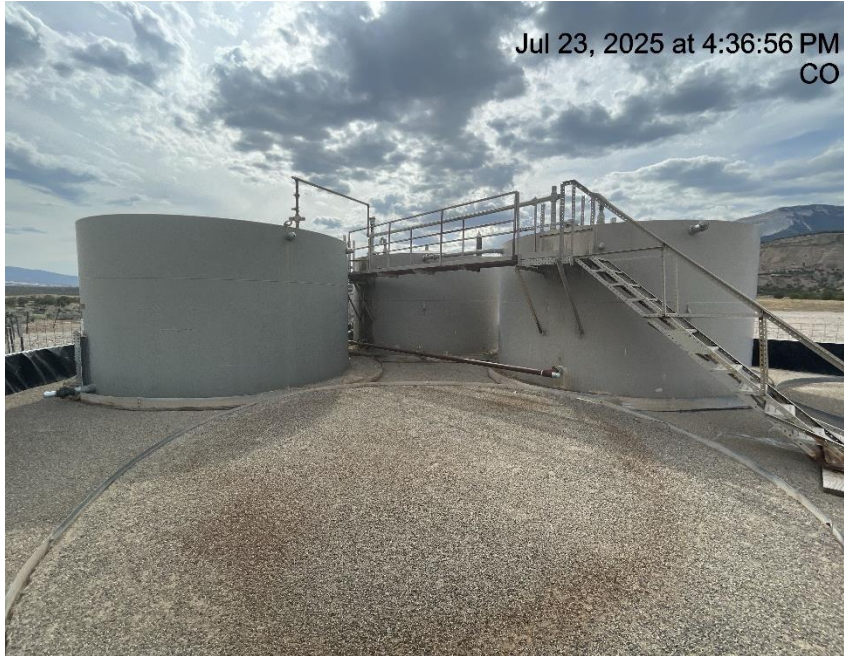
**Photo # 3976 – 2 condensate tanks & 1 produced water tank  
In battery on location. FORM 2A document # 400099288 lists  
no condensate or produced water tanks/not in compliance  
with CECMC rules. Additionally liquid nitrogen tank &  
chemical tank on location are not list in FORM 2A or FORM 4  
SUNDRY/not in compliance with CECMC rules.**
