Final Reclamation Inspection

Operator: NOBLE ENERGY INC - 100322

Location ID: 447067

Location Name: CORBIN RED D 30-4J,9,15,16

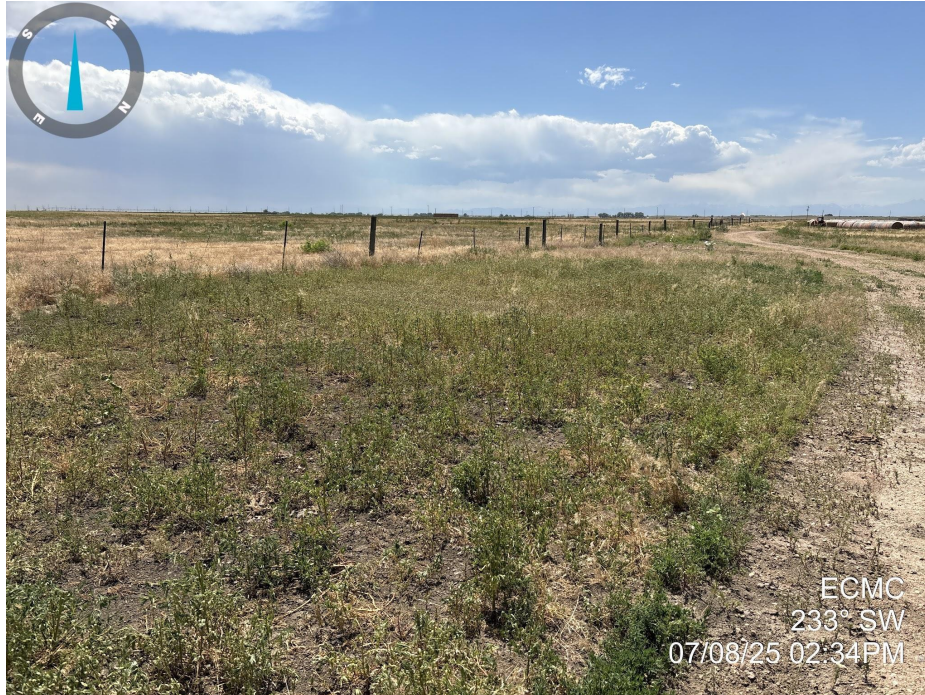
Photo 1. Photo taken of the western portion of the tank battery location, facing southwest. Photo illustrates that the location does not meet Rule 1004 standards as gravel and weedy annual vegetation were observed across the location.

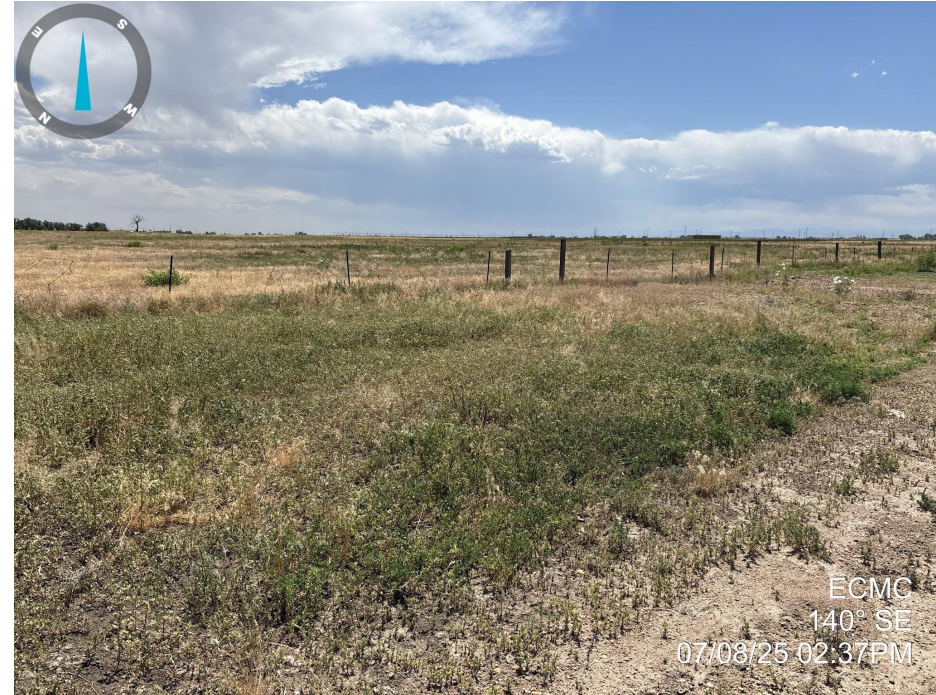
Photo 2. Photo taken of the western portion of the tank battery location, facing southeast. See comments under Photo 1.

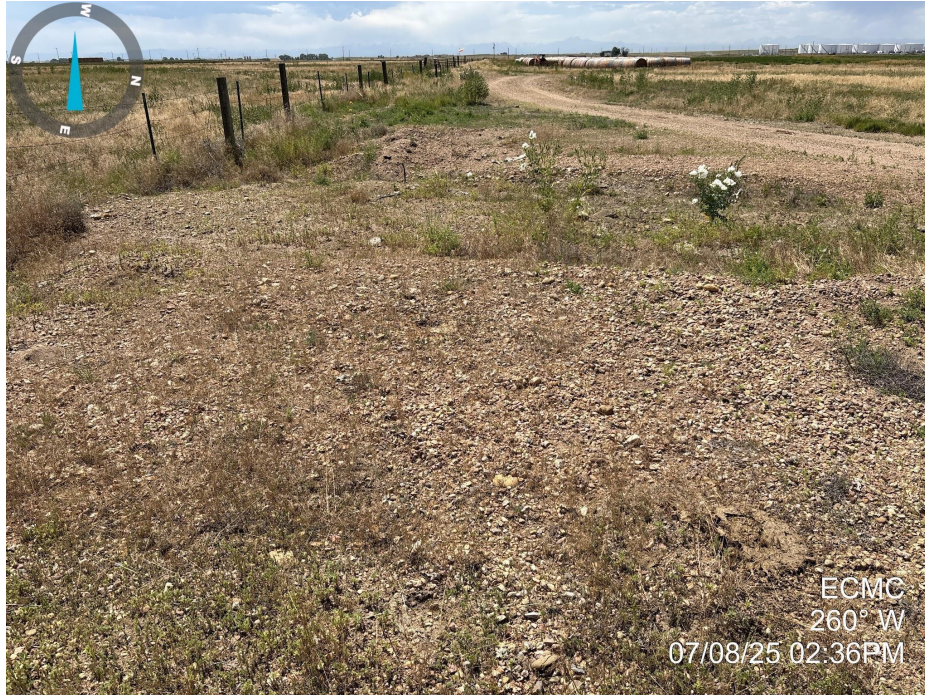
Photo 3. Photo taken from the western portion of the tank battery location, facing west. Photo illustrates that gravel remains on the location.

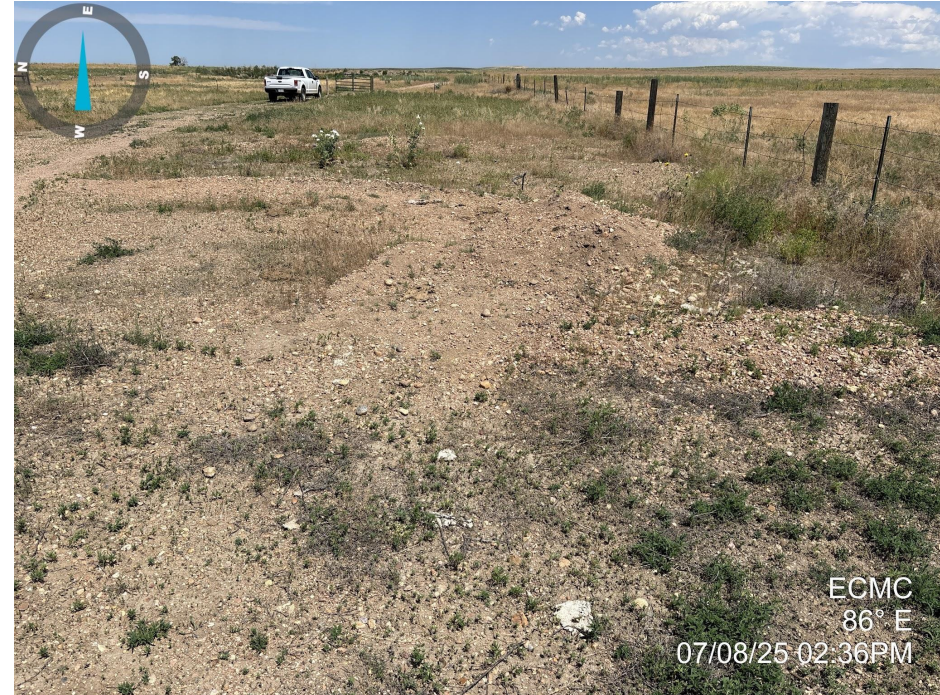
Photo 4. Photo taken of the western portion of the tank battery location, facing east. See comments under Photo 3.

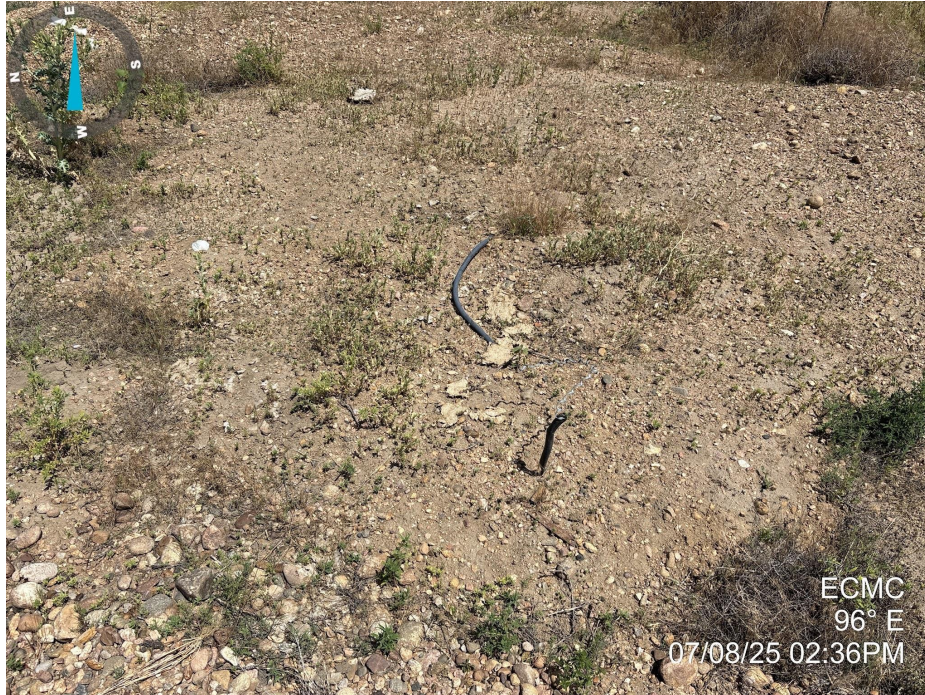
Photo 5. Photo taken of ground cover at the tank battery location. Photo illustrates gravel and weedy annual vegetation.

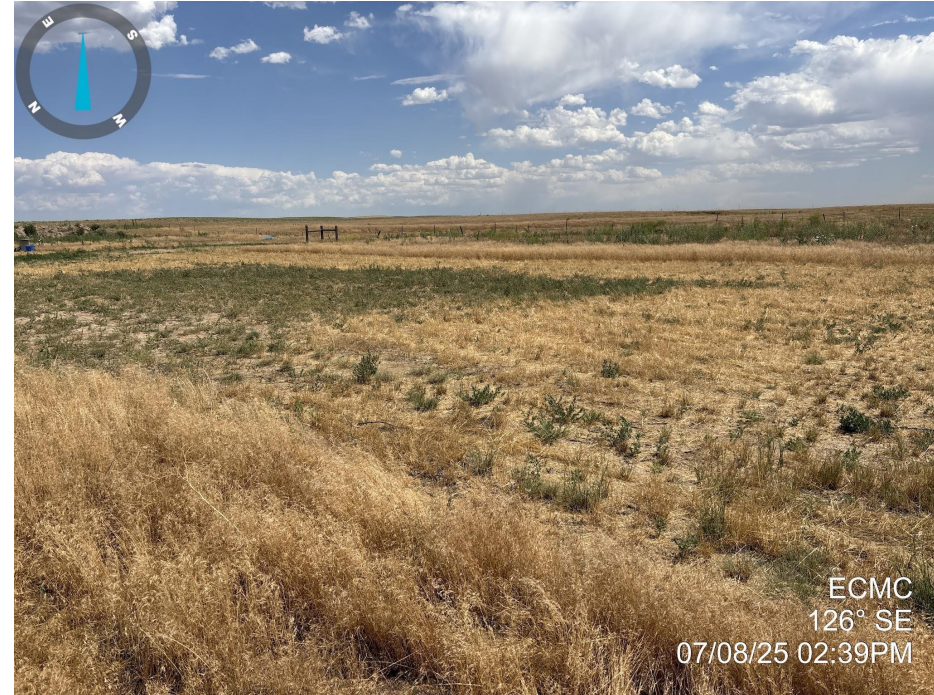
Photo 6. Photo taken from the eastern portion of the tank battery location, facing southeast. Photo illustrates that final reclamation activities have taken place, with evidence of drill row seeding, but gravel and weedy annual vegetation were observed across the location.

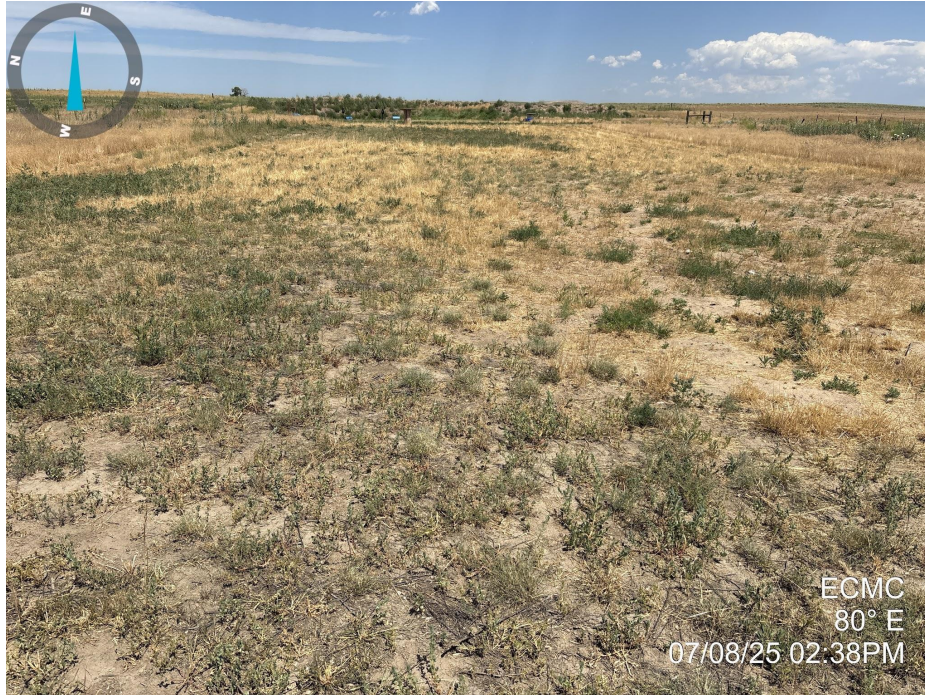
Photo 7. Photo taken of the eastern portion of the tank battery location, facing east. See comments under Photo 6.

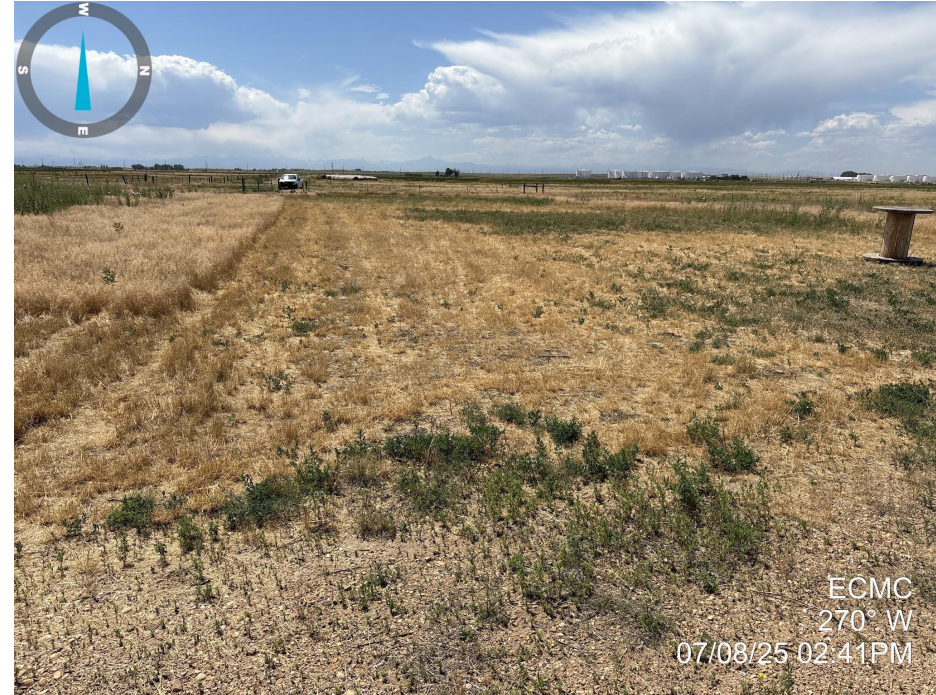
Photo 8. Photo taken from the eastern portion of the tank battery location, facing west. See comments under Photo 6.

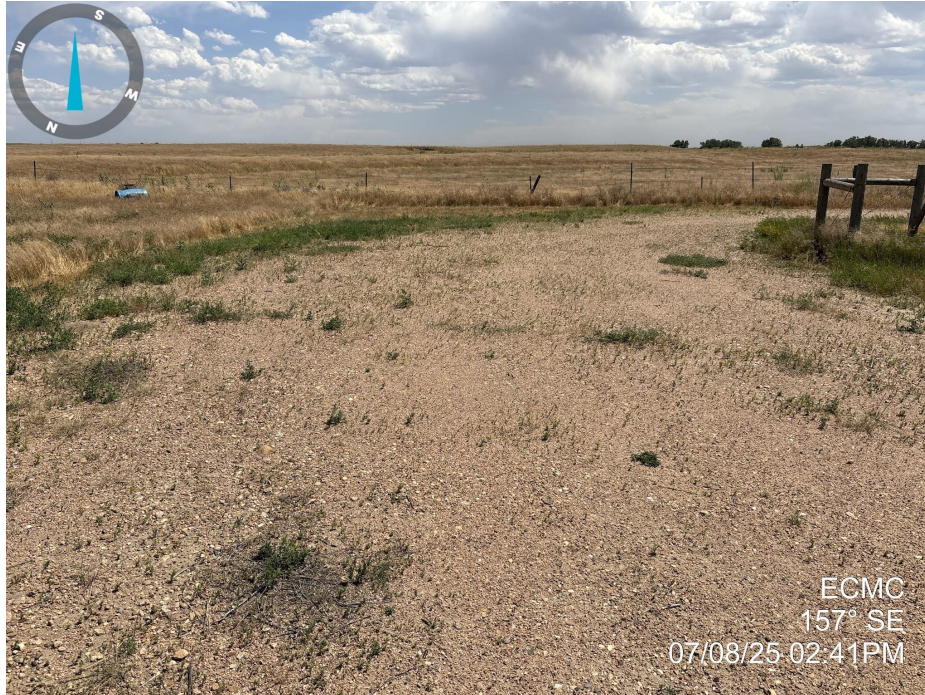
Photo 9. Photo taken of the access road to the tank battery location, facing southeast. Photo illustrates that final reclamation has not taken place along the access road and it appears to remain in use by the landowner.

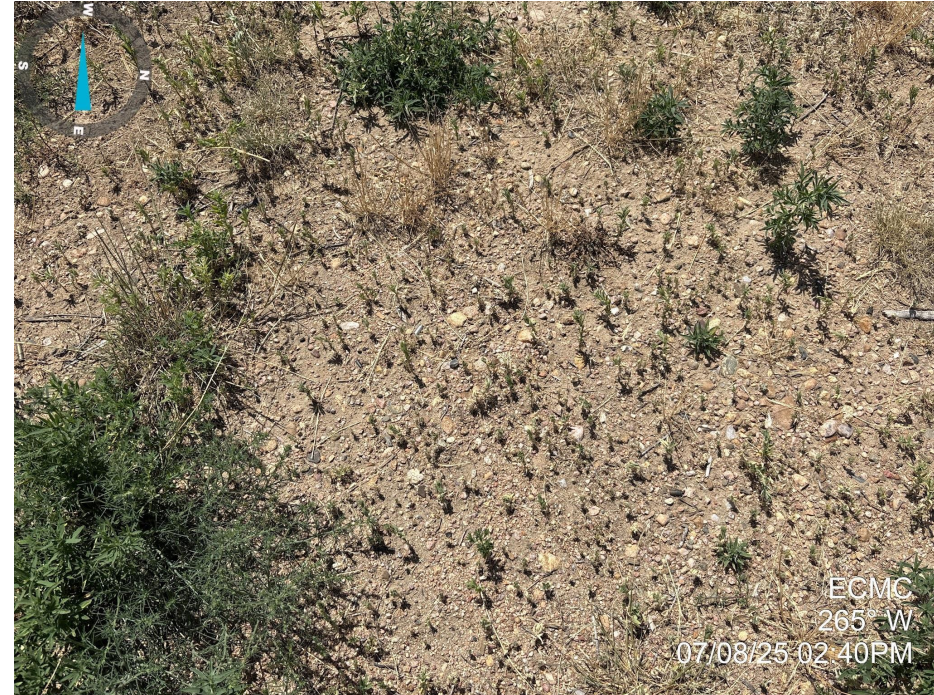
Photo 10. Photo taken of ground cover at the tank battery. Photo illustrates gravel and weedy annual vegetation, including cheatgrass (*Bromus tectorum*), a List C Noxious Weed species, and kochia (*Bassia scoparia*).

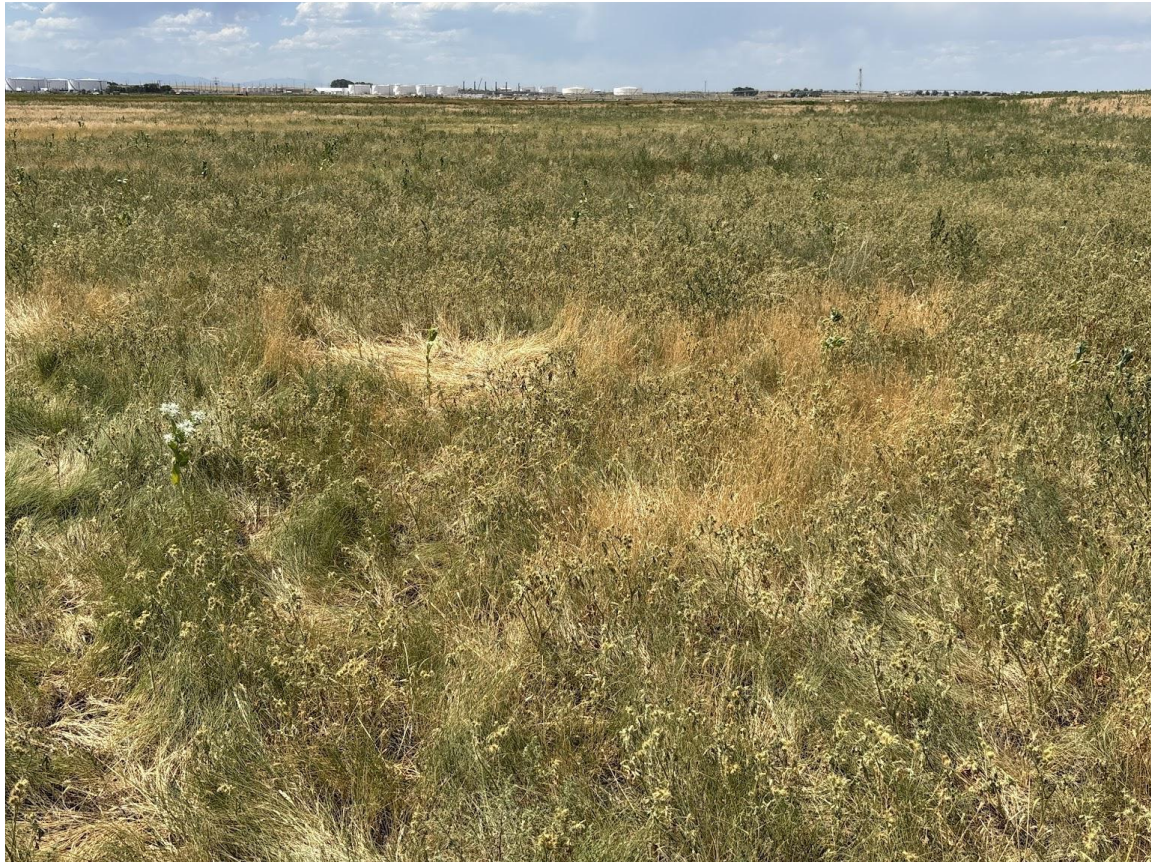
Photo 11. Photo taken of the reference area to the tank battery location, north of the location, facing northwest. Photo illustrates perennial grass and annual vegetation.
