Final Reclamation Inspection

Operator: NOBLE ENERGY INC - 100322

Location ID: 329059

Inspection Photos
Location Name: CORBIN RED D #30-9
Location ID: 329059

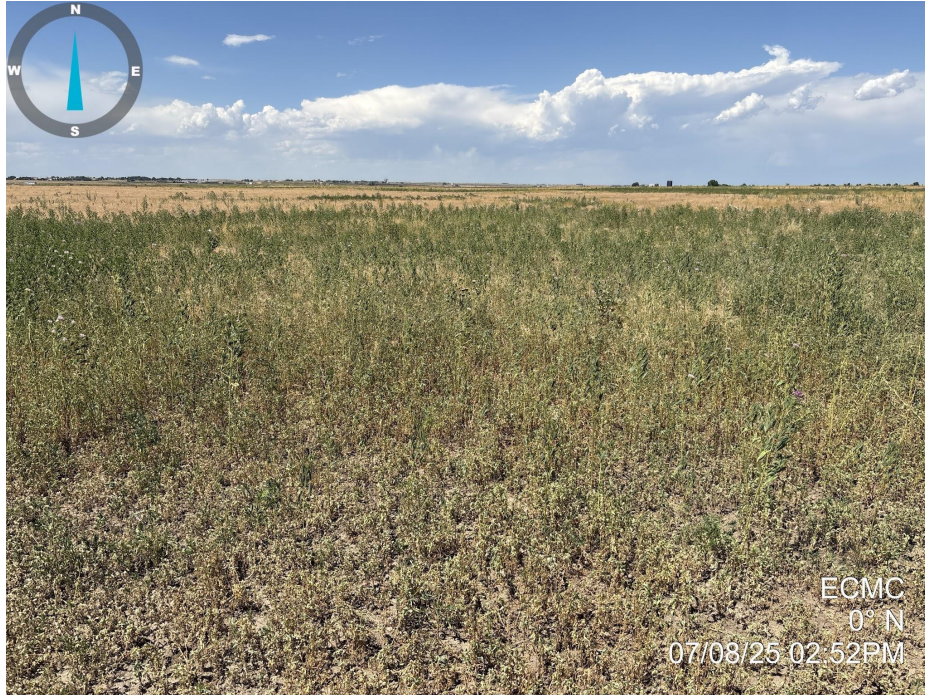
Photo 1. Photo taken from the well location, facing North. Photo illustrates that final reclamation activities have taken place, with evidence of drill row seeding, but vegetation has not established to Rule 1004 standards as the site is dominated by weedy annual vegetation and fencing remains in disrepair around the location.

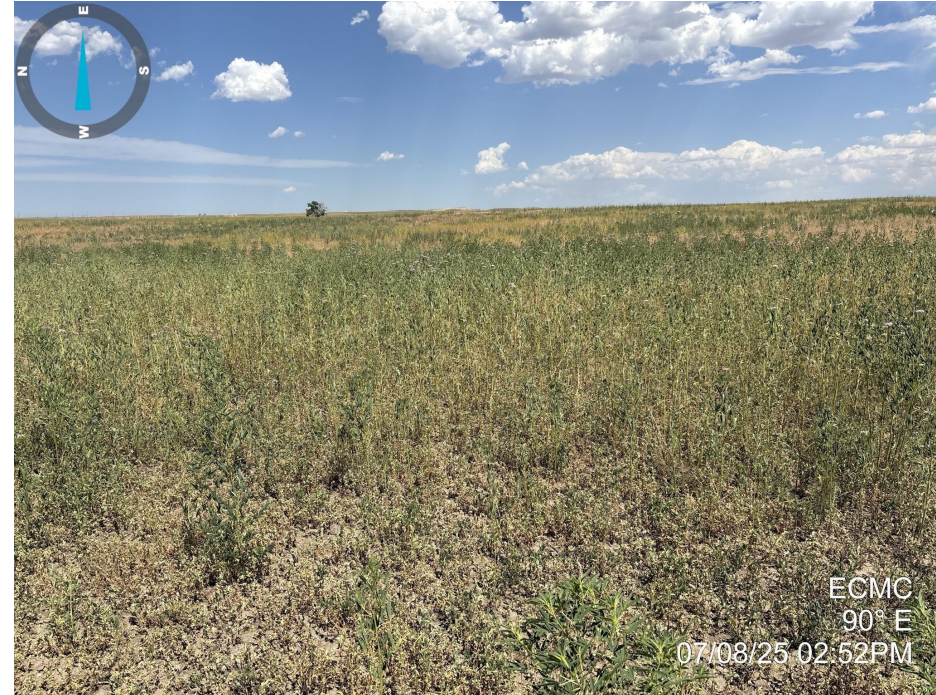
Photo 2. Photo taken from the well location, facing East. See comments under Photo 1.

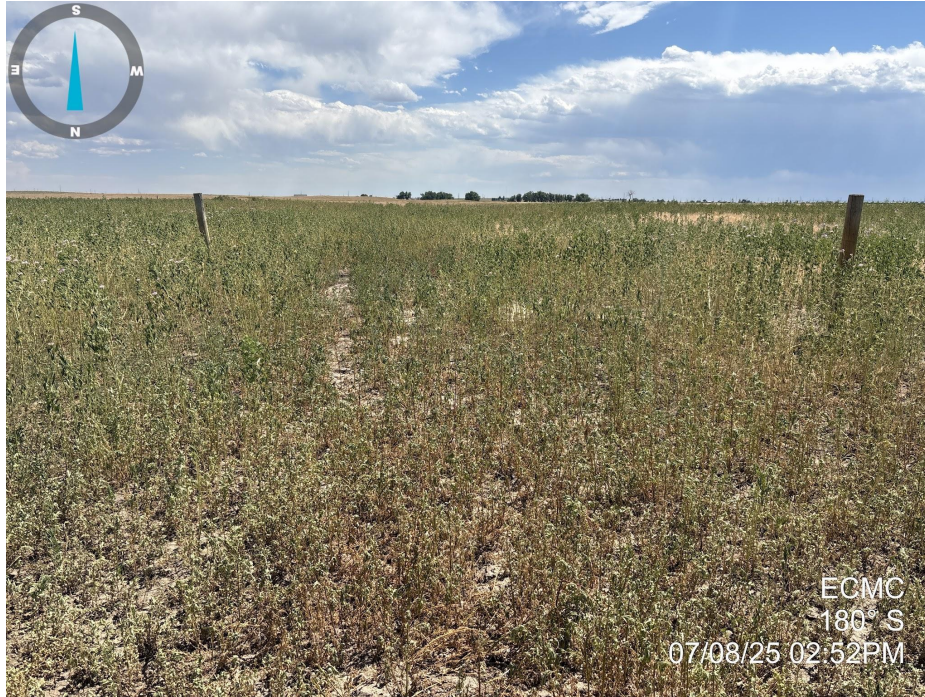
Photo 3. Photo taken from the well location, facing South. See comments under Photo 1.

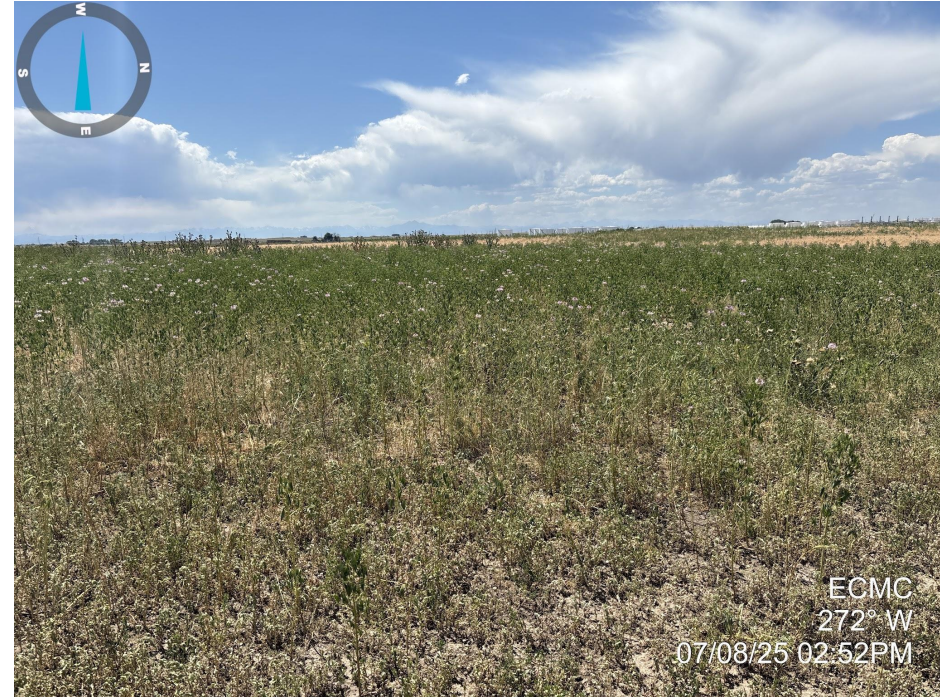
Photo 4. Photo taken from the well location, facing West. See comments under Photo 1.

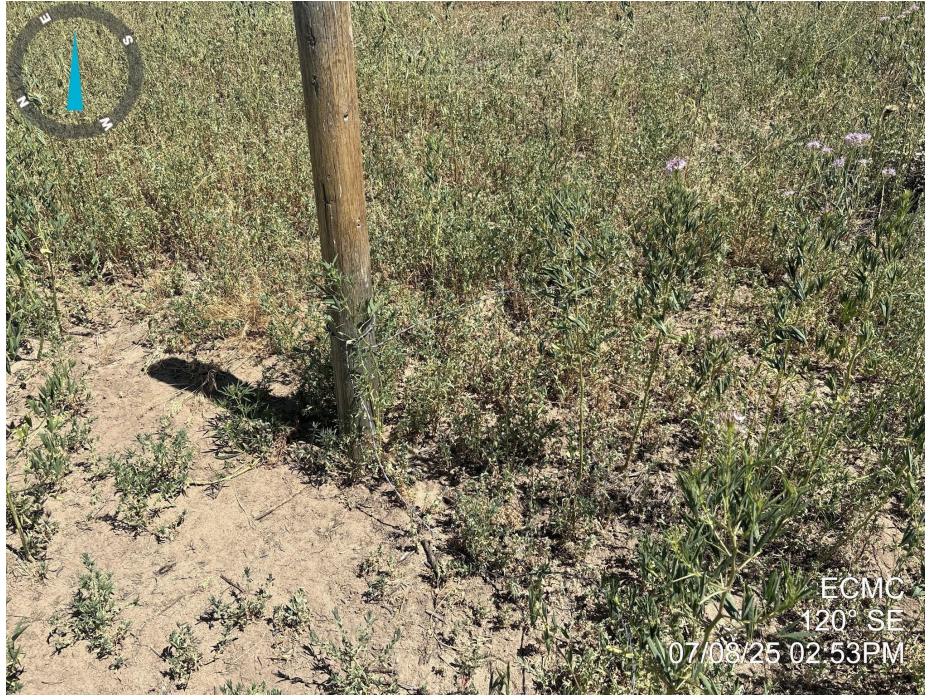
Photo 5. Photo taken of ground cover at the location. Photo illustrates that fencing remains around the location and is in disrepair. Weedy annual vegetation, including kochia (*Bassia scoparia*), was observed across the location.

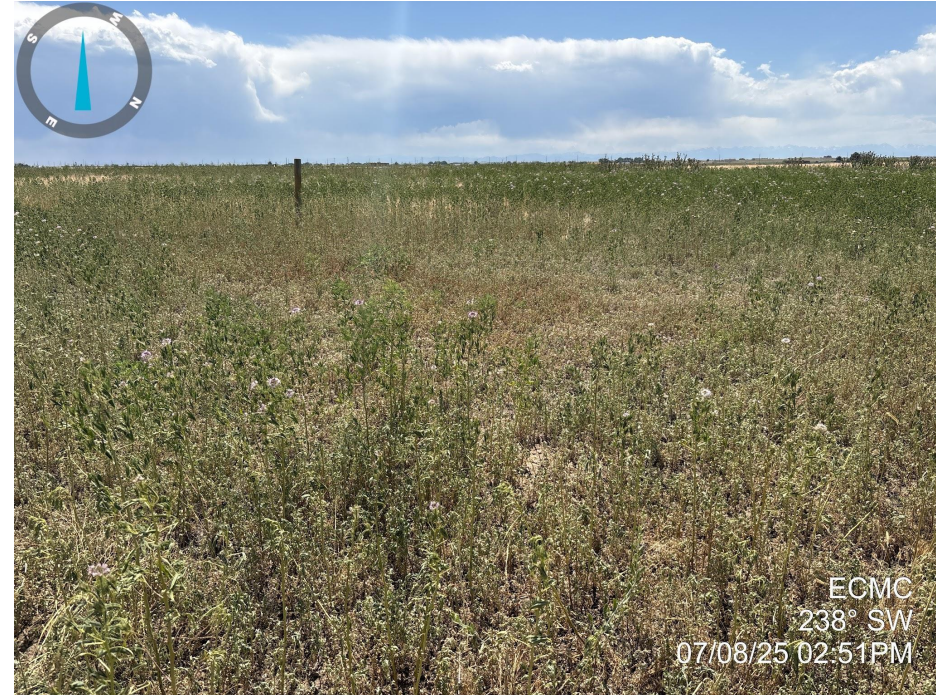
Photo 6. Photo taken of the access road to the well location, facing east. Photo illustrates that weedy annual vegetation remains along the access road.

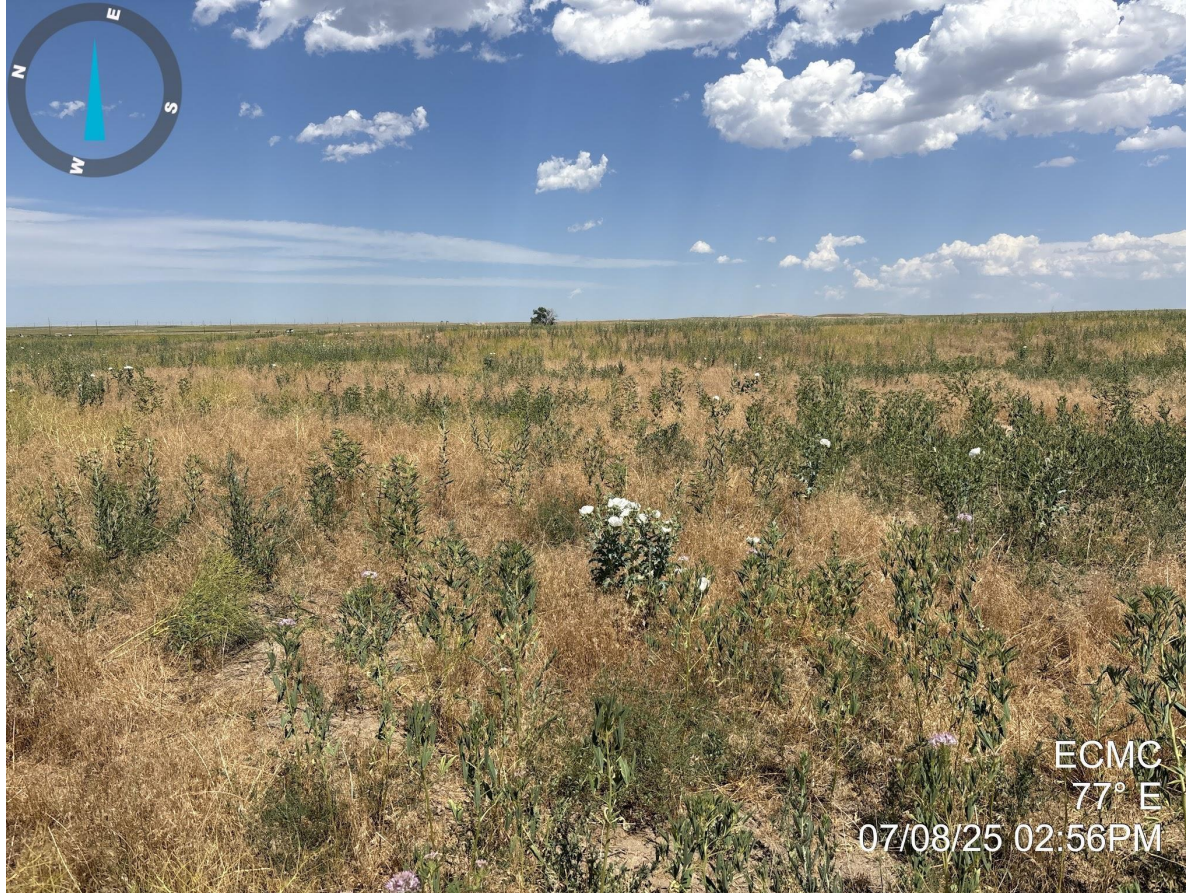
Photo 7. Photo taken of the reference area to the well location, southeast of the location, facing east. Photo illustrates the site is dominated by annual vegetation including Rocky Mountain beeplant (*Cleomella serrulate*) and cheatgrass (*Bromus tectorum*).
