Final Reclamation Inspection

Operator: NOBLE ENERGY INC - 100322

Location ID: 309822

Inspection Photos
Location Name: MCWILLIAMS D #29-32
Location ID: 309822

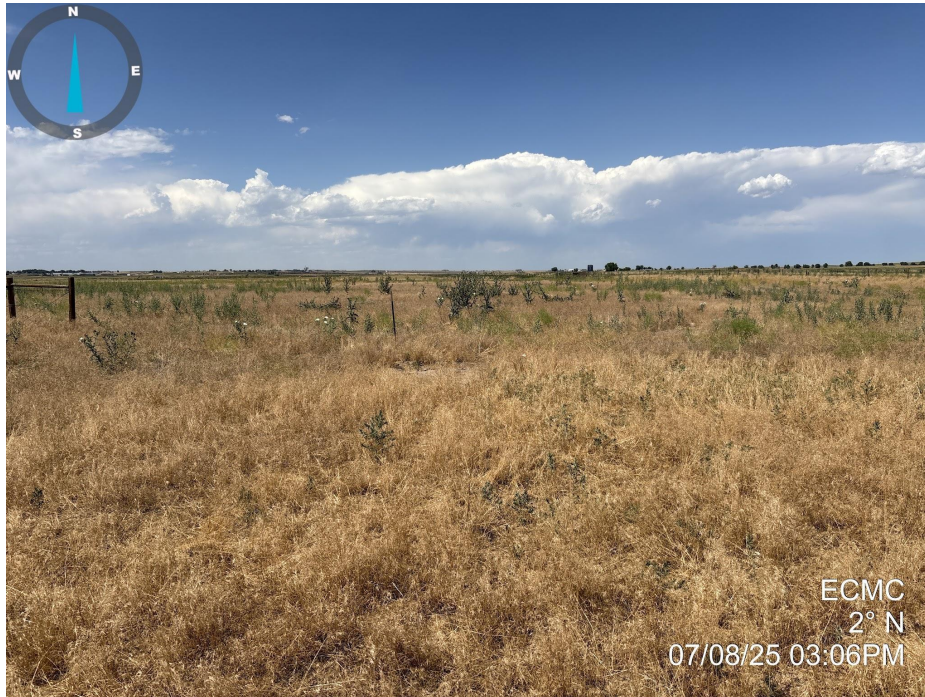
Photo 1. Photo taken from the well location, facing North. Photo illustrates that final reclamation activities have taken place, but vegetation has not established to Rule 1004 standards as the site is dominated by weedy annual vegetation and fencing remains around the location in disrepair.

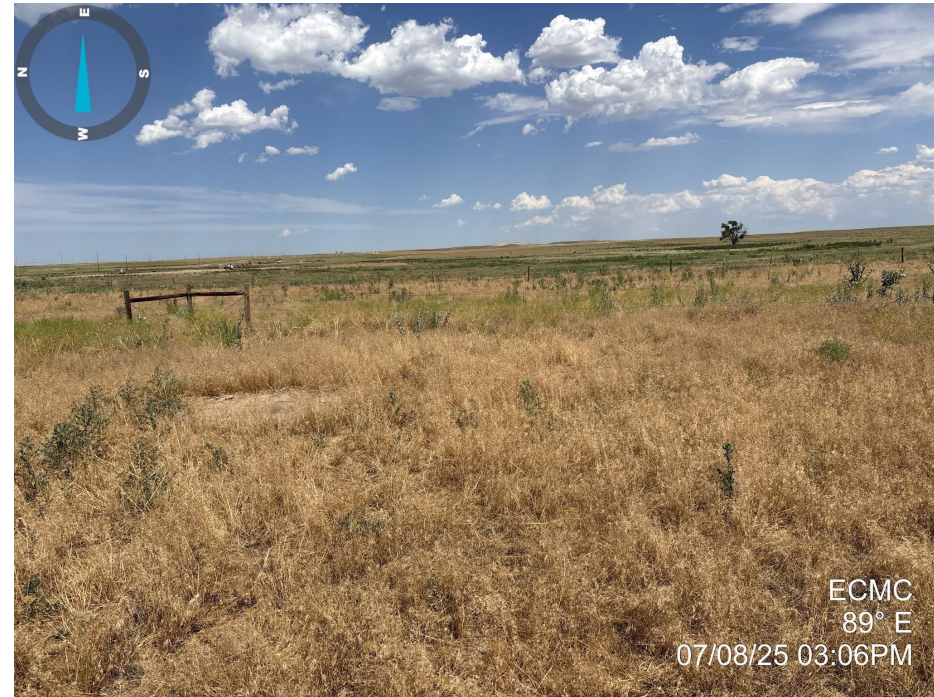
Photo 2. Photo taken from the well location, facing East. See comments under Photo 1.

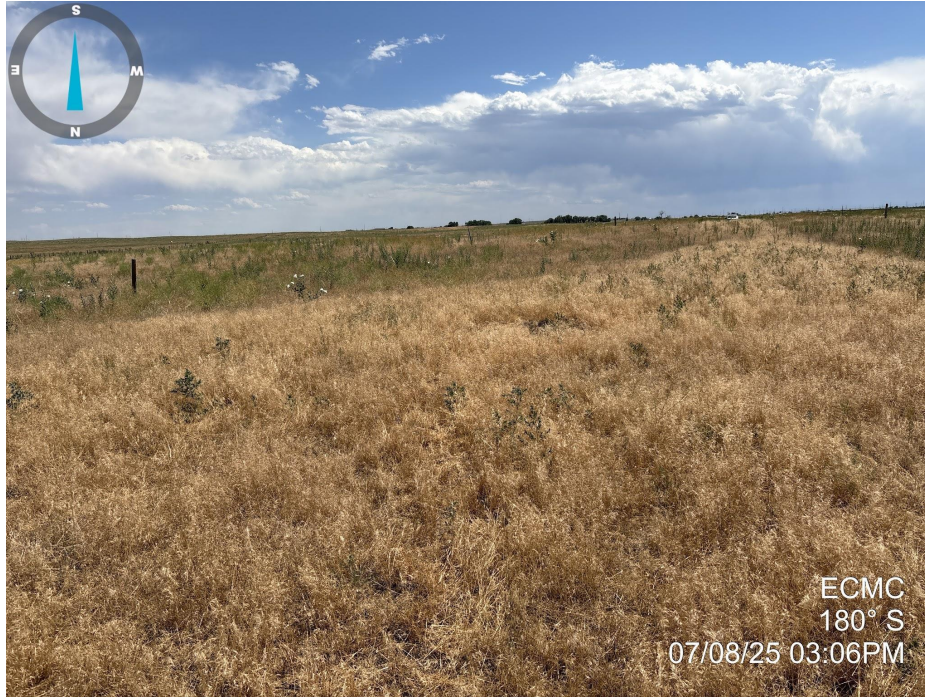
Photo 3. Photo taken from the well location, facing South. See comments under Photo 1.

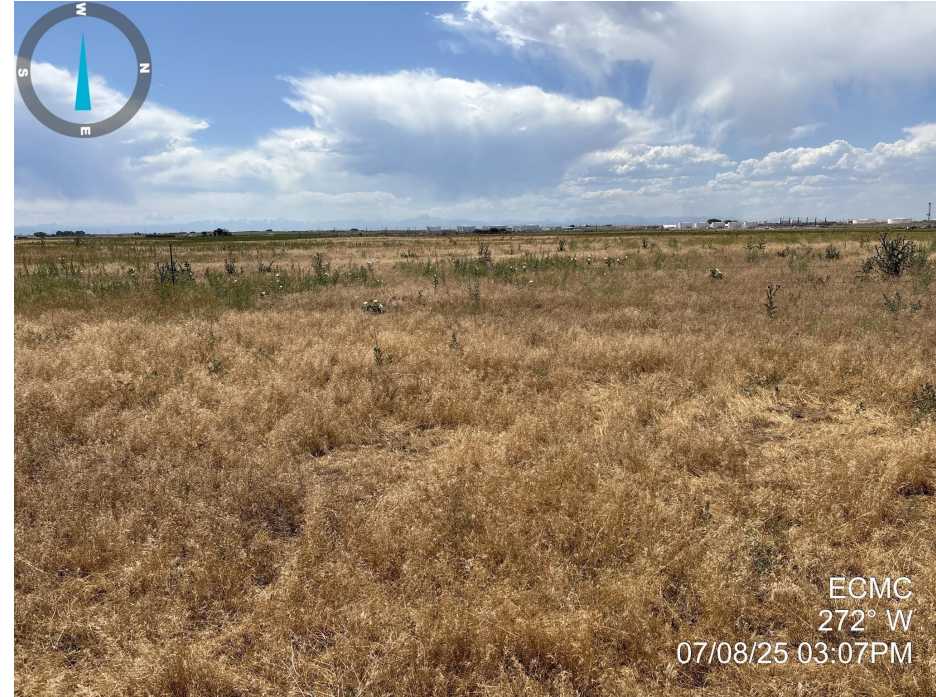
Photo 4. Photo taken from the well location, facing West. See comments under Photo 1.

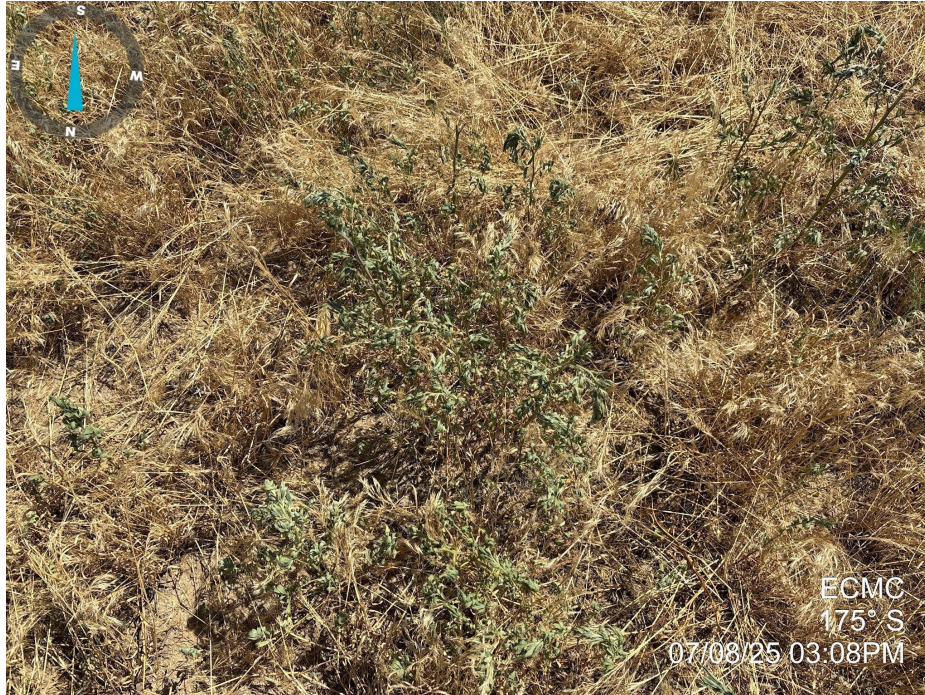
Photo 5. Photo taken of ground cover at the location. Photo illustrates weedy annual vegetation including kochia (*Bassia scoparia*) and cheatgrass (*Bromus tectorum*), a List C Noxious Weed species.

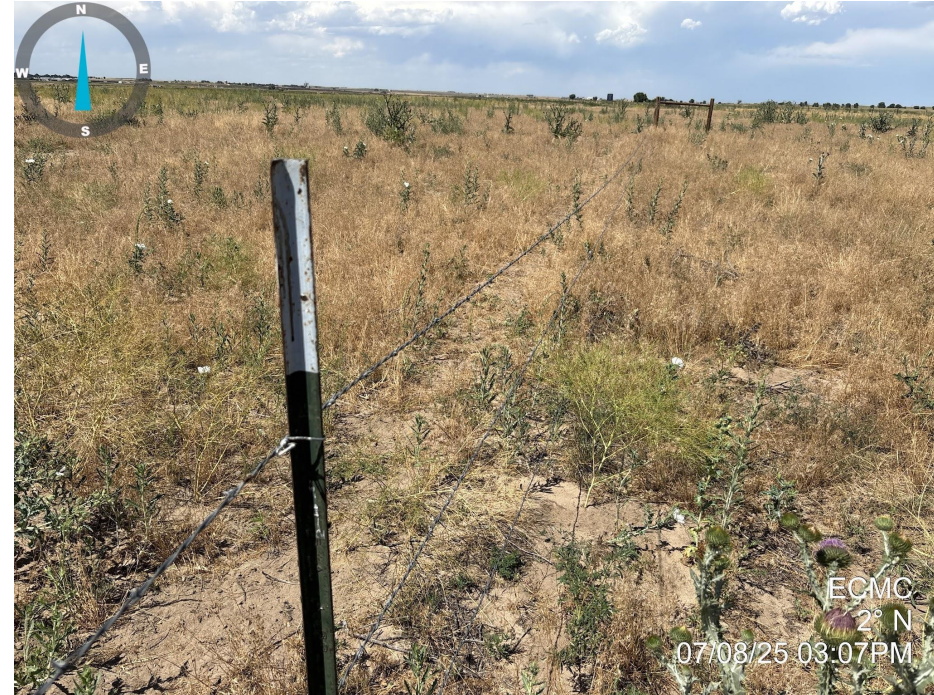
Photo 6. Photo taken of fencing along the western perimeter of the well location, facing North. Photo illustrates that fencing remains at the location. Bare ground and weedy annual vegetation was observed across the location.

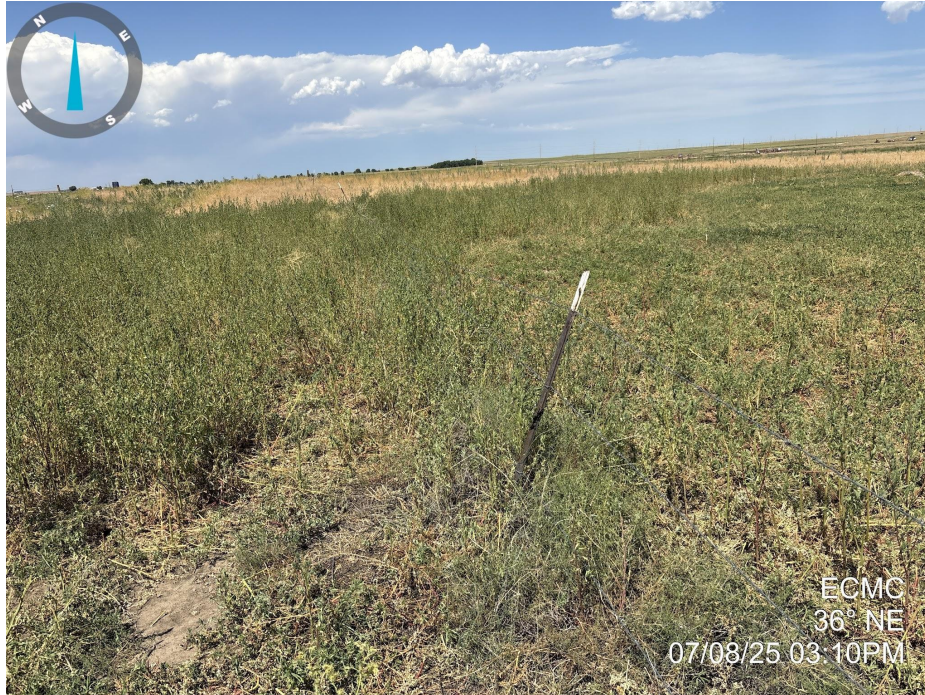
Photo 7. Photo taken of fencing along the access road to the location, facing northeast. Photo illustrates that fencing remains and is in disrepair.

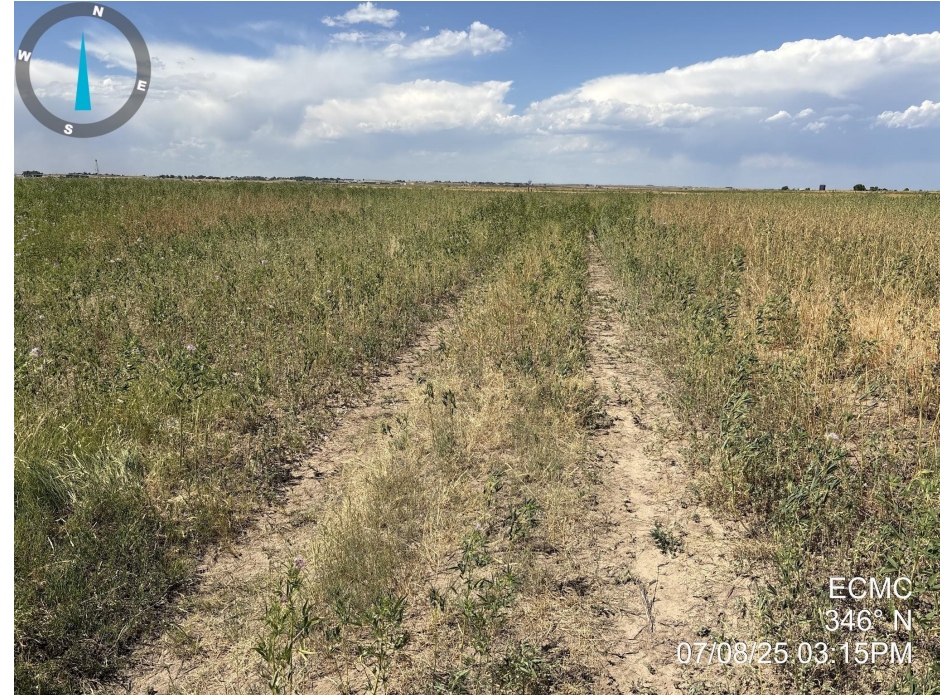
Photo 8. Photo taken of the access road to the well location, facing north. Photo illustrates that bare ground and weedy annual vegetation remain along the access road.

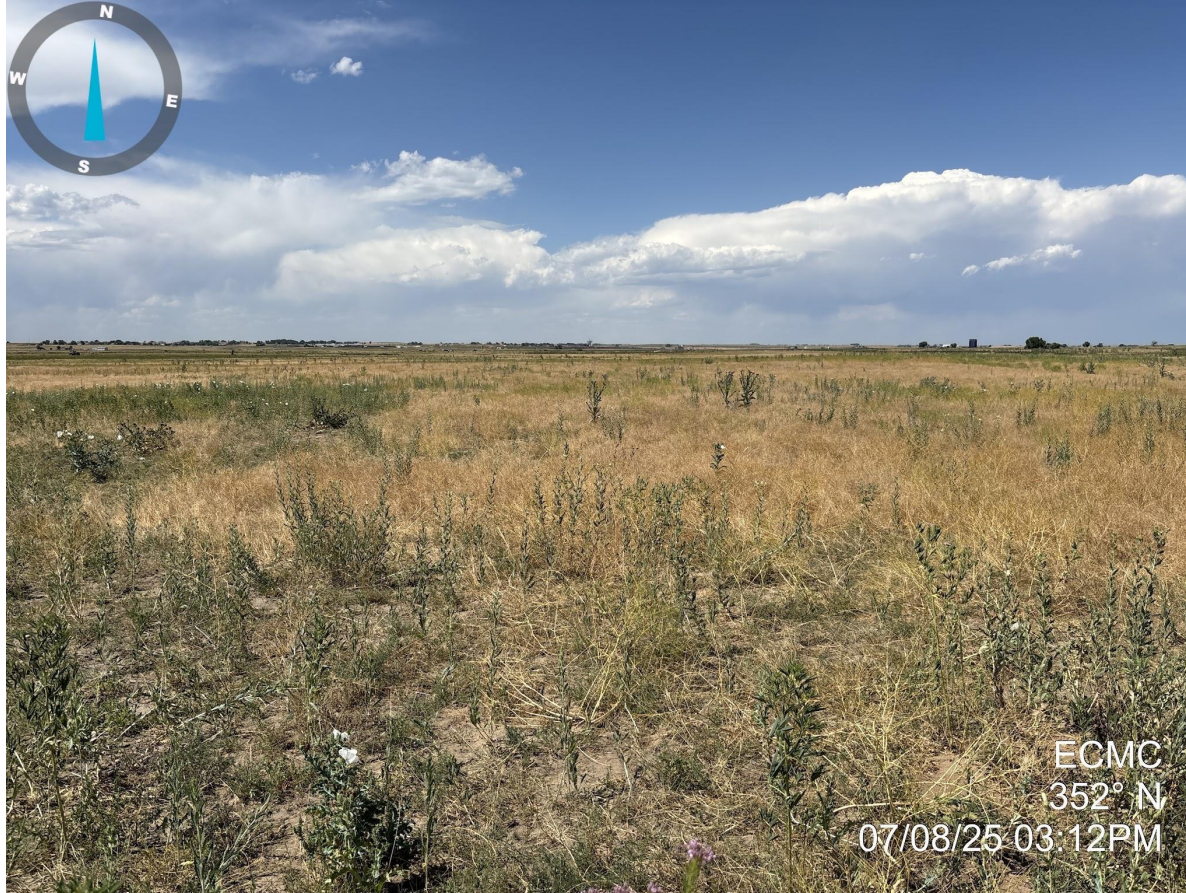
Photo 9. Photo taken of the reference area to the well location, southeast of the location, facing north. Photo illustrates the reference site is dominated by annual vegetation including Rocky Mountain beeplant (*Cleomella serrulate*) and cheatgrass (*Bromus tectorum*).
