Final Reclamation Inspection

Operator: NOBLE ENERGY INC - 100322

Location ID: 458825

Inspection Document #: 718800573

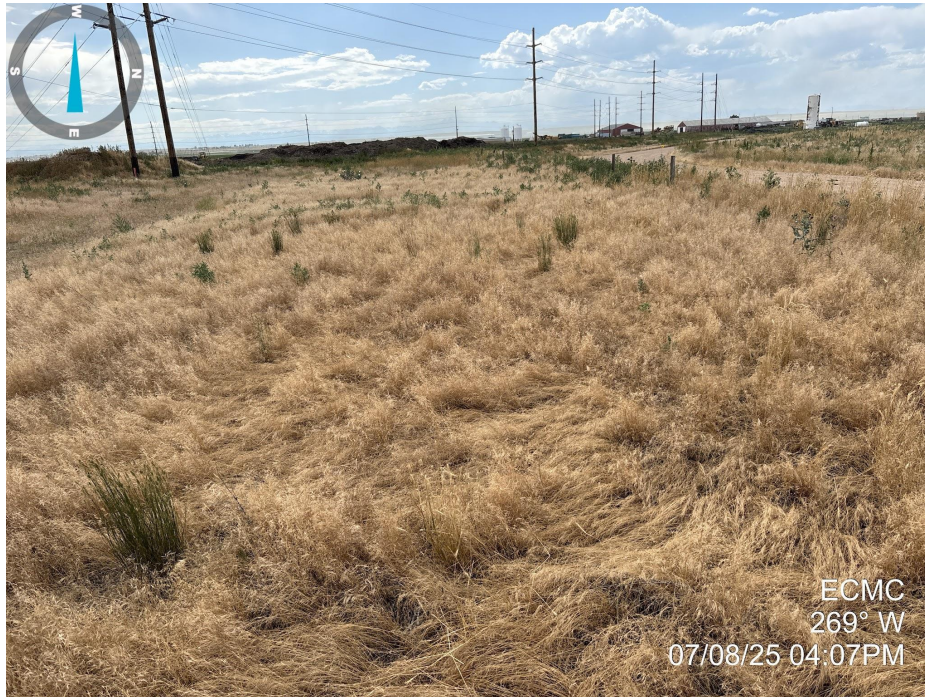
Photo 1. Photo taken of the tank battery location, facing west. Photo illustrates that the final reclamation activities appear to have taken place, but vegetation establishment does not meet Rule 1004 standards as the location is dominated by weedy annual vegetation.

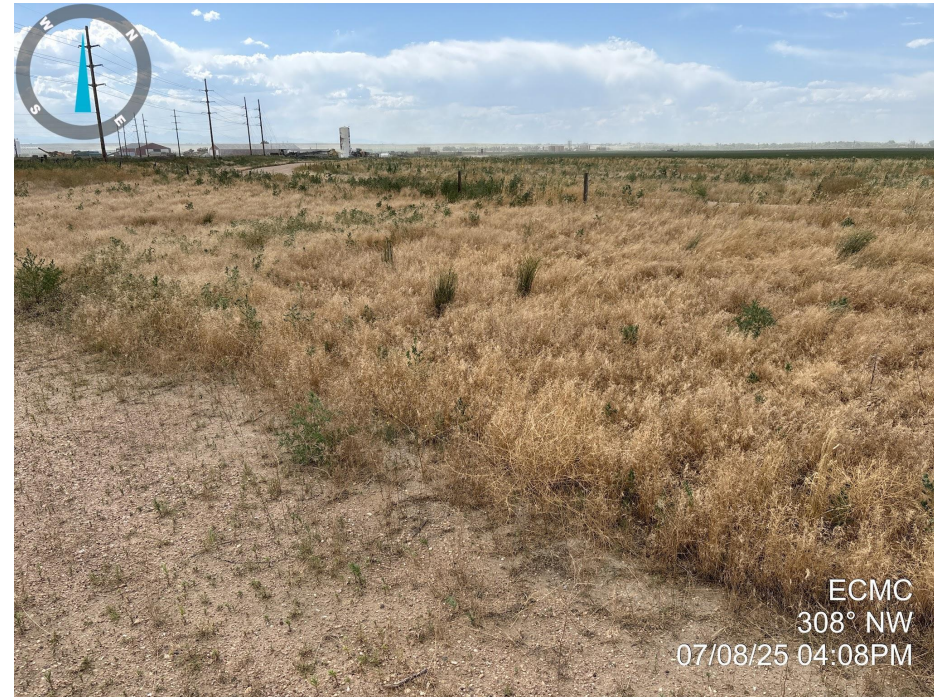
Photo 2. Photo taken of the tank battery location, facing northwest. See comments under Photo 1. Gravel and bare ground remain across the access road adjacent to the location (see Photo 4).

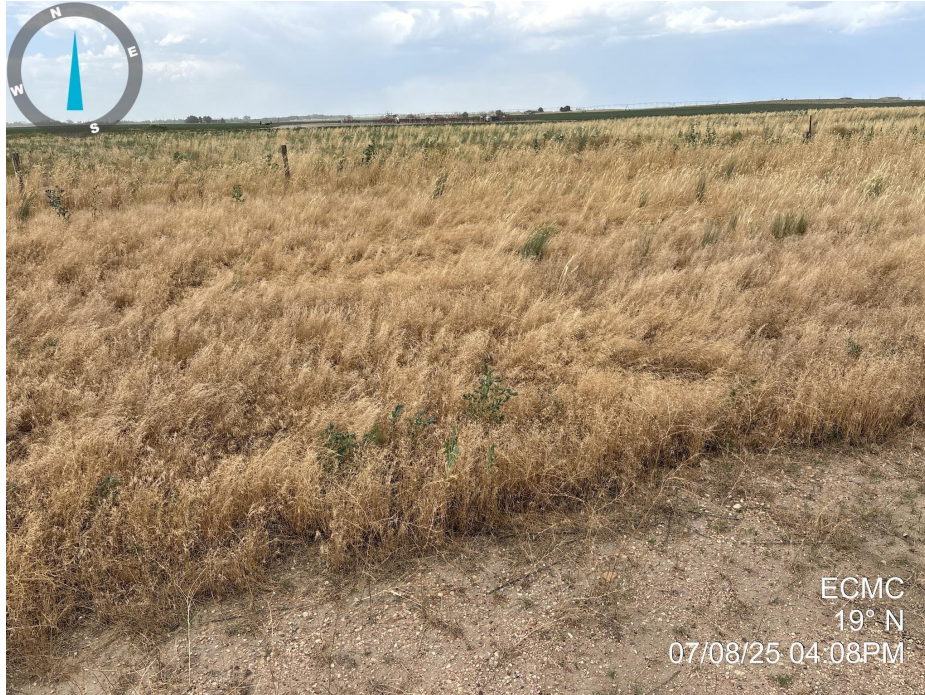
Photo 3. Photo taken of the tank battery location, facing north. See comments under Photo 1.

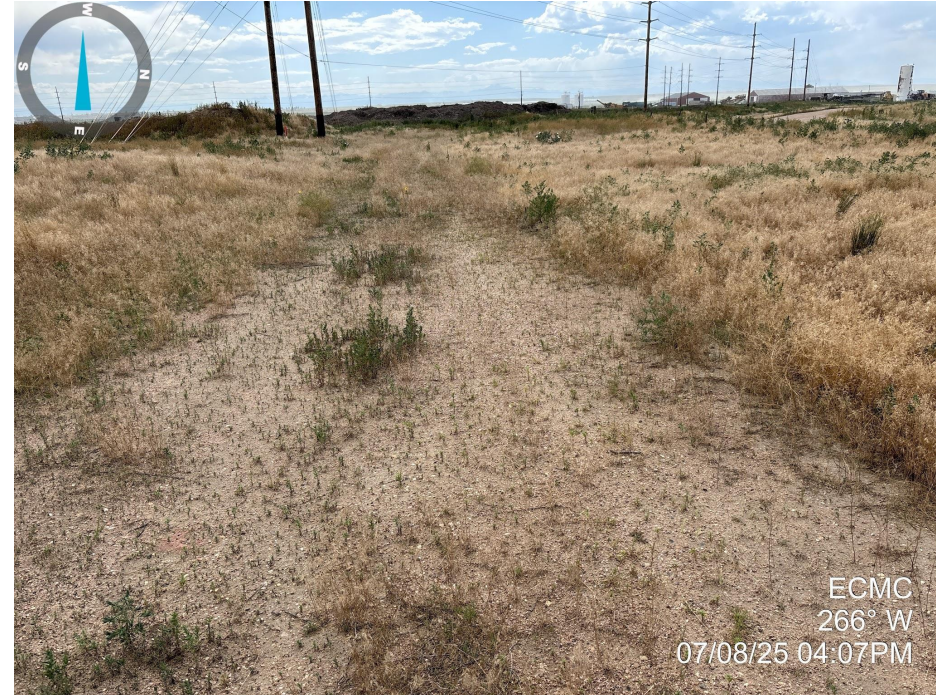
Photo 4. Photo taken of the access road to the tank battery location, facing west. Photo illustrates that final reclamation activities do not appear to have taken place along the access road as gravel and bare ground remain.

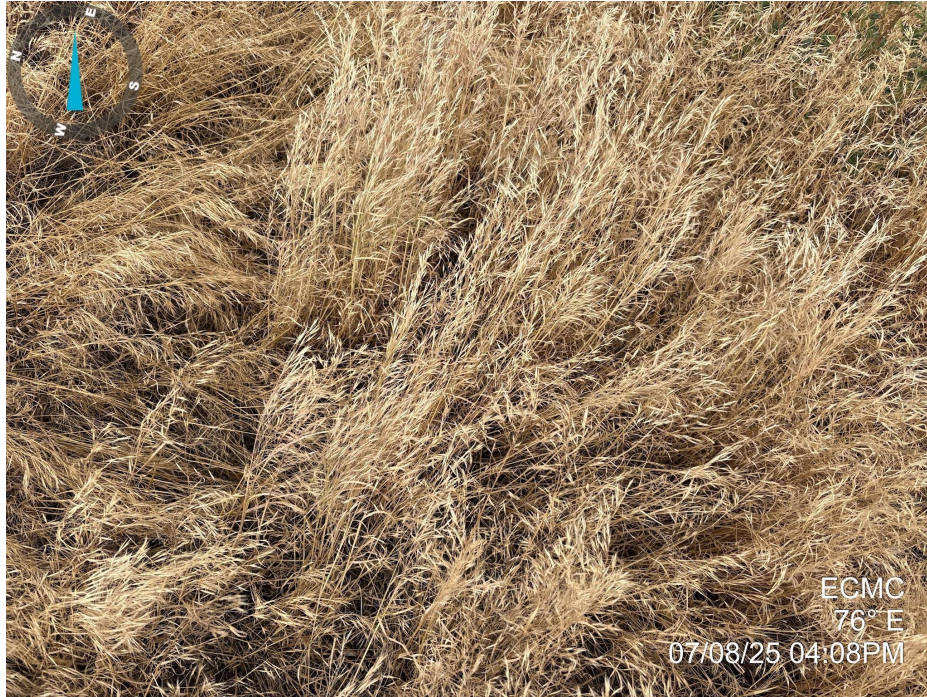
Photo 5. Photo taken of ground cover at the tank battery location. Photo illustrates cheatgrass (*Bromus tectorum*), a List C Noxious Weed species.

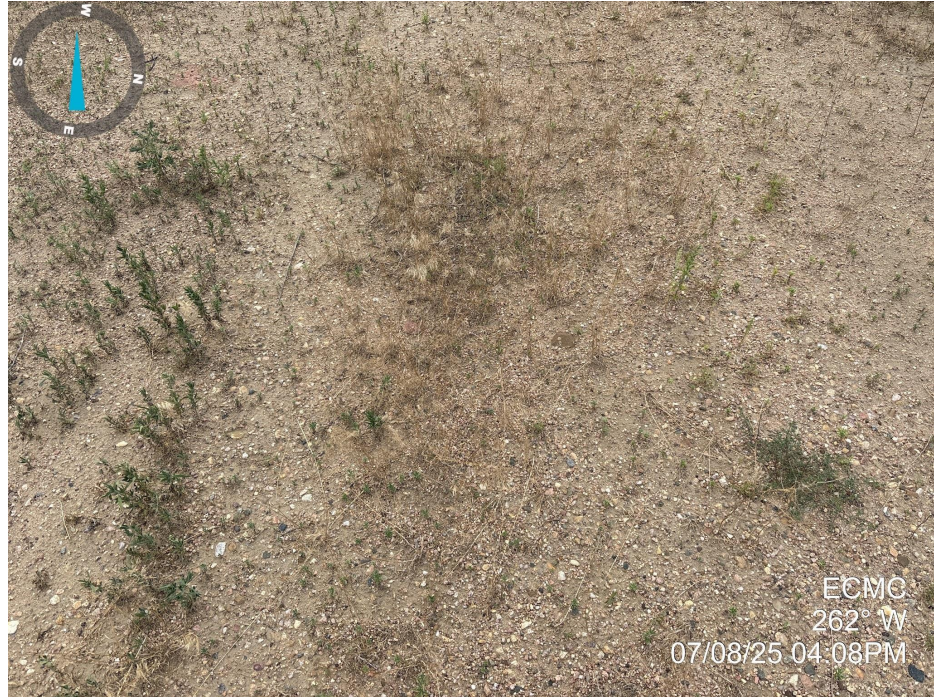
Photo 6. Photo taken of ground cover along the access road for the tank battery. Photo illustrates gravel and weedy annual vegetation.

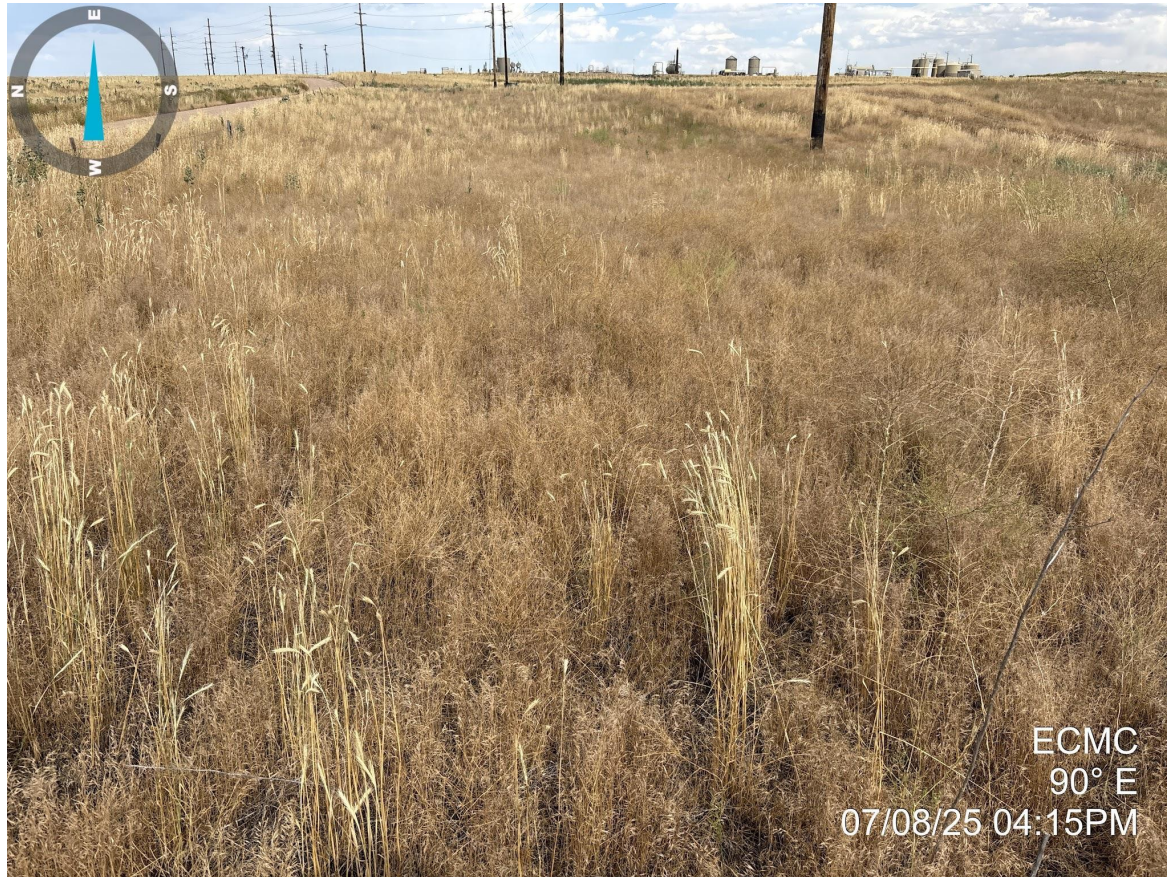
Photo 7. Photo taken of the reference area to the tank battery location, east of the location, facing east. Photo illustrates perennial grass and annual grass vegetation.
