# Inspection Photos

Operator: TEP Rocky Mountain LLC #96850

Location ID: 383325

Inspection Doc: 719200035

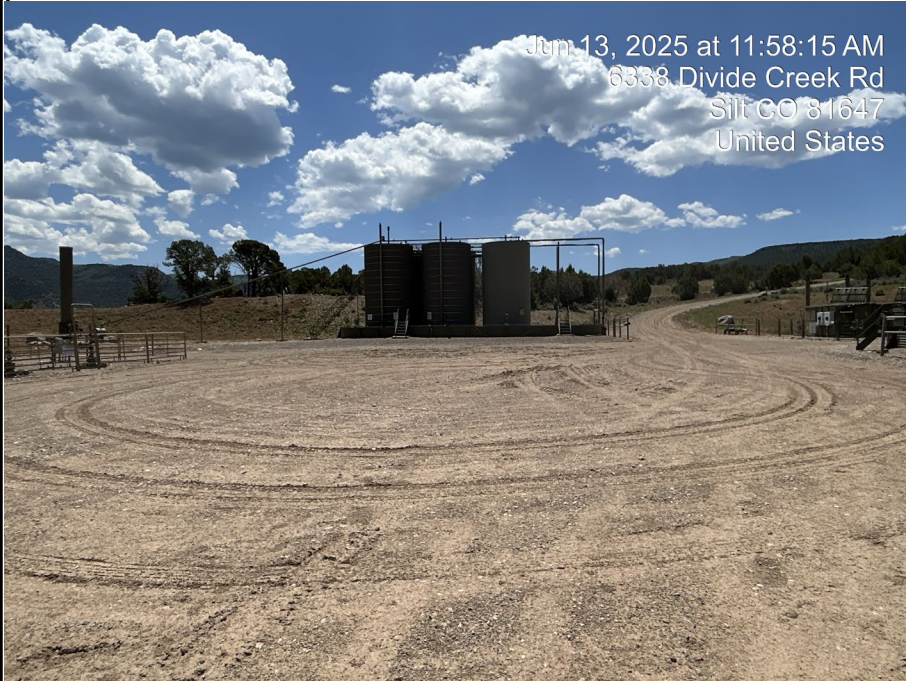
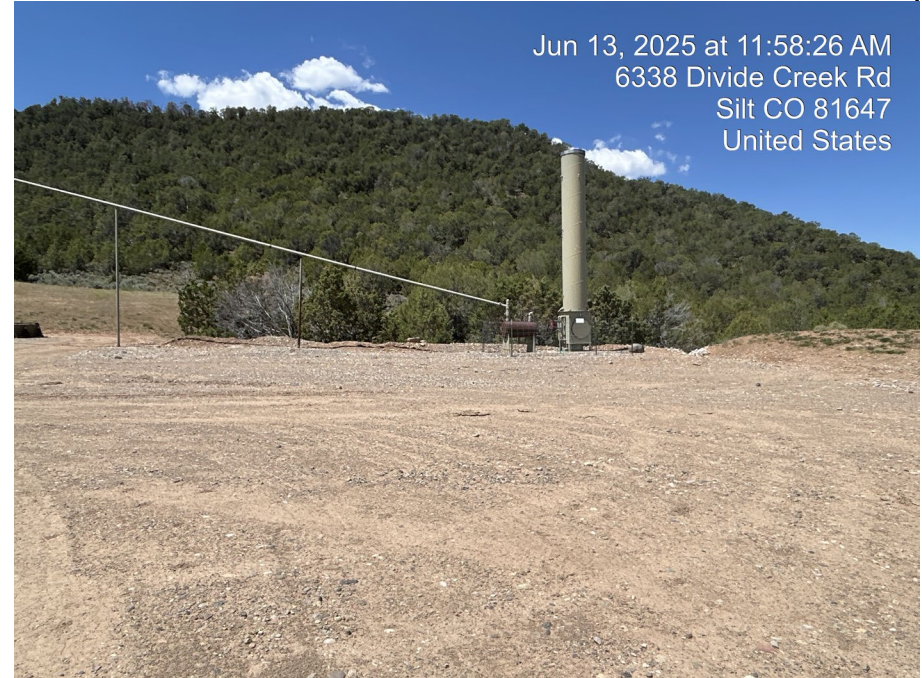
**Photo 1:** Photo taken from the east-central portion of the location and provides an overview looking south and west, respectively.

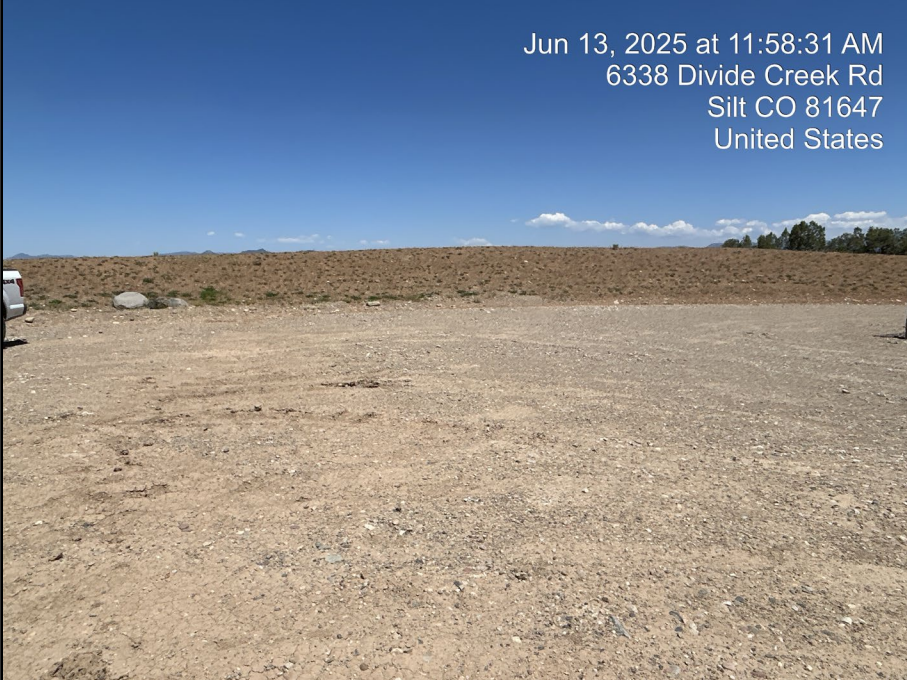
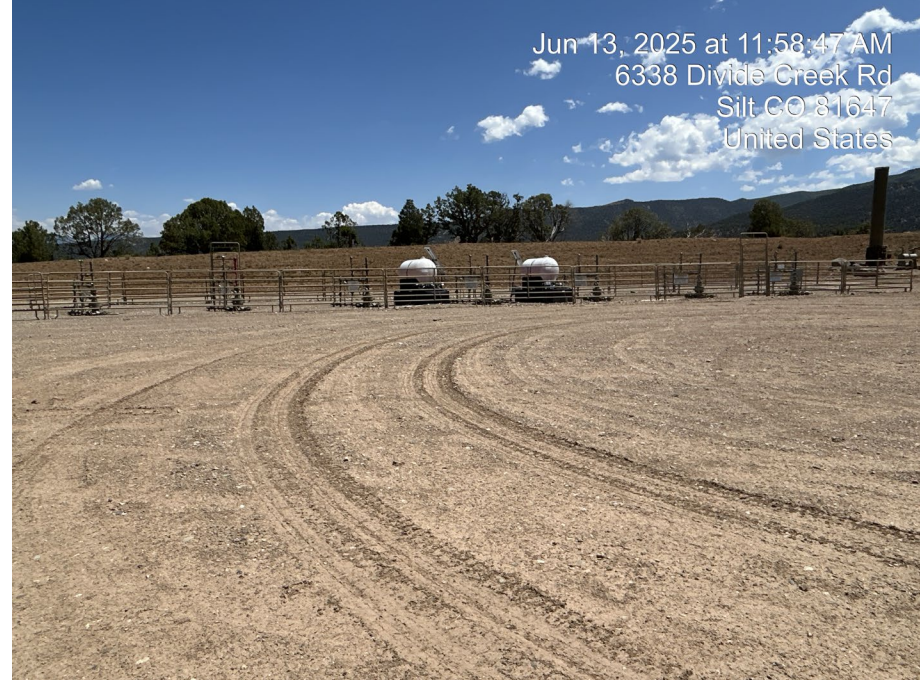
**Photo 2:** Photo taken from the central portion of the location and provides an overview looking north and east, respectively.

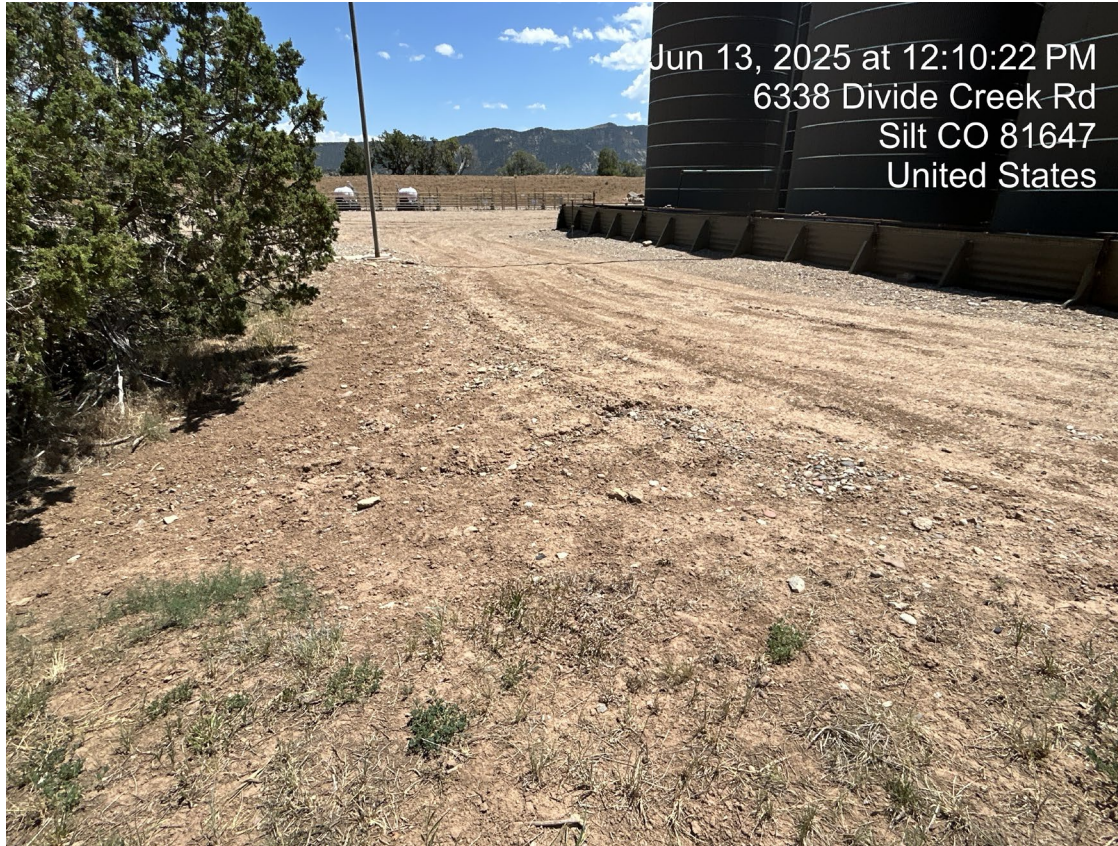
**Photo 3:** Photo taken at the northwestern perimeter of the pad showing light erosion and sediment transport off the location. Maintenance is advised.

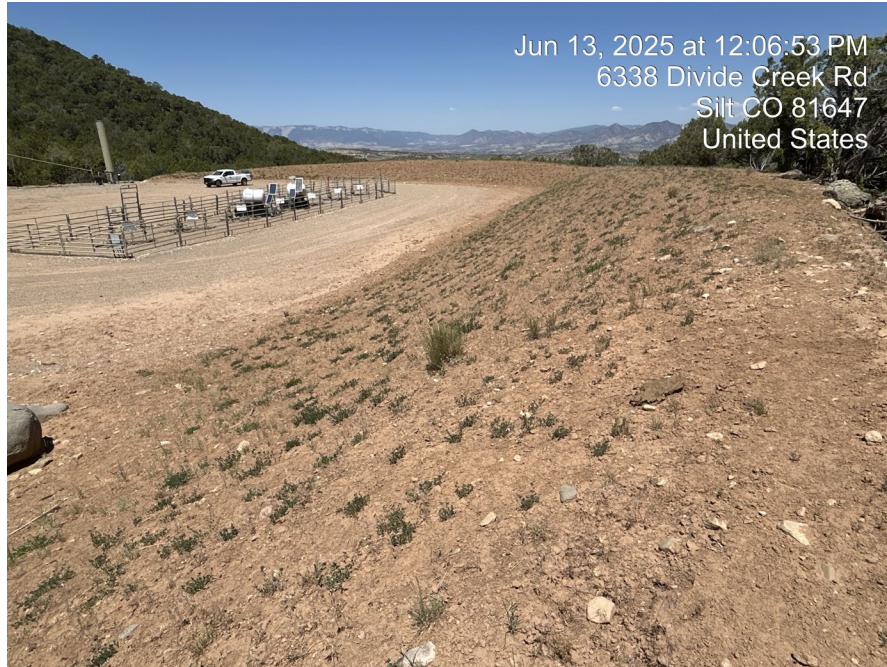
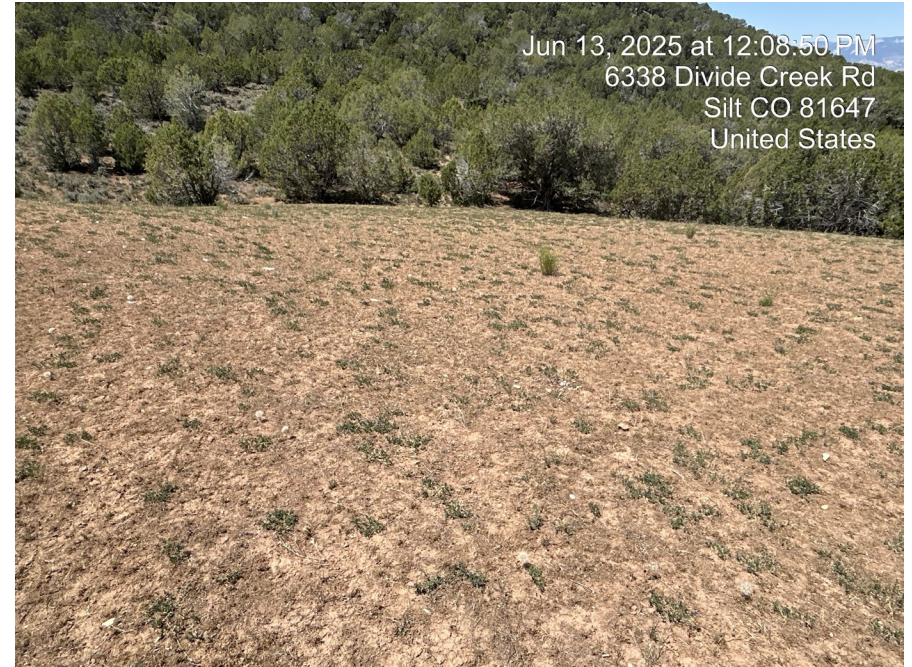
**Photo 4:** Photos taken from the eastern and northern portions of the interim area, respectively. The interim areas do not appear to be progressing towards 1003 requirements.

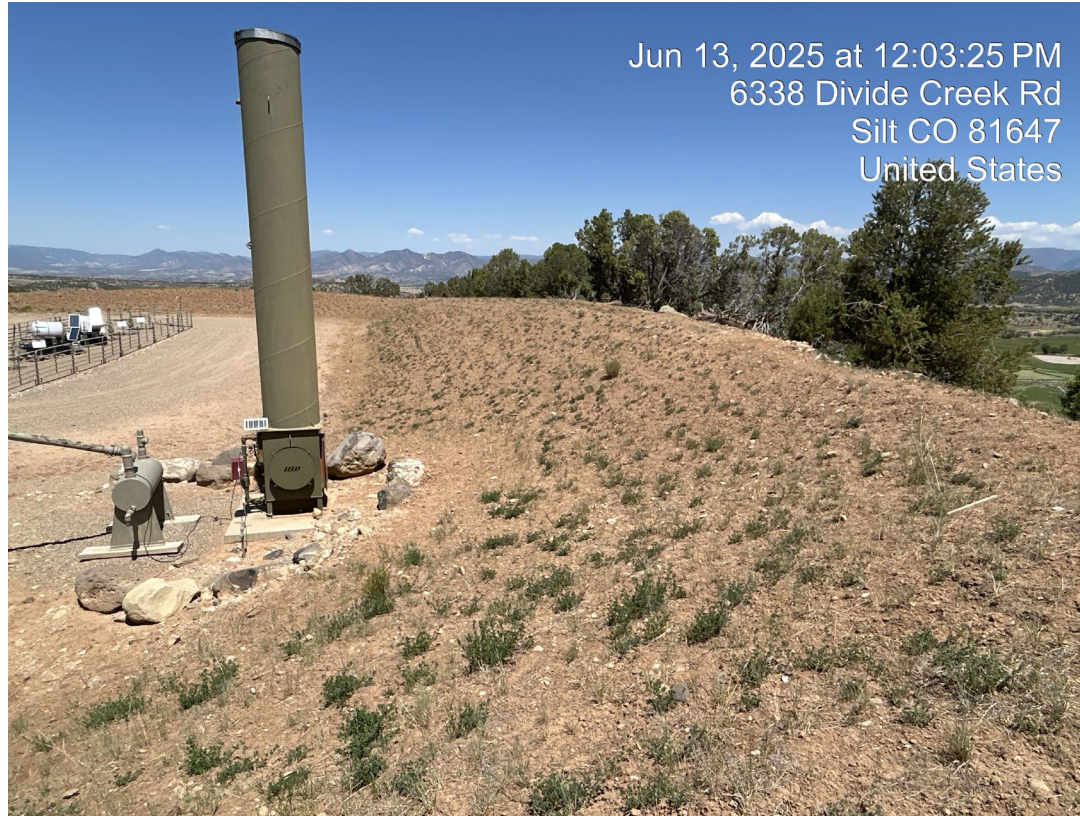
**Photo 5:** Photos taken from the southeastern portion of the interim area at the location looking north. The interim areas do not appear to be progressing towards 1003 requirements.

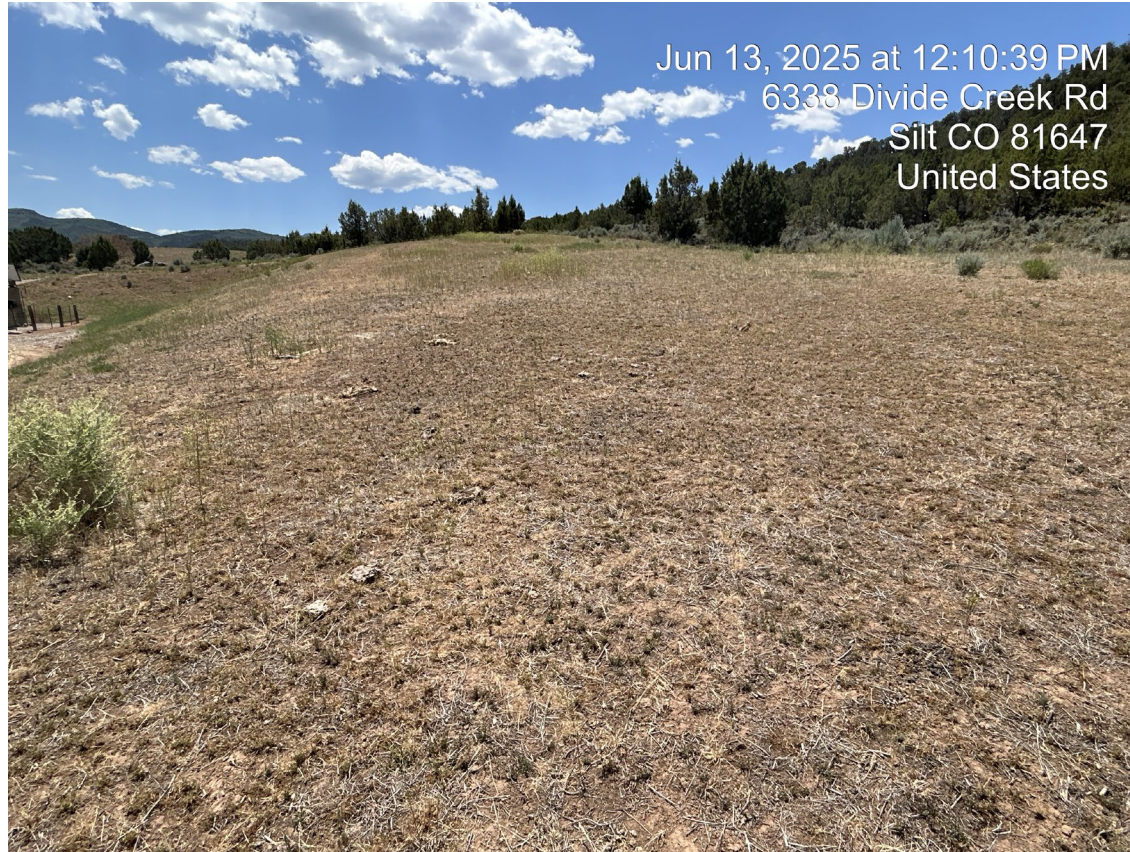
**Photo 6:** Photo taken provides an overview of the western interim location. The interim areas do not appear to be progressing towards 1003 requirements.

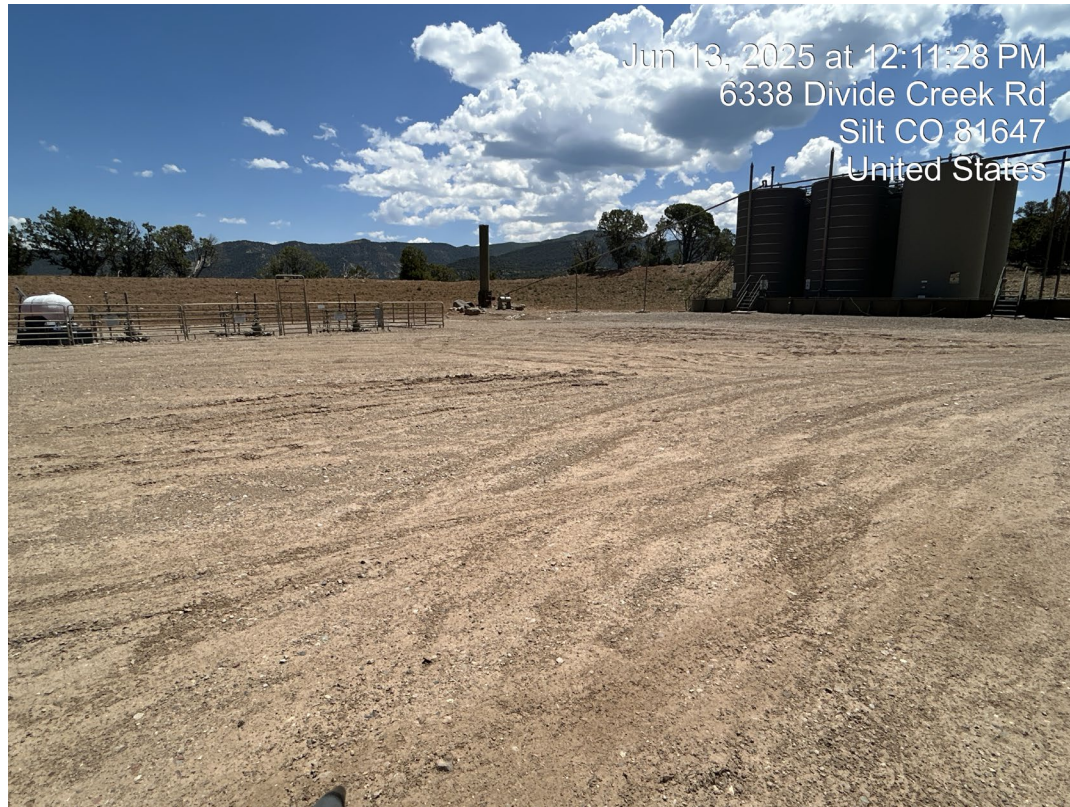
**Photo 7:** Photo shows light sediment tracking on the pad. Erosion and sediment tracking control BMP's are recommended. Maintenance is advised.
