Inspection Photos

Operator: TEP Rocky Mountain LLC #96850

Location ID: 423439

Inspection Doc: 719200036

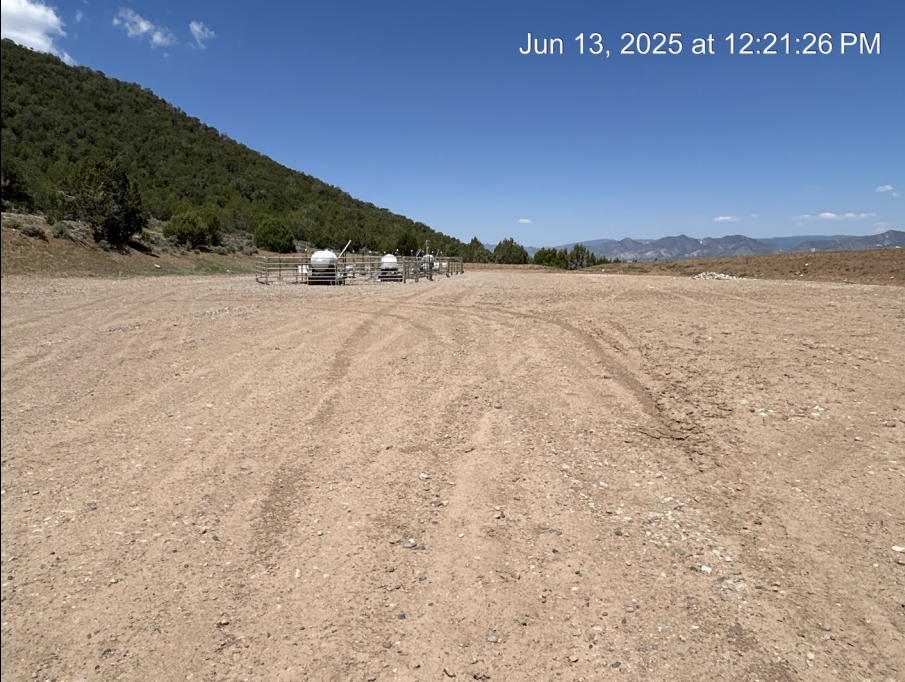
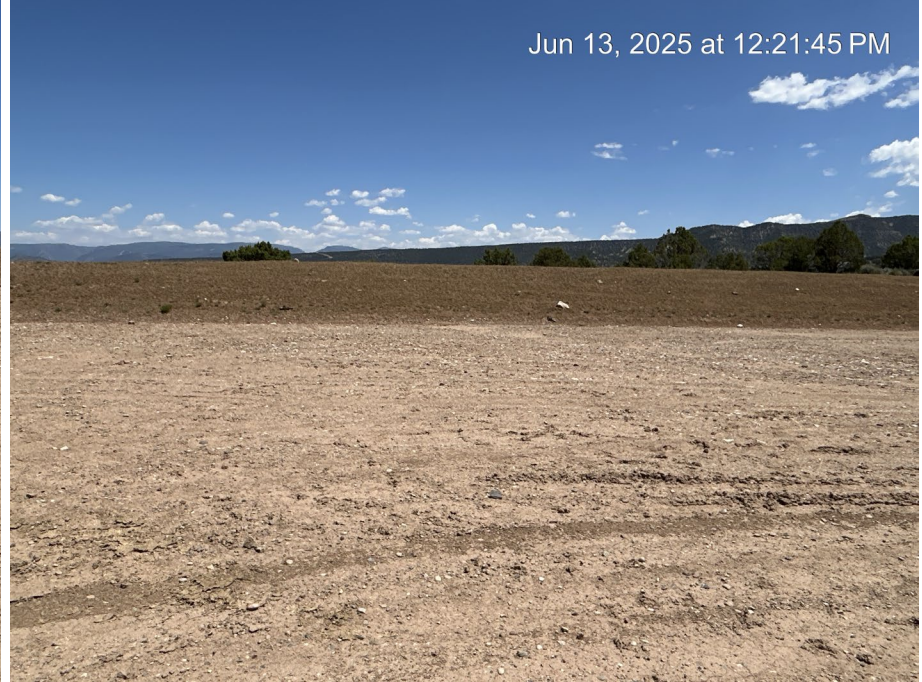
Photo 1: Photo taken from the southern portion of the pad and provide an overview looking northwest and northeast, respectively.

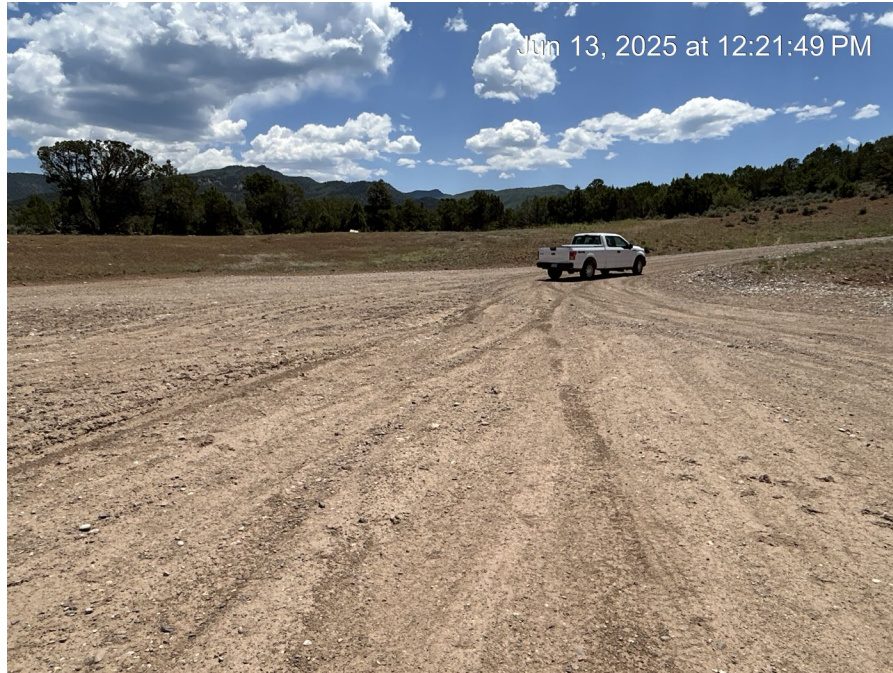
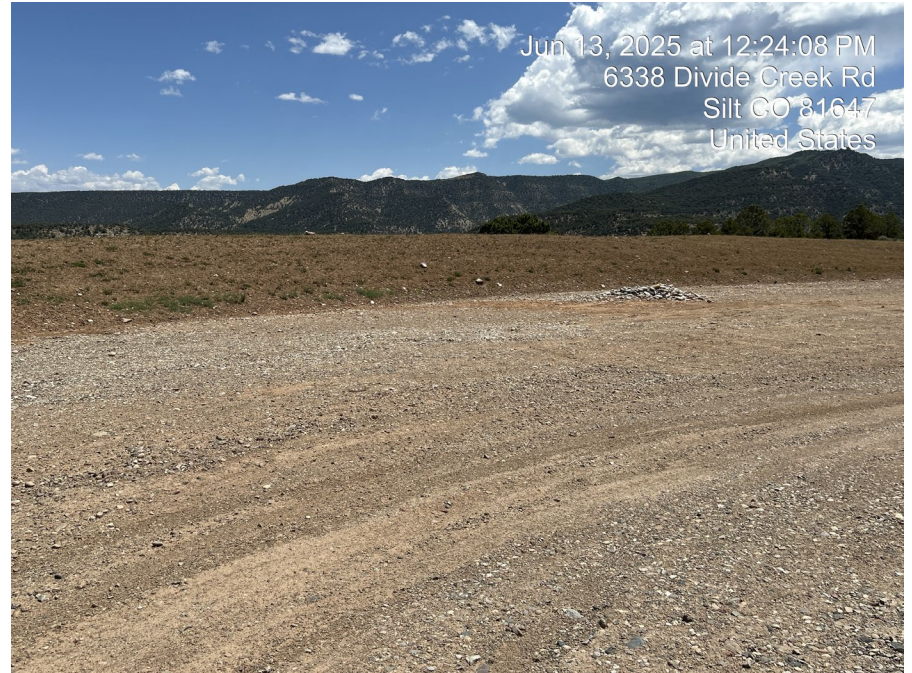
Photo 2: Photos taken from the southern portion of the pad and provide an overview looking southeast and east, respectively.

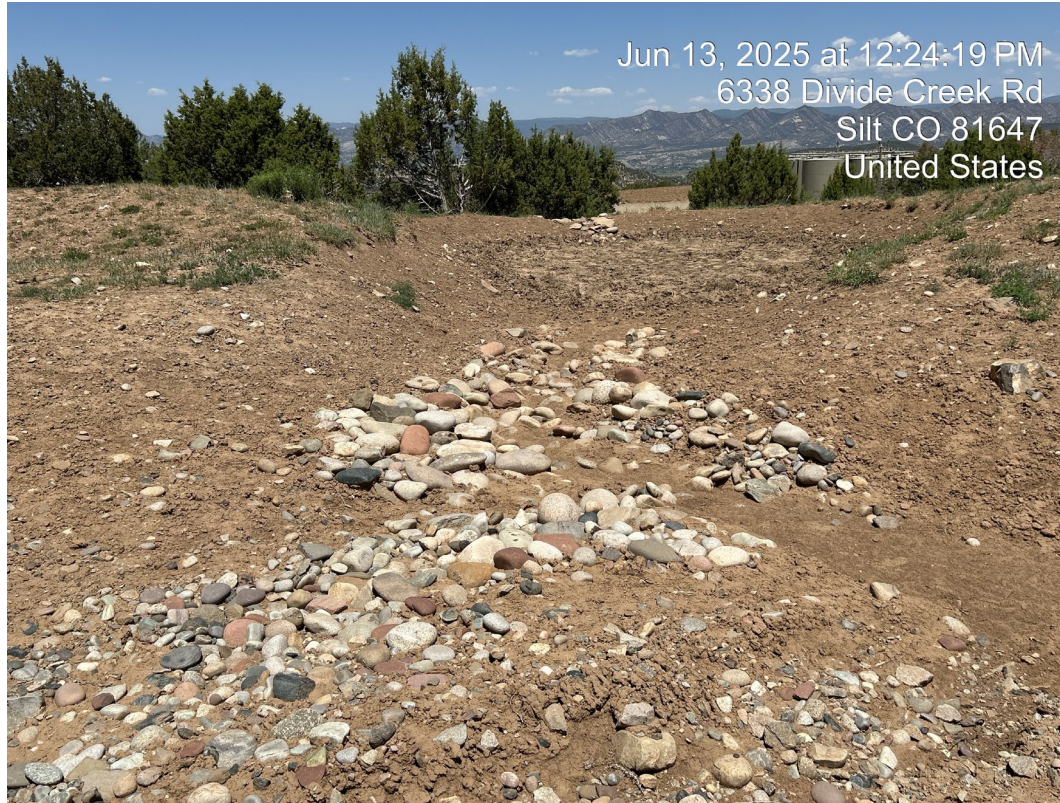
Photo 3: Photos taken from the northern portion of the pad. Stormwater outlets appear to be in disrepair. Maintenance is advised.

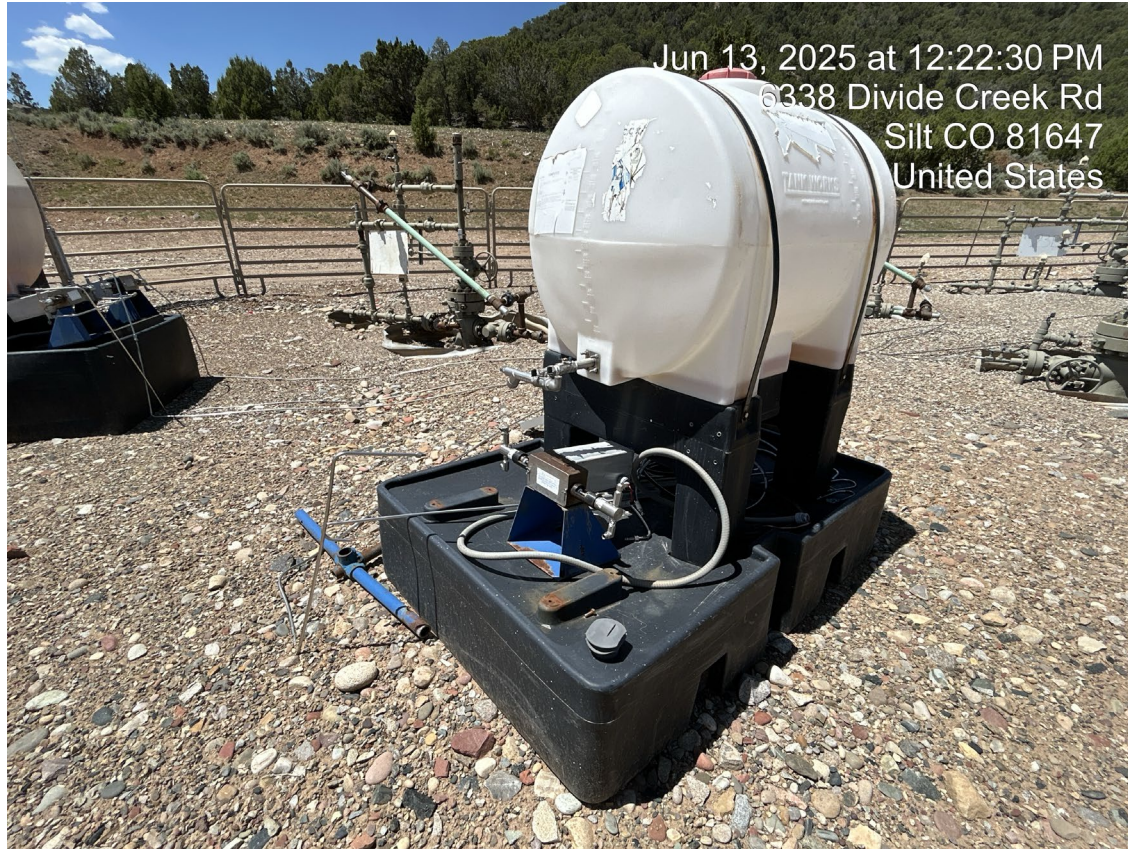
Photo 4: Photo taken shows a chemical tank that appears to be disconnected. Maintenance or removal is required.

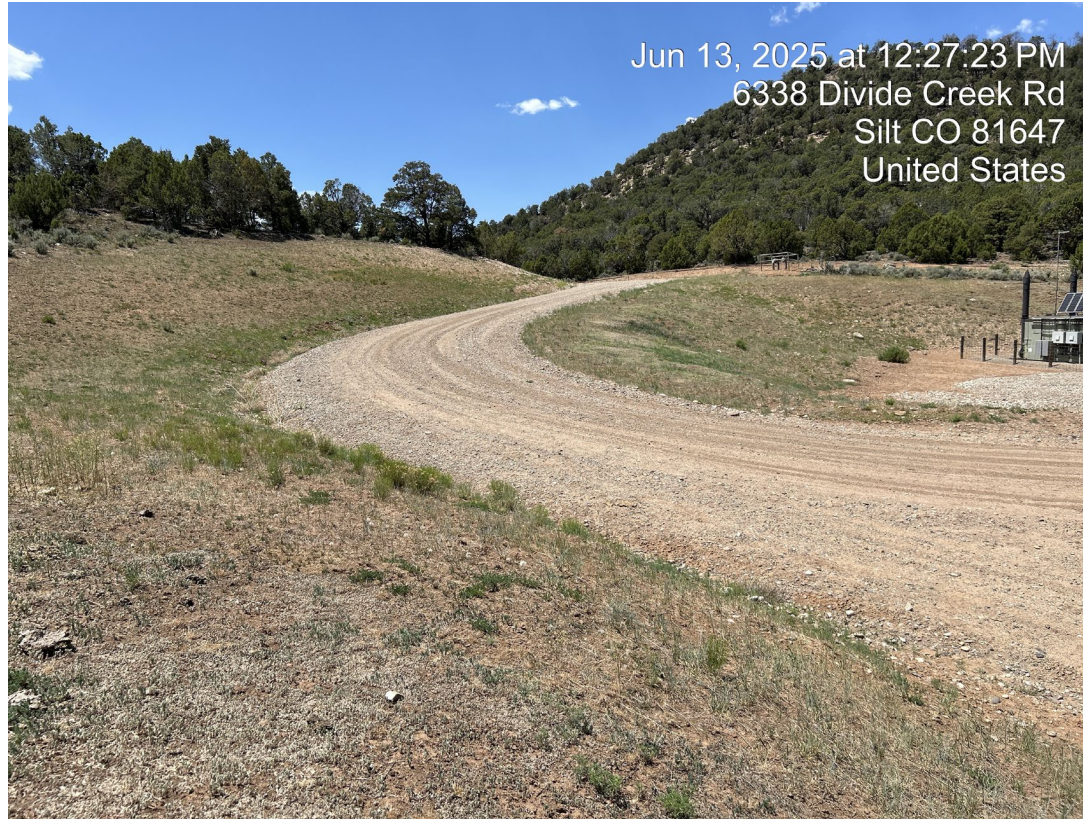
Photo 5: Photos taken from the southern portion of the pad and provide an overview looking at the southern interim area. Native grasses such as western wheatgrass and intermediate wheatgrass have established; this portion of the interim area appears to be progressing towards 1003 standards.

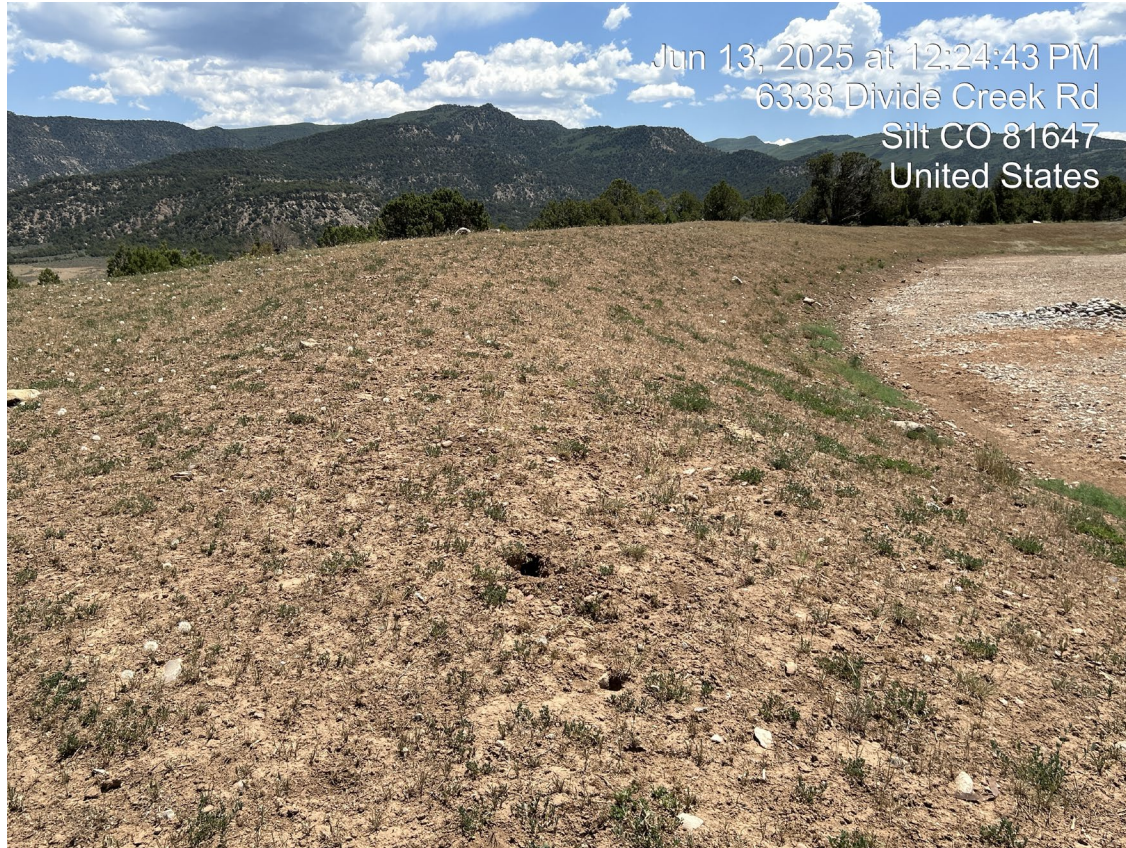
Photo 6: Photos taken from the southern portion of the pad and provide an overview looking at the southern interim area. Reclamation in this area is not progressing towards 1003 requirements.

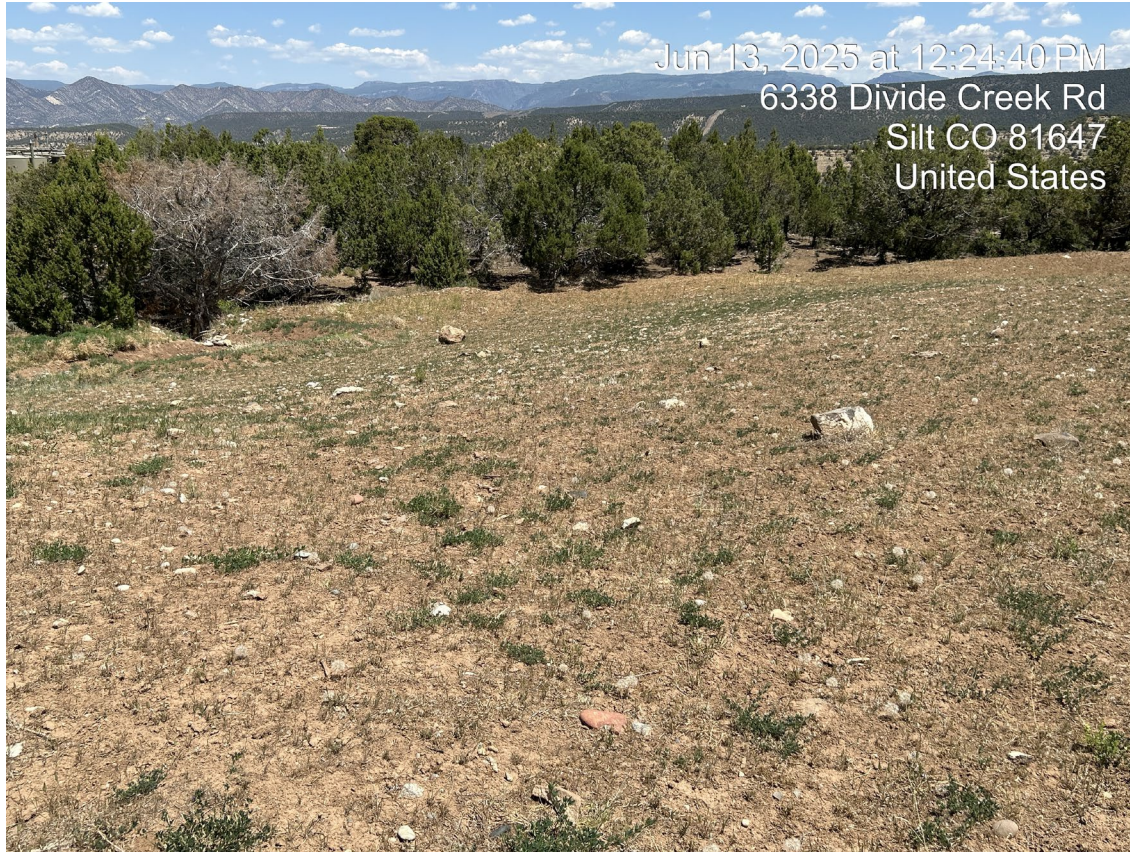
Photo 7: Photos taken from the southern portion of the pad and provide an overview looking at the northern interim area. This portion of the interim location is not progressing towards 1003 reclamation standards.
