Final Reclamation Inspection

Operator: KERR MCGEE OIL & GAS ONSHORE LP - 47120

Location ID: 328204

Inspection Photos
Location Name: DUNCAN D #20-1
Location ID: 328204

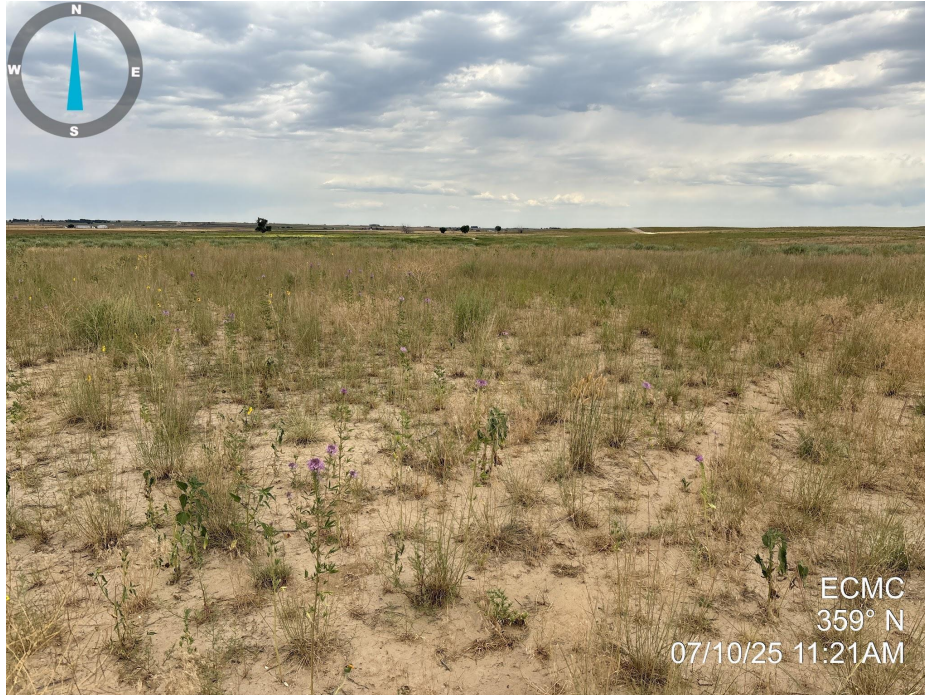
Photo 1. Photo taken from the well location, facing North. Photo illustrates that final reclamation activities appear to have taken place, but vegetation has not established to Rule 1004 standards. Bare ground and weedy annual vegetation were observed across the location.

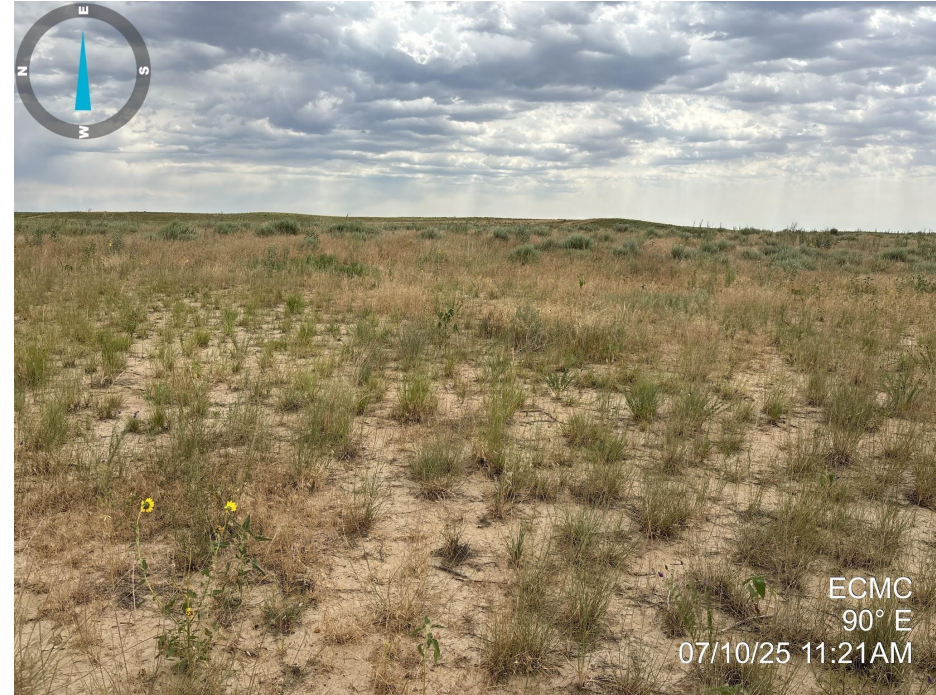
Photo 2. Photo taken from the well location, facing East. See comments under Photo 1.

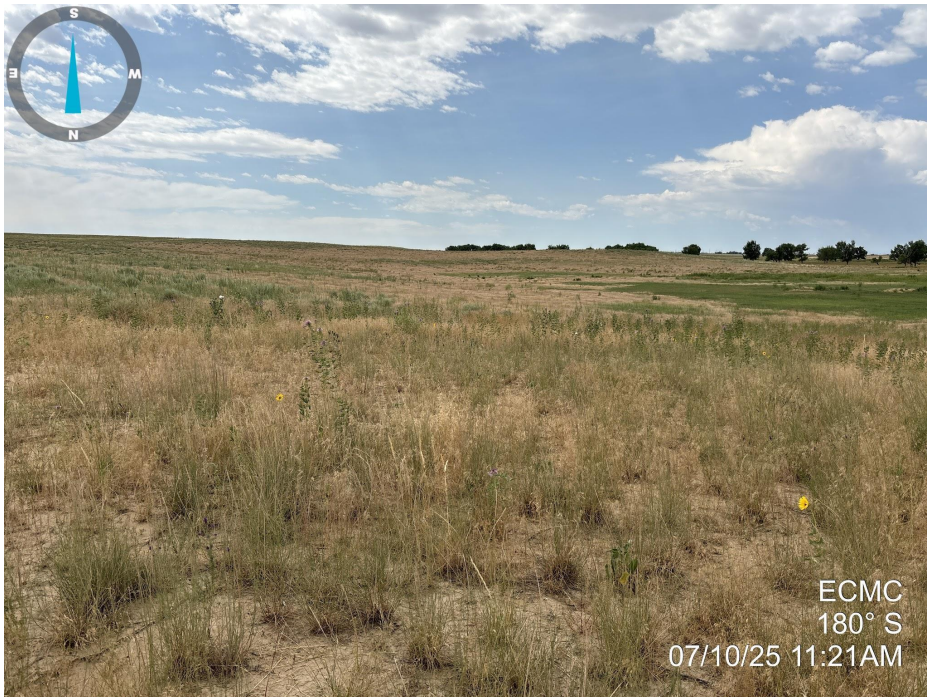
Photo 3. Photo taken from the well location, facing South. See comments under Photo 1.

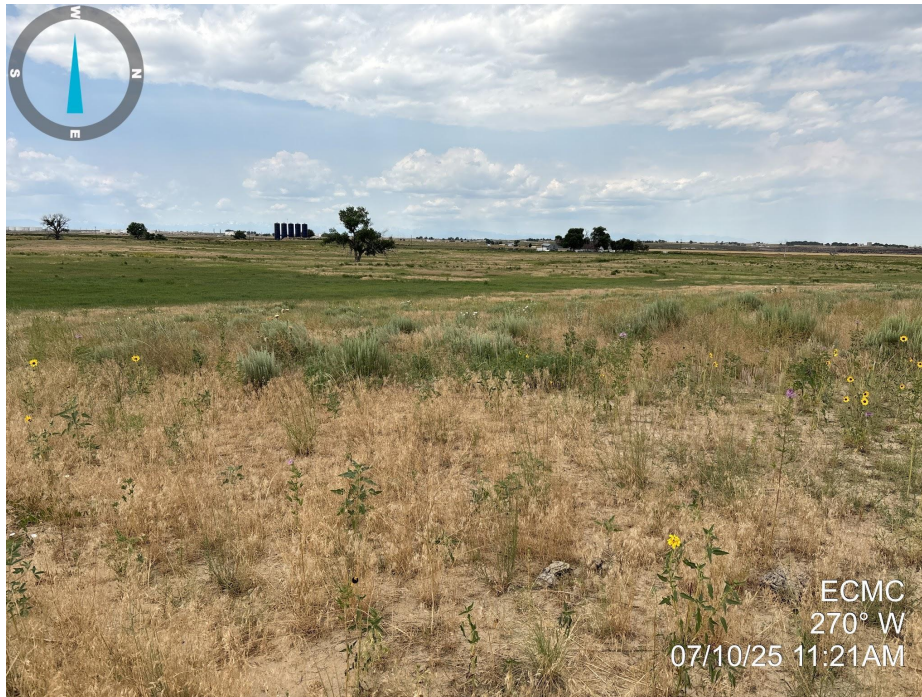
Photo 4. Photo taken from the well location, facing West. See comments under Photo 1.

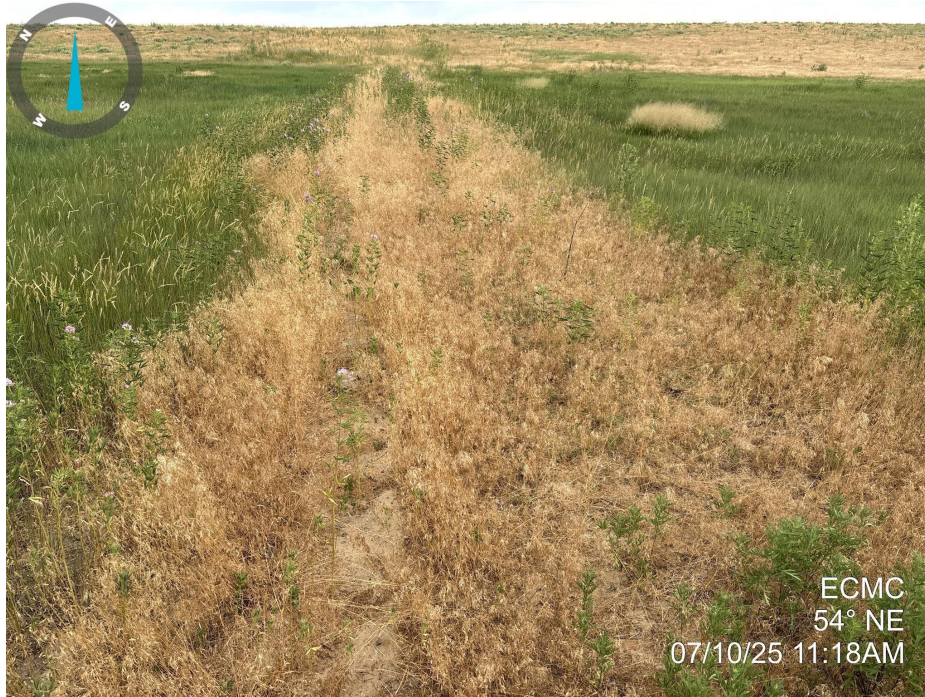
Photo 5. Photo taken of the access road to the well location, facing northeast. Photo illustrates that final reclamation activities appear to have taken place, but vegetation has not established to Rule 1004 standards and the access road is dominated by weedy annual vegetation including cheatgrass (*Bromus tectorum*).

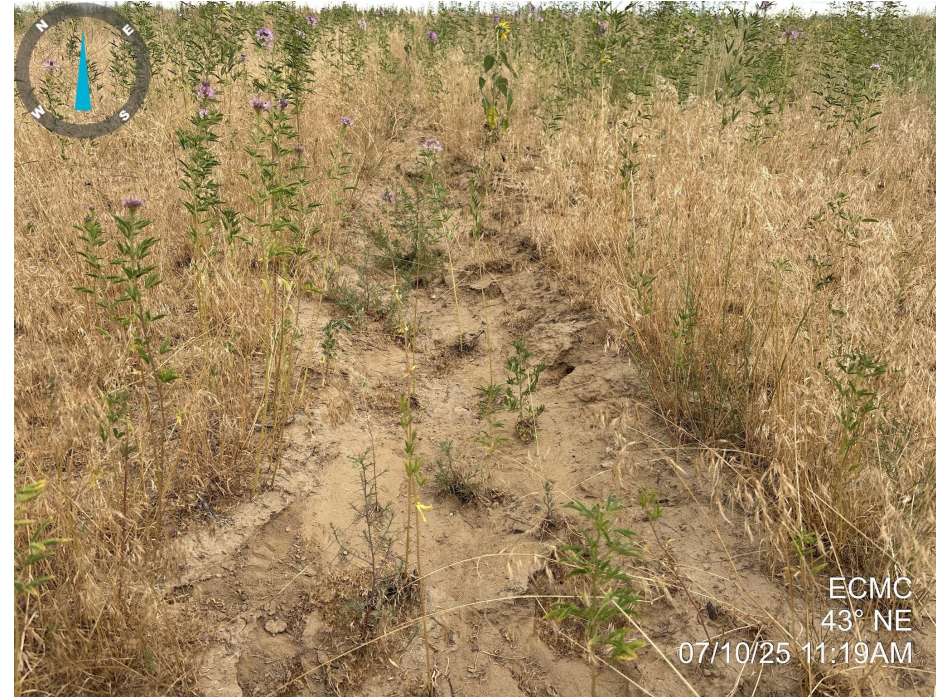
Photo 6. Photo taken of the access road to the well location, facing northeast. Photo illustrates stormwater erosion along portions of the access road.

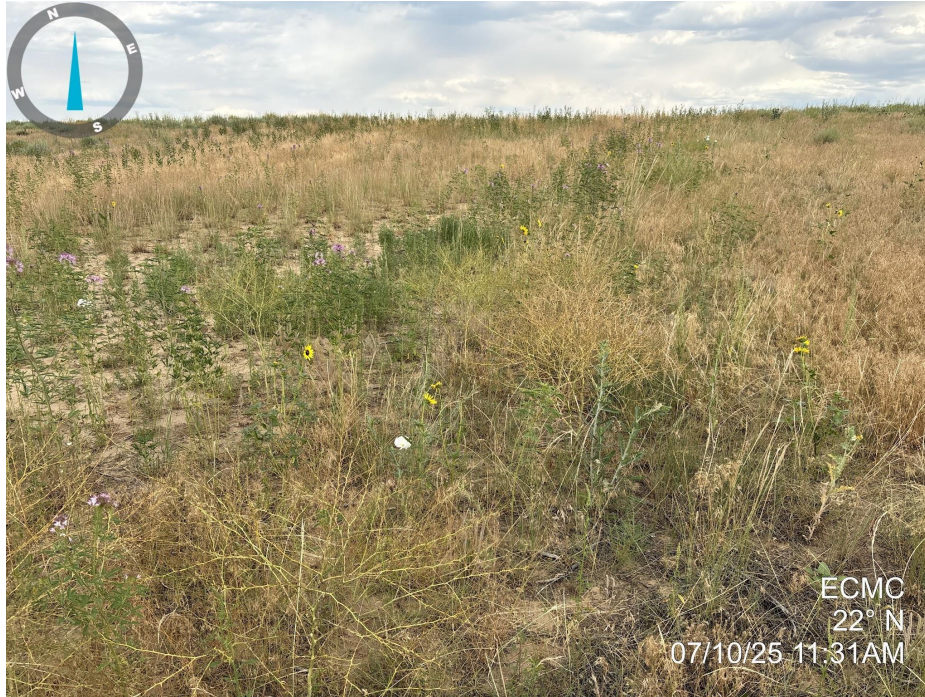
Photo 7. Photo taken of the tank battery location, facing north. Photo illustrates that final reclamation activities have taken place, but vegetation establishment does not meet Rule 1004 standards. Weedy annual vegetation was observed across the location, including cheatgrass (*Bromus tectorum*), a List C Noxious Weed species.

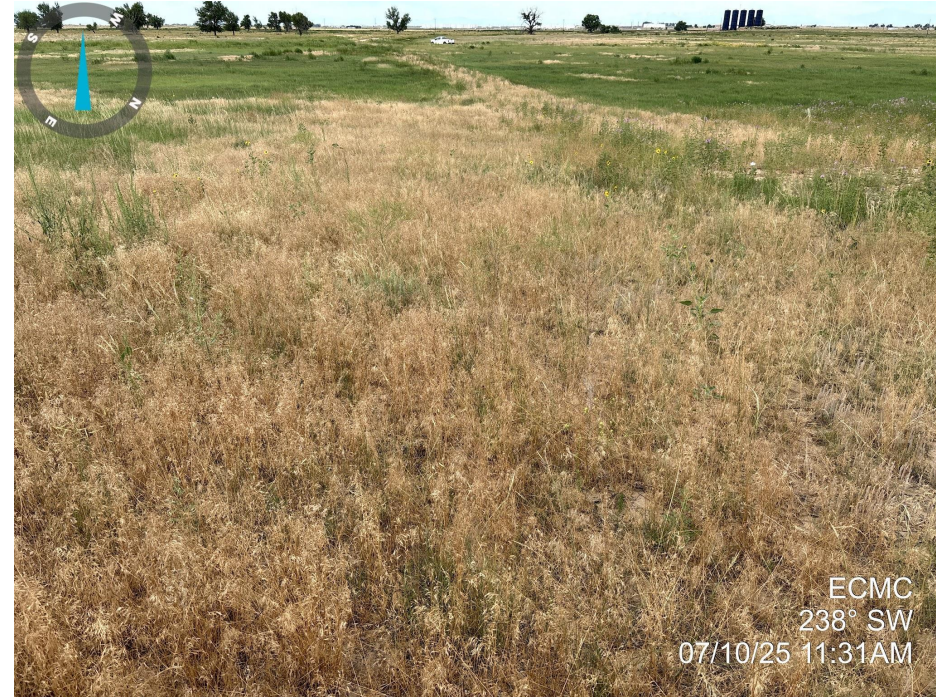
Photo 8. Photo taken of the tank battery location, facing southwest. See comments under Photo 7.

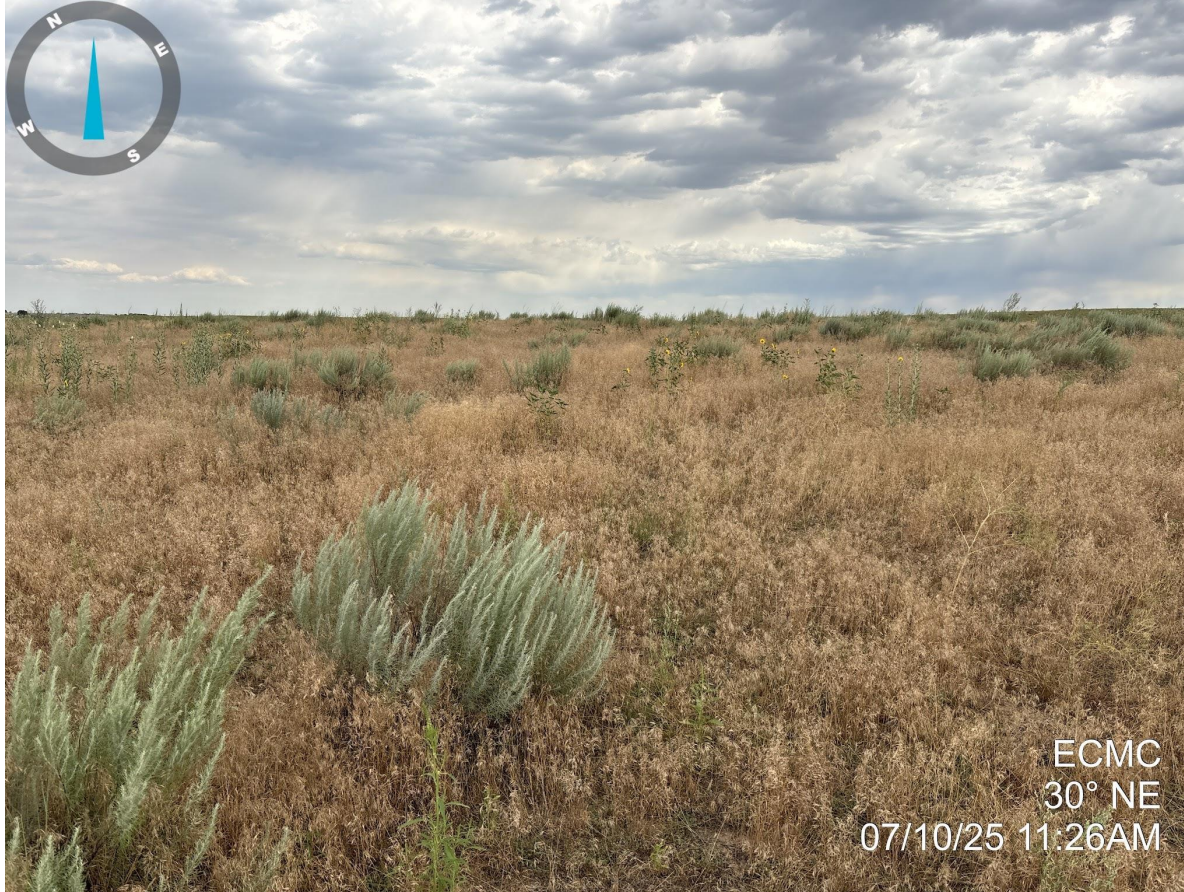
Photo 9. Photo taken of the reference area to the well location, south of the location, facing northeast. Photo illustrates sand sagebrush (*Artemisia filifolia*) and cheatgrass (*Bromus tectorum*).
