Final Reclamation Inspection

Operator: NOBLE ENERGY INC - 100322

Location ID: 328219

Inspection Photos
Location Name: DUNCAN D #20-7
Location ID: 328219

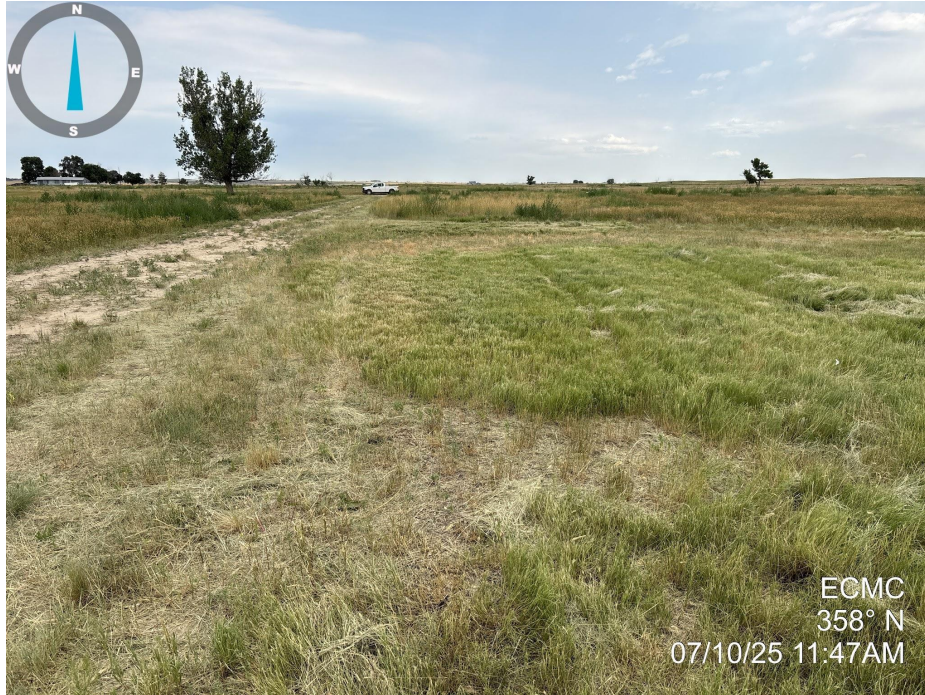
Photo 1. Photo taken from the well location, facing North. Photo illustrates that final reclamation activities appear to have taken place, but vegetation has not established to Rule 1004 standards. The site has been recently mowed.

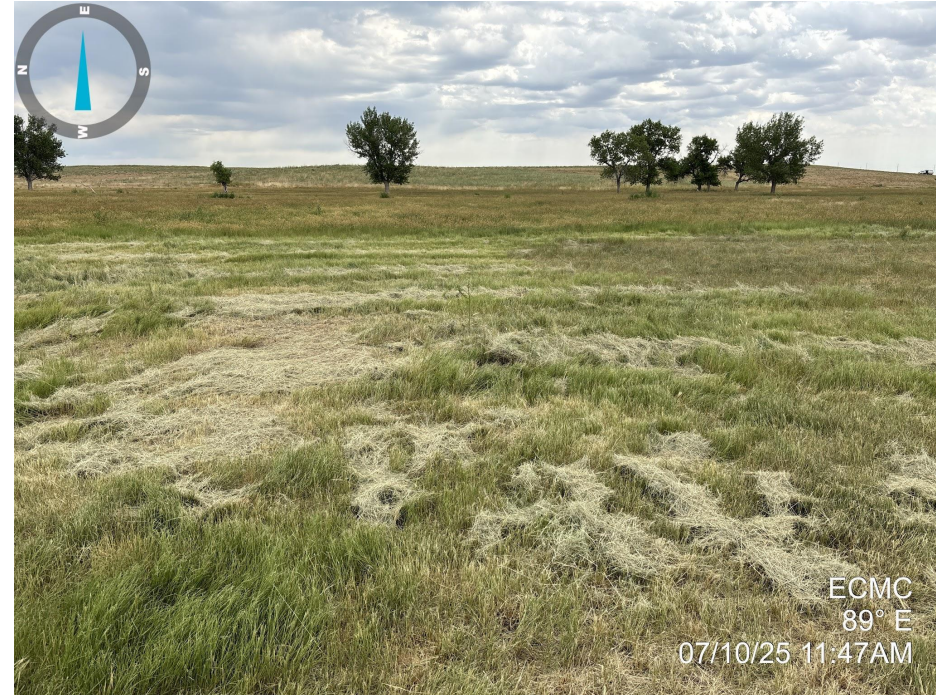
Photo 2. Photo taken from the well location, facing East. See comments under Photo 1.

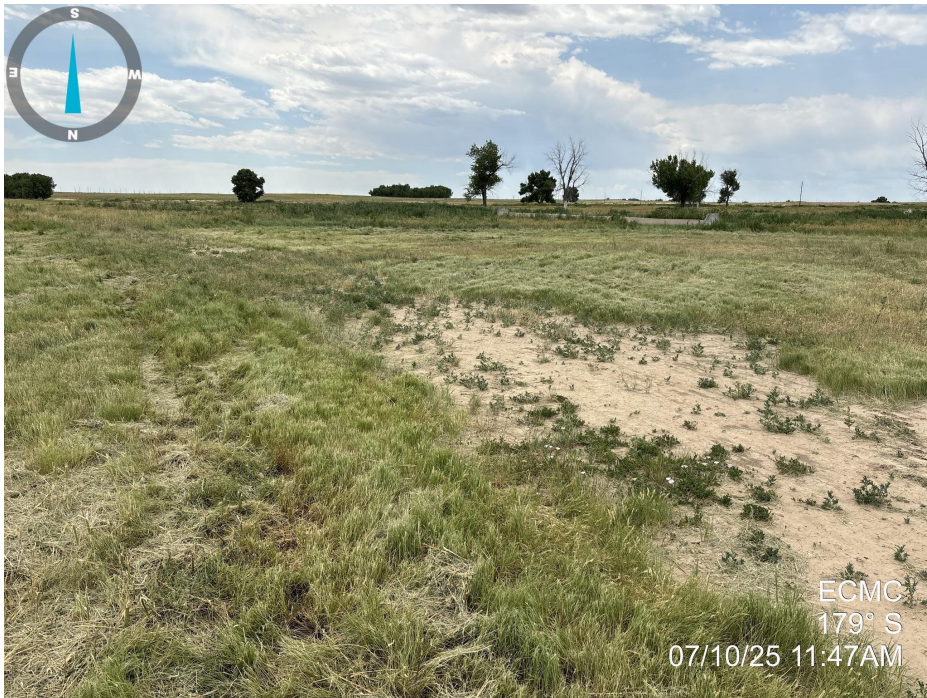
Photo 3. Photo taken from the well location, facing South. See comments under Photo 1.

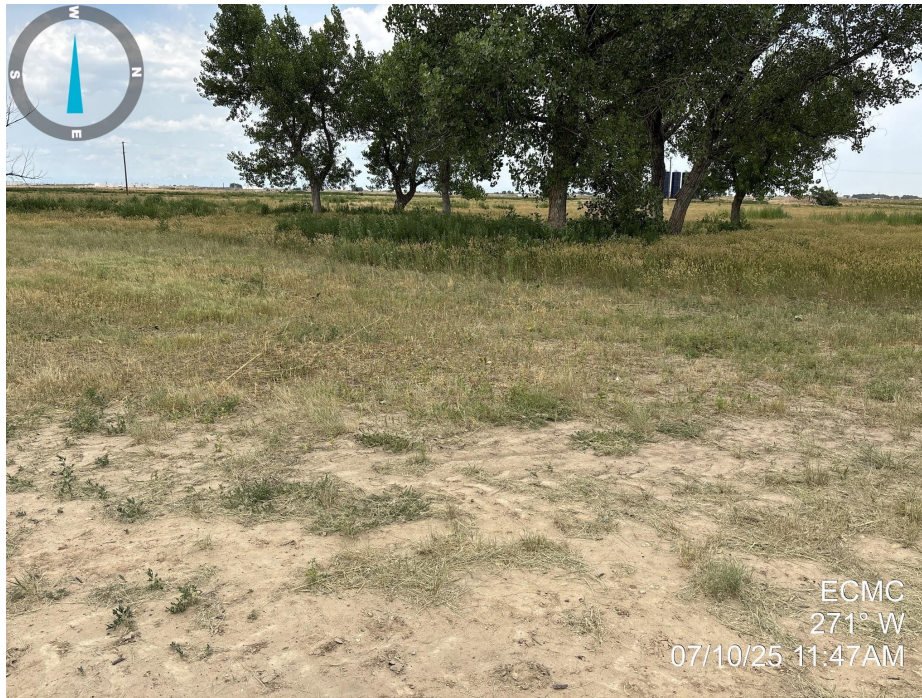
Photo 4. Photo taken from the well location, facing West. See comments under Photo 1.

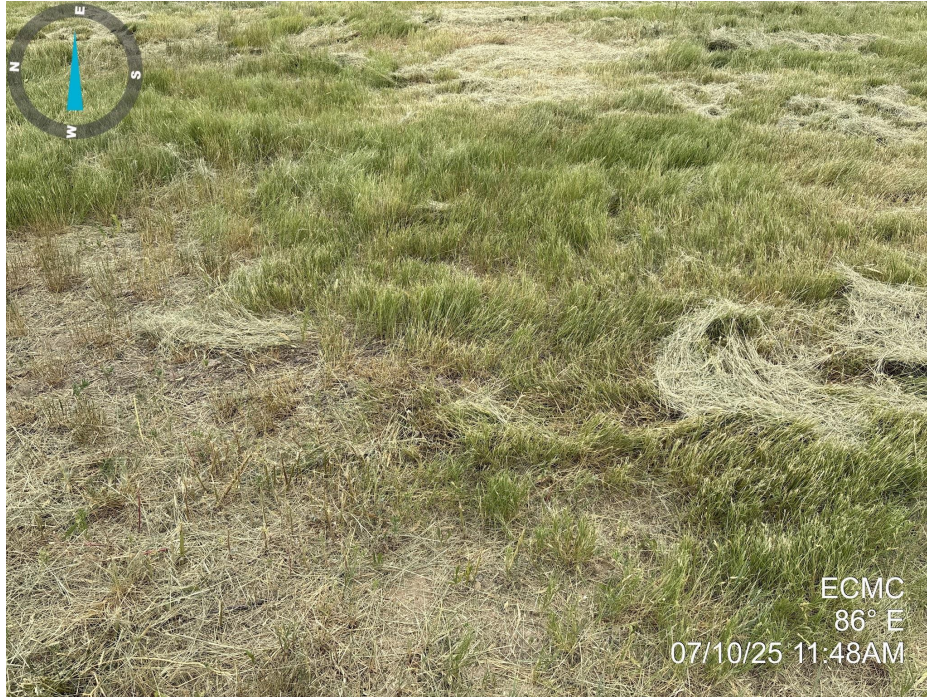
Photo 5. Photo taken of ground cover at the well location. Photo illustrates that the site was recently mowed.

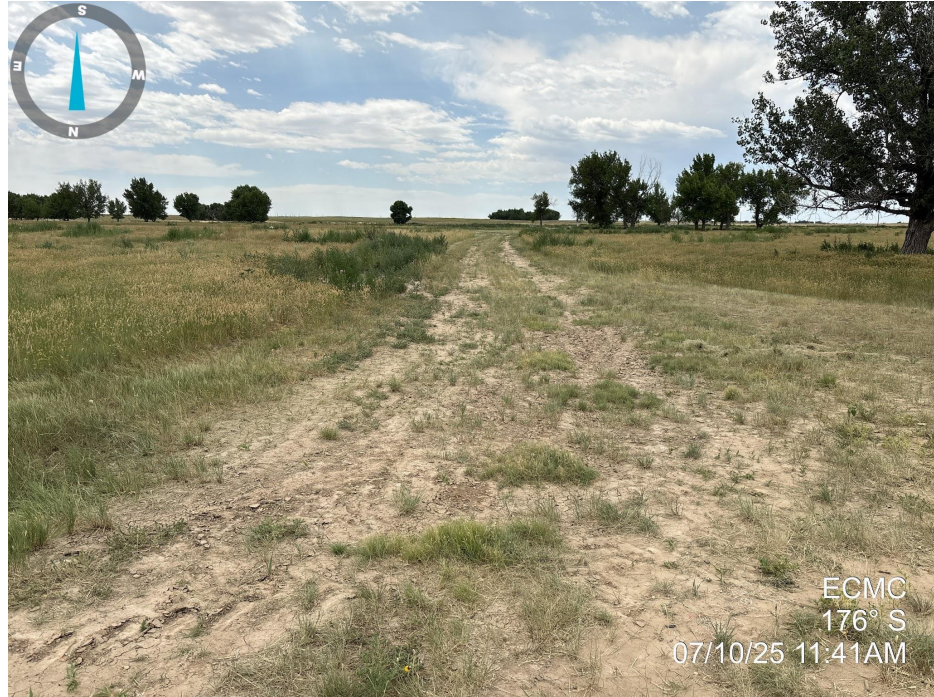
Photo 6. Photo taken of the access road to the well location, facing south. Photo illustrates that bare ground remains across the access road.

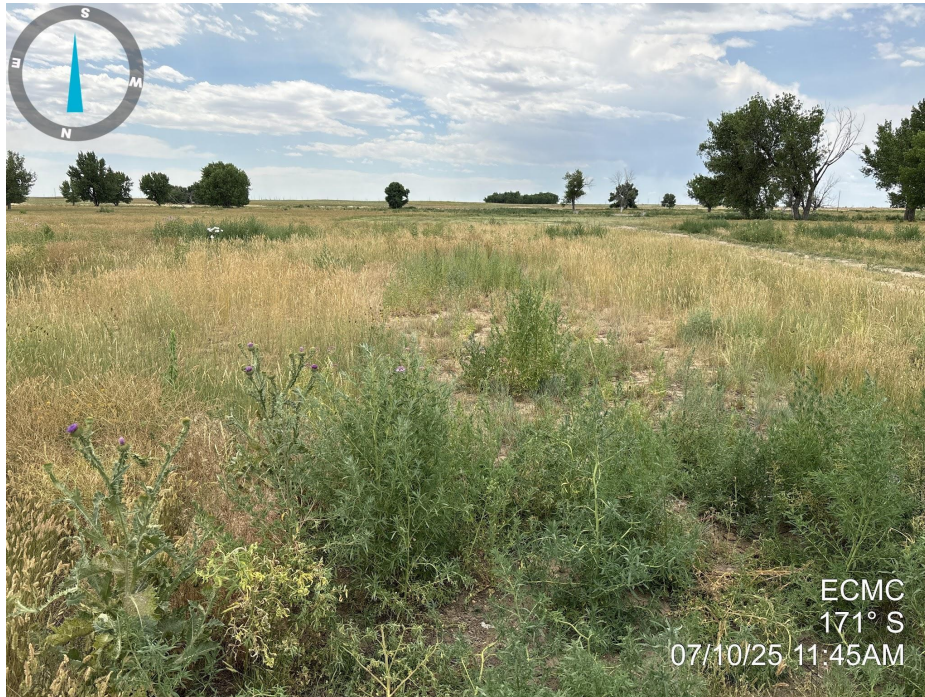
Photo 7. Photo taken of the tank battery location, facing south. Photo illustrates that final reclamation activities have taken place, but vegetation establishment does not meet Rule 1004 standards. Weedy annual vegetation was observed across the location, including kochia (*Bassia scoparia*) and cheatgrass (*Bromus tectorum*).

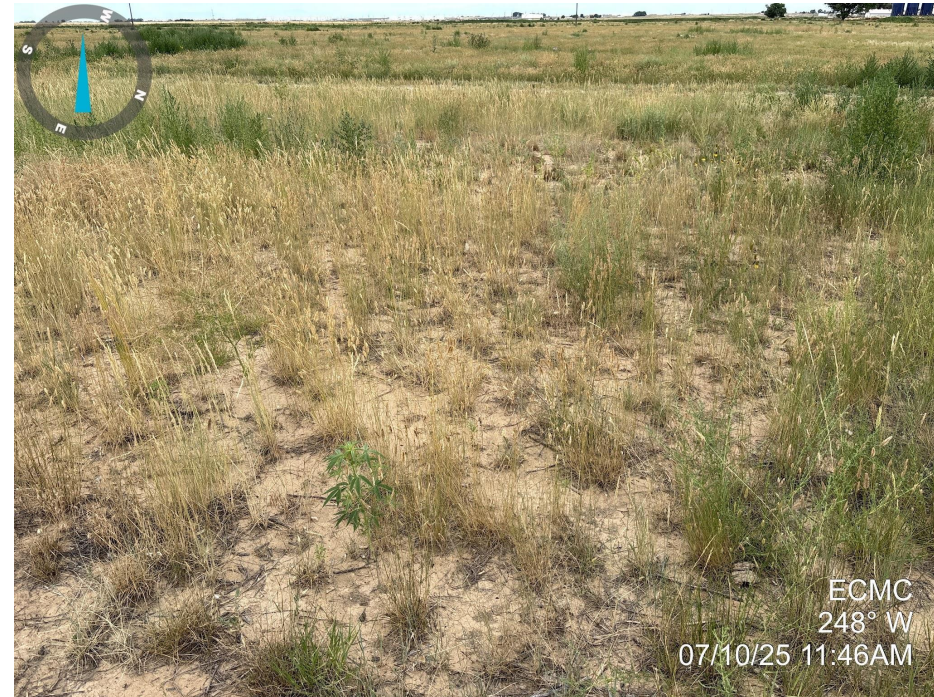
Photo 8. Photo taken of the tank battery location, facing west. See comments under Photo 7.

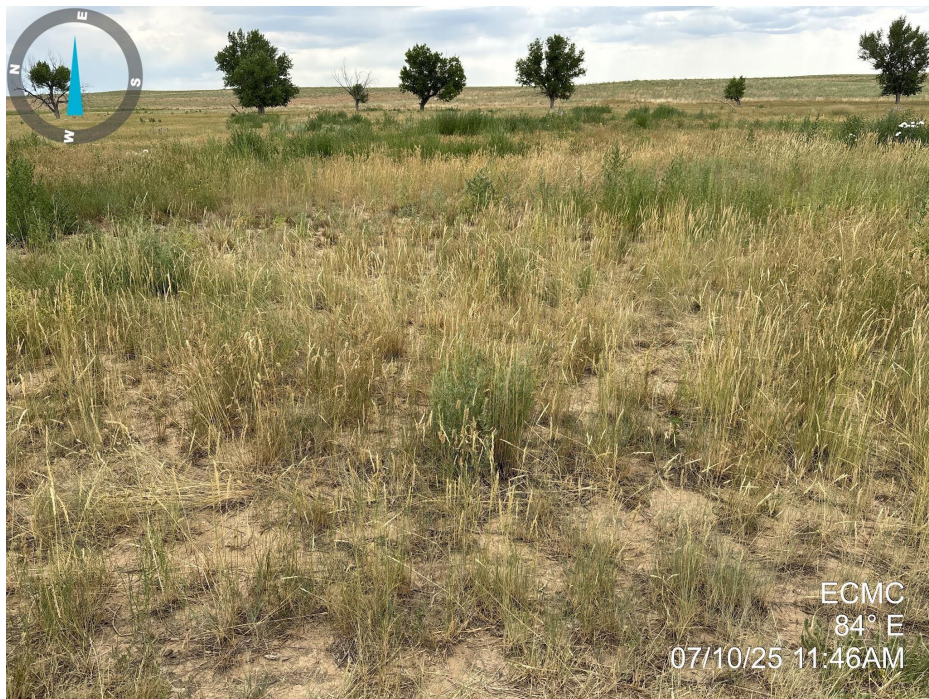
Photo 9. Photo taken of the tank battery location, facing east. See comments under Photo 7.

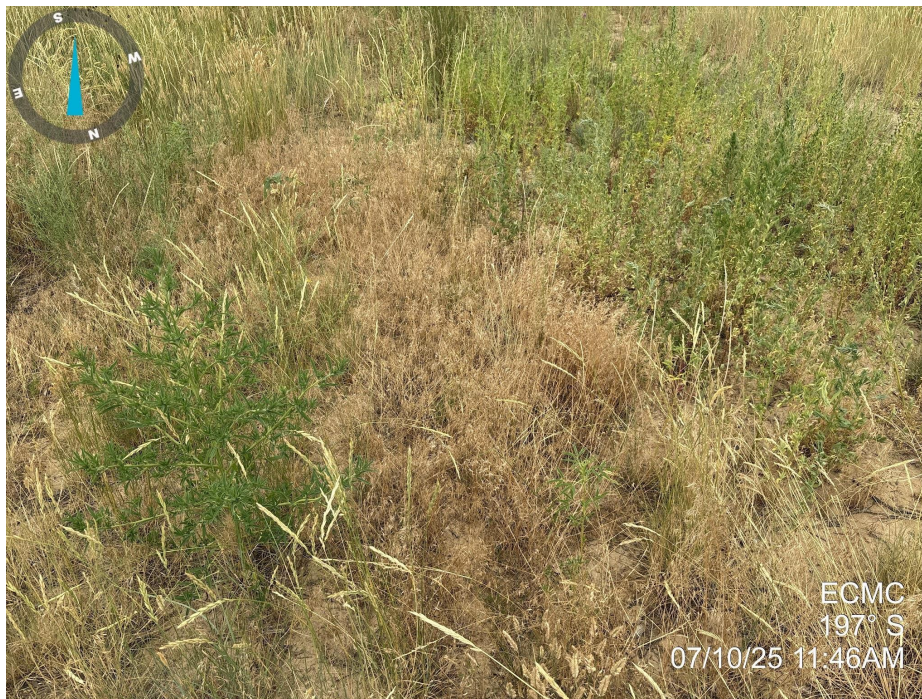
Photo 10. Photo taken of ground cover at the tank battery location. Photo illustrates weedy annual vegetation including cheatgrass (*Bromus tectorum*), a List C Noxious Weed species.

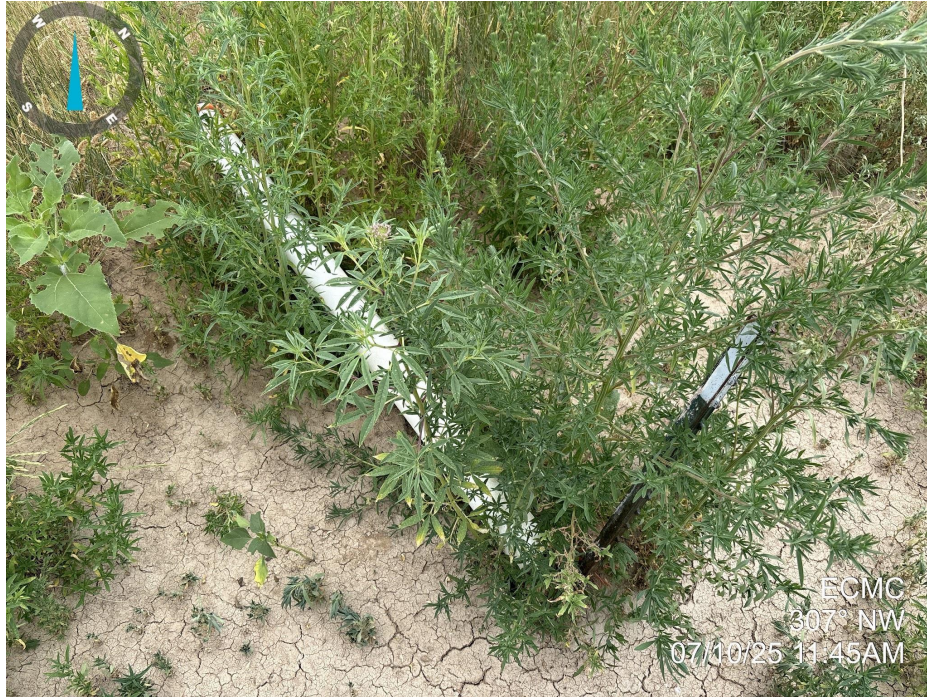
Photo 11. Photo taken of the midstream equipment that remains at the tank battery location. Photo illustrates that equipment is in disrepair.

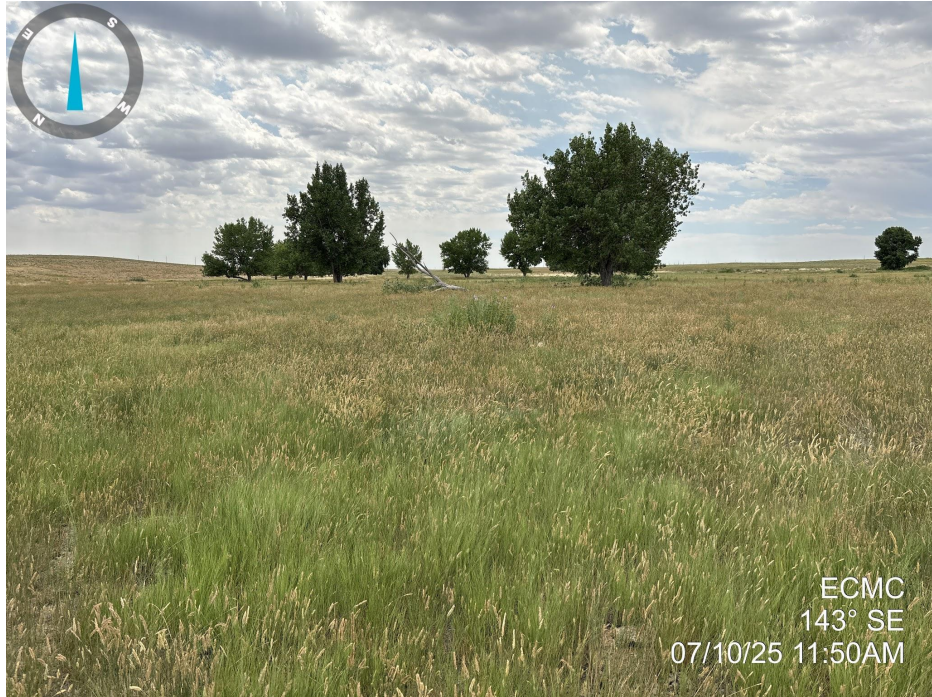
Photo 12. Photo taken of the reference area, southeast of the location, facing southeast. Photo illustrates perennial grass vegetation.
