Final Reclamation Inspection

Operator: NOBLE ENERGY INC - 100322

Location ID: 332003

Inspection Photos
Location Name: GUTTERSEN #10-20
Location ID: 332003

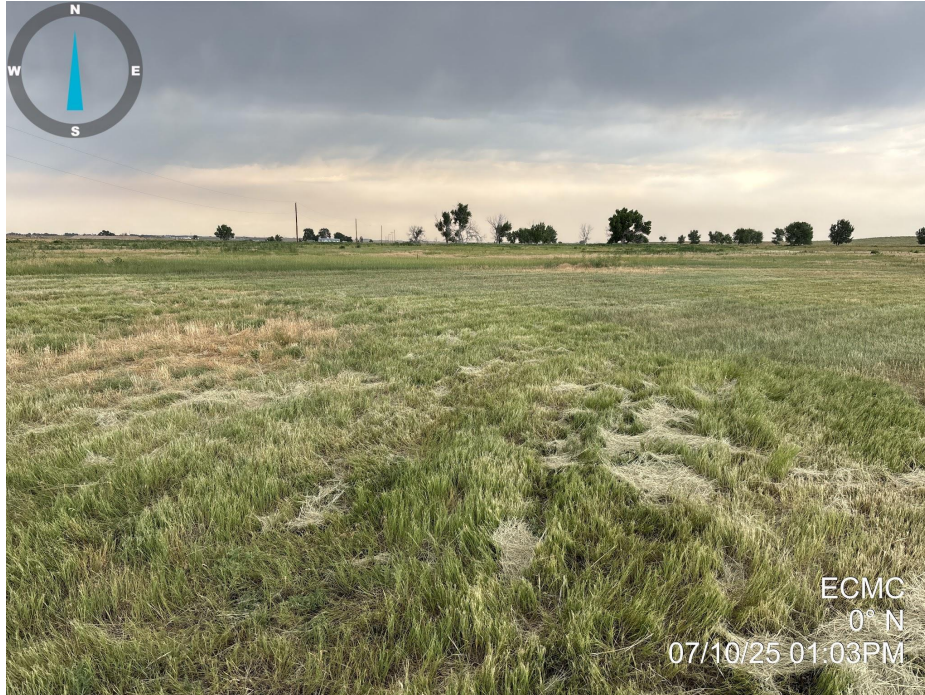
Photo 1. Photo taken from the well location, facing North. Photo illustrates that the well location appears to meet Rule 1004 standards. However, the location has been recently mowed and vegetation establishment will be inspected at a later date.

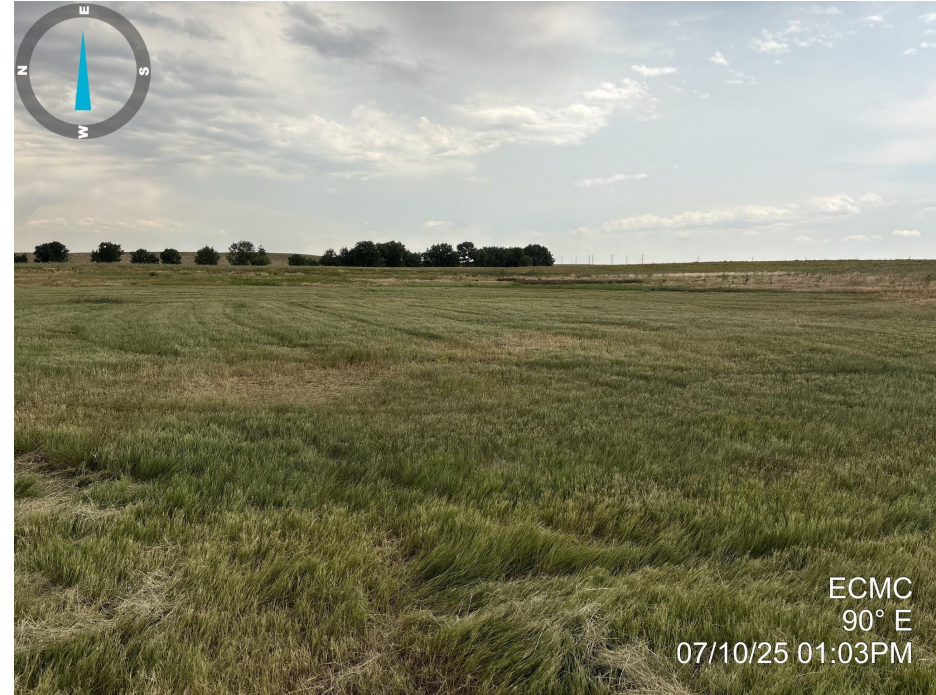
Photo 2. Photo taken from the well location, facing East. See comments under Photo 1.

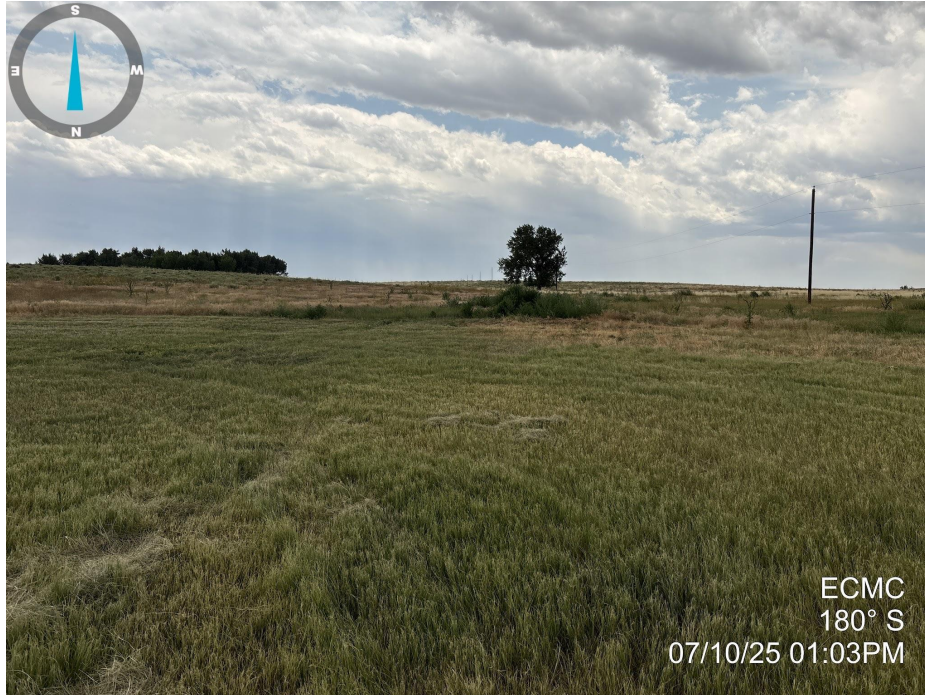
Photo 3. Photo taken from the well location, facing South. See comments under Photo 1.

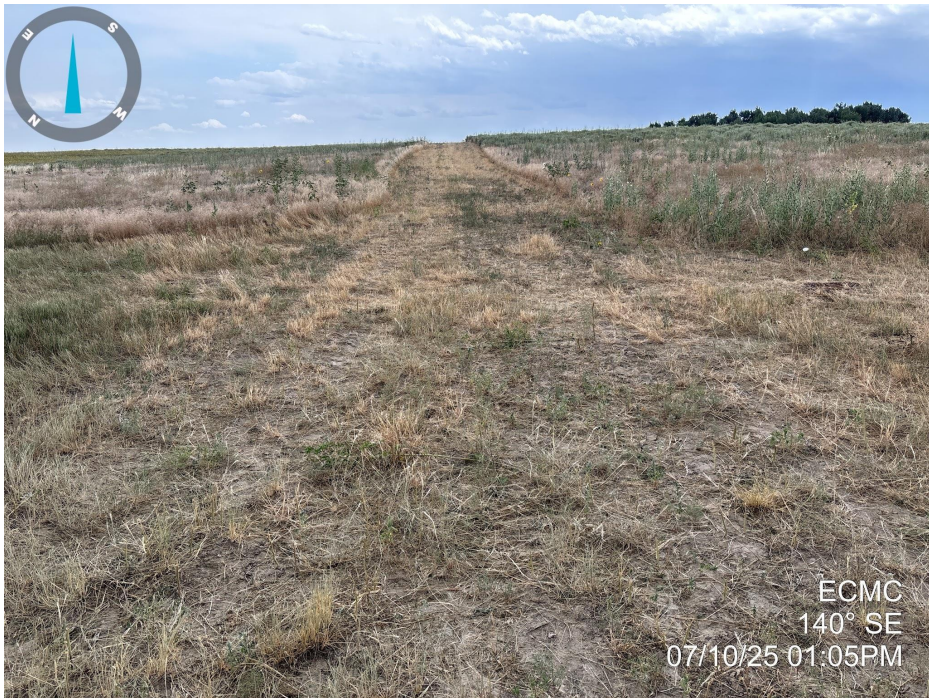
Photo 5. Photo taken of the access road to the location, facing southeast, away from the location. Photo illustrates that final reclamation activities have taken place, but vegetation establishment does not meet Rule 1004 standards. The site has been recently mowed and cheatgrass (*Bromus tectorum*), a List C Noxious Weed species, was observed across the access road.

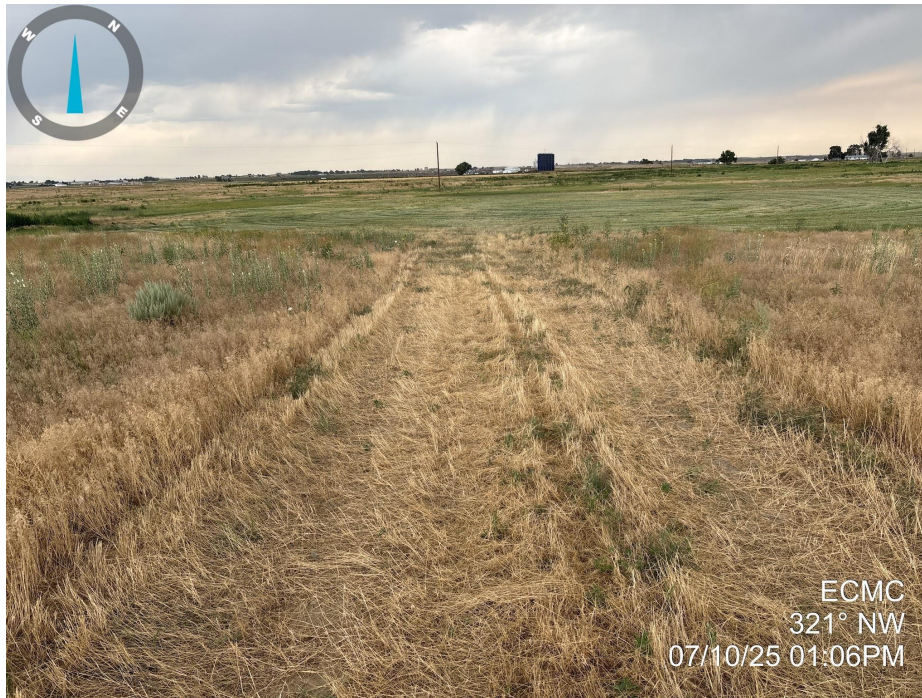
Photo 6. Photo taken of the access road to the well location, facing northwest, towards the well location. See comments under Photo 5.

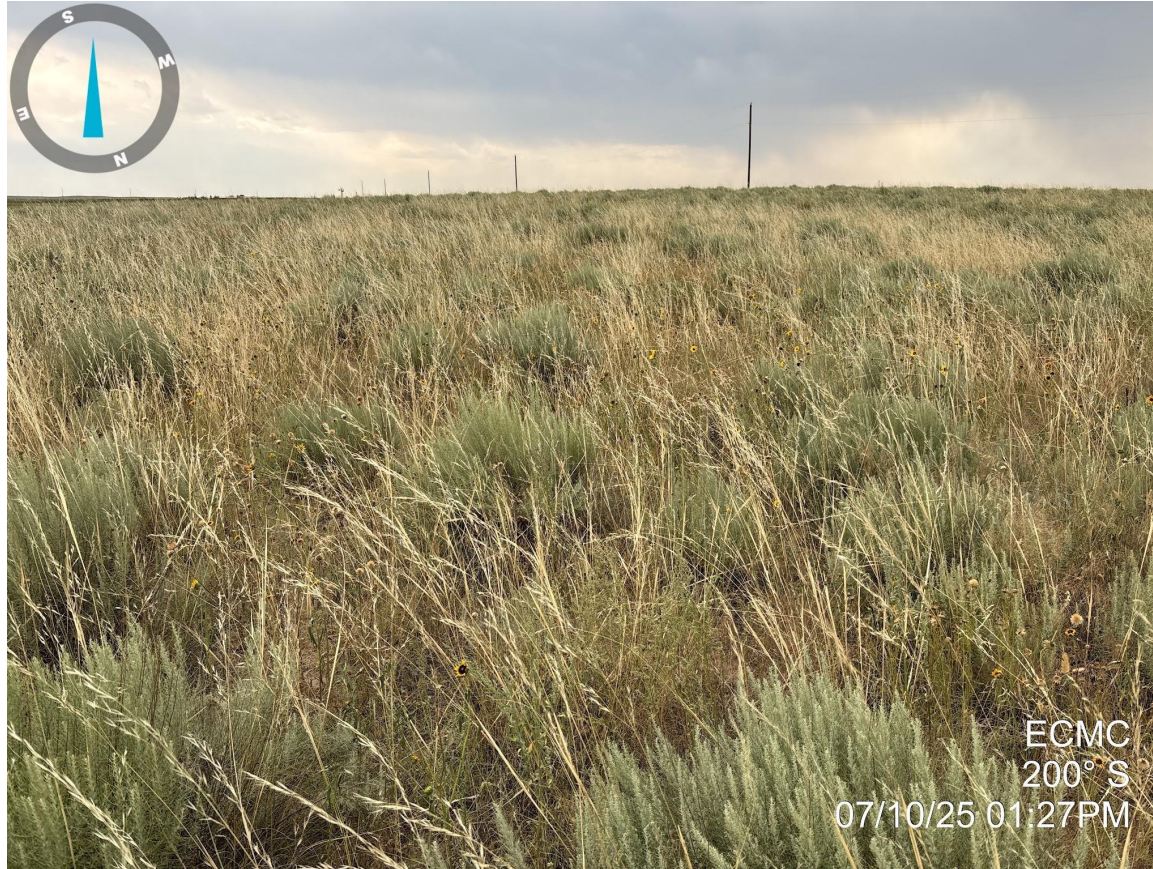
Photo 7. Photo taken of the reference area south of the location, facing south. Photo illustrates perennial grass vegetation and sand sagebrush (*Artemisia filifolia*).
