Final Reclamation Inspection

Operator: NOBLE ENERGY INC - 100322

Location ID: 328052

Inspection Photos
Location Name: DUNCAN D #20-10
Location ID: 328052

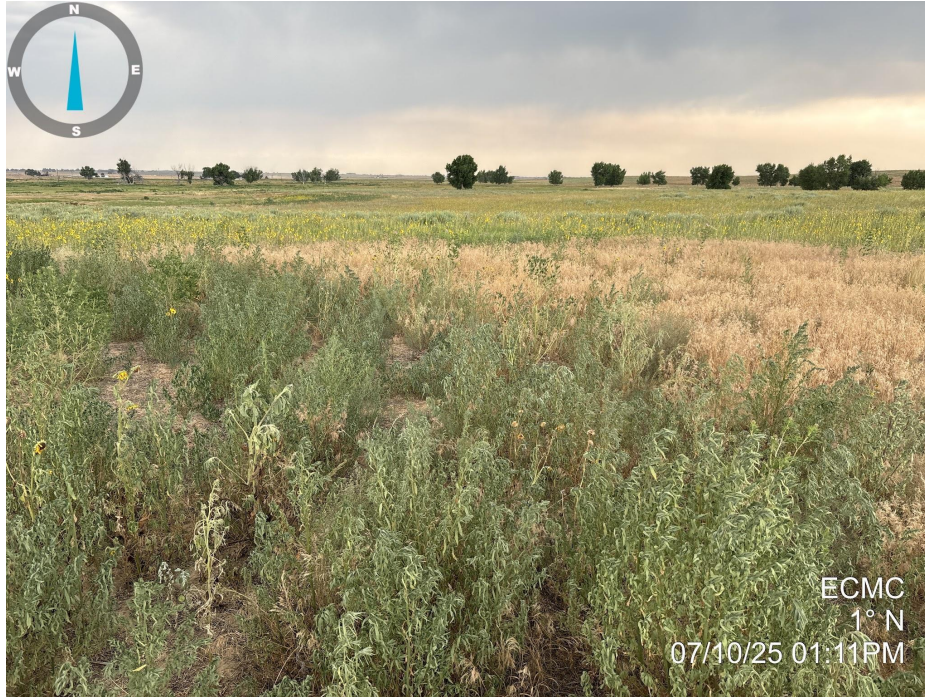
Photo 1. Photo taken from the well location, facing North. Photo illustrates that final reclamation activities have taken place, but vegetation establishment does not meet Rule 1004 standards as the site is dominated by weedy annual vegetation including kochia (*Bassia scoparia*) and cheatgrass (*Bromus tectorum*).

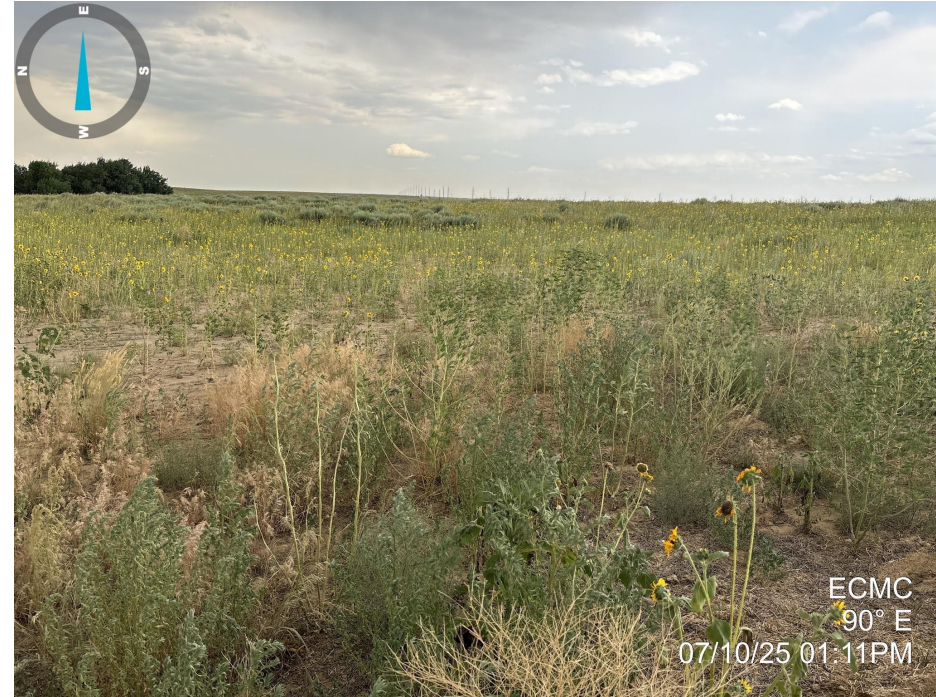
Photo 2. Photo taken from the well location, facing East. See comments under Photo 1.

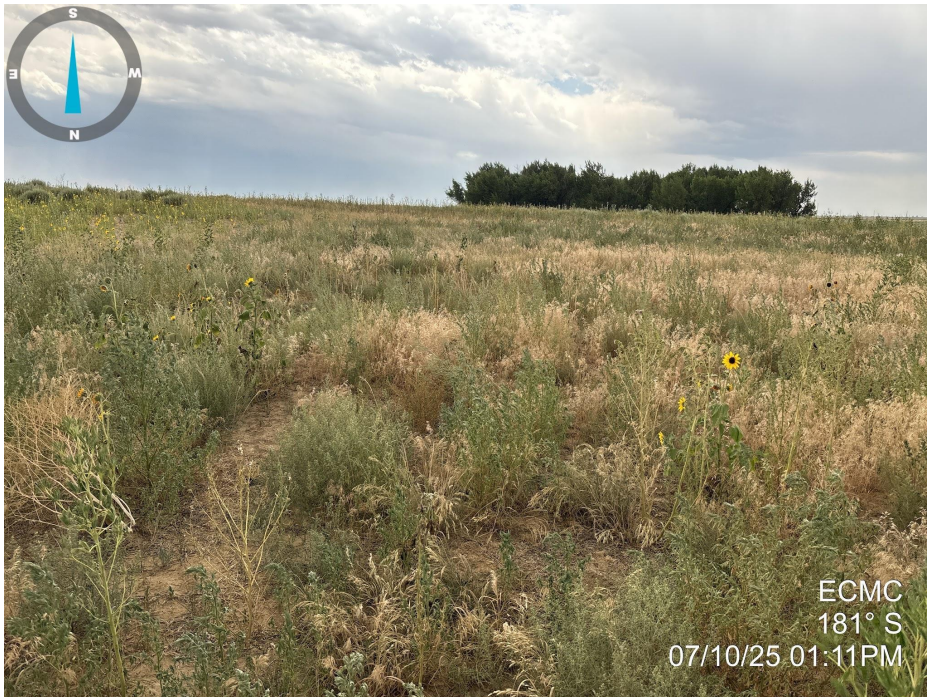
Photo 3. Photo taken from the well location, facing South. See comments under Photo 1.

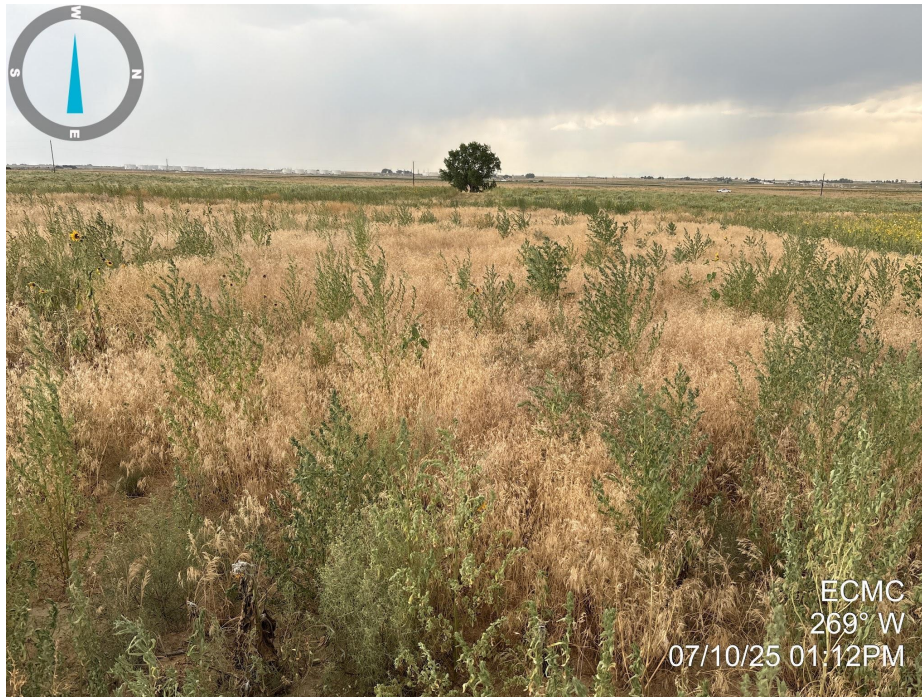
Photo 4. Photo taken from the well location, facing West. See comments under Photo 1.

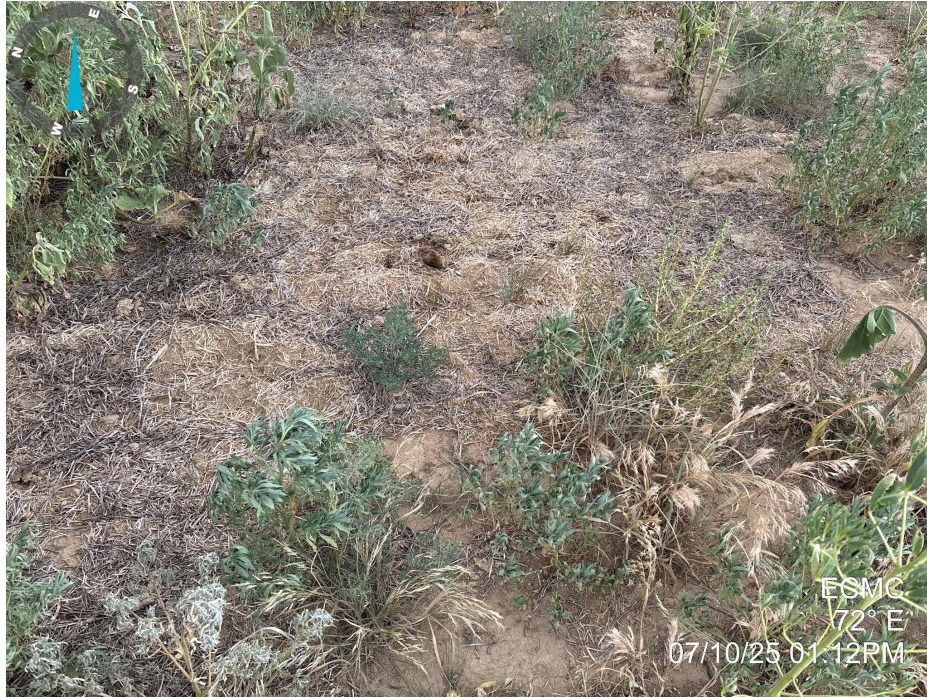
Photo 5. Photo taken of ground cover at the location. Photo illustrates bare ground, straw mulch, and weedy annual vegetation.

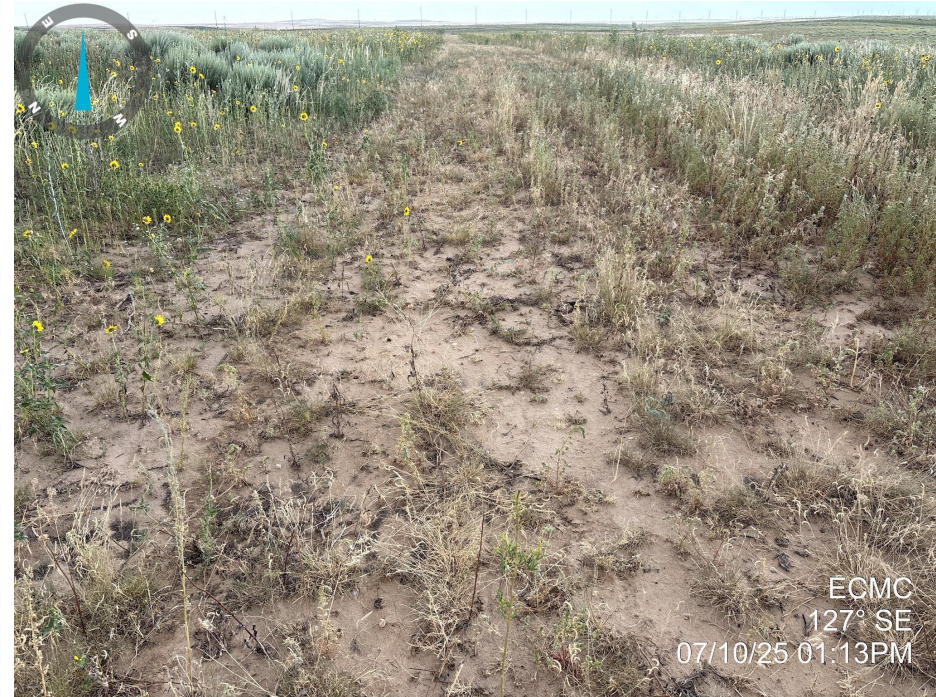
Photo 6. Photo taken of the access road to the location, facing southeast. Photo illustrates that final reclamation activities have taken place, with evidence of drill row seeding, but vegetation establishment does not meet Rule 1004 standards. Weedy annual vegetation including cheatgrass (*Bromus tectorum*), a List C Noxious Weed species, was observed across the access road.

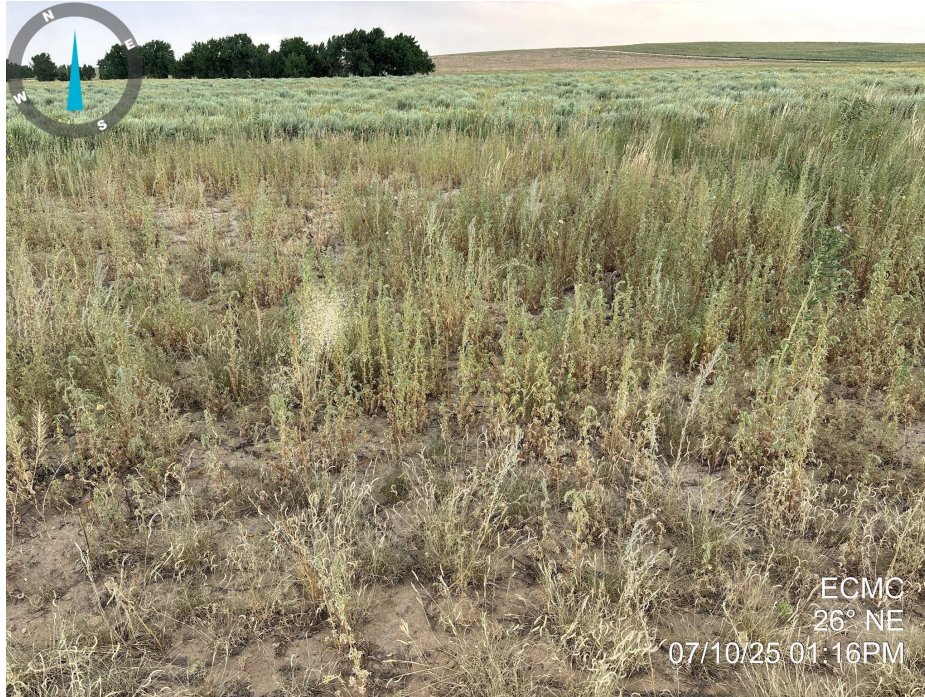
Photo 7. Photo taken of the tank battery location, facing northeast. Photo illustrates that final reclamation activities have taken place, but vegetation establishment does not meet Rule 1004 standards and weedy annual vegetation was observed across the location.

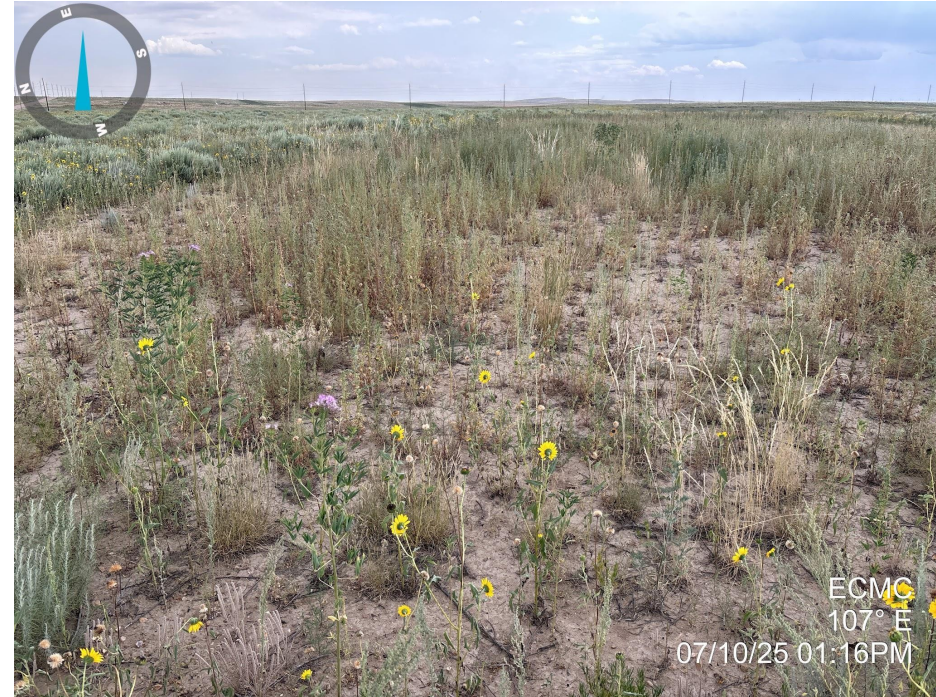
Photo 8. Photo taken of the tank battery location, facing east. See comments under Photo 7.

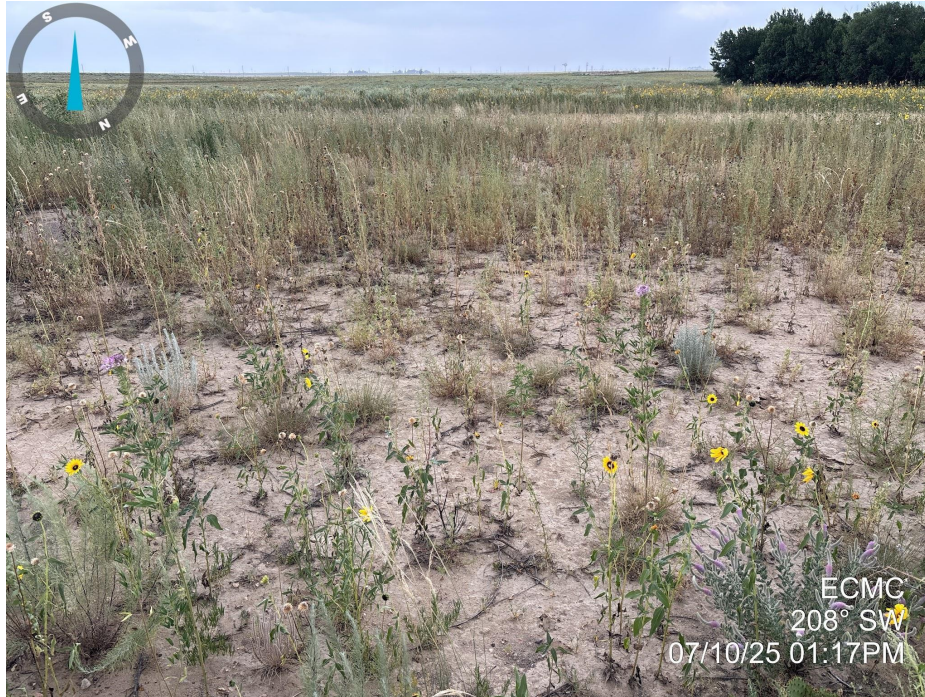
Photo 9. Photo taken of the tank battery location, facing southwest. See comments under Photo 7.

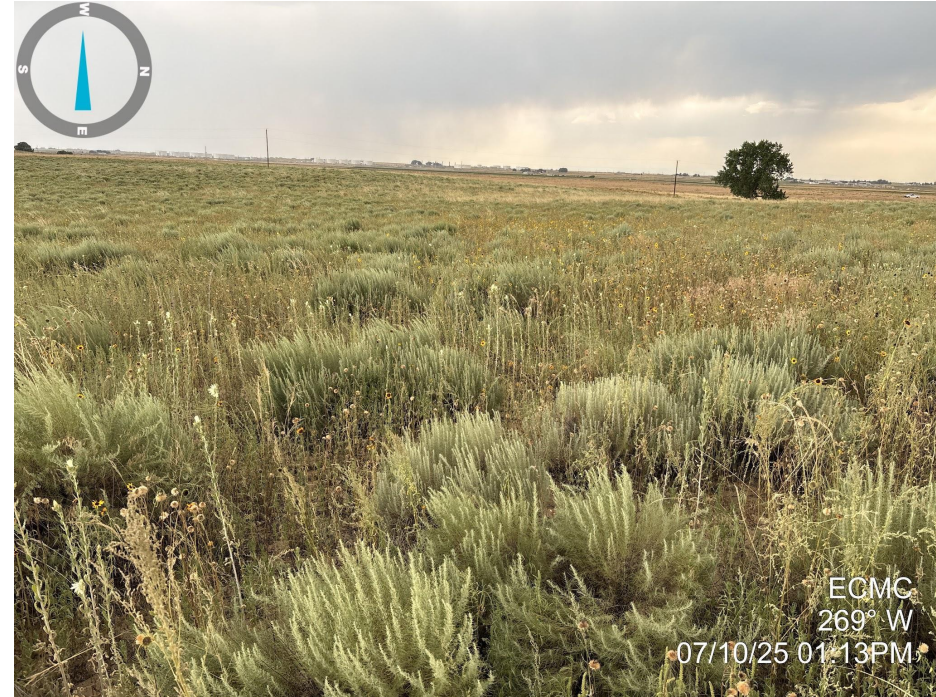
Photo 10. Photo taken of the reference area for the location, south of the location, facing west. Photo illustrates sand sagebrush (*Artemisia filifolia*), perennial grass, and annual vegetation.
