Final Reclamation Inspection

Operator: NOBLE ENERGY INC - 100322

Location ID: 328176

Inspection Photos
Location Name: DUNCAN D #20-16
Location ID: 328176

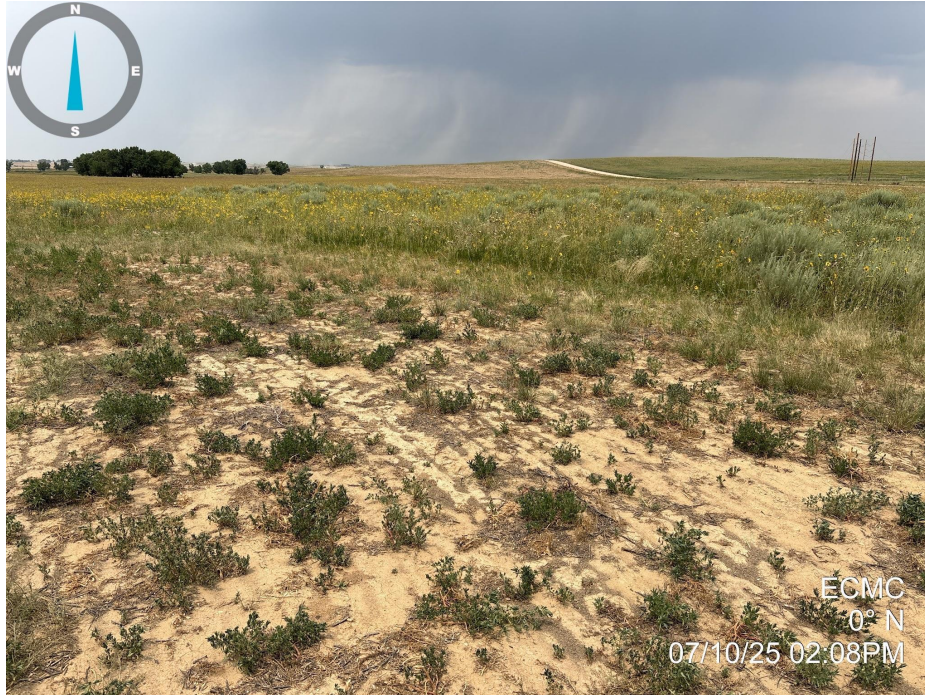
Photo 1. Photo taken from the well location, facing North. Photo illustrates that final reclamation activities have taken place, with evidence of drill row seeding, but vegetation establishment does not meet Rule 1004 standards. Weedy annual vegetation including kochia (*Bassia scoparia*) was observed across the location.

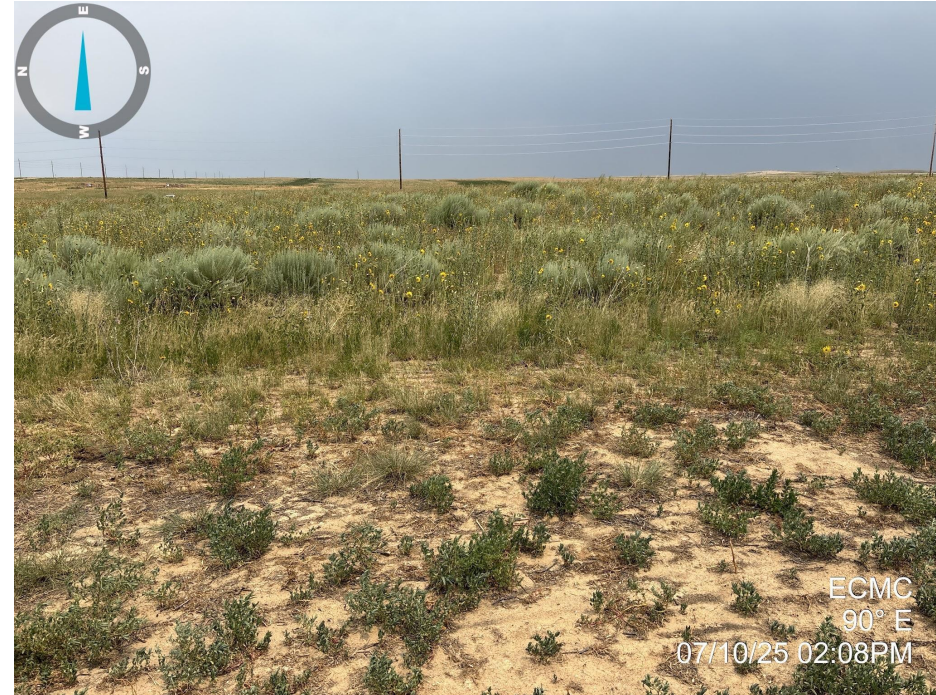
Photo 2. Photo taken from the well location, facing East. See comments under Photo 1.

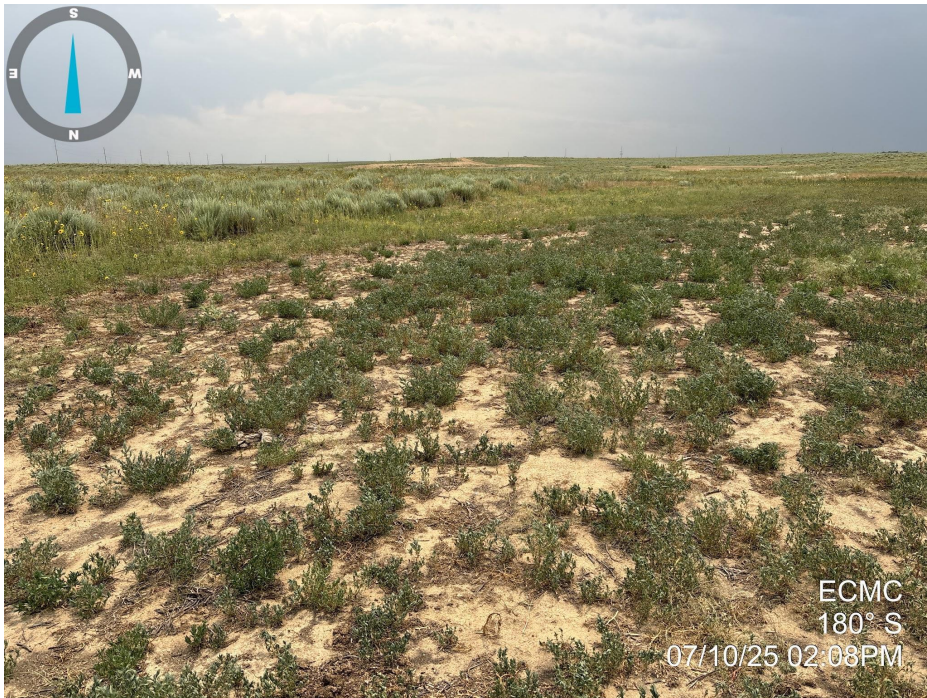
Photo 3. Photo taken from the well location, facing South. See comments under Photo 1.

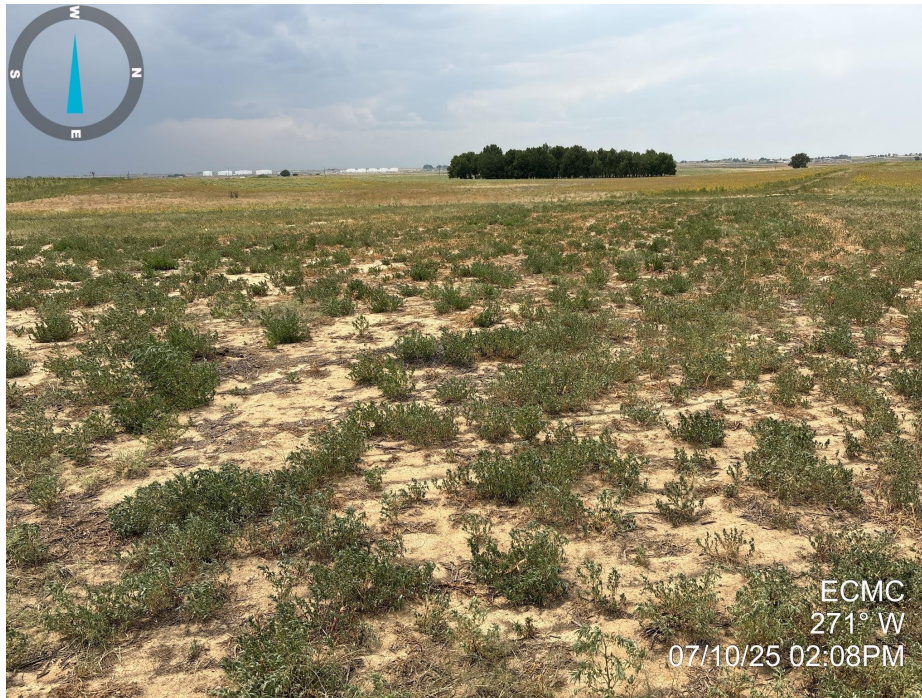
Photo 4. Photo taken from the well location, facing West. See comments under Photo 1.

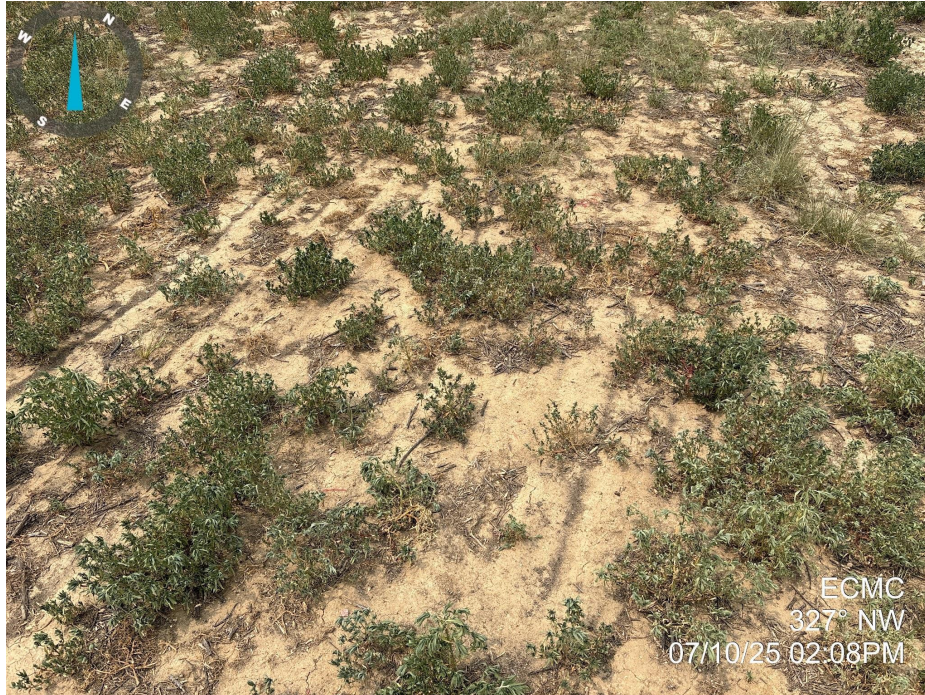
Photo 5. Photo taken of ground cover at the location. Photo illustrates drill rows from seeding, straw mulch, and weedy annual vegetation including Kochia (*Bassia scoparia*).

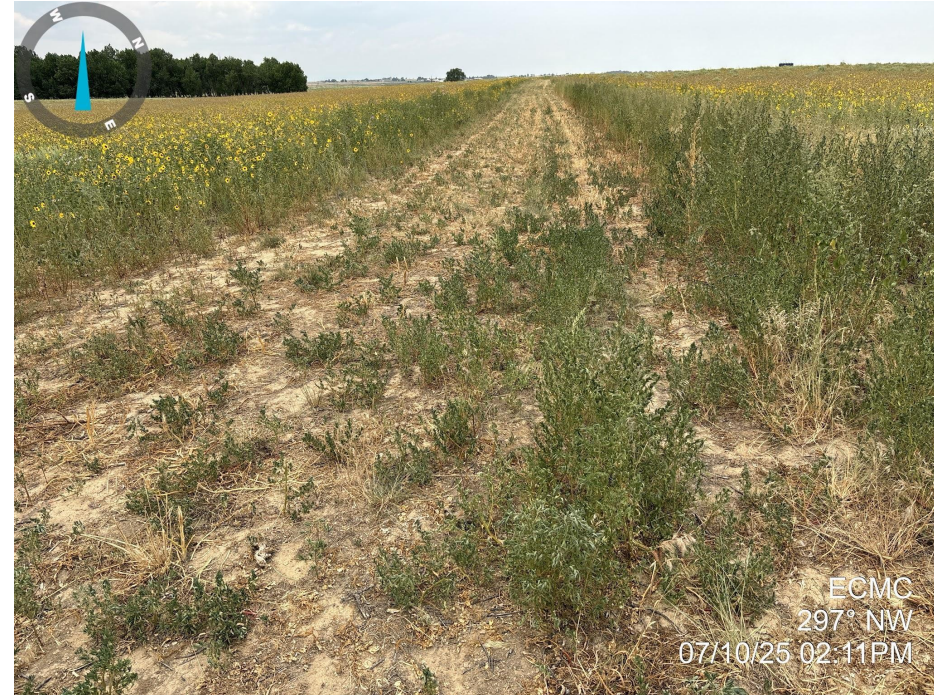
Photo 6. Photo taken of the access road to the location, facing northwest. Photo illustrates that final reclamation activities have taken place, with evidence of drill row seeding, but vegetation establishment does not meet Rule 1004 standards as the access road is dominated by weedy annual vegetation.

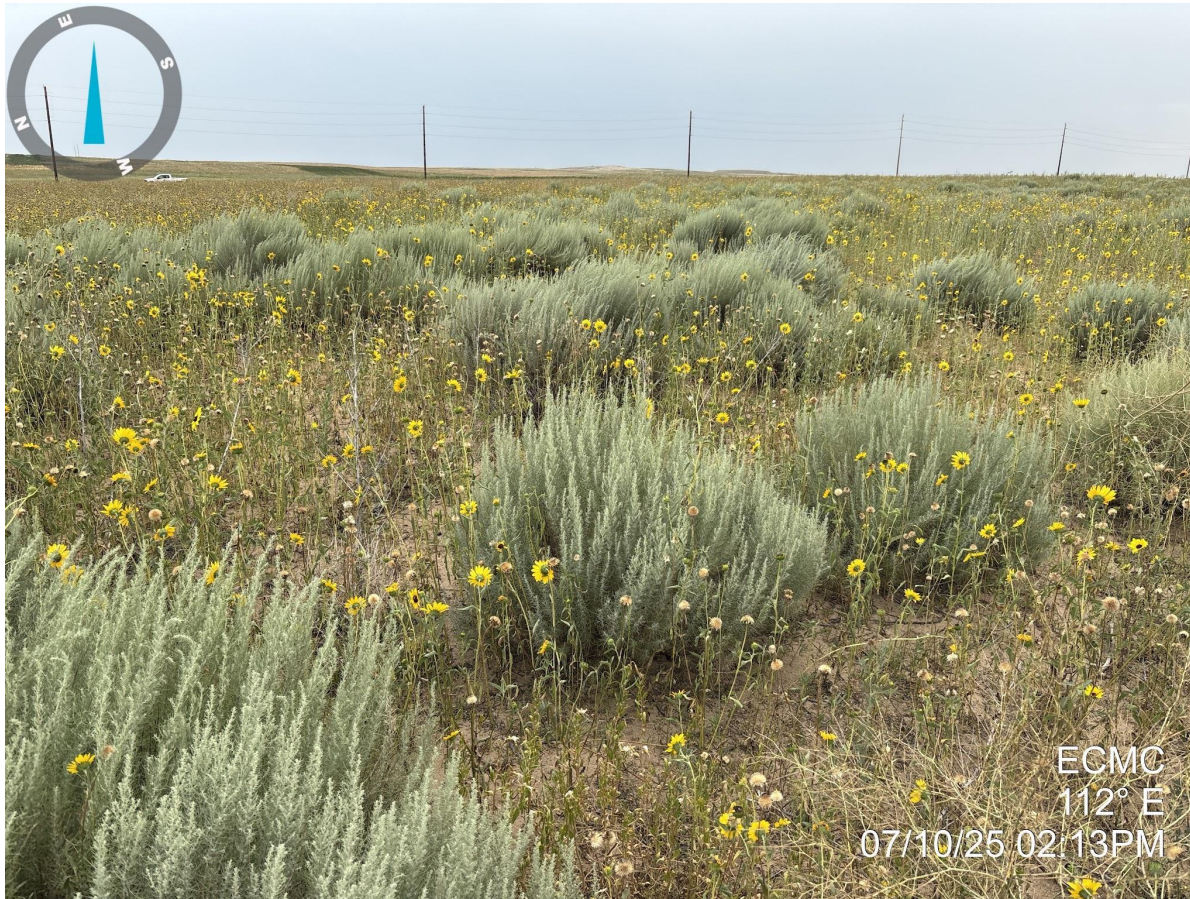
Photo 11. Photo taken of the reference area for the location, north of the location, facing east. Photo illustrates sand sagebrush (*Artemisia filifolia*) and prairie sunflower (*Helianthus petiolaris*).
