Final Reclamation Inspection

Operator: NOBLE ENERGY INC - 100322

Location ID: 465088

Inspection Photos
Location Name: DUNCAN D-63N64W/20SESE
Location ID: 465088

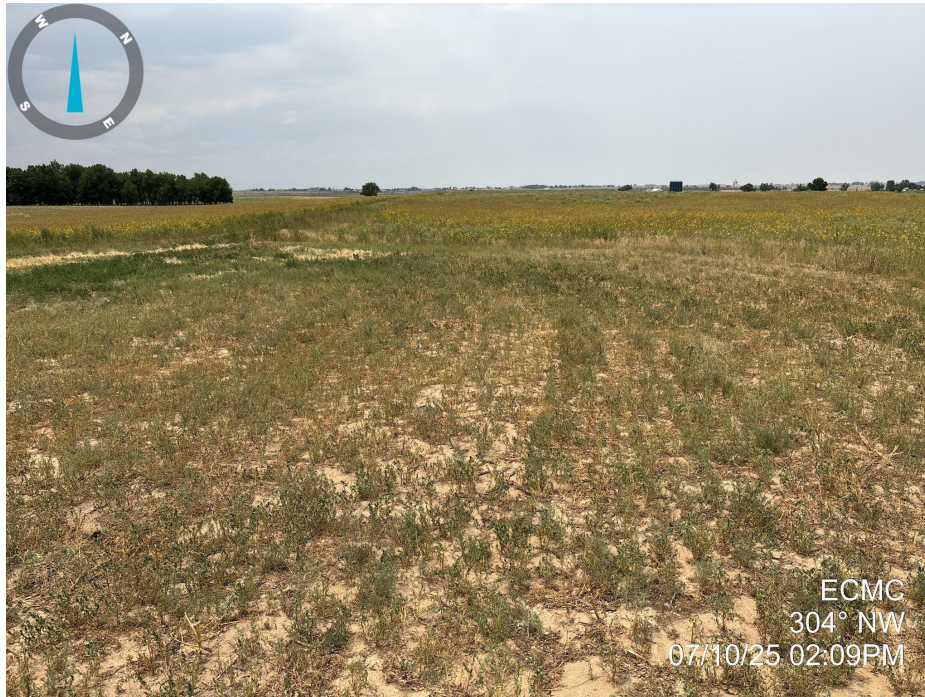
Photo 1. Photo taken of the tank battery location, facing northwest. Photo illustrates that final reclamation activities have taken place, with evidence of drill row seeding, but vegetation establishment does not meet Rule 1004 standards. Weedy annual vegetation including kochia (*Bassia scoparia*) was observed across the location.

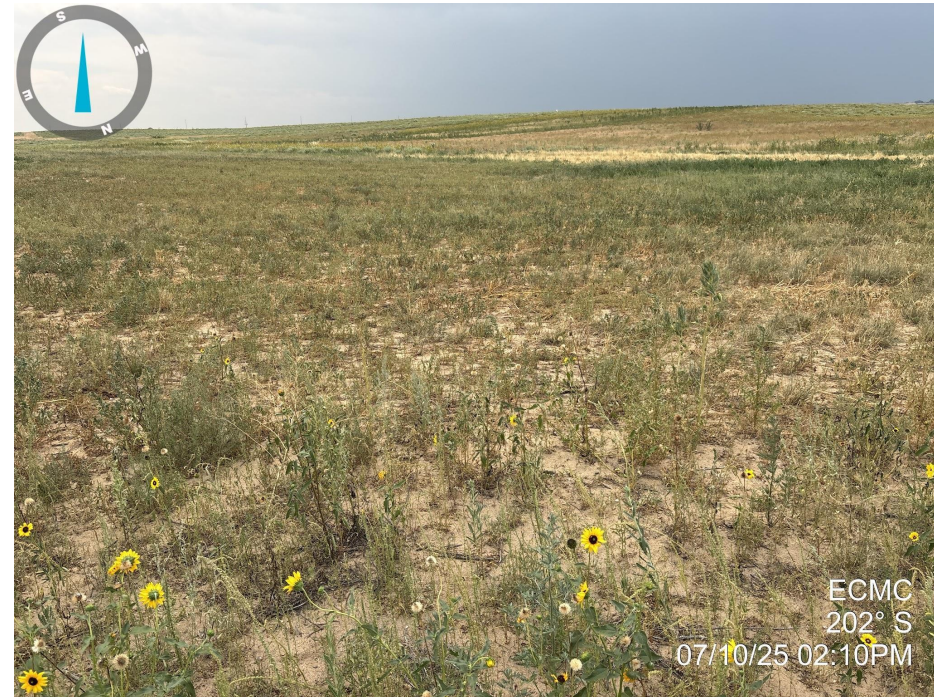
Photo 2. Photo taken of the tank battery location, facing south. See comments under Photo 1.

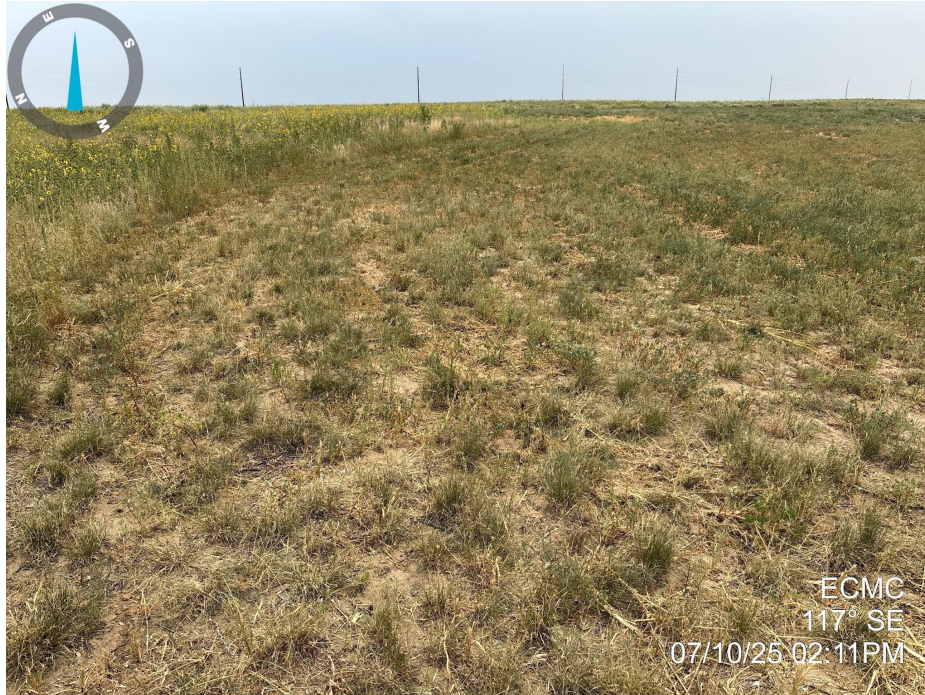
Photo 3. Photo taken from the tank battery location, facing southeast. See comments under Photo 1.

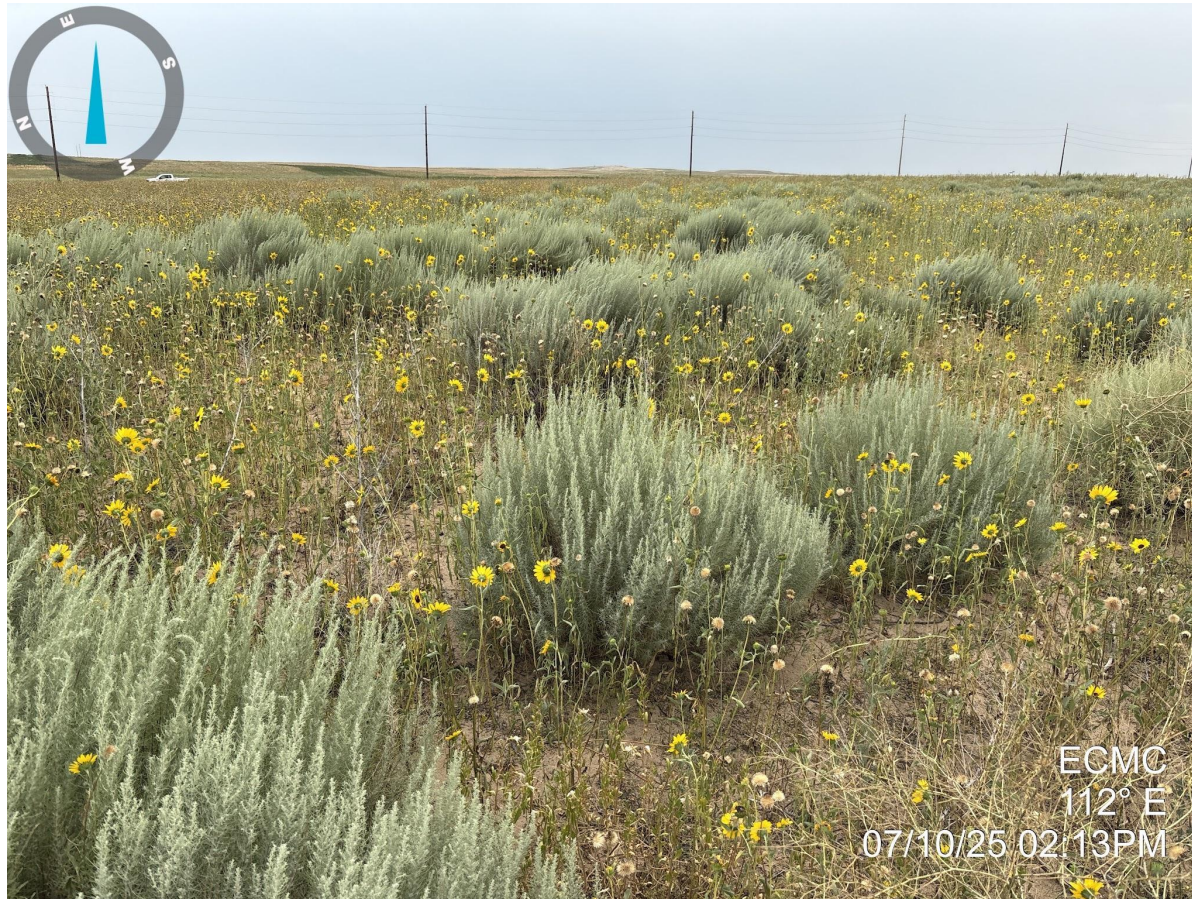
Photo 5. Photo taken of the reference area for the location, north of the location, facing east. Photo illustrates sand sagebrush (*Artemisia filifolia*) and prairie sunflower (*Helianthus petiolaris*).
