Final Reclamation Inspection

Operator: NOBLE ENERGY INC - 100322

Location ID: 305945

Inspection Photos
Location Name: LIAM D #34-11
Location ID: 305945

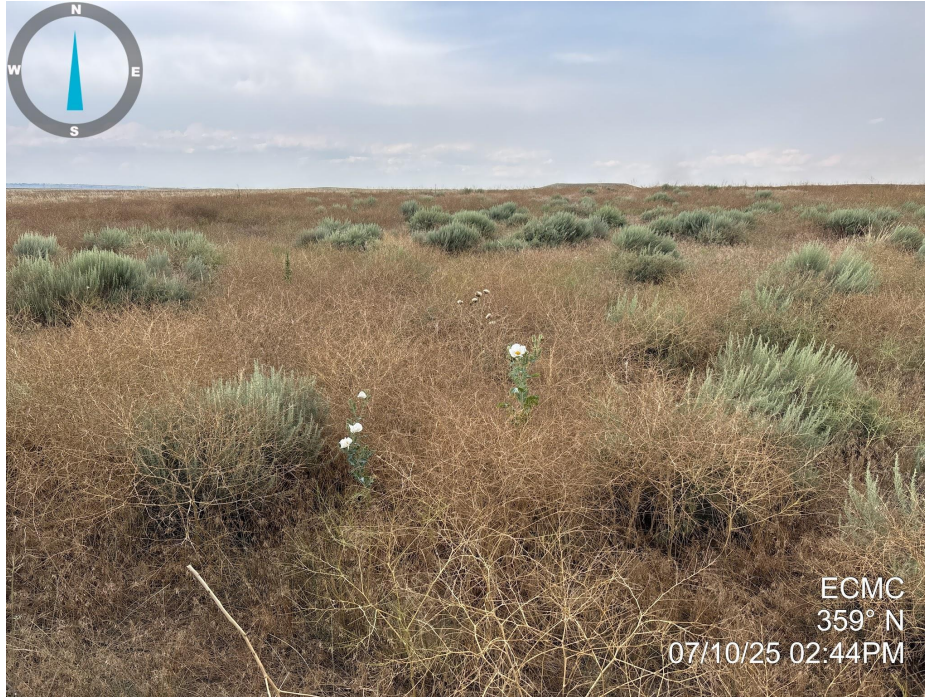
Photo 1. Photo taken from the well location, facing North. Photo illustrates that final reclamation activities have taken place, but vegetation establishment does not meet Rule 1004 standards. Weedy annual vegetation including cheatgrass (*Bromus tectorum*) was observed across the location.

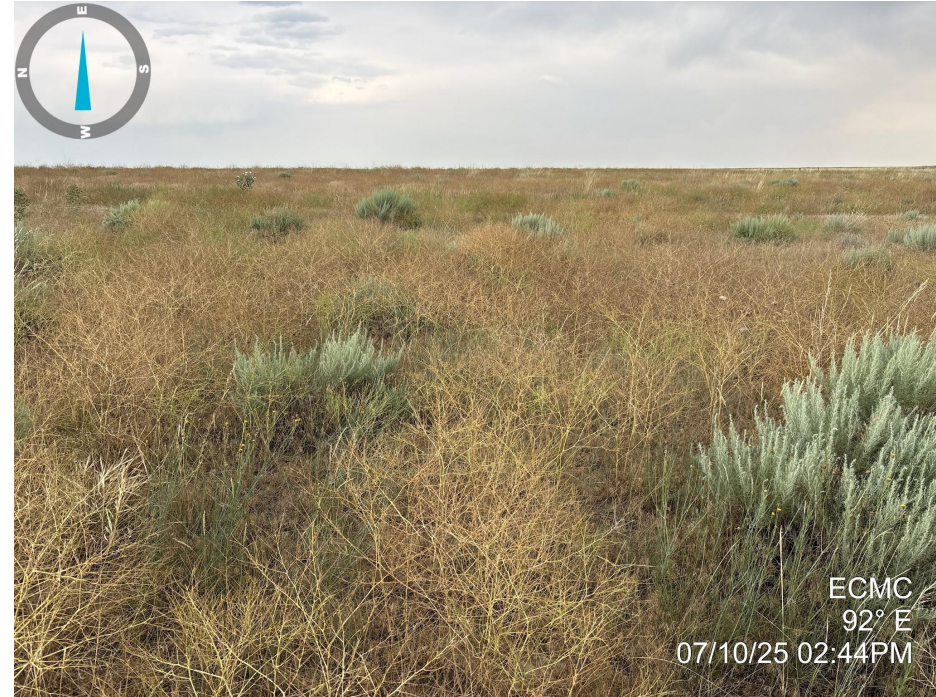
Photo 2. Photo taken from the well location, facing East. See comments under Photo 1.

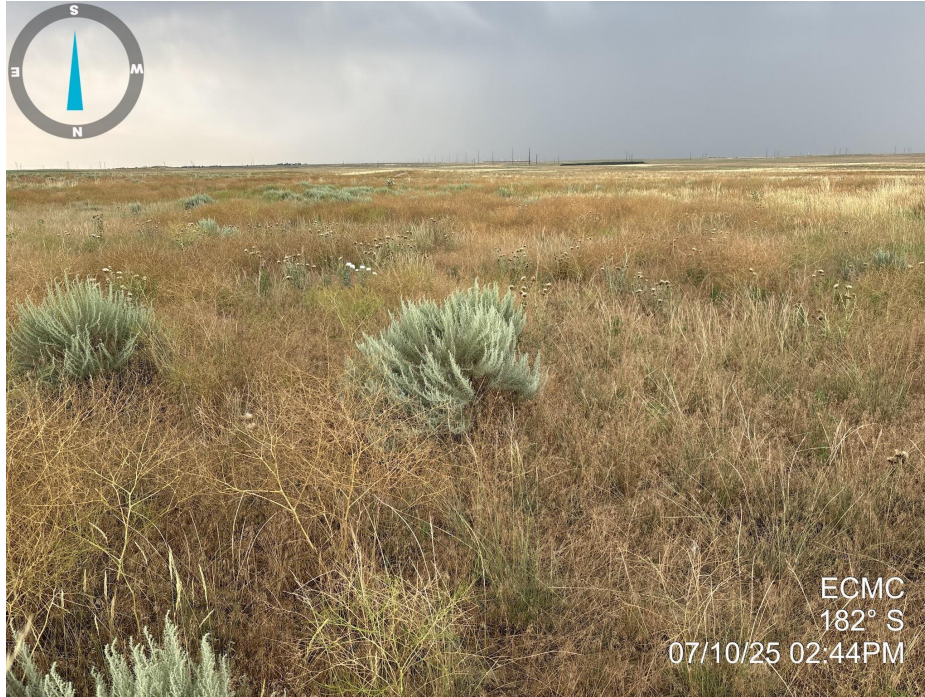
Photo 3. Photo taken from the well location, facing South. See comments under Photo 1.

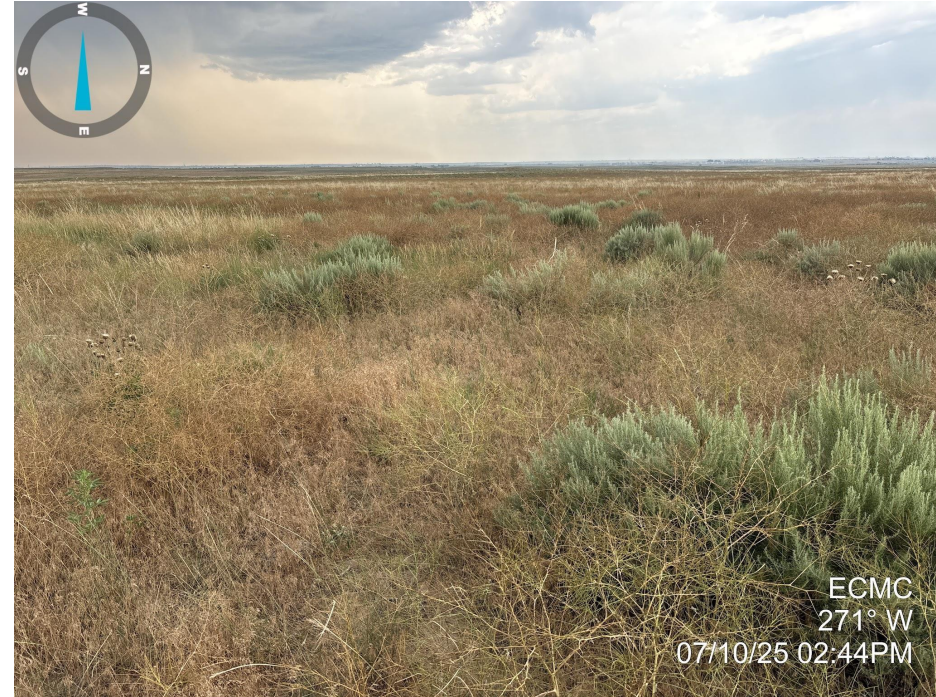
Photo 4. Photo taken from the well location, facing West. See comments under Photo 1.

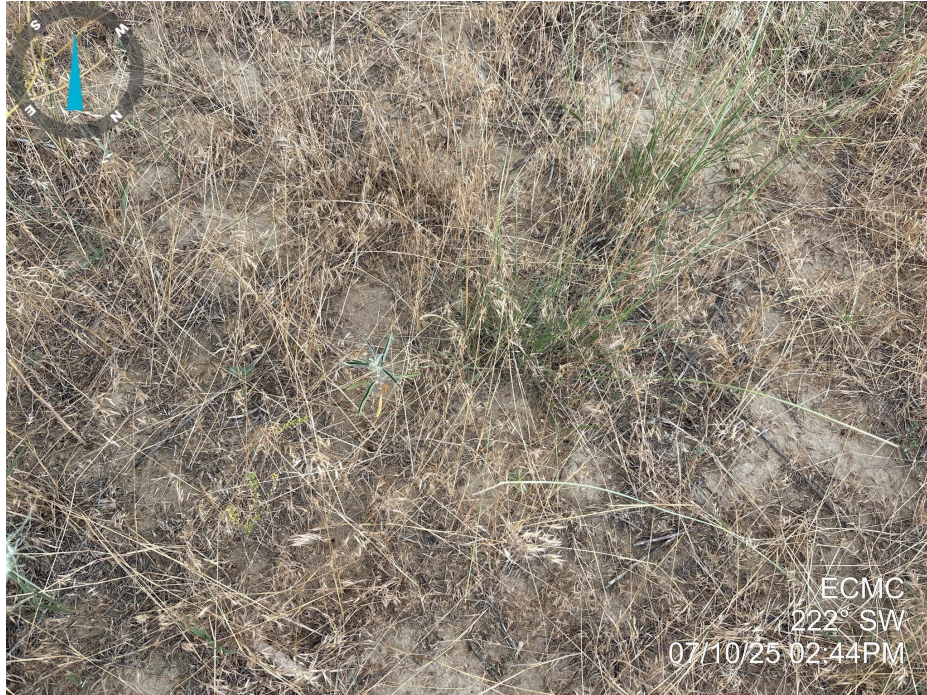
Photo 5. Photo taken of ground cover at the location. Photo illustrates cheatgrass (*Bromus tectorum*), a List C Noxious Weed species.

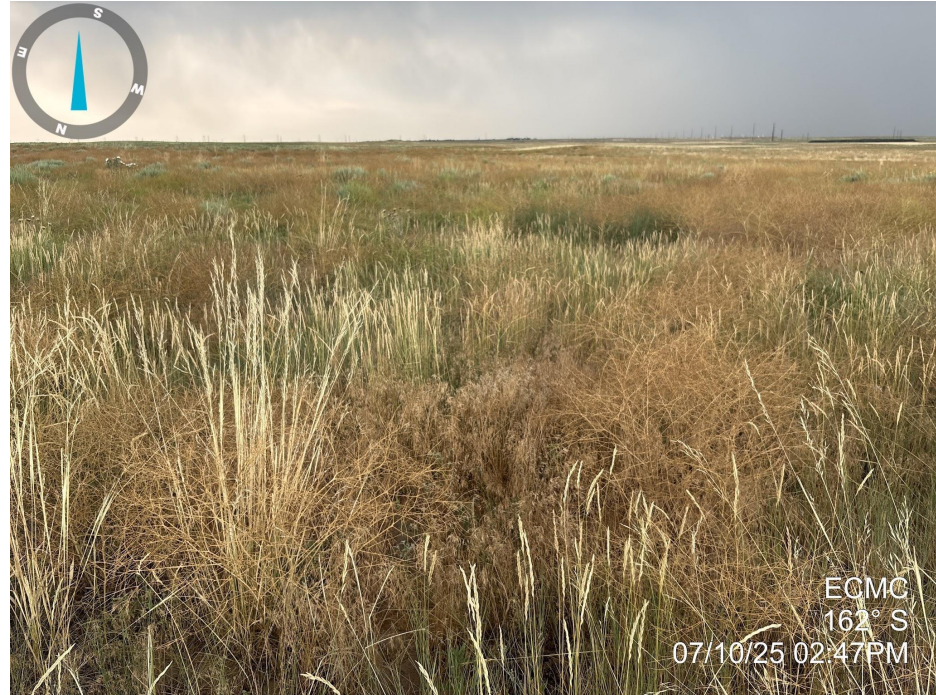
Photo 6. Photo taken of the reference area for the location, south of the location, facing south. Photo illustrates perennial grass vegetation and weedy annual vegetation including cheatgrass (*Bromus tectorum*).
