Final Reclamation Inspection

Operator: NOBLE ENERGY INC - 100322

Location ID: 305946

Inspection Photos
Location Name: LIAM D #34-12
Location ID: 305946

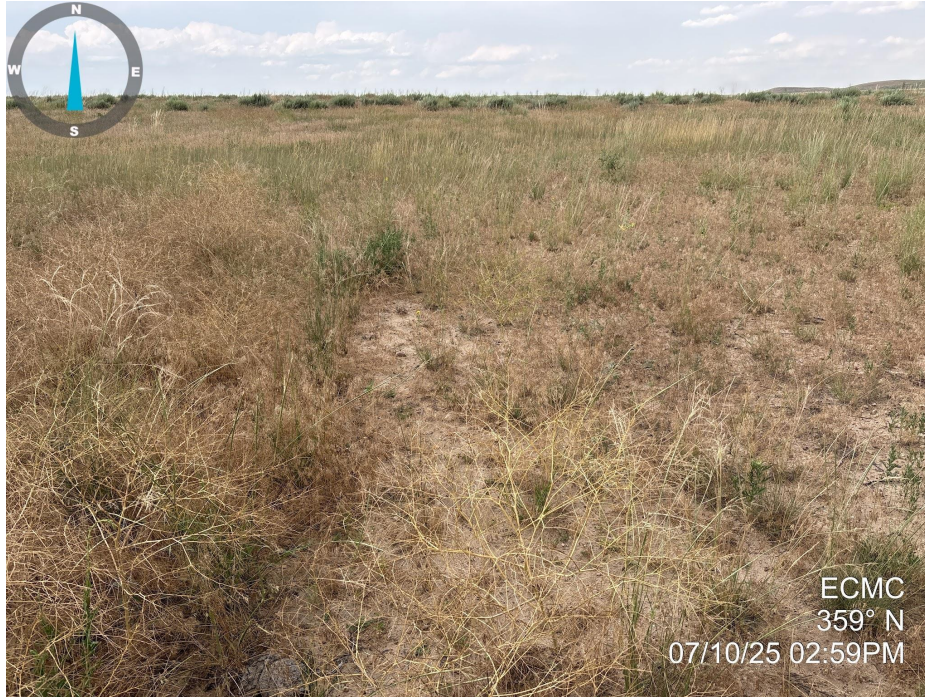
Photo 1. Photo taken from the well location, facing North. Photo illustrates that vegetation establishment does not meet Rule 1004 standards. Gravel and weedy annual vegetation, including cheatgrass (*Bromus tectorum*), were observed across the location.

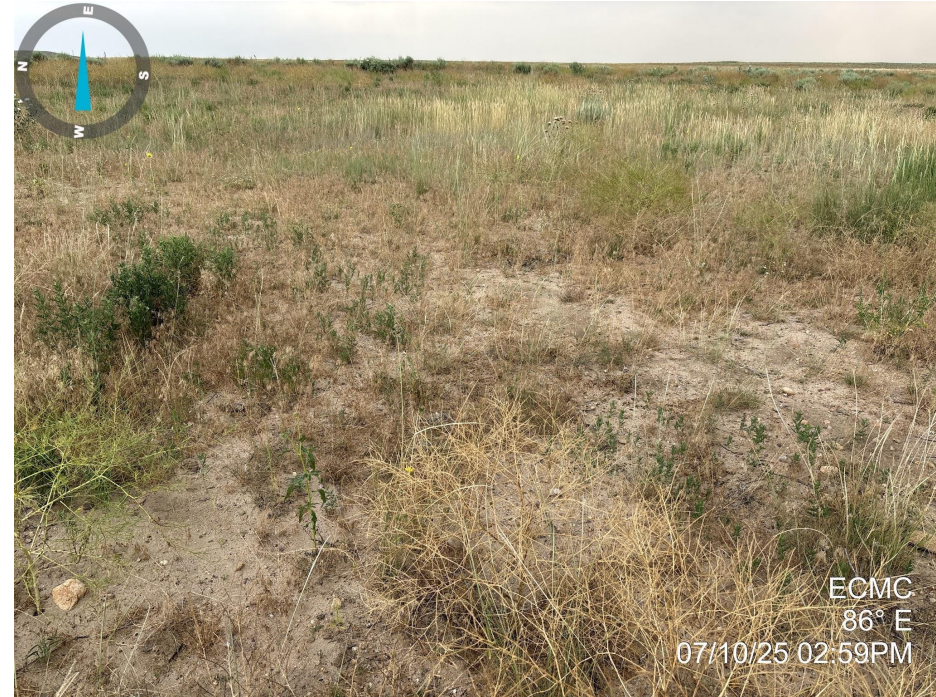
Photo 2. Photo taken from the well location, facing East. See comments under Photo 1.

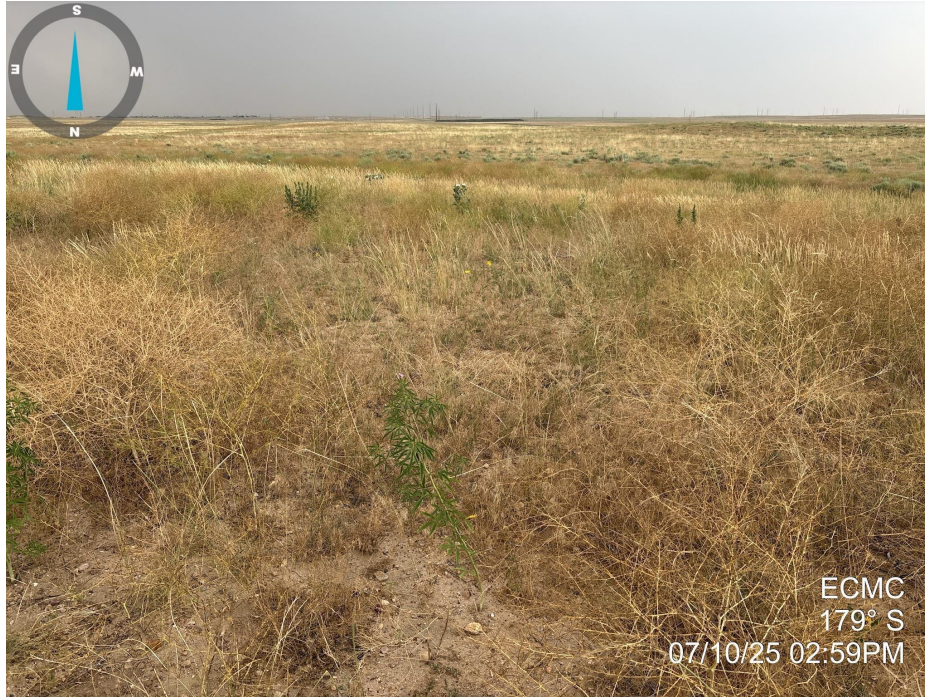
Photo 3. Photo taken from the well location, facing South. See comments under Photo 1.

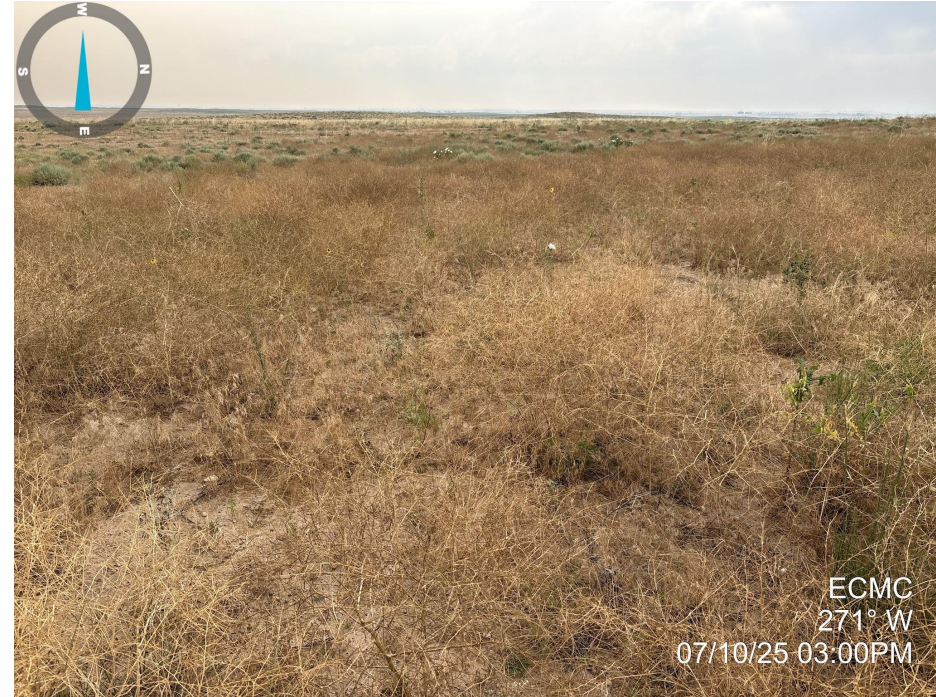
Photo 4. Photo taken from the well location, facing West. See comments under Photo 1.

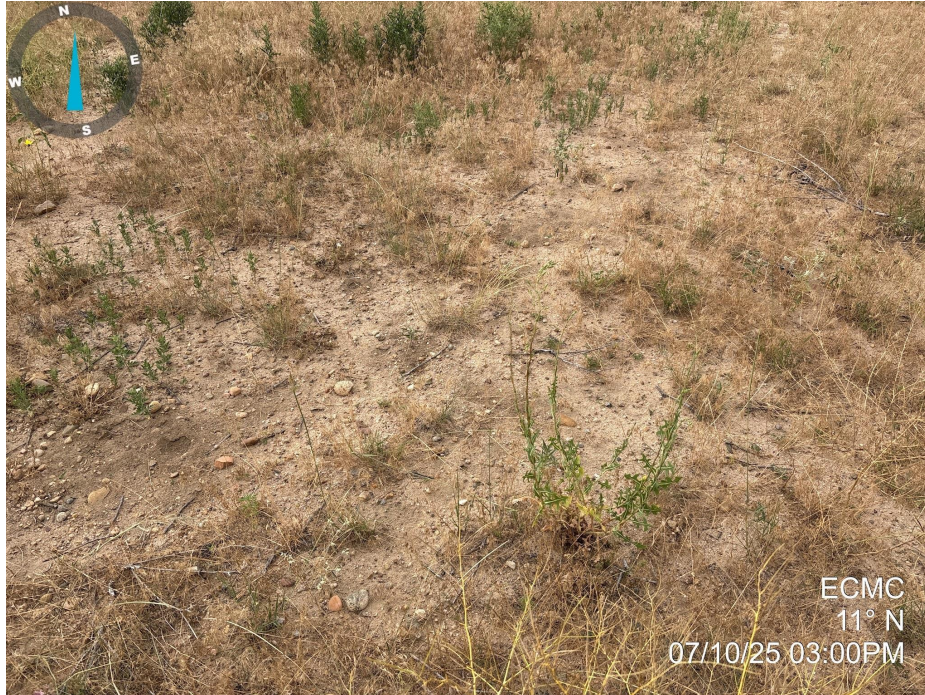
Photo 5. Photo taken of ground cover at the location. Photo illustrates gravel and weedy annual vegetation, including cheatgrass (*Bromus tectorum*), a List C Noxious Weed species.

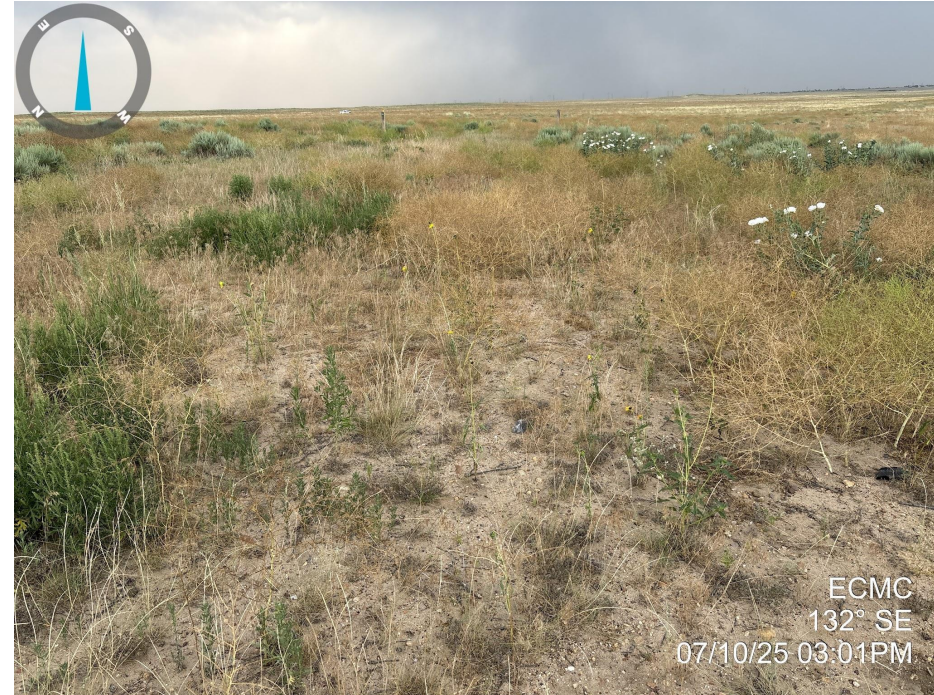
Photo 6. Photo taken of the access road to the location, facing southeast. Photo illustrates that final reclamation at the location does not meet Rule 1004 standards as gravel and weedy annual vegetation were observed across the location.

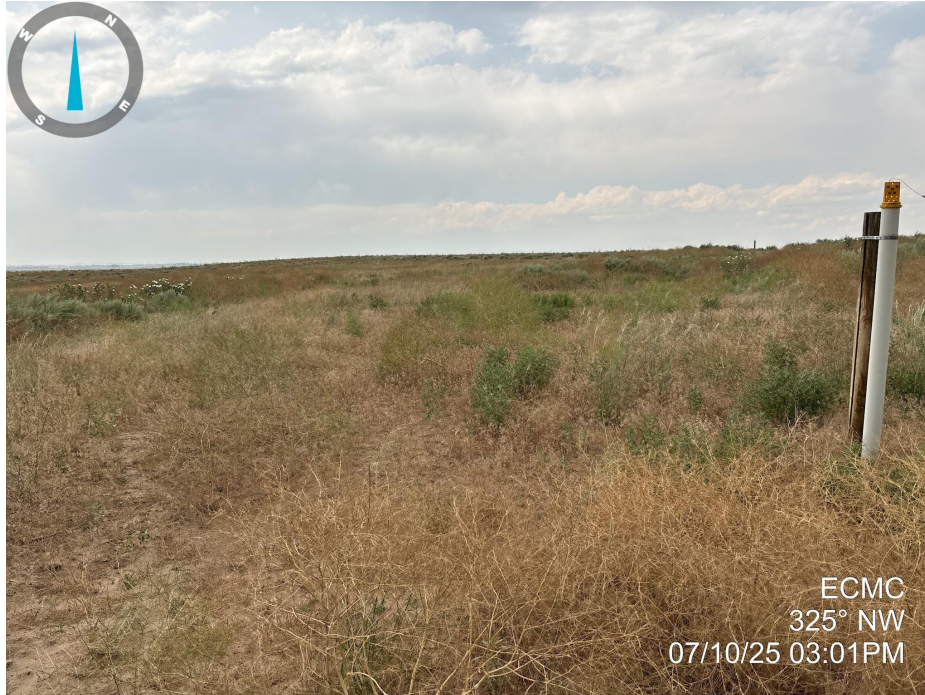
Photo 7. Photo taken of the access road to the location, facing northwest. Photo illustrates midstream equipment remains along the access road.

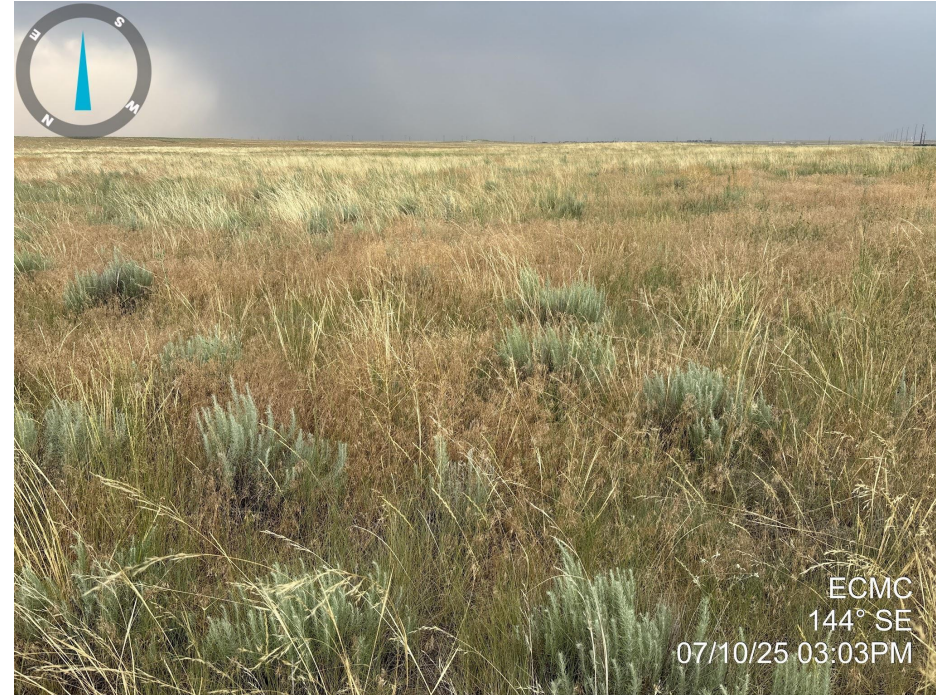
Photo 8. Photo taken of the reference area to the location, southeast of the location, facing southeast. Photo illustrates sand sagebrush (*Artemisia filifolia*), perennial grass, and cheatgrass (*Bromus tectorum*).
