# Final Reclamation Inspection

Operator: NOBLE ENERGY INC - 100322

Location ID: 424203

Inspection Document #: 718800616

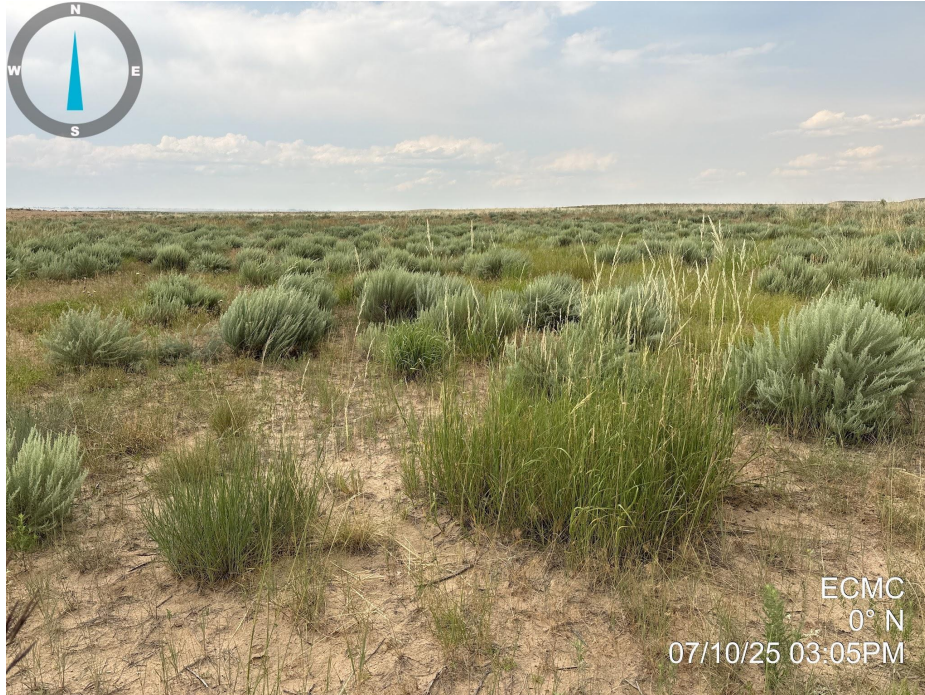
**Photo 1.** Photo taken from the well location, facing North. Photo illustrates that final reclamation activities have taken place, but vegetation establishment does not meet Rule 1004 standards. Bare ground and weedy annual vegetation, including cheatgrass (*Bromus tectorum*), were observed across the location.

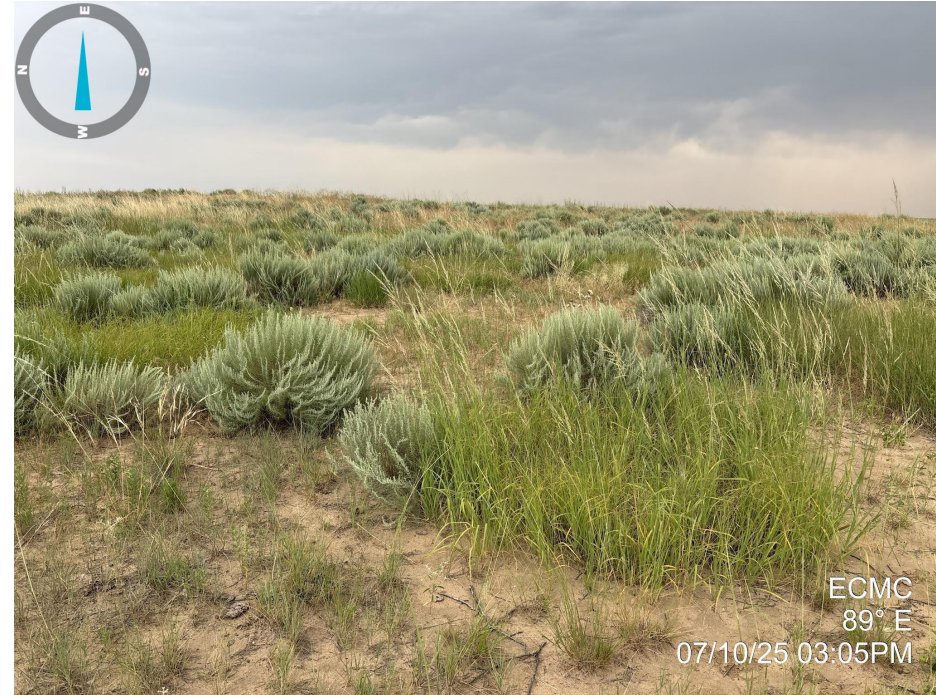
**Photo 2.** Photo taken from the well location, facing East. See comments under Photo 1.

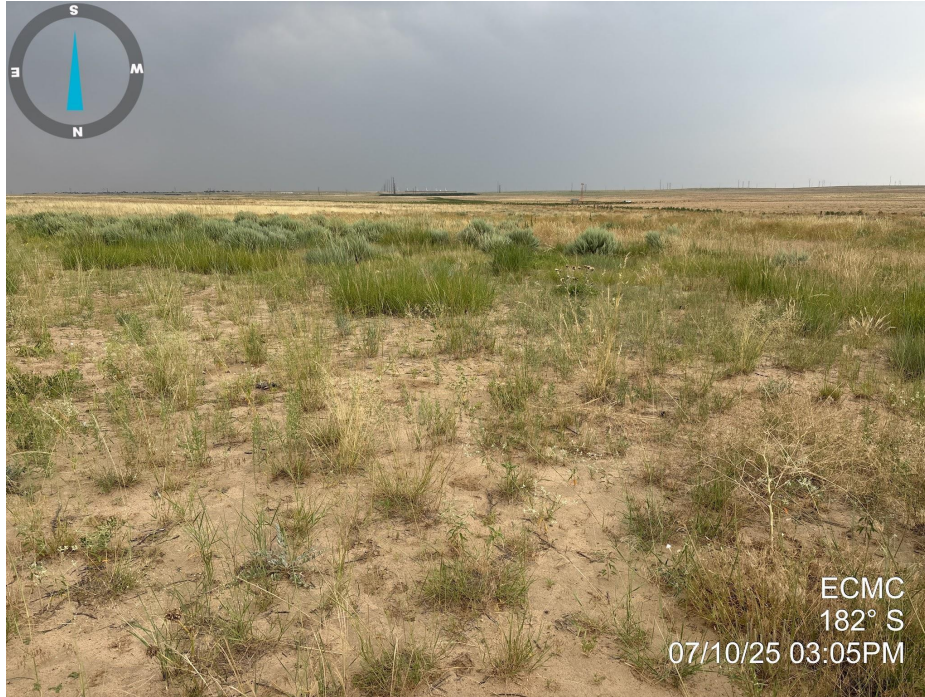
**Photo 3.** Photo taken from the well location, facing South. See comments under Photo 1.

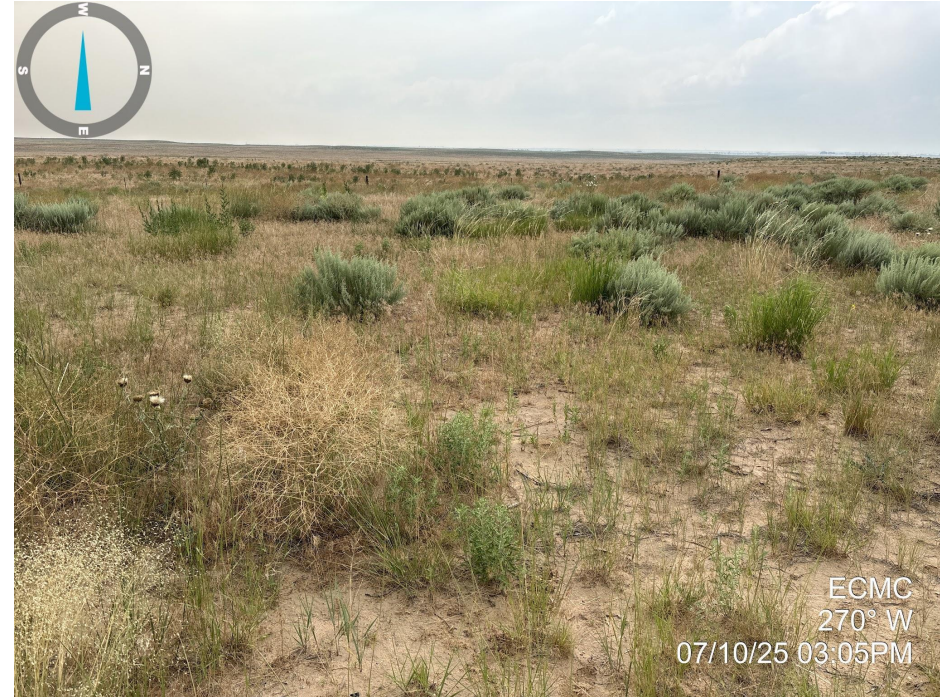
**Photo 4.** Photo taken from the well location, facing West. See comments under Photo 1.

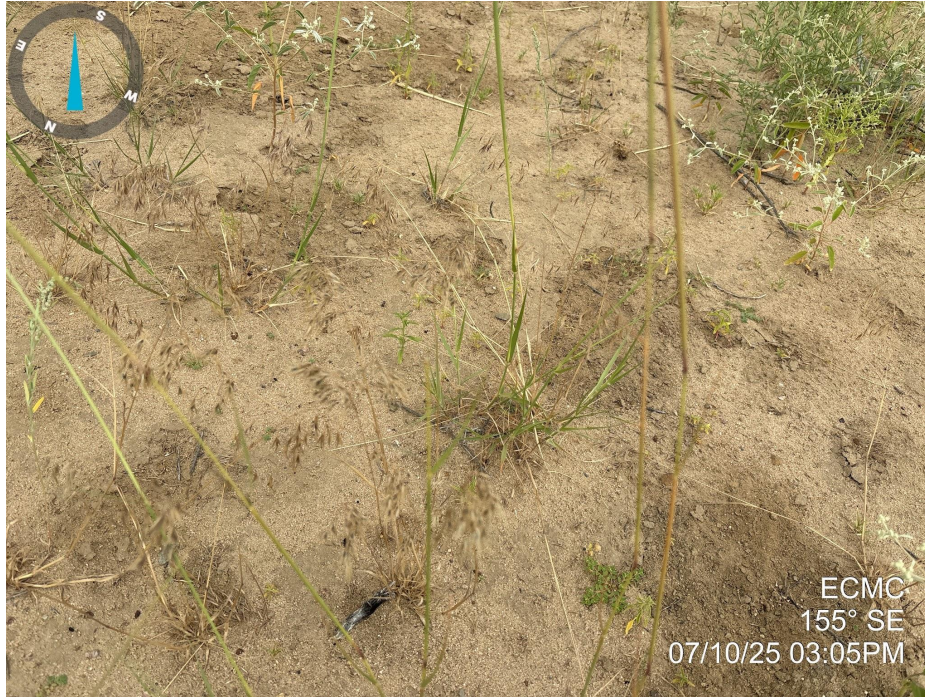
**Photo 5.** Photo taken of ground cover at the well location. Photo illustrates bare ground and cheatgrass (*Bromus tectorum*), a List C Noxious Weed species.

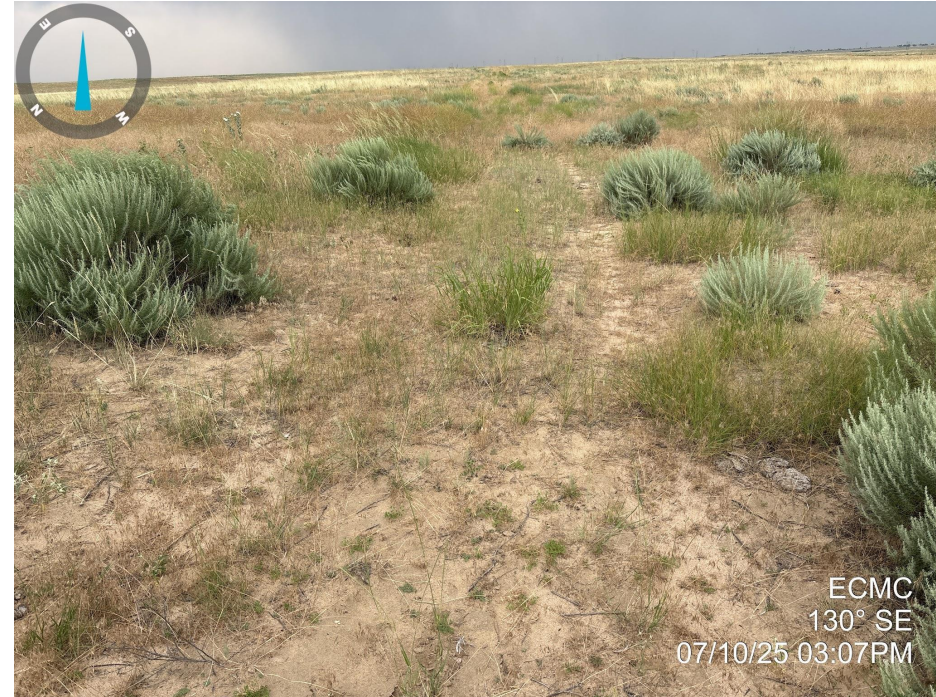
**Photo 6.** Photo taken of the access road to the well location, facing southeast. Photo illustrates final reclamation activities have taken place, but vegetation has not established to Rule 1004 standards and cheatgrass (*Bromus tectorum*) was observed across the location.

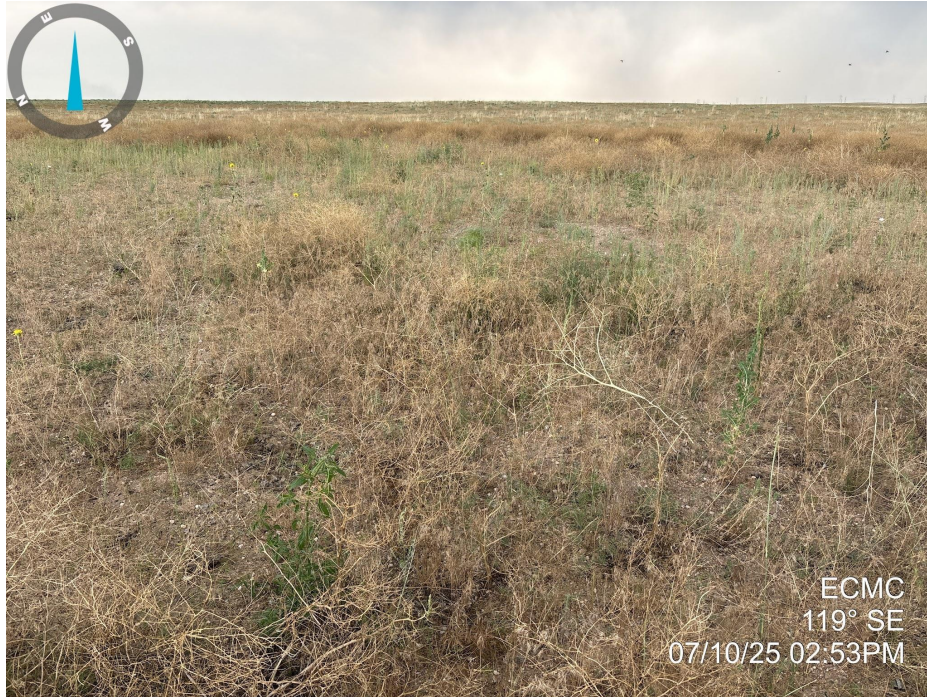
**Photo 7.** Photo taken of the tank battery location, facing southeast. Photo illustrates that final reclamation at the location does not meet Rule 1004 standards as gravel and weedy annual vegetation were observed across the location.

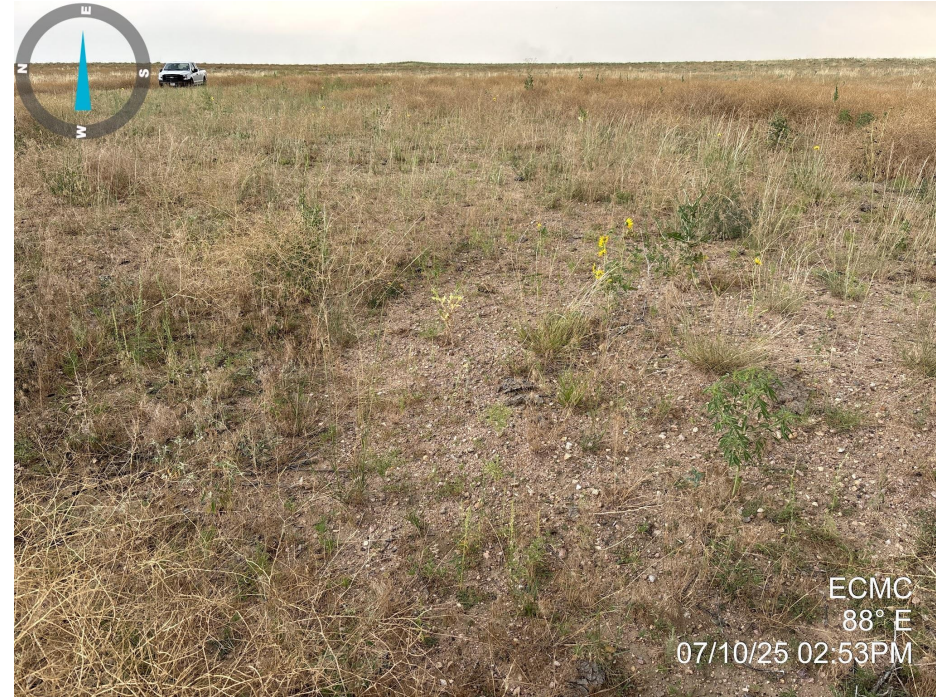
**Photo 8.** Photo taken of the tank battery location, facing east. See comments under Photo 7.

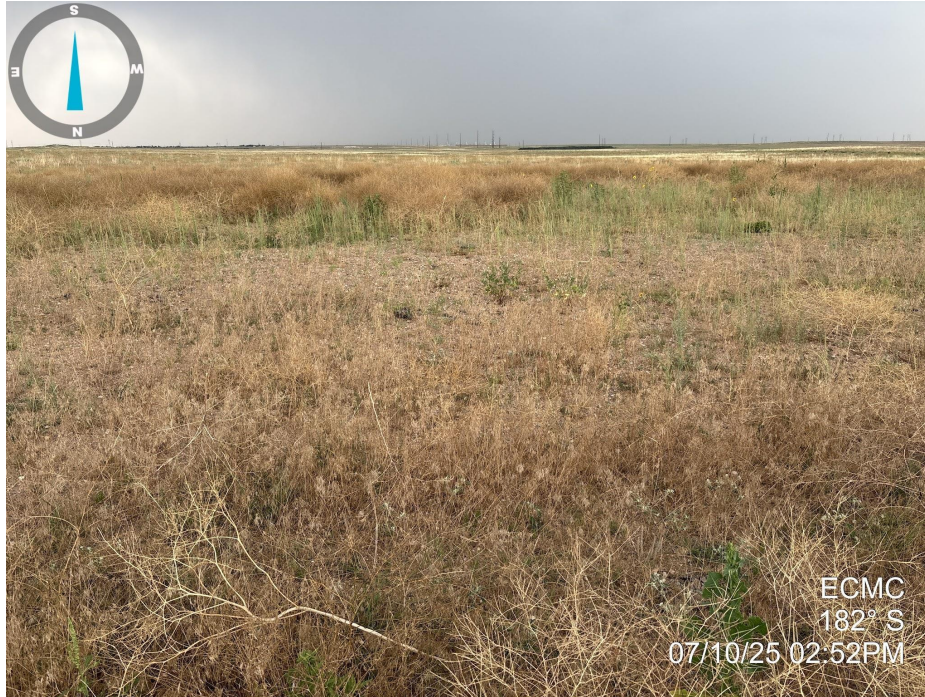
**Photo 9.** Photo taken of the tank battery location, facing south. See comments under Photo 7.

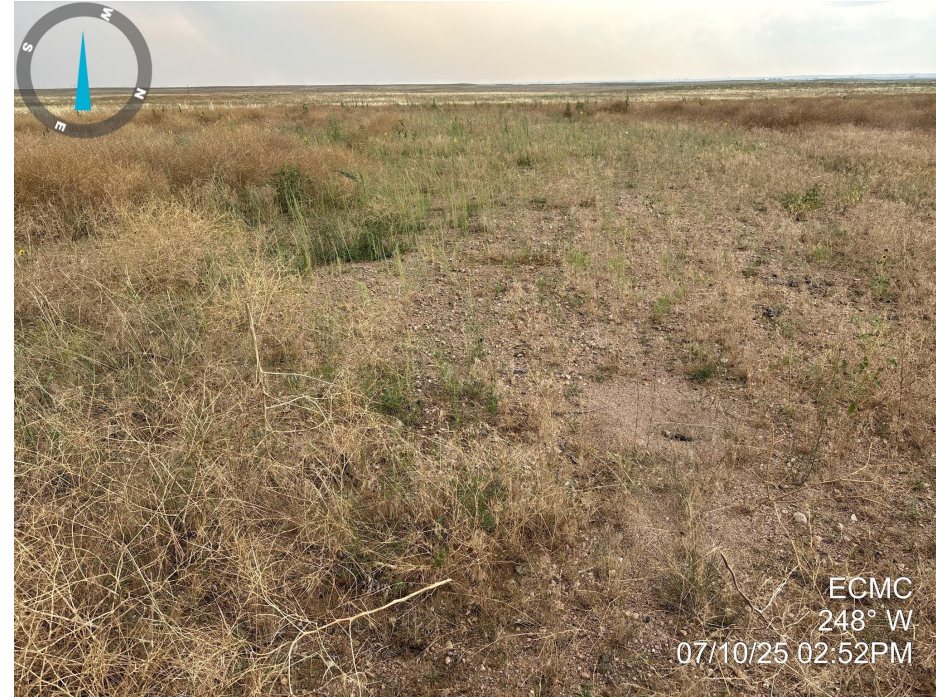
**Photo 10.** Photo taken of the tank battery location, facing west. See comments under Photo 7.

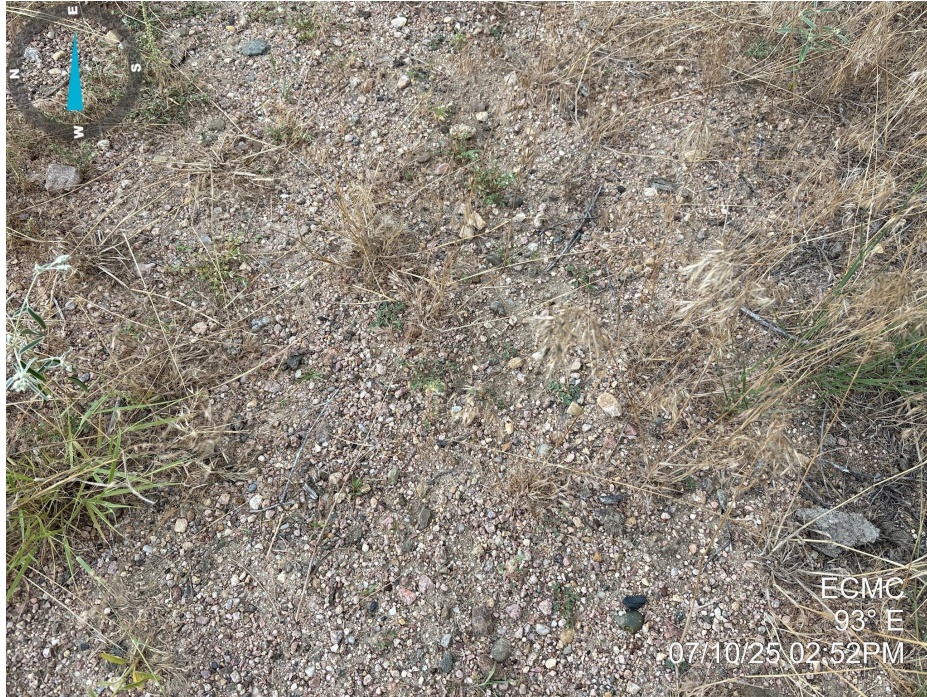
**Photo 11.** Photo taken of ground cover at the tank battery location. Photo illustrates gravel and cheatgrass (*Bromus tectorum*), a List C Noxious Weed species.

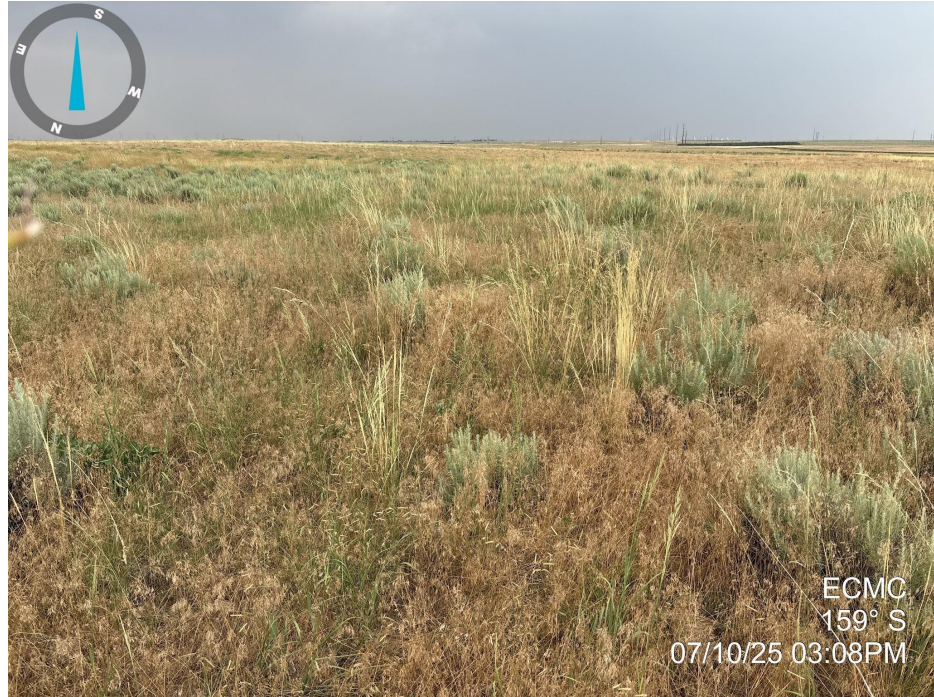
**Photo 12.** Photo taken of the reference area for the location, west of the location, facing south. Photo illustrates perennial grass vegetation, sand sagebrush (*Artemisia filifolia*), and cheatgrass (*Bromus tectorum*).
