# Inspection Photos

**Operator:** QB ENERGY OPERATING LLC

**Location ID:** 312590

**Inspection Doc:** 719200046

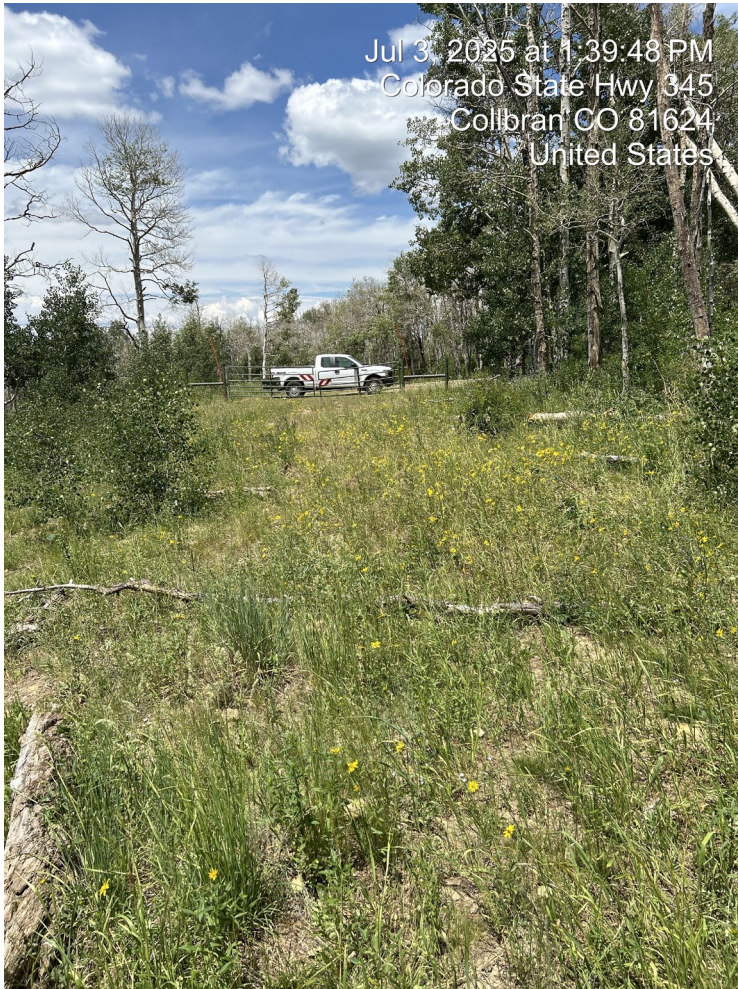
**Photo 1:** Photo taken provides an overview of the reclaimed access road on the northern portion of the Location. The road has been de-compacted, recontoured and reclaimed.

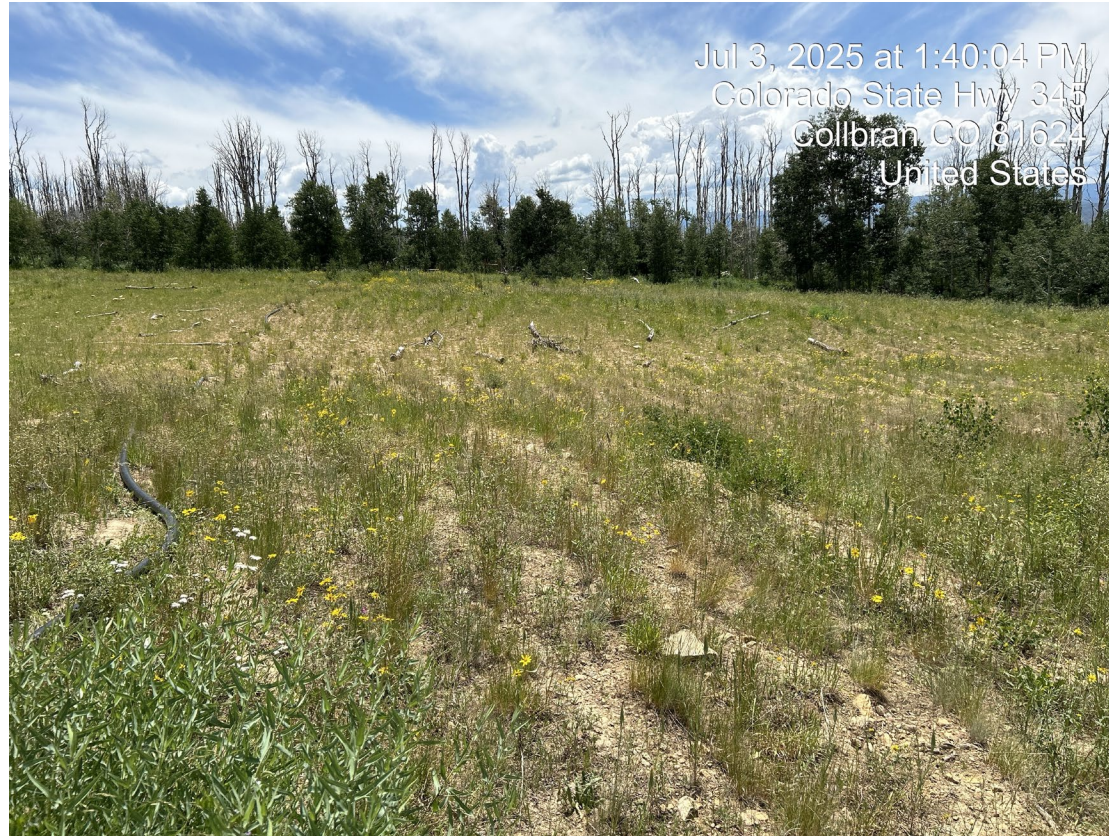
**Photo 2:** Photo taken from the central portion of the Location and provides an overview looking south.

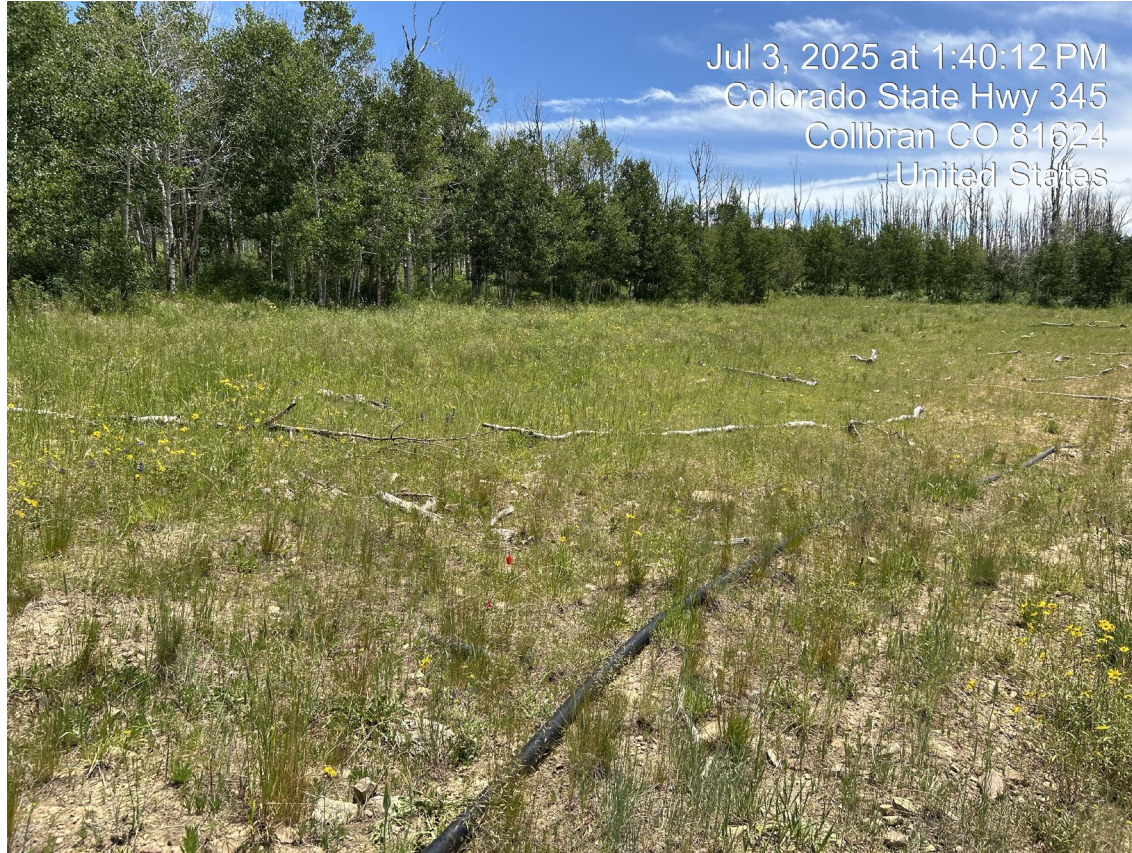
**Photo 3:** Photo taken from the central portion of the Location and provides an overview looking east.

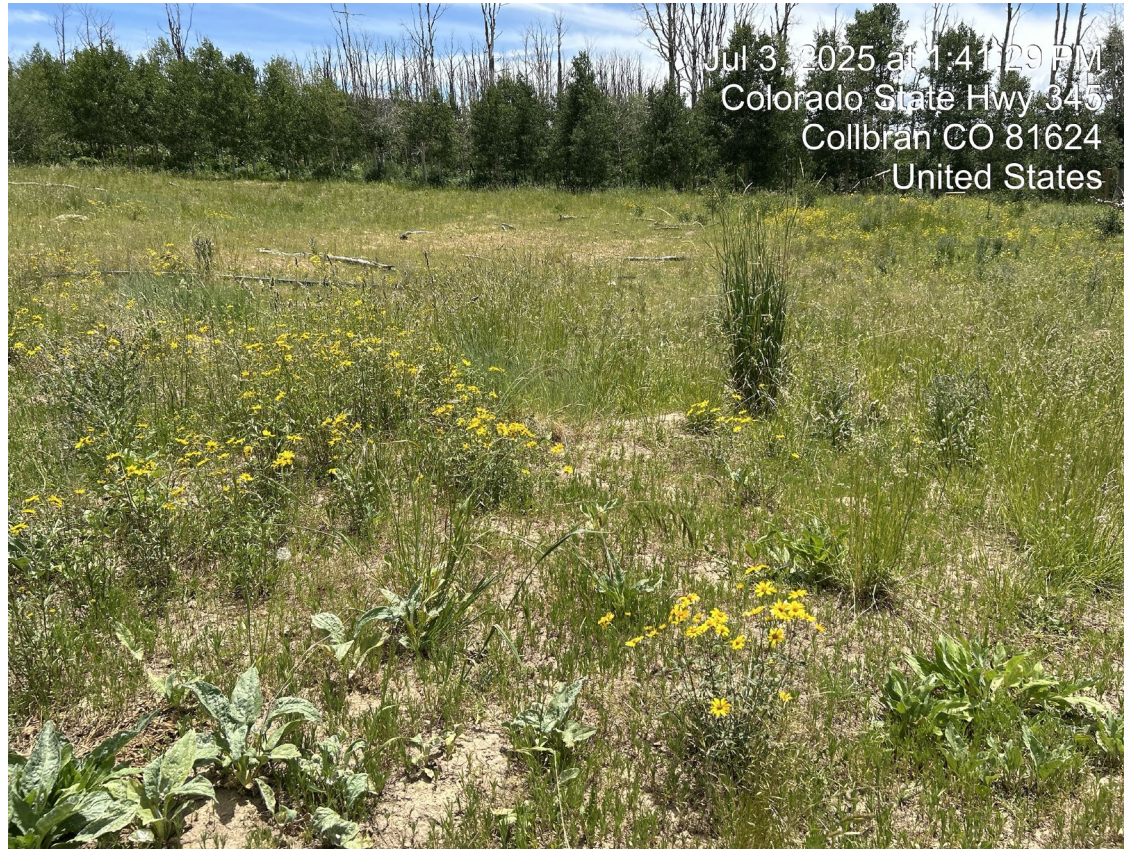
**Photo 4:** Photo taken from the central portion of the Location and provides an overview looking west. Reclamation is progressing towards 1004 requirements.

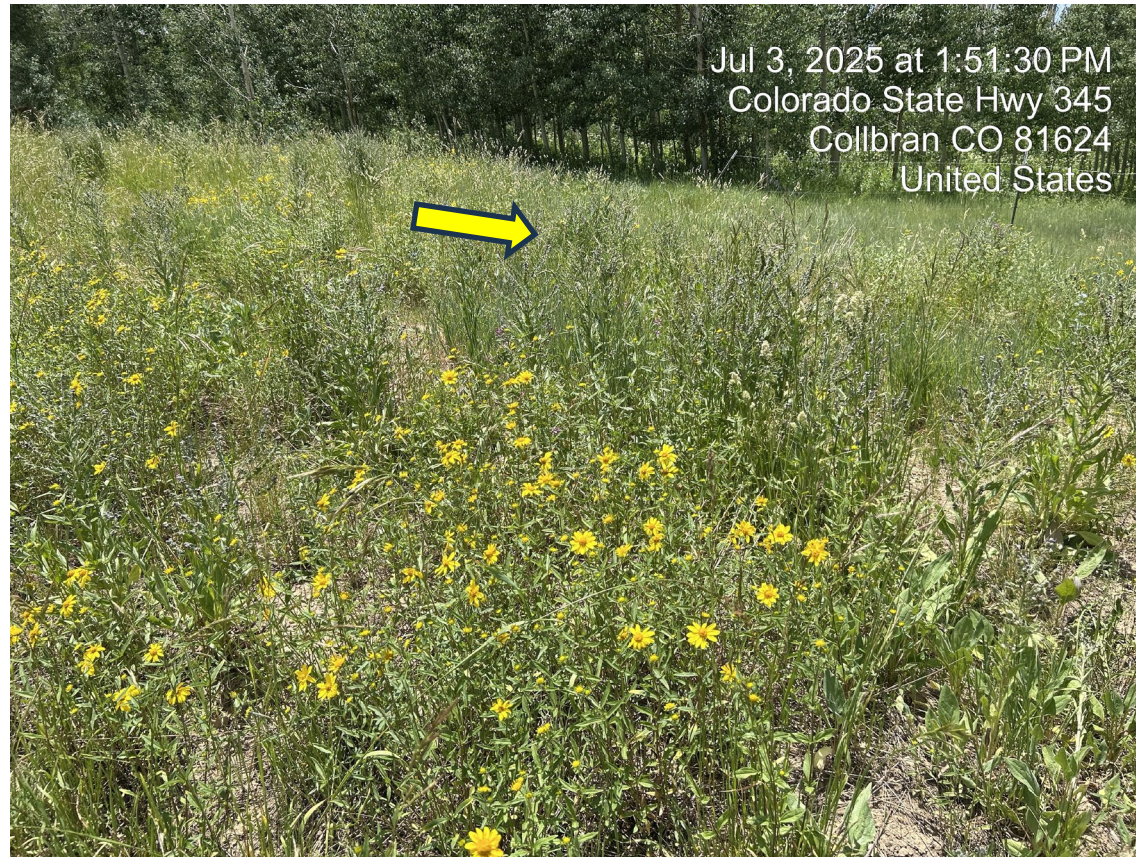
**Photo 5:** Photo taken from the southwest portion of the Location and shows an example of houndstongue dispersed throughout the area. Comply with Rule 1004.e. and remove undesirable plant species.
