# Final Reclamation and Stormwater Inspection

Location ID: 331652

Well Name: FEDERAL NOAA #11-32

Inspection Document #: 718600810

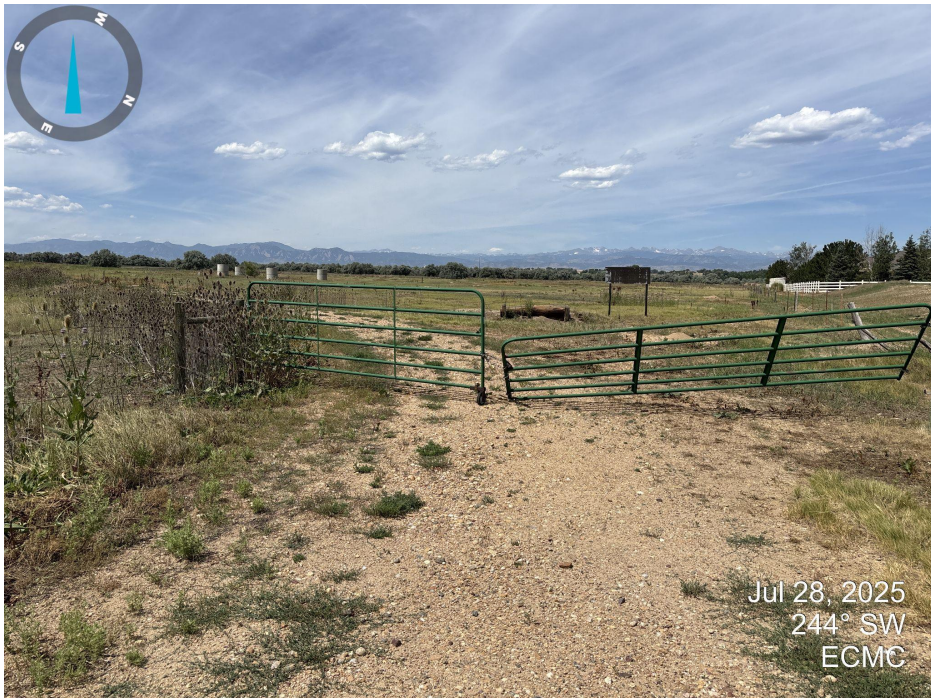
**Photo 1.** Picture taken at the entrance of the access road. The main access road appears to be preexisting to oil and gas.

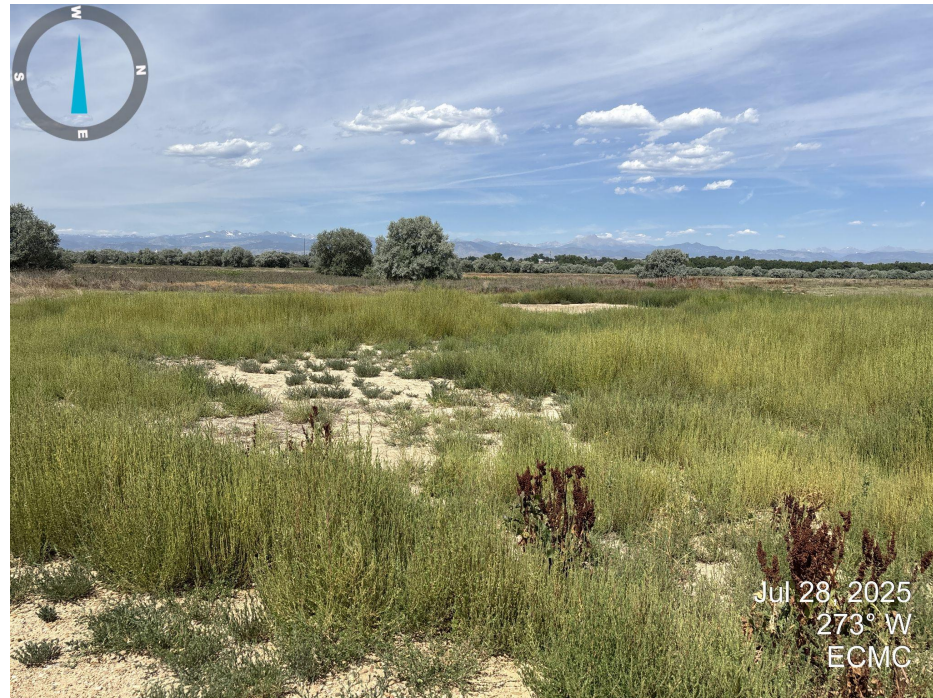
**Photo 2.** Picture taken from the main access road looking west down the access road and across the location. It appears that reclamation was conducted on location with evidence of crimped straw. Desirable germination was not observed on the access road at the time of inspection. Vegetation on location is primarily undesirable weed kochia.

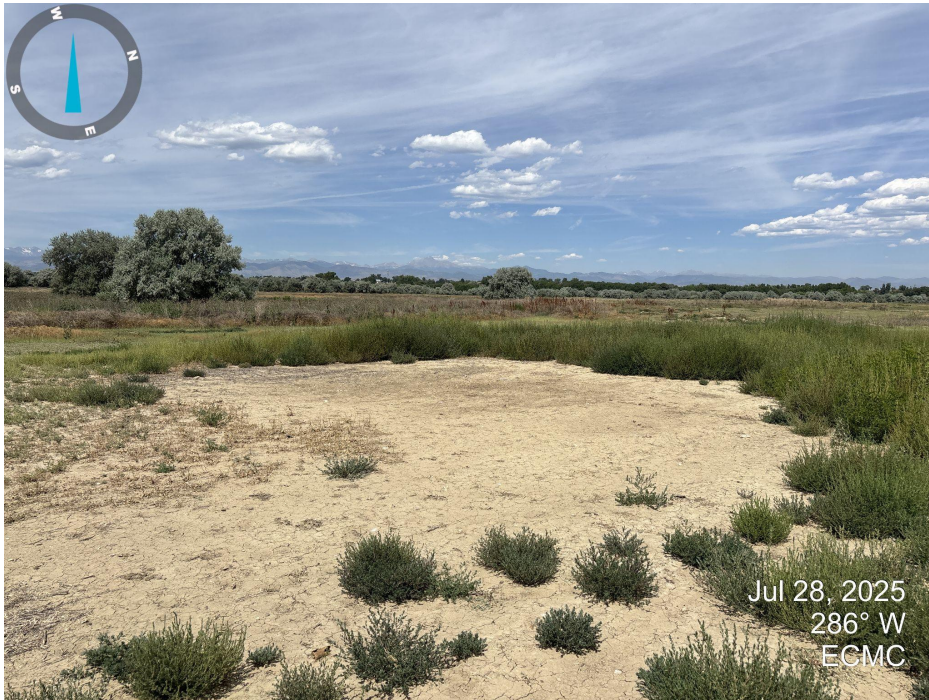
**Photo 3.** Looking west across the wellbore area. No oil and gas equipment remains. Crimped straw is present in this area. Desirable vegetation germination was not observed at the time of inspection. A large bare soil patch is present around the wellbore. Vegetation on location is primarily undesirable weed kochia.

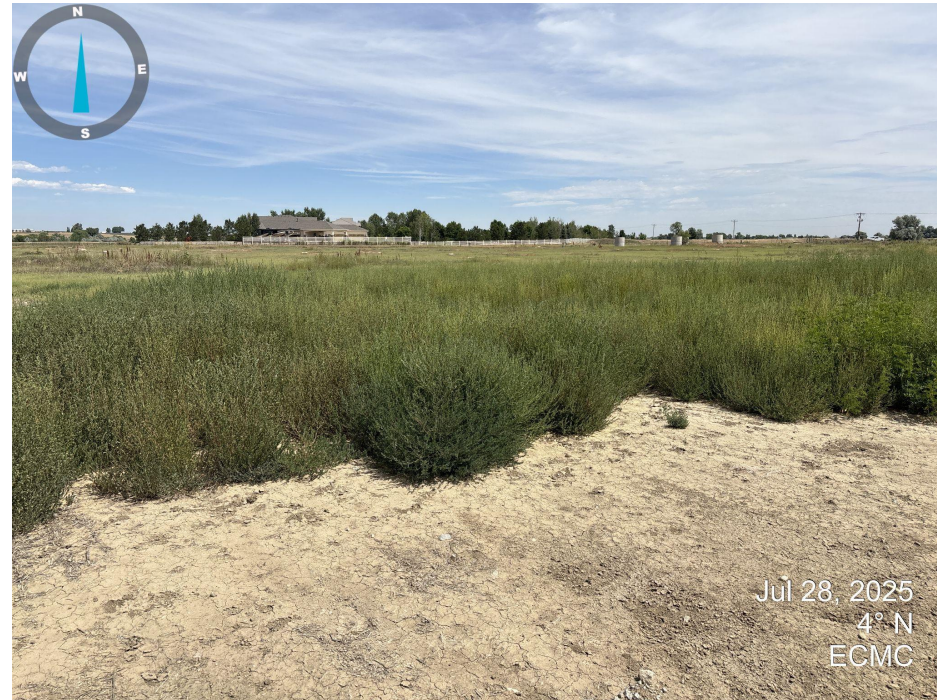
**Photo 4.** Looking north from the wellbore. See photo 3 comments.

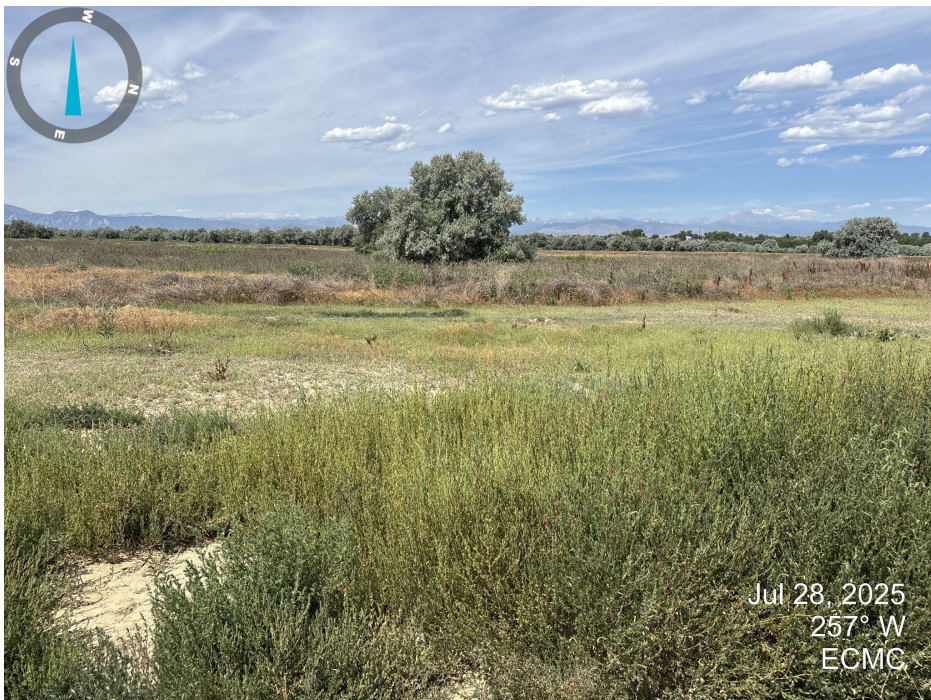
**Photo 5.** Looking west from the wellbore. See photo 3 comments.

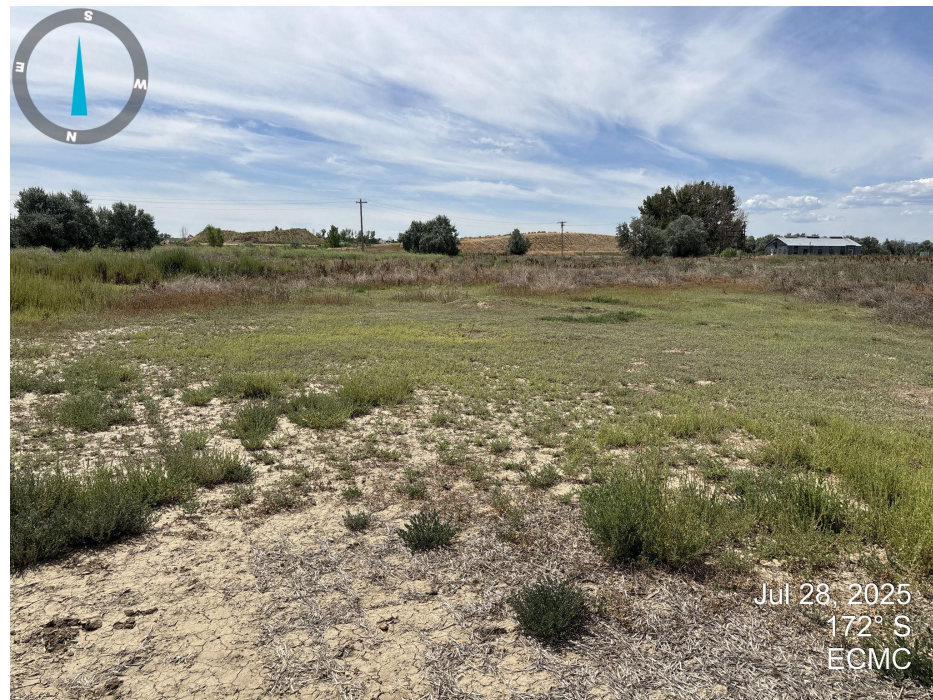
**Photo 6.** Looking south from the wellbore. See photo 3 comments.

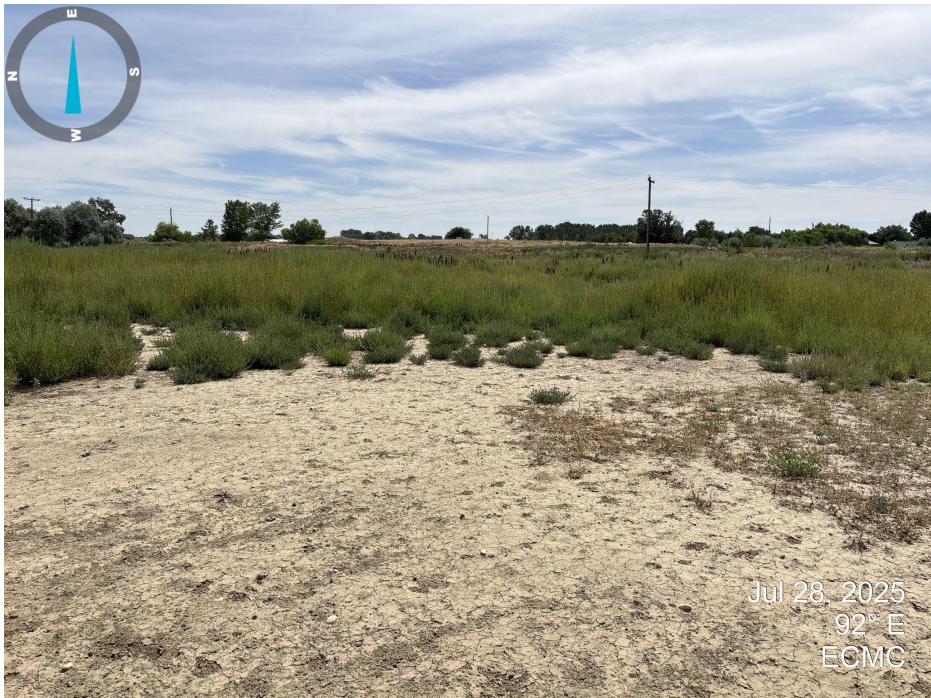
**Photo 7.** Looking east from the wellbore. See photo 3 comments.

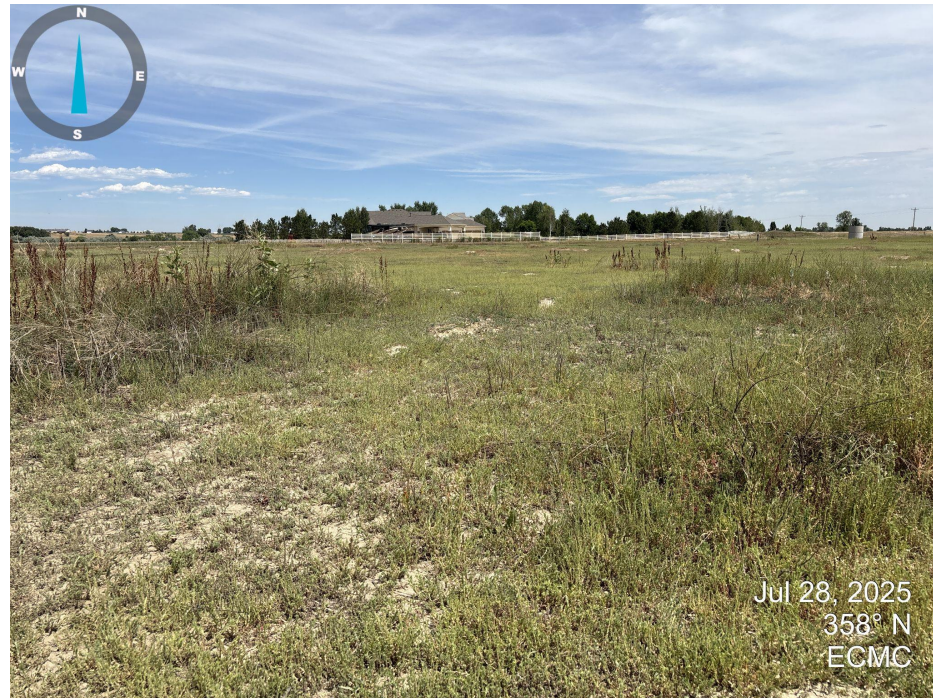
**Photo 8.** Reference vegetation to the north of the well location. Reference vegetation is primarily undesirable weeds such as kochia.
