Final Reclamation and Stormwater Inspection

Location ID: 302888

Well Name: ROLOFF-USX UU #9-7

Inspection Document #: 718600836

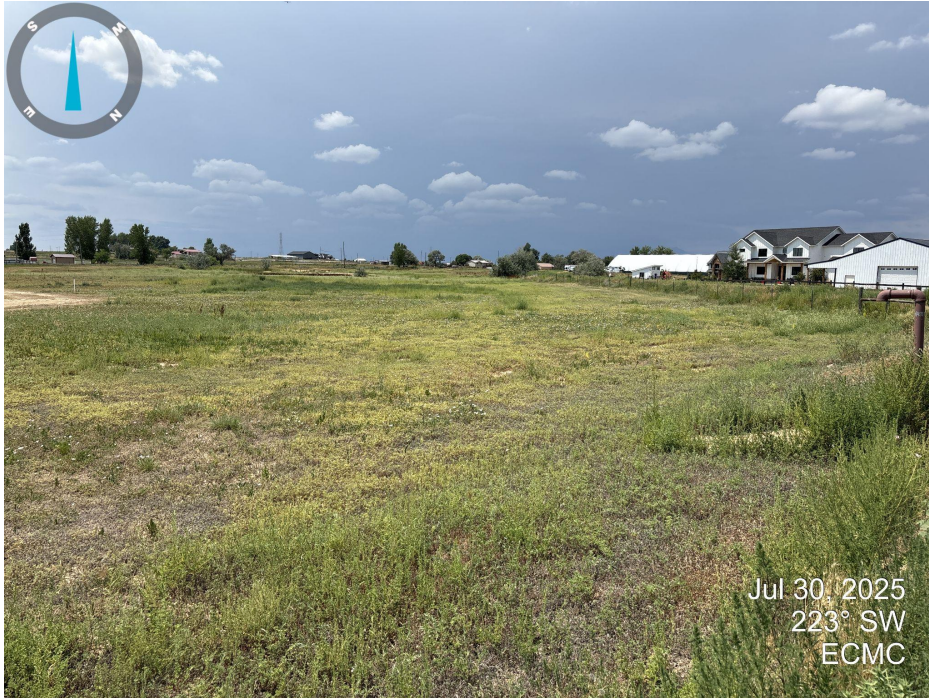
Photo 1. Looking southwest down the access road. The access road has been removed. Vegetation on the access road is primarily undesirable weeds such as kochia and list C noxious weed field bindweed.

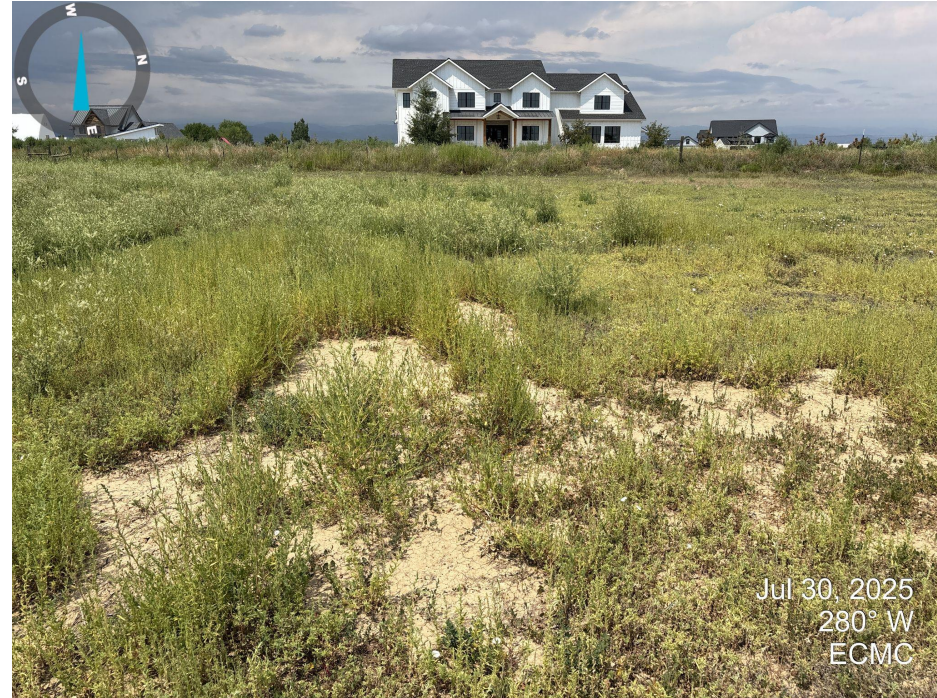
Photo 2. Looking west across the wellbore area. The wellbore area appears to have lower vegetative coverage than the surrounding area. There is little to no establishment of desirable perennial species. Vegetation on the location is primarily undesirable weed kochia.

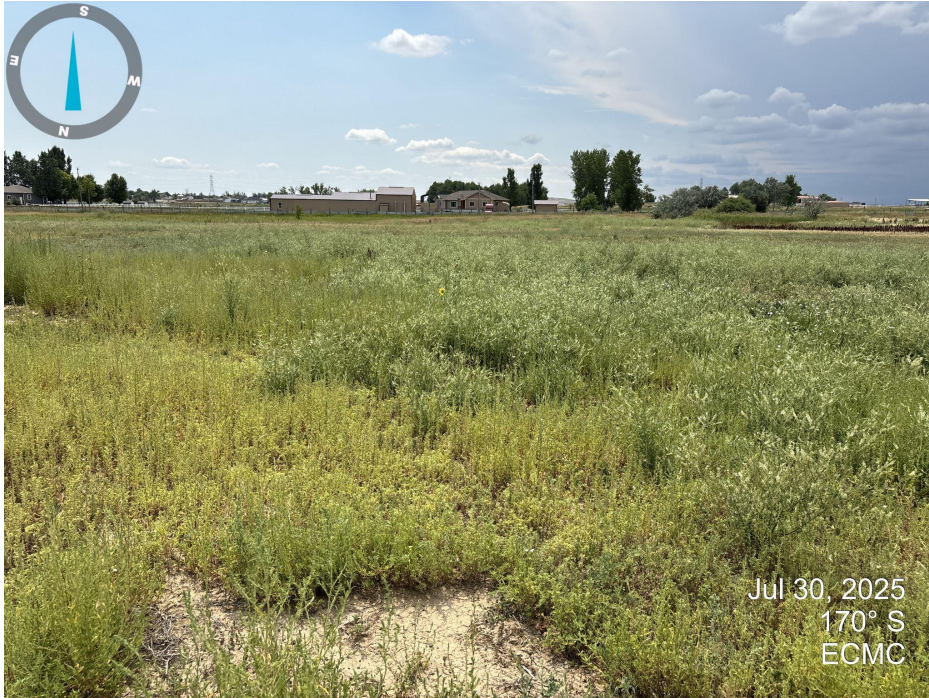
Photo 3. Looking south from the wellbore. See photo 2 comments.

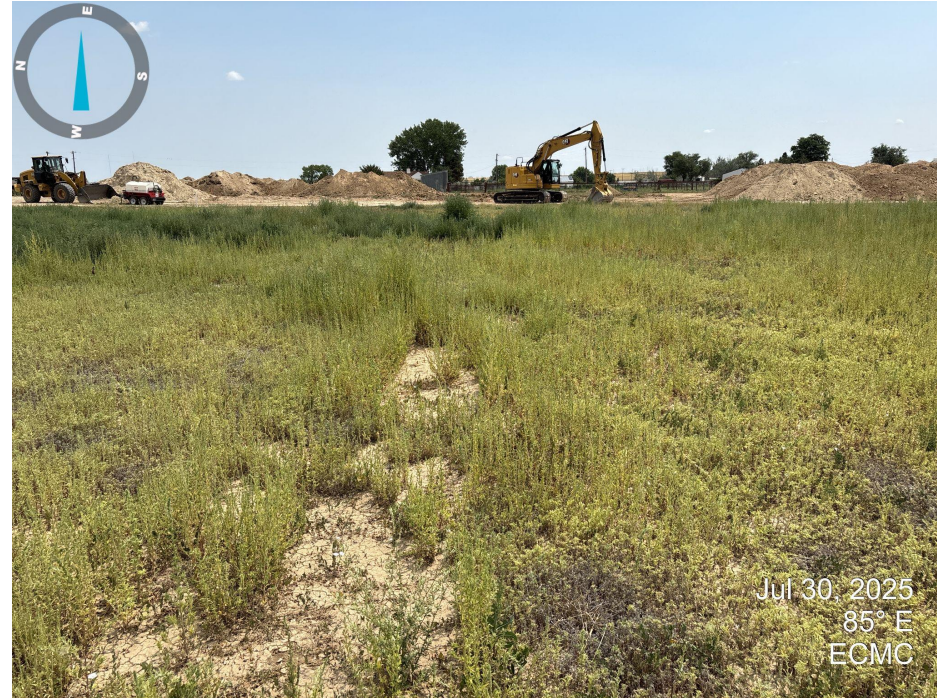
Photo 4. Looking east from the wellbore. See photo 2 comments.

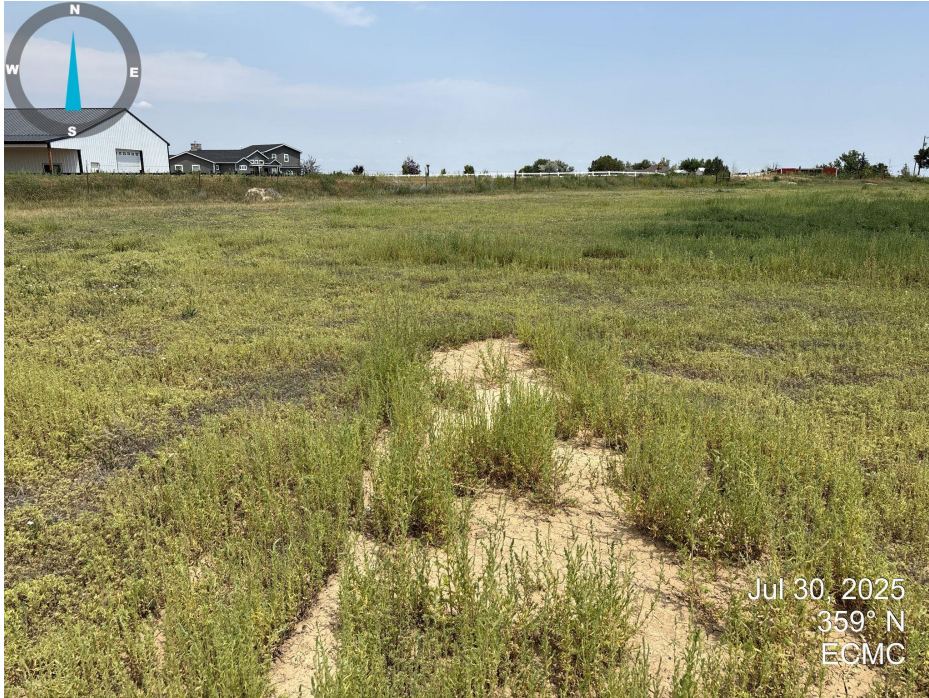
Photo 5. Looking north from the wellbore. See photo 2 comments.

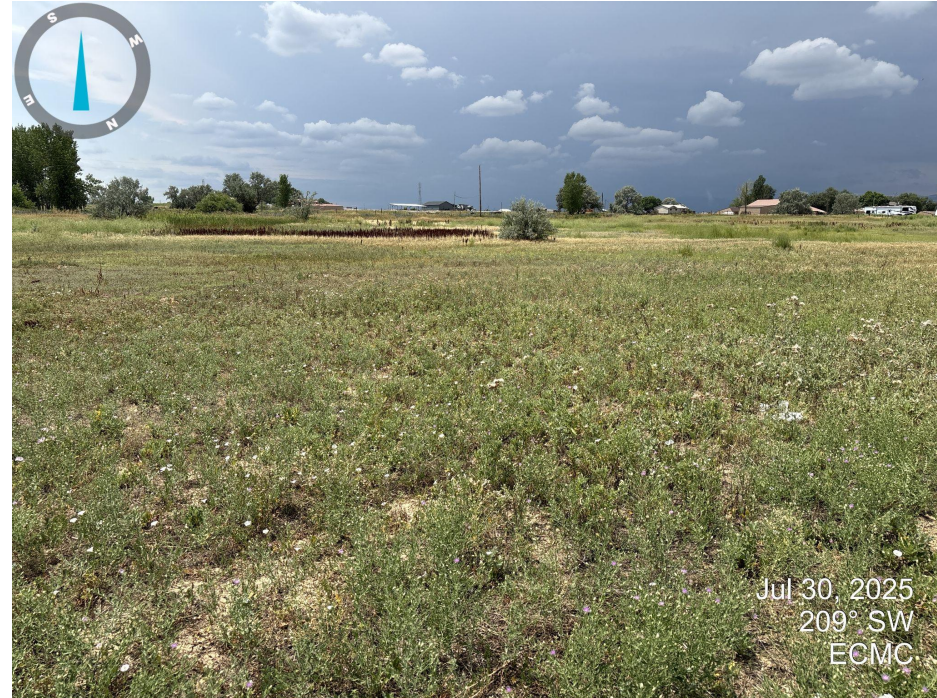
Photo 6. Reference area to the south of the wellbore. Reference area is relatively poor. Reference area consists of vegetation such as sweet clover, alfalfa, field bindweed and kochia.
