# Inspection Photos

**Operator:** QB ENERGY OPERATING LLC

**Location ID:** 312593

**Inspection Doc:** 719200047

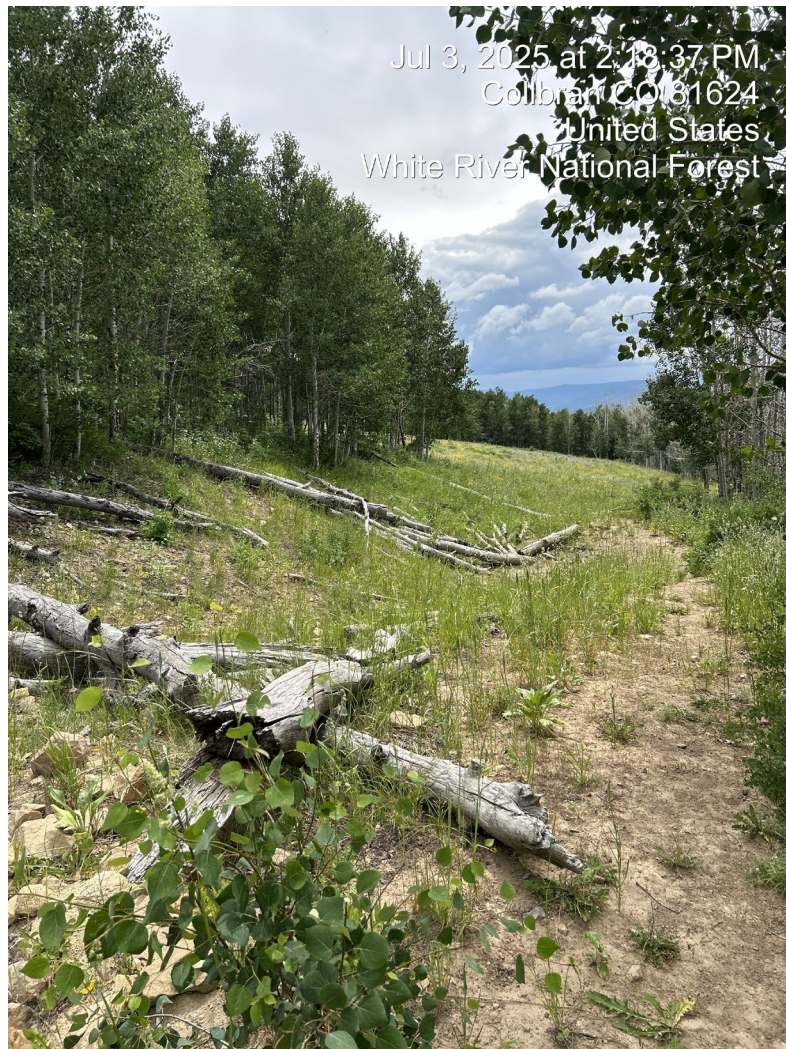
**Photo 1:** Photos taken show the access road leading to the Location. The access road has been reclaimed. Houndstongue is present.

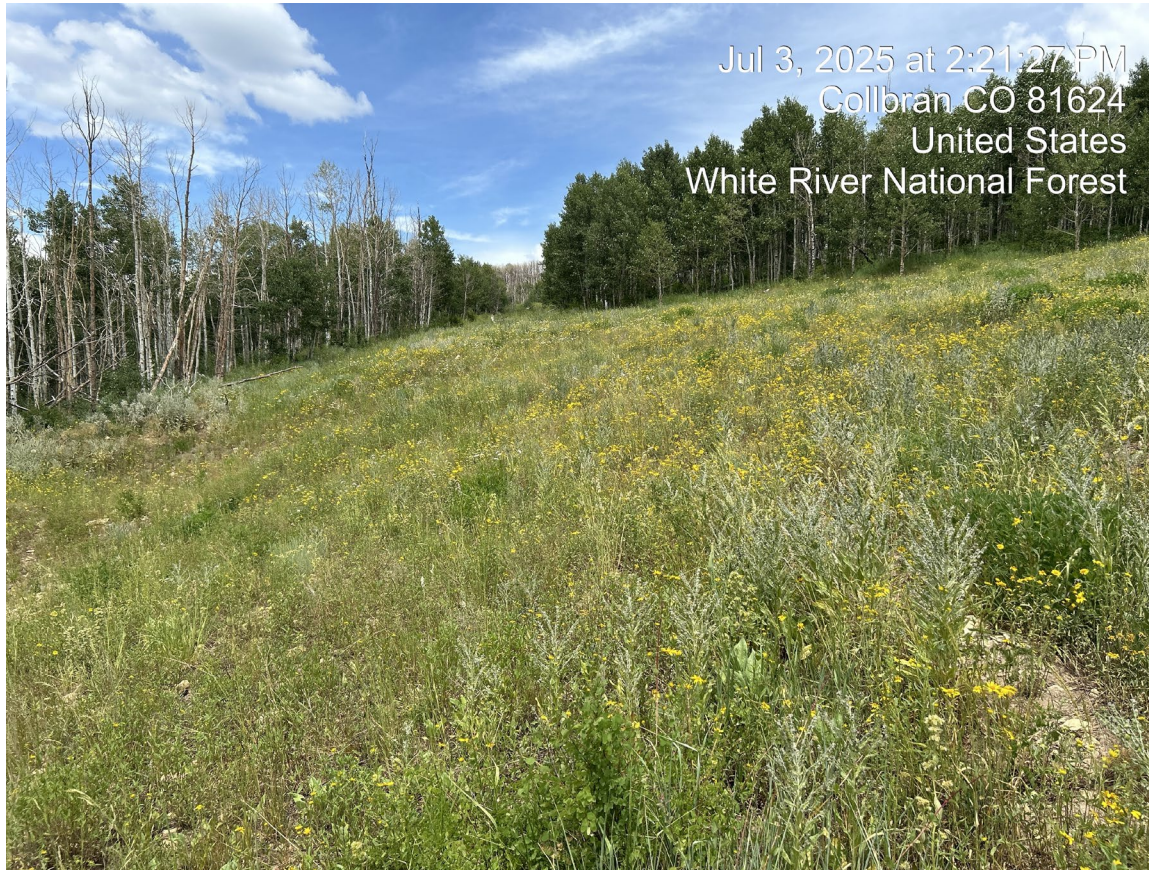
**Photo 1:** Photo taken from the central portion of the Location looking north. The Location is progressing towards 1004 requirements.

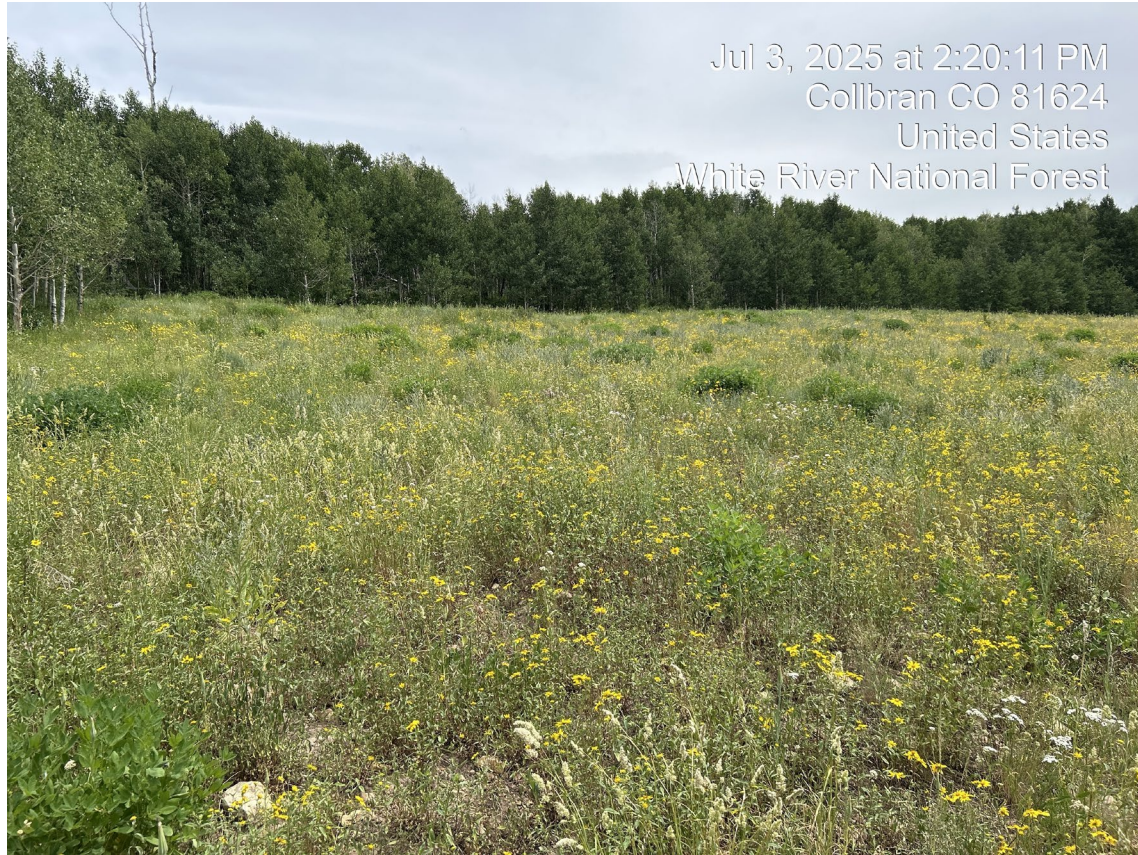
**Photo 1:** Photo taken of the Location looking northeast. Houndstongue is present throughout the Location.

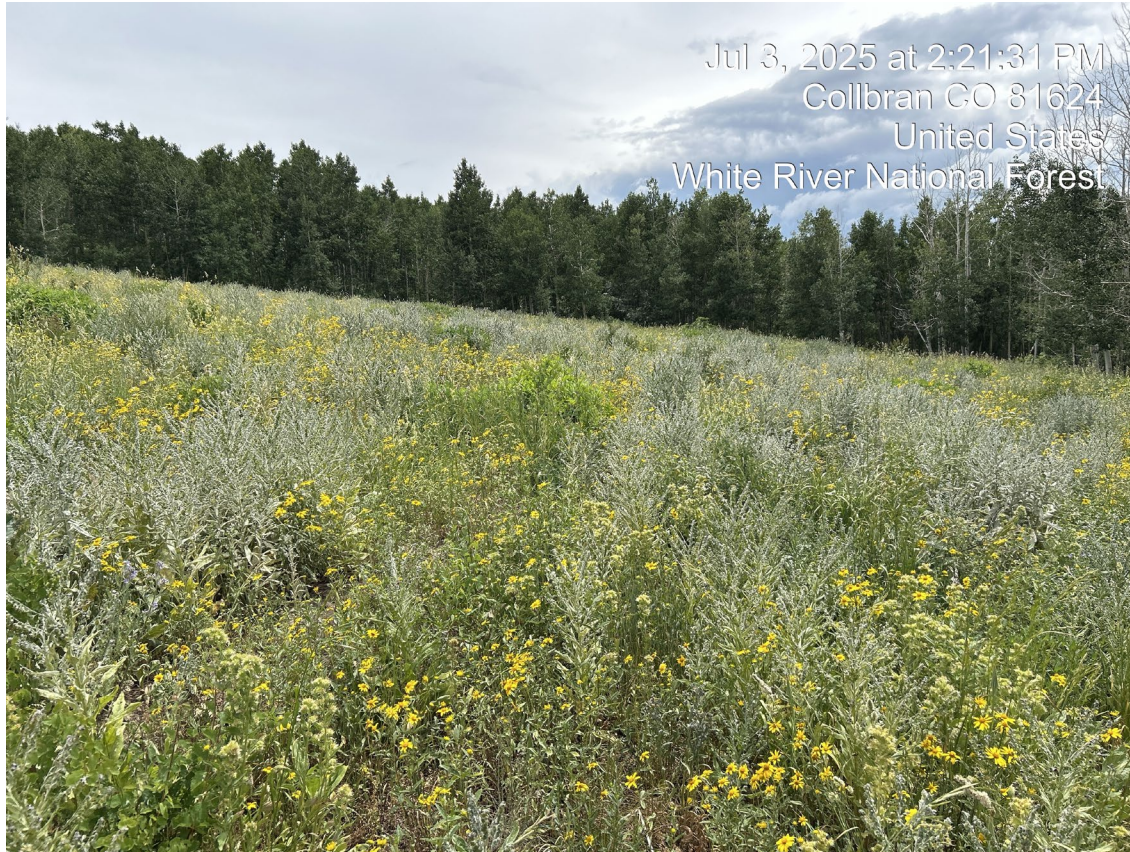
**Photo 1:** Photo taken of the Location looking south. Houndstongue is present throughout the Location.

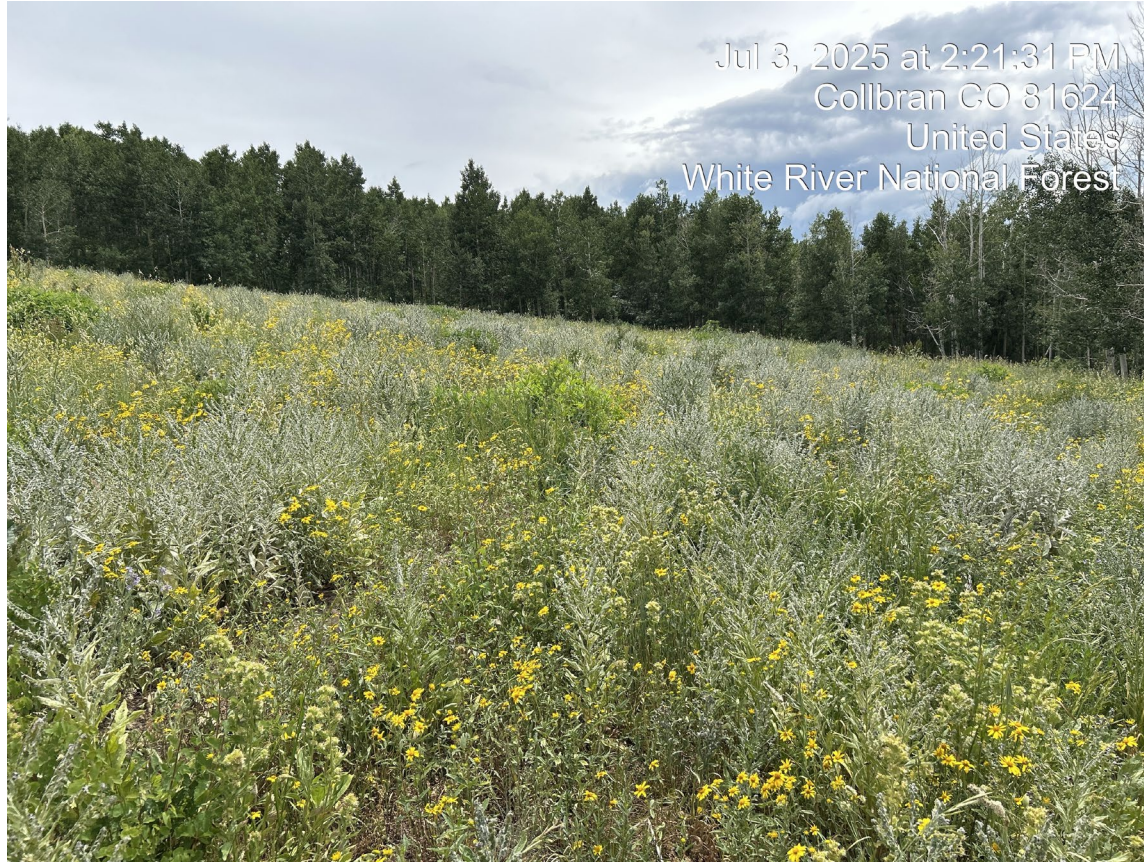
**Photo 1:** Photo taken from the central portion of the Location looking southwest. Houndstongue is dominant in areas. Comply with Rule 1004.e. and remove undesirable plant species.
